Article

Development of a Machine Learning-Based Damage Identification Method Using Multi-Point Simultaneous Acceleration Measurement Results

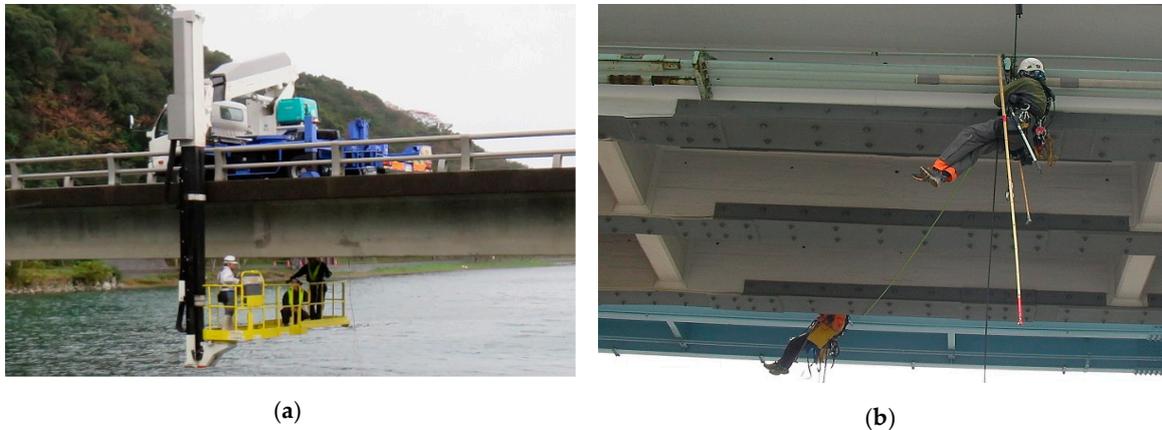
Figure 1. Example of inspection using a high-location work vehicle (a) and rope access (b).

To prevent the failure of these deficient bridges, it is necessary to conduct appropriate inspections to accurately assess their condition. Typically, in bridge inspections the inspector performs a visual inspection in close proximity to the bridge. Following this, a hammering test is performed in which the bridge is struck with an inspection hammer to determine if there are abnormal sounds. However, when inspecting bridges at high locations, it is not easy to reach them to perform a proximate visual inspection and hammering test. Methods for approaching high locations include, for instance, inspection through rope access or using a high-location work vehicle for the bridge inspection, as shown in Figure 1 [5]. However, considering the large number of bridges, performing these types of

inspection would be expensive and would require extensive effort. In addition, there is the issue of large disparities in the results of proximate visual inspections depending on the experience, knowledge, and competence of the inspector. Therefore, such inspection methods lack reliability.

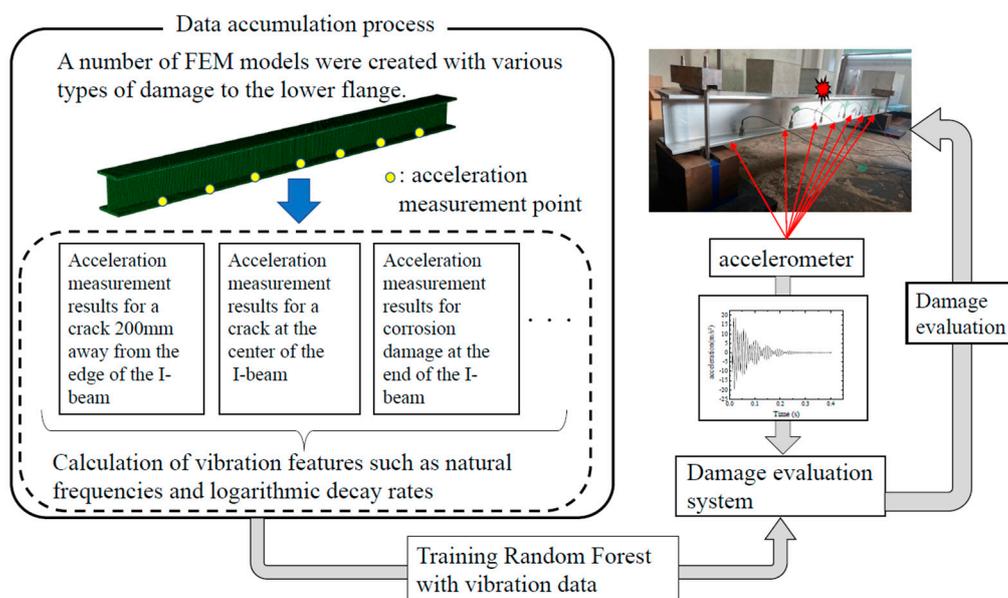
Figure 2. Overview of the methodology of this study.

However, even for such a simple structure, it is currently unclear to what extent the vibration features, such as the maximum response acceleration, are related to the damage. Therefore, in this study we use a supervised machine learning framework, as shown in Figure 2, to identify the location, type, and extent of the damage from the obtained features. Supervised machine learning is a method of learning based on a training dataset consisting of input and output pairs, so that the correct output can be predicted even for input cases whose output is unknown. In this study, we develop an algorithm that outputs the location, type, and extent of damage from the vibration features which are inputs.

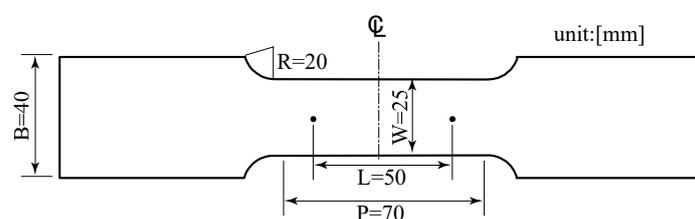
Figure 3. Japanese Industrial Standards No. 5 specimen dimensions.

In this study, a general-purpose aluminum alloy (Al-Mg-Si alloy, Japanese Industrial Standards A6061S) manufactured by UACJ Extrusion Corporation was used. The standard mechanical properties can be found in Aluminum Standards and Data [25]. However, in order to obtain more detailed material properties, the Japanese Industrial Standards No. 5 specimen shown in Figure 3 was prepared and subjected to tensile tests by Shimadzu Corporation's Universal Load Testing Machine with a loading capacity of 10 tonf. The tensile test is shown in Figure 4, and the material constants obtained from the tensile test are shown in Table 1.

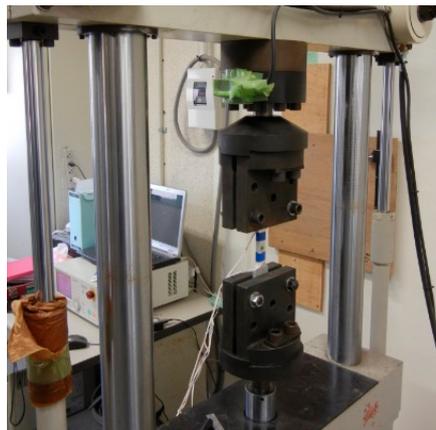
Figure 4. Tensile test of Japanese Industrial Standards No. 5 specimen.

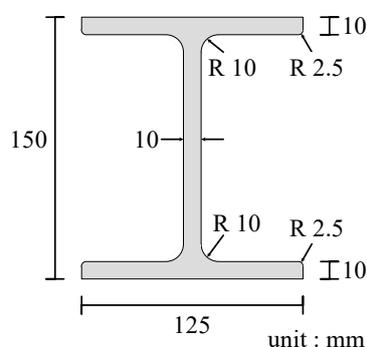
Figure 5. Cross-sectional dimensions of the I-beams.

The total length and distance between the supports of the beam used in this study were 2000 and 1900 mm, respectively. The cross-sectional dimensions are shown in Figure 5. In this study, we generated a total of five such I-beams, one in sound condition and four damaged. The purpose of the fabrication of these specimens was to investigate the effect of damage on the vibration characteristics and to examine the validity of the damage identification method. In the following description, the undamaged specimen is called the "sound specimen", and the damaged specimens are referred to as "damaged specimen A" through to "damaged specimen D". The damage we inflicted on the I-beams was an incision that simulated a crack, and a plate thickness reduction that simulated corrosion thinning on the underside of the lower flange. The size of the incision was 10 mm wide and 125 mm long,

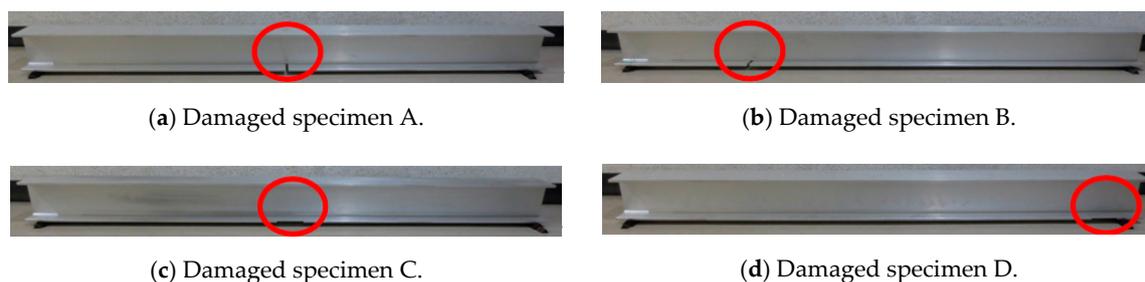
Figure 6. Damaged specimens A to D (The area indicated by the red circle is the damaged area).

while the size of the area subjected to wall thinning was 100 mm wide, 5 mm deep, and 125 mm long. The details of the damage to the damaged specimens A to D are shown in Table 2 and photographic images are shown in Figure 6.

Damaged specimen A	Crack 1000 mm from the end.
Damaged specimen B	Crack 500 mm from the end.
Damaged specimen C	Thickness reduction from the end to 950 mm from 1050 mm
Damaged specimen D	Thickness reduction from the end to 1800 mm from 1900 mm

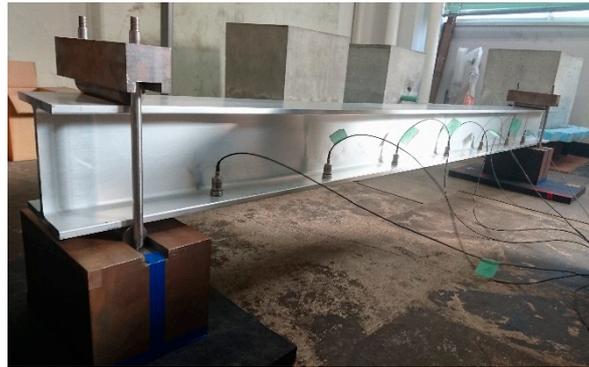
Figure 7. Vibration experiment in this study.

In this study, vibration experiments were carried out on both sound and damaged specimens A to D, as shown in Figure 7 and as described in the previous section. A rubber ball (136.10 g) was dropped from a height of 200 mm to the center of the upper flange of this member, causing it to vibrate from the shock. Seven piezoelectric acceleration sensors, MODEL2304A, manufactured by Showasokki Co., Ltd. (Tokyo, Japan) were installed on the lower flange to measure the vibration, as shown in Figure 8. The charge generated by the accelerometer was recorded on a personal computer through an amplifier built-in power supply and an A/D converter (A/D conversion rate of 2 μ sec, maximum sampling frequency of 160 kHz, A/D conversion resolution of 16 bits). In this study, the sampling frequency was set to 20 kHz and a finite impulse response filter was applied. As an example of the acquisition of vibration waveforms, the acceleration waveforms and Fourier analysis results of the sound specimen at position d are shown in Figure 9.

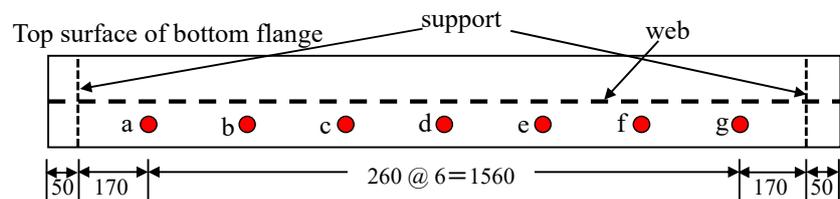
Figure 8. Accelerometer installation position (unit: mm).

The maximum value of response acceleration is characterized by a larger value near the damage. At the same time, however, it is highly dependent on the magnitude of the impact load, so the ratio to the maximum response acceleration at the center of the flange is calculated to eliminate the effect of the magnitude of the impact load. In this study, acceleration was measured at seven points, as shown in Figure 8, which can be expressed by the following Equation (3).

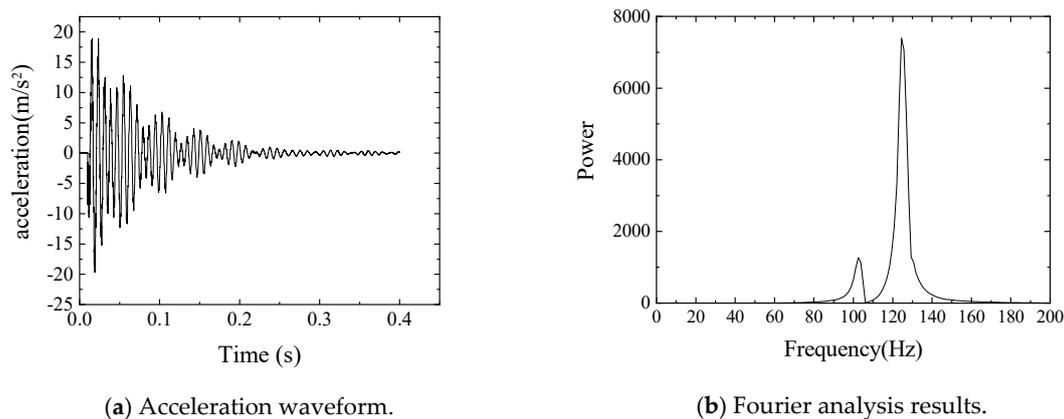
Figure 9. Acceleration waveform and Fourier analysis results of a sound specimen at position d.

In addition to the natural frequency of the structure (124.52 Hz), the vibration mode could be confirmed for all the girders around 102.54 Hz, which may have been due to the influence of the floor and bearings. In addition, a vibration mode around 20 Hz is visible from the acceleration waveform, which was due to the two types of rumbling vibrations mentioned above.

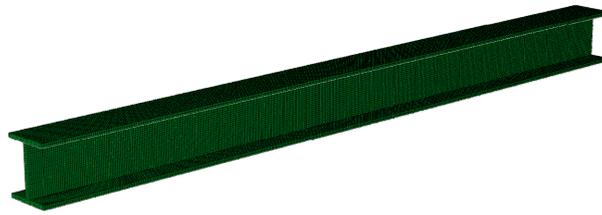
Figure 10. Finite element model of sound specimen.

In this section, we describe how the vibration experiment in the previous section was simulated as a finite element model. The commercial finite element analysis package Abaqus 6.14 from Dassault Systèmes was adopted for the finite element analysis. Figure 10 shows the finite element model of a sound specimen. The element used in the model was a 3D eight-node isoparametric brick element with a reduced integration (C3D8R). The number of nodes was 97,443 and the number of elements was 62,400. The mesh size was 5 mm × 5 mm × 5 mm. The boundary condition was a simple support at 50 mm from both ends of the lower flange, as in the experiment in Section 2.2. The impact load was applied to the center of the upper flange of this member to replicate the ball drop test shown above. The change in the impact load over time is shown in Figure 11. The time increment in the

In order to verify the validity of the model, the primary natural frequency obtained by the finite element model was compared with the primary natural frequency obtained by applying fast Fourier transform (FFT) to the vibration test results of the sound specimens described in the previous section. The finite element analysis result was 124.32 Hz and the actual beam was 124.52 Hz, so the two values were very close to each other, indicating that the finite element model developed here reproduced the experimental conditions adequately.

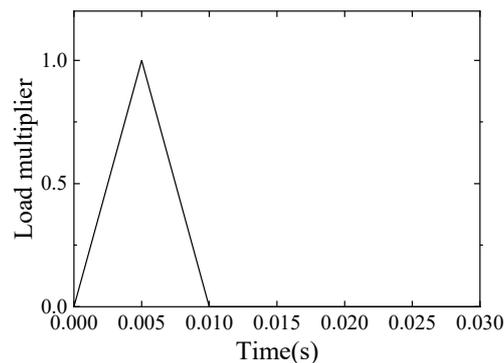
Figure 11. The impact load applied to the finite element model.

explicit method was set to $5 \mu\text{s}$, the same as the sampling interval in the vibration experiment. This also satisfied the Courant-Friedrichs-Lewy condition.

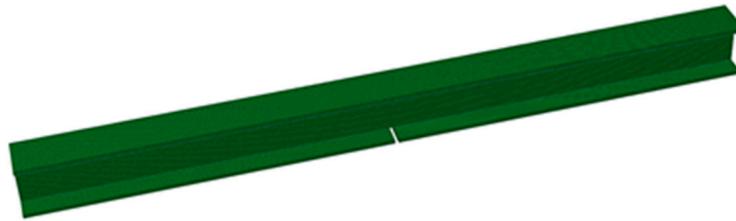
Figure 12. Finite element model of damaged specimen A.

Another advantage of the finite element model is that it is easy to use it to model damage. An example of a damaged specimen A is shown in Figure 12. In addition to reproducing the actual specimen as shown in Figure 12, it is also easy to create a number of specimens with arbitrary damage and analyze them. These results can be used to train the damage detection system in the lower right part of Figure 2. It would be ideal if these data could be obtained only from the results of vibration tests on actual structures. However, it is difficult to produce a large number of actual damaged members, so we generated and analyzed a number of finite element models. The specific way to inflict damage is as follows. First, the lower flange is divided into seven areas, as shown in Figure 13. In Figure 13, the circled numbers are the area numbers. For the areas that were determined to be subjected to corrosion damage, the area was thinned according to Poisson's random number in reference to [26,27]. For the areas that suffered crack damage, the location of the crack in the area was randomly determined according to a uniform random number. In this study, 2000 such models were created and a dynamic analysis was performed on each of them.

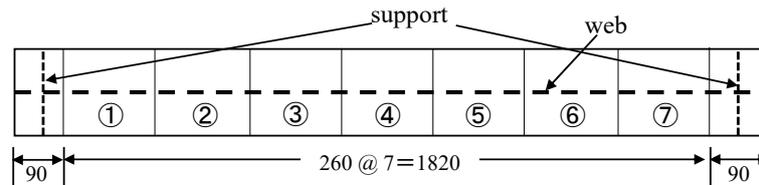
Figure 13. Lower flange area division (in mm).

As described in the introduction, this study attempts to identify the degree of damage and the presence of cracks in the area shown in Figure 13 using the supervised machine learning framework from the obtained data by the finite element analysis, as explained in the previous section. In this study, we used one of the machine learning methods, Random Forest, which is known for its high accuracy and generalization performance of both classification and regression. In this study, the Random Forest is divided into three steps in order to improve the accuracy. First, the degree of anomaly of the focused area was examined in the first step of the Random Forest, and then the presence of cracks was examined in the second step. Finally, the third step of Random Forest evaluated the degree of damage using the results obtained from the first and second steps.

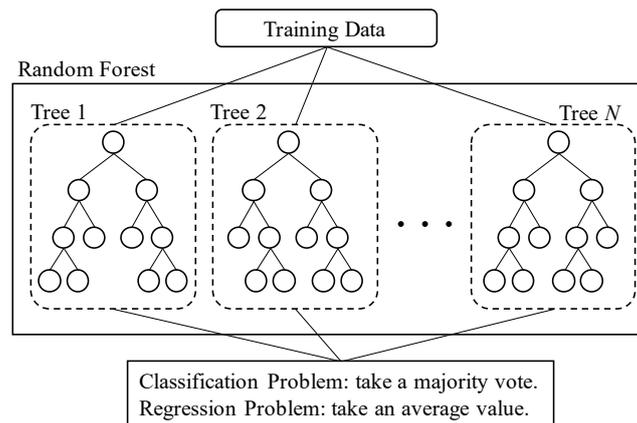
Figure 14. Random Forest.

The Random Forest method is an ensemble method that finalizes results based on the average or majority of a series of decision trees trained from the supervised data. A conceptual outline of Random Forest is shown in Figure 14. In the Random Forest method, each decision tree is constructed based on multiple subsets randomly selected from the original dataset while allowing overlap (i.e., the features randomly selected from bootstrap samples). In this study, the classification and regression trees (CART) method [30] is used for the development of each decision tree. In the CART method, the standard for dividing data at node t is determined so that the decline rate of an indicator called impurity, represented in Equation (1), is maximized. In this case, the Gini coefficient was used as the impurity.

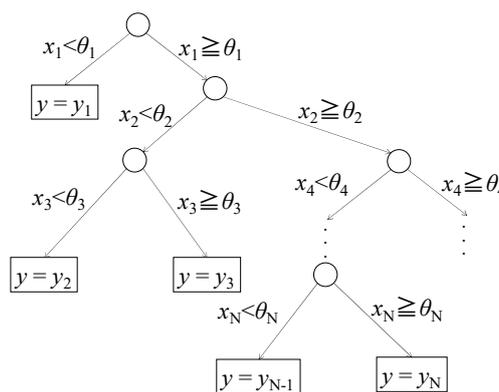
Figure 15. Schematic diagram of the decision tree.

In the above Equation (2), n is the number of class and $p(C_i|t)$ is the probability that the data in class i would be selected at node t . In the first equation on the right, if we consider the product of probabilities $p(C_i|t)$ and $p(C_j|t)$, where class $j \neq i$, this equation can be interpreted as the error rate for a given node t . Thus, with Equation (2), the procedure is designed to branch into decision trees that will be able to reduce this error rate to its lowest value. Figure 15 shows a schematic diagram of the decision tree constructed by the CART method, where θ_n is the reference value of the branch at each node, x_n is the value of the feature at that time, and y_n is the output.

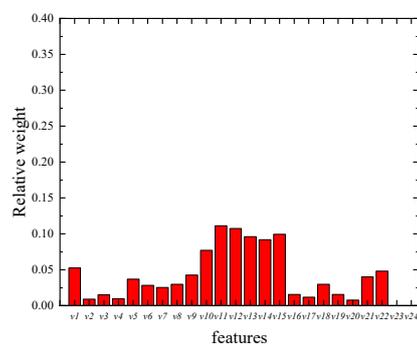
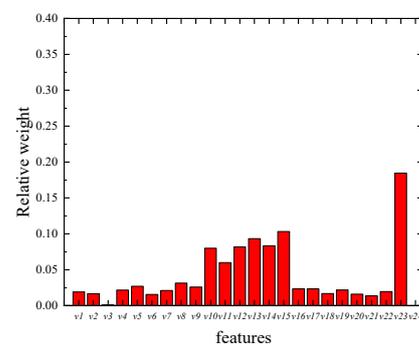
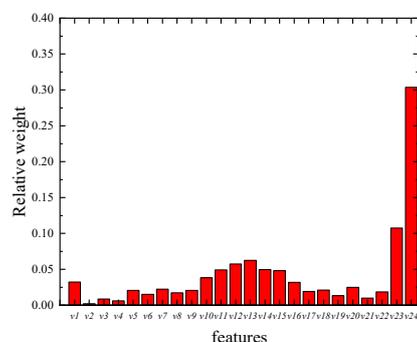
(a) First stage of Random Forest.

(b) Second stage of Random Forest.

(c) Third stage of Random Forest.

Figure 16. Relative weight of each parameter.

Furthermore, the Random Forest method is capable of weighing the importance of each parameter in its evaluation. The relative weight of each Random Forest parameter can be determined by evaluating the frequency of each corresponding coefficient, which was used as the classification standard in each decision tree, as shown in Figure 16. It can be seen from the figure that the effect of the standard deviation (v_{10} to v_{15}) is significant. The natural frequency of the first order bending (v_1) has a large influence in the first and third stages of Random Forest. This means that although v_1 is less effective in crack detection, it is still important information for thinning detection. In addition, the relative weights of v_{23} in the second stage and v_{23} and v_{24} in the third stage of Random Forest indicate the effectiveness of the three-stage Random Forest analysis.

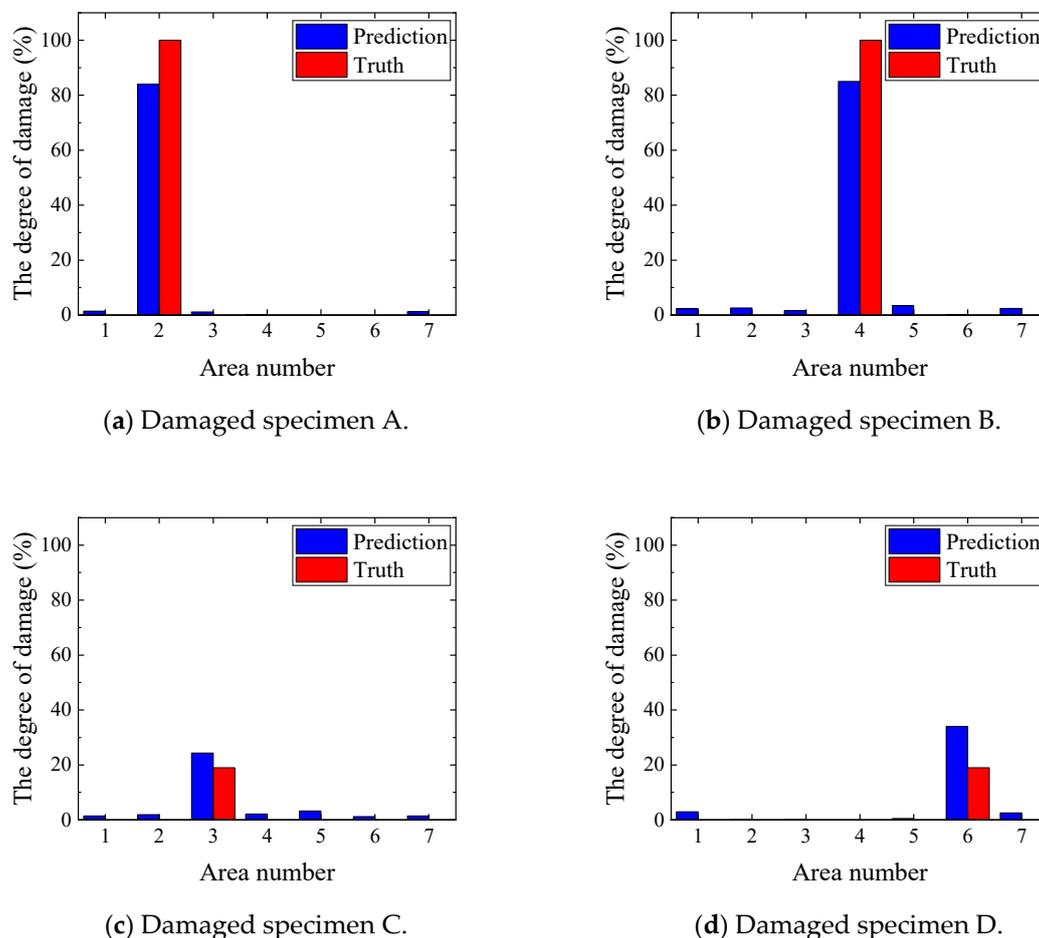
Figure 17. Analysis results of actual damaged specimens.

The results of the analysis are shown in Table 4 and Figure 17. It can be seen from Table 4 that the assessments of whether or not cracks existed are all correct. In addition, it can be seen from Figure 16 that the difference between damaged and non-damaged areas can be accurately assessed.
