Article

Infrared Thermography for the Detection and Characterization of Photovoltaic Defects: Comparison between Illumination and Dark Conditions

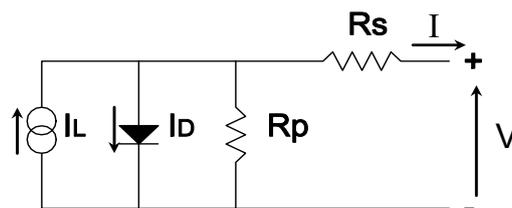
Figure 1. One-diode model of a photovoltaic (PV) cell including the series and shunt resistances.

The working principle of a solar PV cell consists in absorbing the light and convert it into electricity. The I-V curve under illumination represents all the possible combination of current and voltage of the PV device under certain conditions of irradiance and temperatures. It represents the superposition of the dark diode current with the photogenerated current, due to illumination, and can be described with the well-known one exponential model, including the series and shunt resistances [34], as shown in Figure 1. Equation (1) shows this expression:

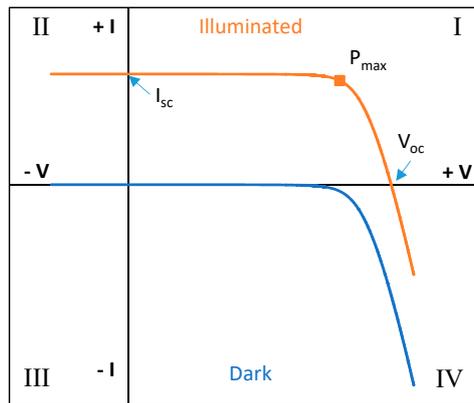
Figure 2. Illuminated and dark I-V curve of a PV device. Characteristic points are shown.

The optimum operational point of a PV device is the maximum power point, which is the point searched by the PV inverters in power plants. Nevertheless, under certain conditions it is possible that some devices move to second quadrant, or operate in the fourth quadrant (dark I-V curve) for testing purposes.

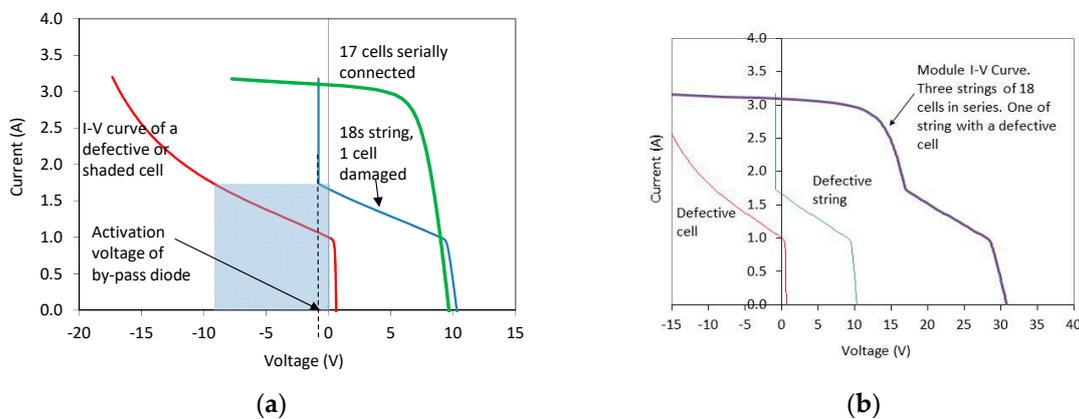
Figure 3. Working principle of the bypass diode. (a) Left: a damaged cell is associated in series with other 17 cells serially connected. The string has a bypass diode. The activation point of the bypass diode is shown. (b) Right: I-V curve of a PV module with three strings of 18 cells serially connected (18 s). One of the strings has a defective cell.

Operation in the second quadrant usually happens in PV modules with defective cells or in case of partial shading. A PV module is an association of PV cells, typically serially connected. If all the module cells are identical and connected in series, under maximum power point conditions the working current will be the cell I_{max} current, and the module V_{max} will be the sum of each cell voltage. If all the cells in the module are not identical, due to differences in production, defects or shading, then the defective cell with lower current will move its operation point to the second quadrant, trying to reach the string current. In these conditions, the cell will dissipate the power produced by the other cells in the association, causing an increase in temperature. To avoid a high power dissipation which could damage the cell due to overheating [35,36], PV modules are manufactured with bypass diodes in their connection box. Bypass diodes are connected in parallel to a number of cells serially connected, and have the function of limiting the number of cells that can dissipate power into a defective one and to offer an alternative path to current in case of severe defects or partial shading. The operation of the bypass diode produce a knee in the module I-V curve, whose position depends on the number and distribution of bypass diodes in the module, and the type of defects or shading [37,38]. Figure 3 illustrates the working principle of the bypass diode.

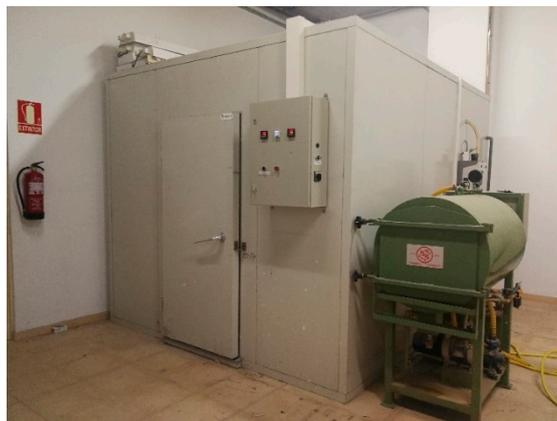
Figure 4. Temperature and humidity-controlled chamber at the School of Forestry, Agronomic and Bioenergy Industry Engineering (EIFAB) in Soria, Spain.

Indoor tests include indoor (dark) EL, which has been performed in controlled ambient conditions simultaneously than indoor (dark) IRT in the fourth quadrant. For these two tests, the University has a temperature and humidity-controlled chamber, which is shown in Figure 4.

Indoor measurements have been done at 25 °C, in the temperature-controlled chamber showed in Figure 4. Outdoor and indoor IRT images irradiation, ambient temperature and module temperature are presented in Table 1. The module temperature corresponds with the average temperature of the whole surface of the module. This information will be used in the results discussion in the following section. The current level could produce quantitative variations in the temperature of the defect. However, the authors consider that there are no qualitative variations regarding the identification of the defect.

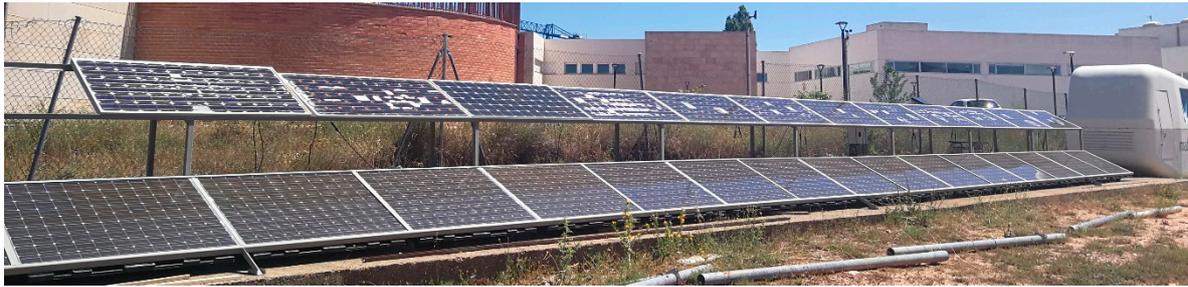
Figure 5. PV field of the Campus Duques de Soria of the University of Valladolid in Soria, Spain.

On the other hand, outdoor tests, including outdoor (illuminated) IRT in the first quadrant, outdoor (illuminated) IRT in the fourth quadrant and outdoor (dark) IRT have been carried out in the PV field of the Campus Duques de Soria of the University of Valladolid, which can be seen in Figure 5. The thermographic camera used outdoor is a Workswell Wiris Pro camera, with a 640×512 pixels resolution, a thermal sensitivity of $0.05 \text{ }^\circ\text{C}$ and an accuracy of $\pm 2\% \text{ o } \pm 2 \text{ }^\circ\text{C}$. This camera has a frame rate of 30 Hz, is calibrated to be used with two different lenses, 32° and 69° , and includes a Full HD RGB sensor with a resolution of 1920×1080 pixels and $\times 10$ zoom. In this case, the forward voltage for tests in the fourth quadrant has been applied with a bidirectional inverter, adjusting the voltage to feed the I_{sc} to the string of modules. This novel device, which is the key of the research performed as it extremely facilitates the outdoor EL inspections, as well as the outdoor (dark) IRT inspection and the outdoor (illuminated) IRT in the fourth quadrant, is in-depth detailed in the following subsection.

Solar irradiance has been taken from ATERSA 4-20mA Compen solar cell, which registers the irradiance level every minute. The ambient temperature has been taken from Advanticsys CO₂, temperature and humidity sensor, which registers the temperature every hour. All this information is registered in the ADVANTICSYS PV plant data logger, model MPC374.

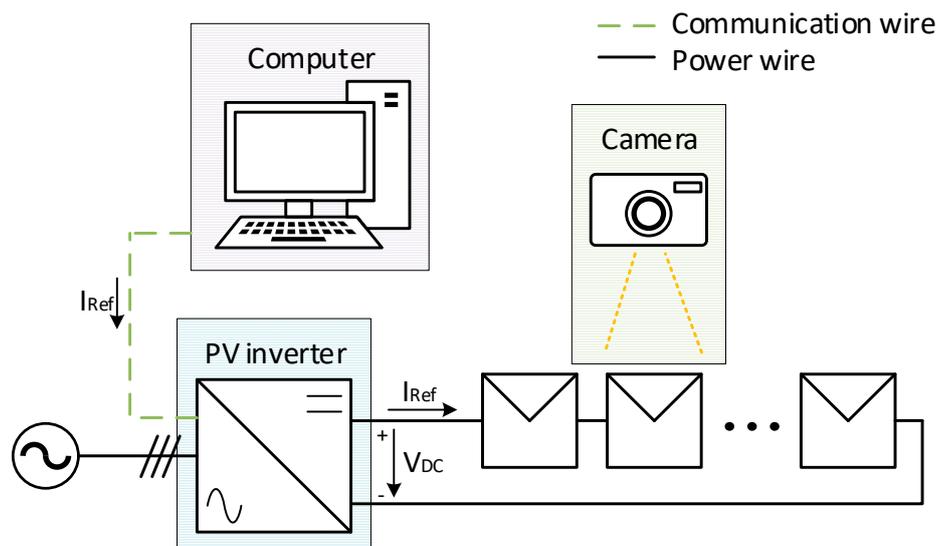
Figure 6. Inspection process diagram. The current setpoint (I_{Ref}), sent from the computer to the inverter, is controlled by means of the PV side voltage (V_{DC}).

The image capturing procedure is as follows: in standard working operation conditions, the power inverter works autonomously, taking energy from the panels and feeding it into the grid whenever there is enough solar irradiance. However, when an inspection is required, as Figure 6 shows, a computer connected to the inverter gives it the right orders.

The user can set the desired inspection setpoint in the computer, usually the current necessary to carry out the inspection, and afterwards, proceeds to send a command to the inverter. The system, from that instant, ignores the maximum power point tracking (MPPT) algorithm, and follows the reverse reference current (I_{Ref}), by means of varying the DC side voltage (V_{DC}), until the desired current has been reached.

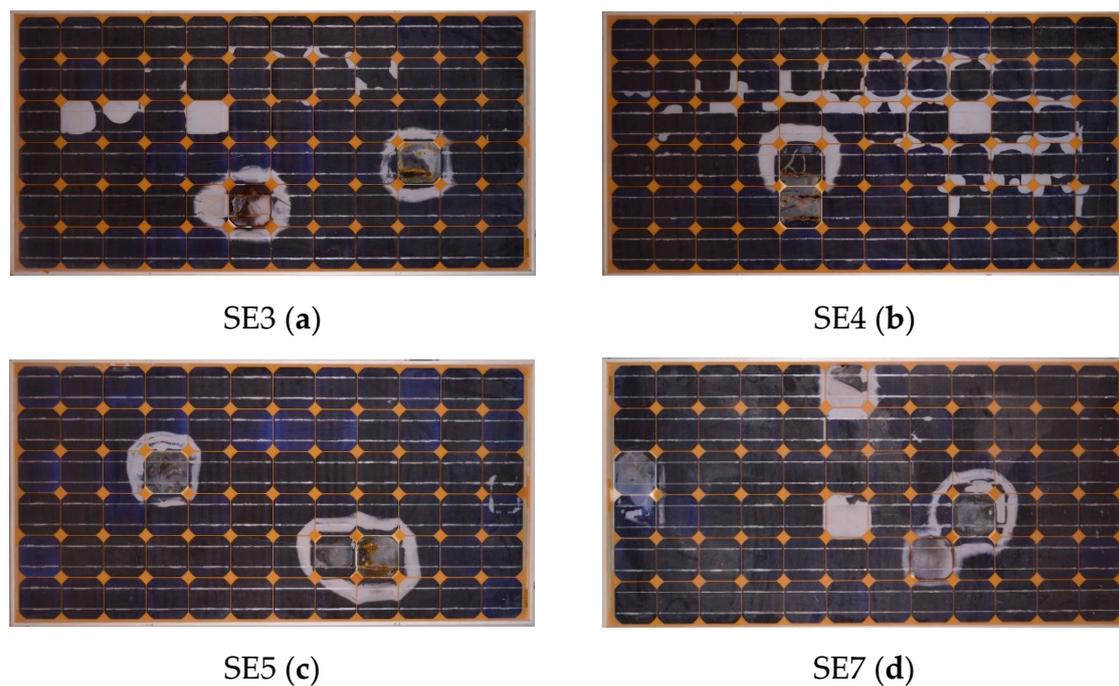
Figure 7. Red, green, blue (RGB) images of the 175W Eoply mono-crystalline defective modules analyzed in the research: (a) module 1; (b) module 2; (c) module 3; (d) module 4.

Four mono-crystalline modules with different kinds of defects have been tested in the present research. The main characteristics of the modules are: 72 cells (6×12) with 3 bypass diodes (one each 24 cells), power (P) 175 W, open circuit voltage (V_{oc}) 44.35 V, maximum power point (V_{mp}) 36.26 V, I_{sc} 5.45 A and maximum power current (I_{max}) 4.83 A. The modules selected for the study contain several defects, in order to be able to identify failures with the different techniques, and to be able to carry out the comparison. If the modules were new and they did not show defects, the assessment would not be possible. The following Figures 7 and 8 present the RGB images and the I-V curves of the analyzed modules, respectively. I-V curves have been traced using an I-V tracer Solar IV HT 1500 V at 800, 859, 839 and 792 W/m^2 for modules 1 to 4, respectively. The interpolation to standard test conditions (STC) has not been applied, as the significant deterioration of the modules could importantly modify the coefficients of variation of I_{sc} (α), V_{oc} (β) and P (γ) with the temperature or other interpolation equations used by the I-V tracer, not obtaining real results. In Figure 8, typical knees of the operation of the bypass diode can be observed in the I-V curves, in which the defects induce the bypass conduction of current, as in module 1, module 2 and module 4. The defects present in module 3 do not seem to cause the operation of the bypass diodes. However, in module 1, module 2 and module 3 there is a reduction in the V_{oc} values with respect to module 4, which could indicate the presence of short-circuited cells according to reference [11], as will be further analyzed in the discussion.

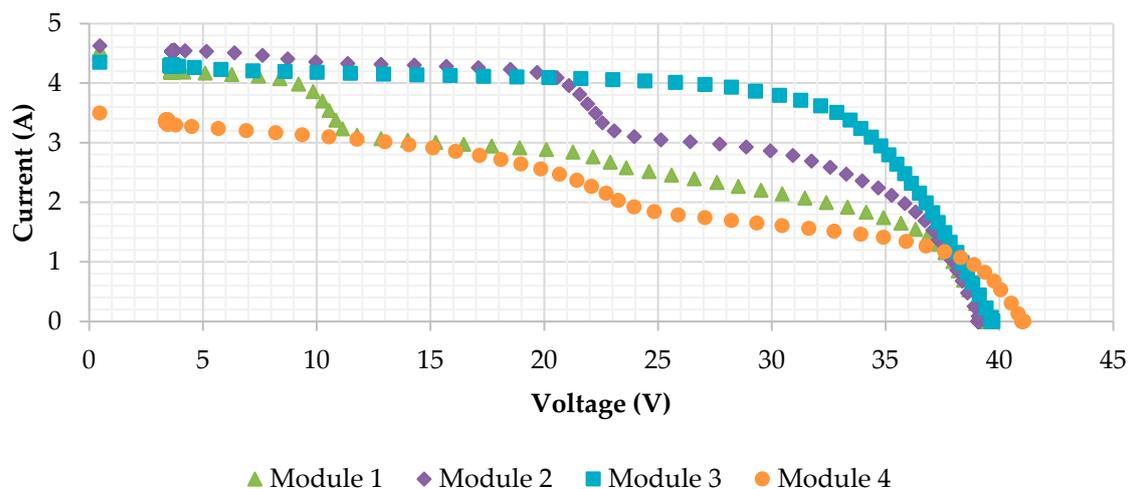
Figure 8. I-V curves of the 175W Eoply mono-crystalline defective modules analyzed in the research, drawn using an I-V tracer Solar IV HT 1500V at 800, 859, 839 and 792 W/m² for modules 1 to 4, respectively. Typical knees of the operation of the bypass diode can be observed in the I-V curves.

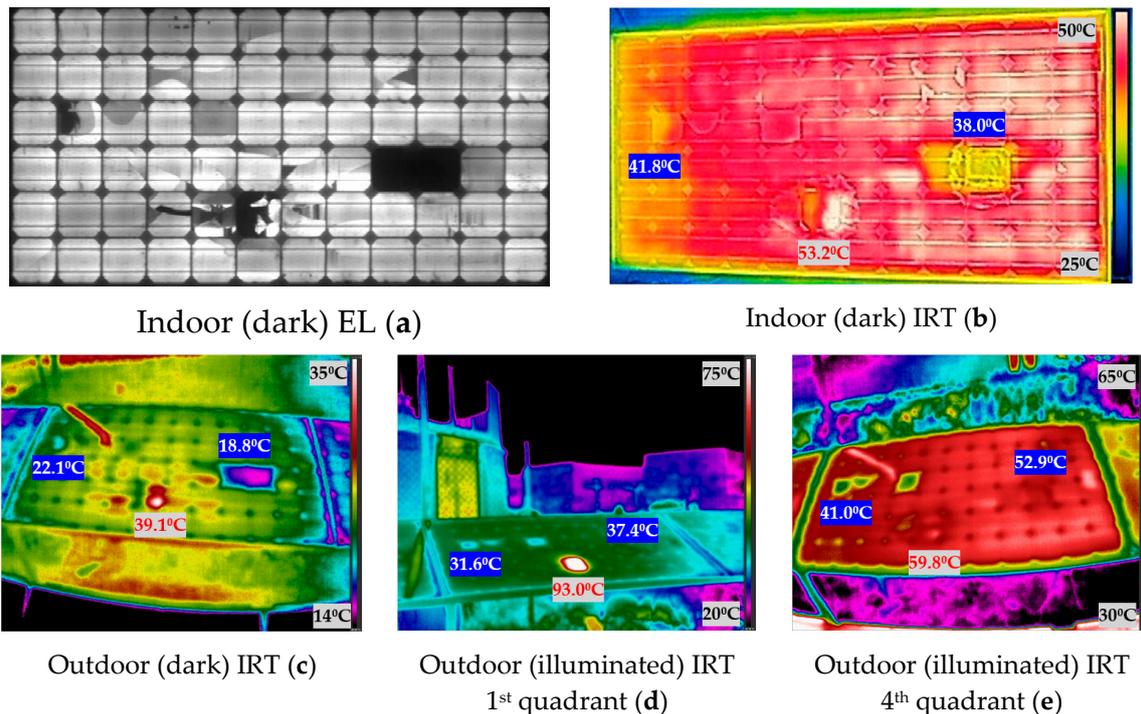
Figure 9 shows the experimental results obtained when measuring the photovoltaic module 1. The Figure 9 shows the images taken indoor and outdoor, both in darkness and in illumination. In IRT images, the temperature of the spots hotter than the average temperature of the module is indicated in red, while the temperature of spots cooler than the average of the module is indicated highlighted in blue.

Figure 9. Indoor and outdoor characterization images of module 1: (a) indoor (dark) electroluminescence (EL); (b) indoor (dark) infrared thermography (IRT); (c) outdoor (dark) IRT; (d) outdoor (illuminated) IRT first quadrant; (e) outdoor (illuminated) IRT fourth quadrant.

The first subject which will be discussed is the analysis of outdoor (illuminated) IRT first quadrant and outdoor (illuminated) IRT fourth quadrant. IRT in both situations is performed in illumination but the effect on the PV module is different. When the module is in illumination and receiving the injected current (fourth quadrant) (e) figures from the bidirectional inverter, the protection diodes cannot bypass the current, because they work as an open circuit with this polarity, and all cells (including damaged cells) receive all the injected current. Therefore, the damaged cells can receive all the current injected into the module. Instead, in illumination and operating normally (in the first quadrant), (d) images, the bypass diodes will protect the sub-strings with defective cells, limiting the power dissipation. In the previous figures, from Figure 9 to Figure 12, this slight difference in IRT can be seen in (d) and (e).

The operation of a PV module in the fourth quadrant under illumination is a condition that would be difficult to achieve in the field. Nevertheless, with the aid of the bidirectional inverter and for testing purposes, the operation point of the modules was moved to this quadrant to investigate the differences in temperature with respect to the other conditions. As future work, it is proposed to apply all these techniques in other plants. This research group collaborates with a company that has inverters of these characteristics in a real plant in operation. However, the objective of this article is the comparison of the different IRT techniques (illumination and darkness). It was observed that in some of the cases, for instance, in Figure 11d,e, the faulty cells increase their temperature over the module 3 average temperature, due to power dissipation in both conditions, outdoor illuminated first and fourth quadrant. In Figure 11d, the difference of temperature between the two hotspots and the module average temperature is 2.31 °C and 5.41 °C, for the left and right hotspots respectively. In Figure 11e, these differences are 4.33 °C and 6.33 °C, respectively. This can be due to the difference in the irradiation conditions between both cases, as image in Figure 11d was taken with 680 W/m² and (e) with 917 W/m². However, regarding Figure 12d,e, there is agreement among the spotted cells, however, they appear hotter than the module 4 average temperature in outdoor (illuminated) IRT in the first quadrant (d), and one hotter and the rest cooler in outdoor (illuminated) IRT in the fourth quadrant (e). A similar effect is found in module 2 (Figure 10).

Secondly, with respect to the dark IRT, the technique can be performed both indoor (dark) and outdoor (dark), as can be seen in images from Figure 9 to Figure 12b,c in Section 3, respectively. Both images are similar, and complementary to the image obtained in EL (a). This means that dark IRT can be used to identify faults in PV modules similar to those identified with the EL technique, as it will be further discussed in Section 4.4. As seen in the previous Figures 9–12, cold-spot failures can be identified, which have been defined by authors in [11], and are recognized as black cells in EL images (a). This fact can be observed in Figure 9a, which has two contiguous black cells, detected as cold spots in Figure 9b,c. Additionally, module 1 presents two cells with some inactive areas (C2 and E6) in EL (Figure 9a). One of those cells (cell C2) is detected as a cold spot, while the other one, cell E6, is shown as a hotspot in Figure 9b,c. The difference of temperature of the inactive cells (D9 and D10) with respect to the average of the module is −8.80 °C in indoor (dark) IRT (b) and −7.82 °C in

outdoor (dark) IRT (b). The differences of temperature of the broken cells (C2 and E6) with respect to the average of the module are $-5.0\text{ }^{\circ}\text{C}$ and $+6.4\text{ }^{\circ}\text{C}$, respectively, in indoor (dark) IRT (b), and $-4.52\text{ }^{\circ}\text{C}$ and $12.48\text{ }^{\circ}\text{C}$, respectively, in outdoor (dark) IRT (b). As seen, similar results are obtained in indoor and outdoor (dark) IRT.

The working point in an illumination curve is different from the working point in dark conditions (in the dark curve), which is responsible of the different results between the illumination and dark IRT. This can be seen comparing Figure 9 to Figure 12 in Section 3 (b), (c) versus (d) and (e). As can be seen in the figures in Section 3, when comparing images in darkness (b) and (c) and images in illumination (d) and (e), the results are different. In dark images, the cold spots of the PV module are easily recognizable, as seen with the inactive cells in Section 4.2, while in the illuminated images, these spots do not appear, and hot spots are located. This effect can be seen in Figure 10b,c, in which the three inactive cells (D5, E5 and E6) are seen as cold spots in indoor and outdoor (dark) IRT. On the other hand, in the illuminated IRT images, Figure 10d,e, these cold spots are difficult to identify, while hot spot of damaged cell C9 is easily located. The images in darkness are equal comparing the images taken indoors and outdoors (b) and (c), respectively, since, in both cases, we work on the darkness curve as already detailed in Section 4.2. They could present some minor differences, since those outdoors could be affected by weather conditions (mainly temperature), which are introduced in Table 1.

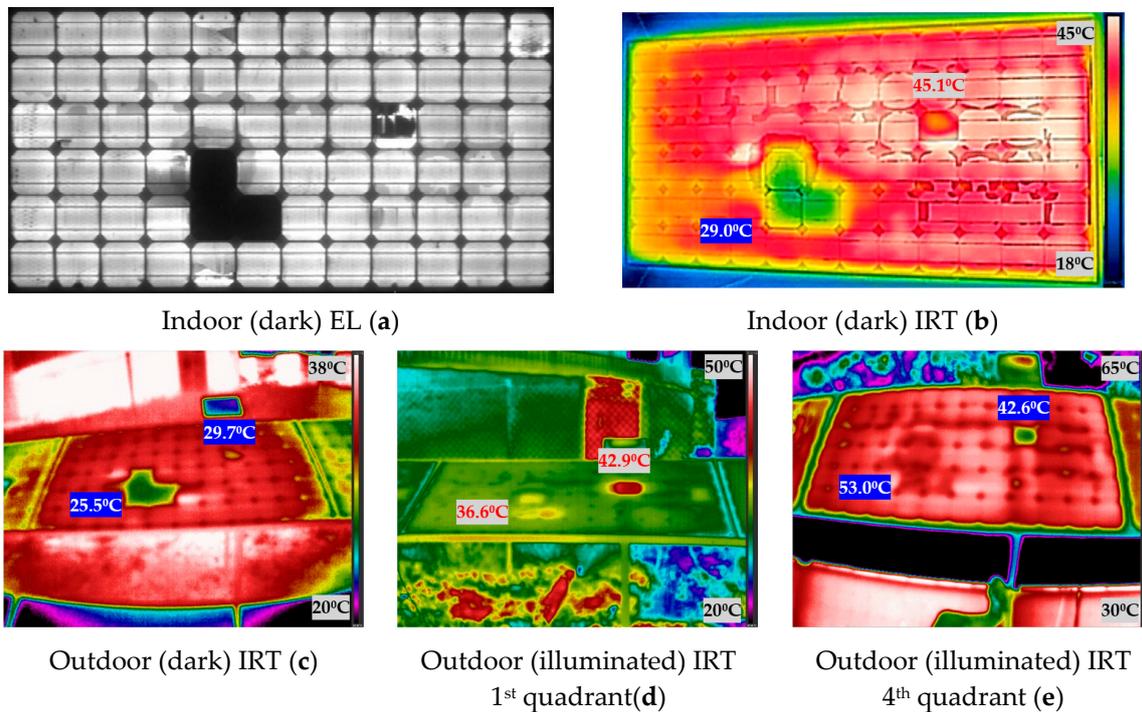
Figure 10 shows the experimental results obtained when measuring the photovoltaic module 2. The Figure 10 shows the images taken indoor and outdoor, both in darkness and in illumination. In IRT images, the temperature of the spots hotter than the average temperature of the module is indicated in

red, while the temperature of spots cooler than the average of the module is indicated highlighted in blue.

Figure 10. Indoor and outdoor characterization images of module 2: (a) indoor (dark) EL; (b) indoor (dark) IRT; (c) outdoor (dark) IRT; (d) outdoor (illuminated) IRT first quadrant; (e) outdoor (illuminated) IRT fourth quadrant.

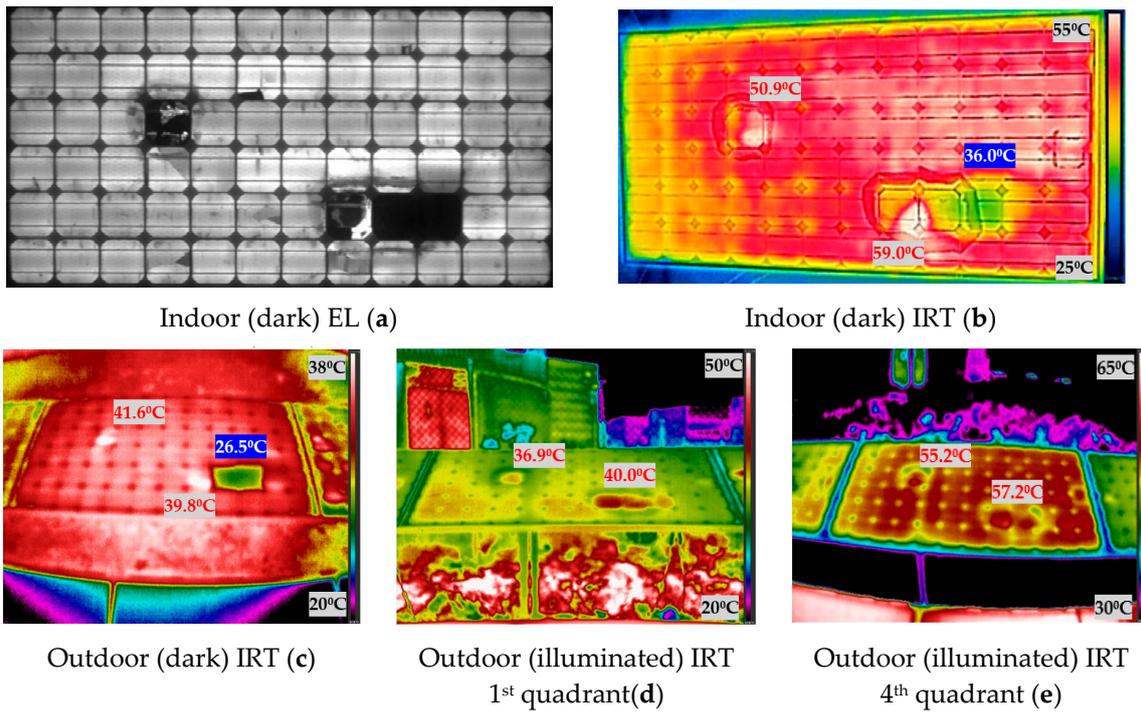
Figure 11 shows the experimental results obtained when measuring the photovoltaic module 3. The Figure 11 shows the images taken indoor and outdoor, both in darkness and in illumination. In IRT images, the temperature of the spots hotter than the average temperature of the module is indicated in red, while the temperature of spots cooler than the average of the module are indicated highlighted in blue.

Figure 11. Indoor and outdoor characterization images of module 3: (a) indoor (dark) EL; (b) indoor (dark) IRT; (c) outdoor (dark) IRT; (d) outdoor (illuminated) IRT first quadrant; (e) outdoor (illuminated) IRT fourth quadrant.

It can be highlighted the similarity between the outdoor (dark) IRT images (equally for those indoors) with EL images. It is possible to affirm that outdoor (dark) IRT images are capable of detecting failures inherent in cells, and that they only appear in EL and do not appear in IRT in illumination, as seen in Section 4.3. Finally, it can be reviewed the cold-spots temperatures in (dark) IRT of completely inactive areas in the modules evaluated (cells D9 and D10 in module 1 (Figure 9a), cells D5, E5 and E6 in module 2 (Figure 10a) and cells E9 and E10 in module 3 (Figure 11a), which could correspond with short-circuited cells according to reference [11]. For the temperatures comparison, will be used the indoor (dark) IRT information (b), as it has been captured simultaneously to EL images (a). The difference of temperatures of the inactive cells with respect to the average of the module are: $-8.80\text{ }^{\circ}\text{C}$ in module 1 Figure 9b, $-11.9\text{ }^{\circ}\text{C}$ in module 2 Figure 10b, and $-9.9\text{ }^{\circ}\text{C}$ in module 3 Figure 11b. Therefore, the cooling is similar in the three cold-spot evaluated.

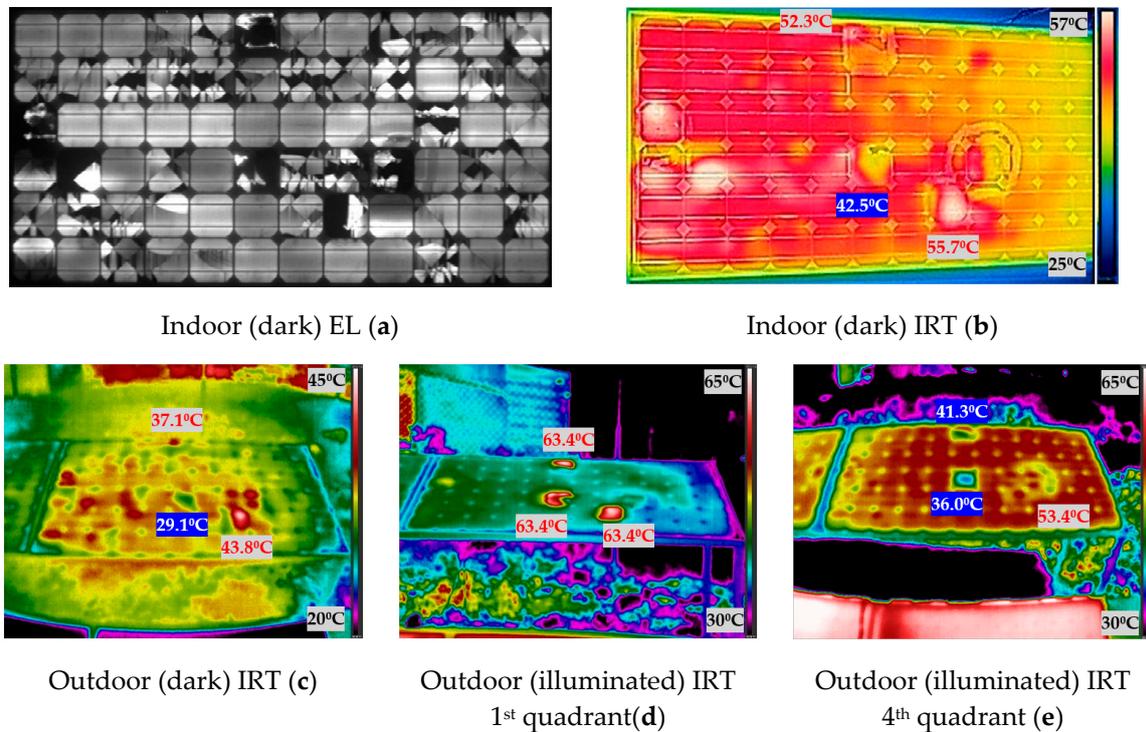
Figure 12 shows the experimental results obtained when measuring the photovoltaic module 4. The Figure 12 shows the images taken indoor and outdoor, both in darkness and in illumination. In IRT images, the temperature of the spots hotter than the average temperature of the module is indicated in red, while the temperature of spots cooler than the average of the module is indicated highlighted in blue.

Figure 12. Indoor and outdoor characterization images of module 4: (a) indoor (dark) EL; (b) indoor (dark) IRT; (c) outdoor (dark) IRT; (d) outdoor (illuminated) IRT first quadrant; (e) outdoor (illuminated) IRT fourth quadrant.
