# Characterization of Anisotropic Salt Weathering through Nondestructive Techniques Mapping Using a GIS Environment

**Abstract:** Doctrinal texts on architectural heritage conservation emphasize the importance of fully understanding the structural and material characteristics and utilizing information systems. Photogrammetry allows for the generation of detailed, geo-referenced Digital Elevation Models of architectural elements at a low cost, while GIS software enables the addition of layers of material characteristic data to these models, creating different property maps that can be combined through map algebra. This paper presents the results of the mechanical characterization of materials and salt-related decay forms of the polygonal apse of the 13th-century monastery of Santa María de Bonaval (Guadalajara, Spain), which is primarily affected by salt crystallization. Rock strength is estimated using on-site nondestructive testing (ultrasound pulse velocity and Leeb hardness). They are mapped and combined through map algebra to derive a single mechanical soundness index (MSI) to determine whether the decay of the walls could be dependent on the orientation. The presented results

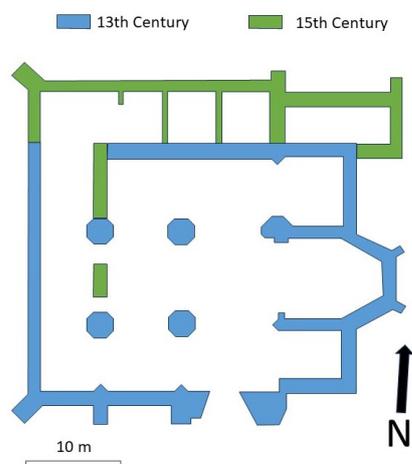
**Figure 1.** Schematic plan of the preserved ruins showing the different building phases.

The Monastery of Santa María de Bonaval is a Cistercian Monastery located in the municipality of Retiendas (Guadalajara) in Central Spain, around 80 km NNE from Madrid. The oldest parts of this Monastery date back to the 13th century, and they were built in Gothic style. Only a portion of the original building has been preserved, primarily consisting of the church’s apses, transepts, southern naves, and an attached sacristy (Figure 1).

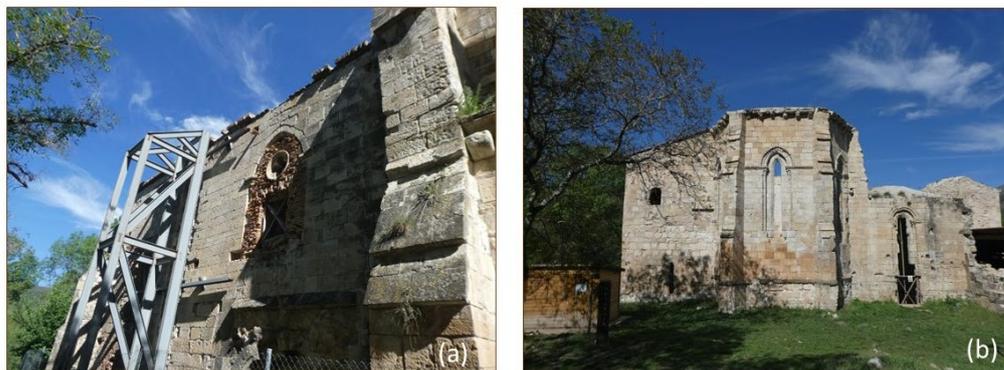
**Figure 2.** Views of the monastery of Santa María de Bonaval from the south (a) and the east (b). The building shows a marked anisotropy of decay: the south and west sections of the building show more overall structural failure. The south and east sections show the largest proportion of salt-related decay forms. Nevertheless, the east part of the building is the best-preserved area.

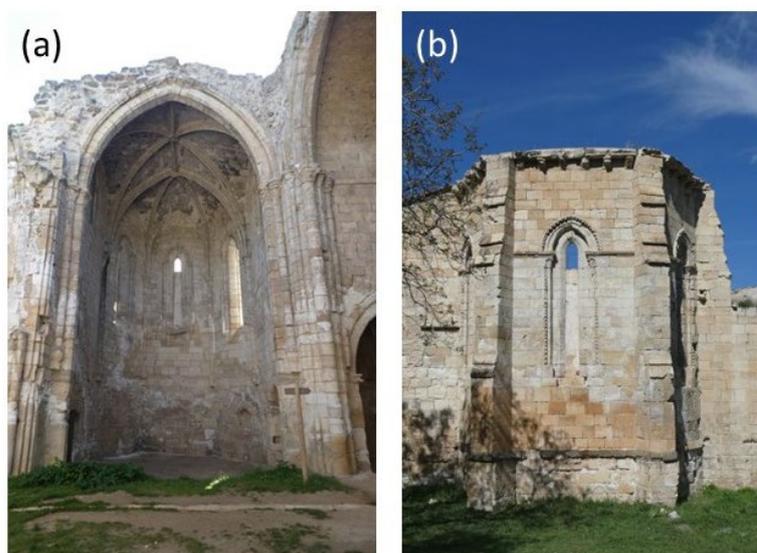
**Figure 3.** Pictures of the main apse of the monastery's church from the inside (a) and the outside (b).

The building is located around 100 m to the south of the Jarama River and 100 m to the north of a hill within the so-called Bustar’s ravine. In addition to large-scale structural damage (Figure 2), the location of the monastery near the floodplain in an agricultural area promotes salt crystallization as the most extensive decay process involved, particularly in

the inside part of the main apse of the church (Figure 3a). Nevertheless, the external side of the main apse is the best-preserved area of the building (Figure 3b).

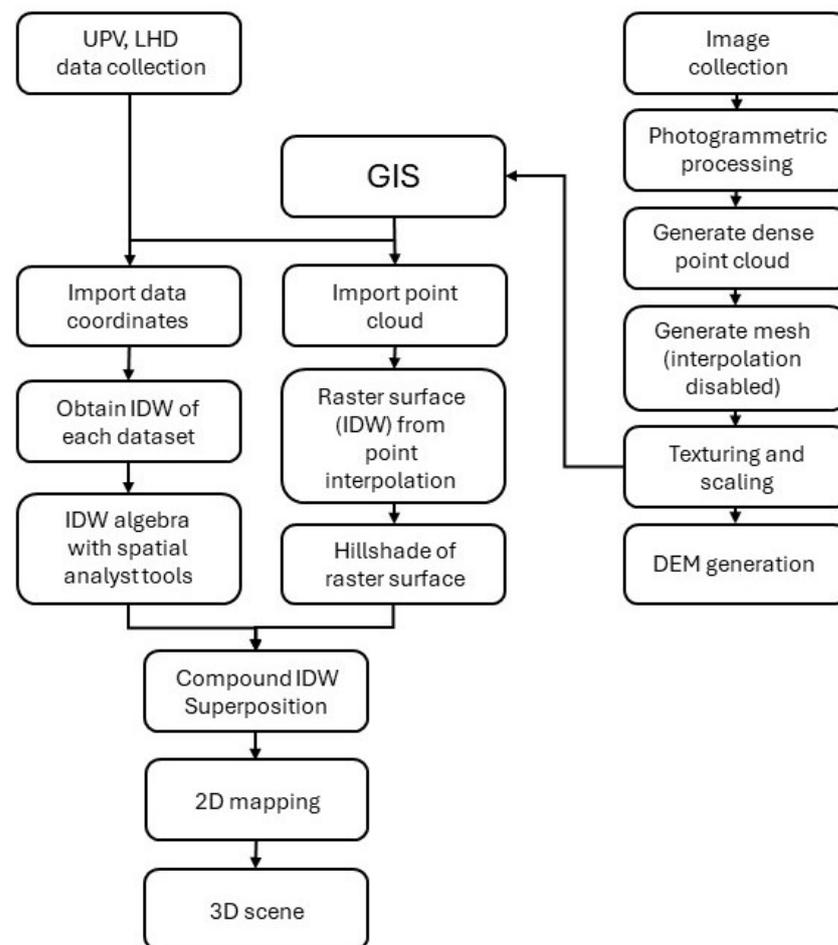
**Figure 4.** Methodological workflow of photogrammetry and data mapping.

To capture a three-dimensional Digital Elevation Model (DEM) of the apse's walls, multi-image photogrammetry was used. This technique involves capturing rectified photographs of the object from various angles and processing them with specialized software (Agisoft Metashape Professional 1.8.5). Figure 4 shows a simplified workflow of the methodology in relation to photogrammetry and data mapping.

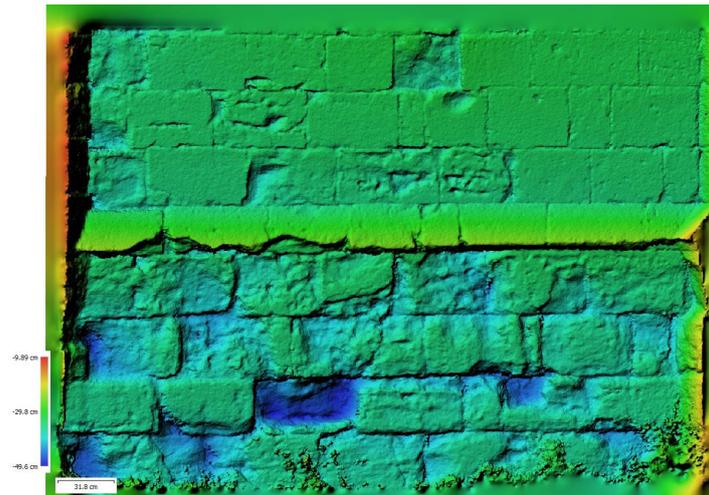
**Figure 5.** Colored DEM of the SE wall of the apse with a scale showing receded areas in blue. Distances were measured from an arbitrary datum placed in front of the DEM.

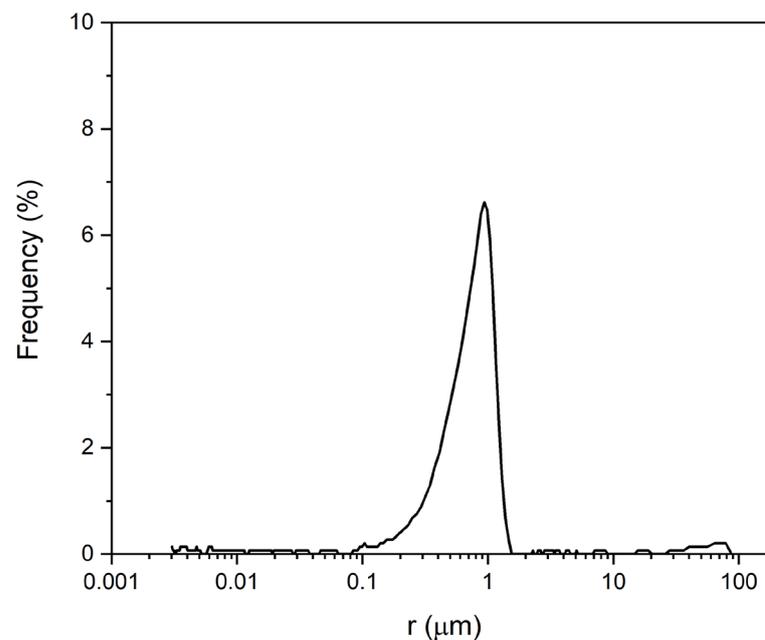
**Figure 6.** Pore-size distribution of the Santa María de Bonaval dolostone.

The monastery is built with a homogeneous dolostone with 29.1% connected porosity, which is similar to the open porosity measured in the 4 cm cubic samples (Table 1). The pore-size distribution of the building stone shows a main pore population that ranges from 0.1 to 1  $\mu\text{m}$  (Figure 6), which is related to its well-sorted texture.

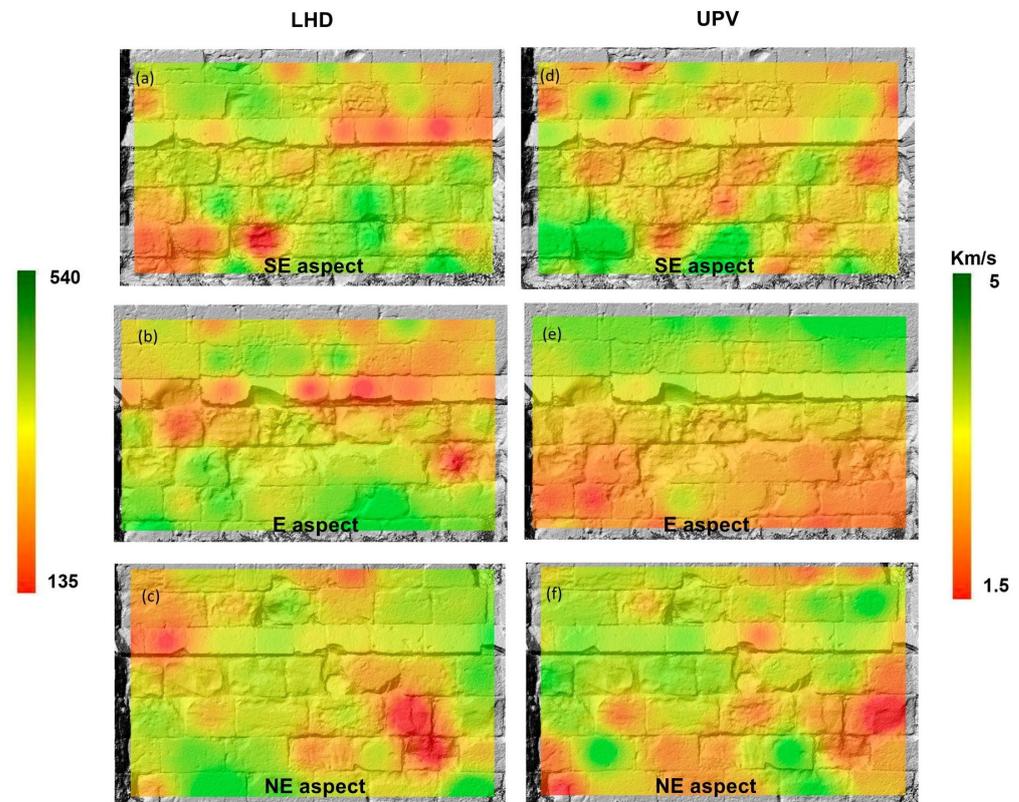
**Figure 7.** LHD (a–c) and UPV (d–f) maps obtained from GIS of each of the surveyed walls expressed on a color scale from the minimum to the maximum values obtained during the survey. LHD is a non-dimensional magnitude; hence, the scale does not have units.

Figure 7 shows the cartographic results of LHD and UPV overlapping the raster layers. Although the representation on paper makes it look like a static 2D representation, it must

Both sets of results demonstrate how, although both parameters link directly to compressive strength, they yield different attributes of what causes the diminishing of strength. However, in either case, a decay pattern emerges in both the external walls of the apse of strips, seemingly converging to the central (east) wall.

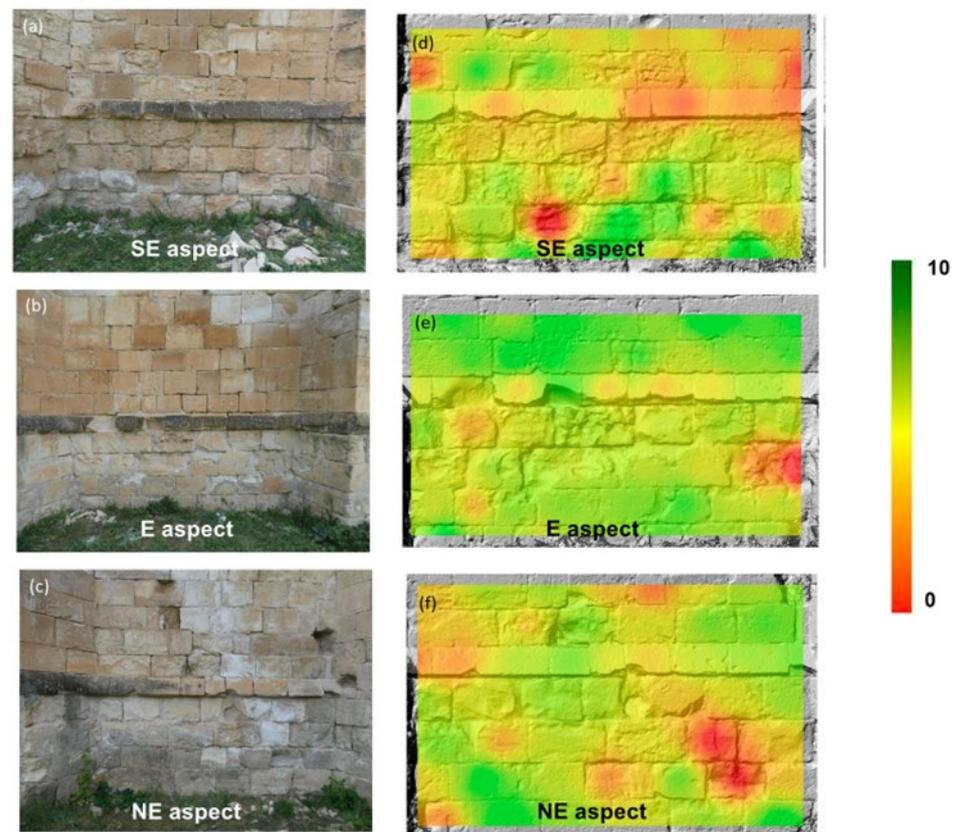
**Figure 8.** Pictures of the three walls of the studied apse correspond to the different aspects (a–c) and the equivalent MSI maps (d–f) obtained from the GIS map algebra. MSI is non-dimensional.

Figure 8 displays the mechanical soundness index map (Figure 8d–f) obtained using map algebra within a GIS that used DEMs of each section of the apse as a topographic base. The lower the MSI, the lower the combined normalized value of UPV and HLD. Therefore, the most decayed areas had lower values of the MSI.

MSI combines the normalized measurements of UPV and LHD and gives them the same weight. The results of MSI mapping make the decay patterns converging to the central part of the apse more noticeable, which, as shown in the photographs, correspond to stripes where salt efflorescences are visible. The MSI map also shows that the SE wall of the apse displays the most extensive strength loss.

more epsomite–hexahydrite phase transitions as a consequence, multiplying the destructive effects of salt crystallization in this part of the apse, which is consistent with the overall reduced MSI map (Figure 8).

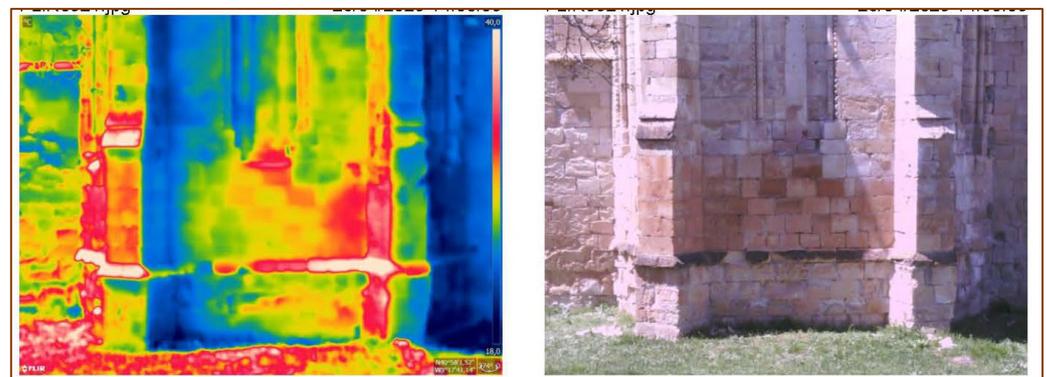
**Figure 9.** IR (left) and visible (right) images of the apse at local midday close to the Spring equinox.

Figure 9 shows a representative IR and visible image of the apse taken at local midday from the east. At midday, the south-facing areas of the apse show a significantly higher surface temperature (average temperature of around 34 °C) in comparison to the north-facing areas of the apse (average temperature of around 21 °C). The environmental conditions at the time were 20 °C and 50% RH.

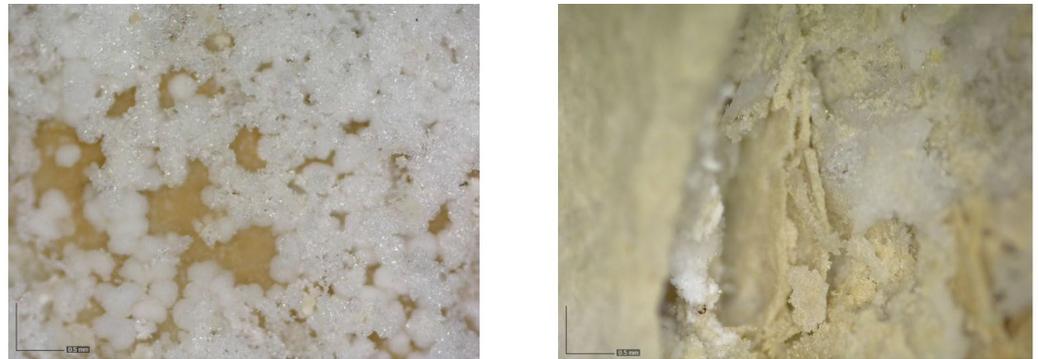
**Figure 10.** Photomicrographs obtained with a portable digital microscope showing powdery efflorescences (**left**) and subefflorescences associated with flacks and scales (**right**).

The main decay factor of the walls is salt crystallization, as shown by the efflorescences and subefflorescences throughout the walls (Figure 10). Salts appear as powdery aggregates, with slight skeletal development. Crystallization in the rock surface and in subsurface layers causes granular disintegration and scaling of the rock (according to the terminology of the ICOMOS-ISCS glossary [28]). The place where the salt crystallizes is controlled by both the hydric properties of the stone and the evaporation conditions of

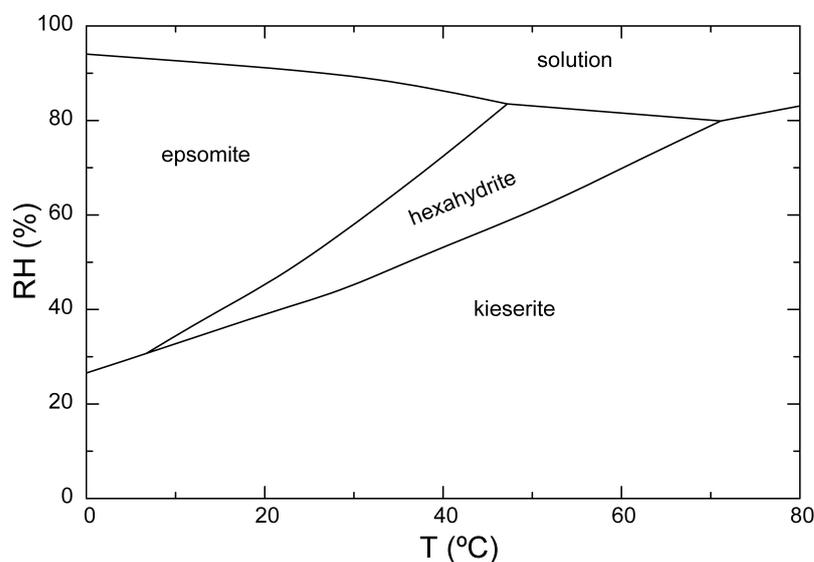
Figure 11. Phase diagram of the  $\text{MgSO}_4$  system (modified from [37]).

Epsomite (MgSO<sub>4</sub>·7H<sub>2</sub>O) is the main phase observed in the efflorescences. The MgSO<sub>4</sub> mineral group presents different hydrated mineral phases such as epsomite, hexahydrate (MgSO<sub>4</sub>·6H<sub>2</sub>O), and kieserite (MgSO<sub>4</sub>·H<sub>2</sub>O), which are considered to be one of the most aggressive salt systems in comparison to other salts, such as nitrates and chlorides [31,32]. In particular, the dissolution of the less hydrated form (hexahydrate), which is followed by the precipitation of the hydrated salt (epsomite), is the most aggressive weathering mechanism for these types of salts. This precipitation pathway occurs by crossing the phase boundary (Figure 11), and it can generate enough stress to damage the stone [33,34]. In particular, the transition between epsomite and hexahydrate takes place under common environmental conditions, and daily and seasonal T and RH variations have been shown to be factors in this phase transition [35].
