# Evaluating the Performance and Stability of the Highway Subgrades in Seismic Events, a Case Study of the Changning Earthquake, Sichuan

**Abstract:** On 17 June 2019, an M6.0 earthquake occurred in Changning County, Sichuan Province, China. Considerable highway subgrades were damaged in this earthquake. By investigating seismic damage of these subgrades, a systematical analysis of influence factors and failure mode of the damages on highway subgrade have been given. There is a close relationship between the damaged degree of subgrade and the distance of epicenter, fault distance, and structure type of subgrade. The seismic hazard investigation shows that the seismic damage of the cut-and-fill subgrade was more severe than that of the fill subgrade. Taking the Changning earthquake ground motion record as input, 3D dynamic finite element analyses were performed. The seismic damage mechanisms of cut-and-fill subgrade and fill subgrade were revealed. The numerical simulation confirmed that the cut-and-fill subgrade was more easily damaged by earthquakes compared with the fill subgrade. The fill-and-cut interface of the cut-and-fill subgrade had a notable plastic strain band after the

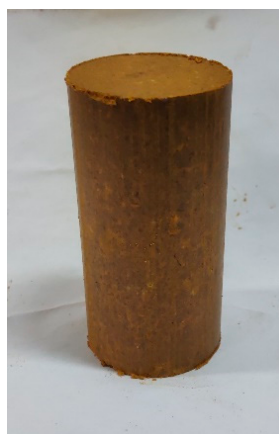
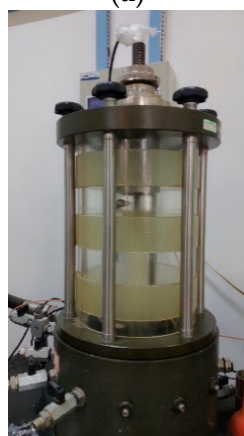
Therefore, silty clay samples of fill subgrades were obtained from K38 + 550–K38 + 750 section and prepared into test specimens. Remodeled samples were prepared; that is, the collected soil samples were dried, ground, and sieved to prepare bulk soil with a water content of 20%, which was kept in an airtight and non-evaporating environment for 6 h to make the soil uniform, and then samples with a diameter of 38 mm and a height of 76 mm were molded (Figure 4a). The cyclic loading test was carried out on the GDS dynamic triaxial test system with variable confining pressure (Figure 4b). The dynamic cyclic mode with stress control was selected; the target confining pressures were set at 50 kPa, 100 kPa, and 150 kPa; the frequency was set at 1 Hz; a half-sine wave was chosen. Then, after setting the amplitude of dynamic stress and vibration cycles, dynamic mechanical parameters of silty clay samples were obtained.

**Figure 4.** Dynamic triaxial test of silty clay. (a) Silty clay specimen. (b) GDS dynamic triaxial test system.
