# Diesel-Injection Equipment Parts Deterioration after Prolonged Use of Biodiesel

**Abstract:** The application of biodiesel blends is known to significantly affect operation of diesel-injection equipment, especially the injectors and fuel pump. This paper summarizes experience on this subject from burning fuel blends with high-percentages of biodiesel (up to 70%) on a common-rail, high-pressure-injection diesel engine and a conventional DI engine. Both engines were unable to start after running for 100 h each and staying shut off for more than two months. In order to understand the wear characteristics of the injector nozzle, pump pistons, and elastomer parts (in the case of the high-pressure pump of the common-rail engine), due to the prolonged operation with high-percentage biodiesel blends, their injectors and pumps parts were examined and compared by performing normal photography and low magnification microscopy. Additionally, the various elastomer parts of the high-pressure fuel pump of the common-rail engine were examined for wear and deterioration. The results are compared with existing literature results from other researchers. The observed deterioration of diesel-injecti

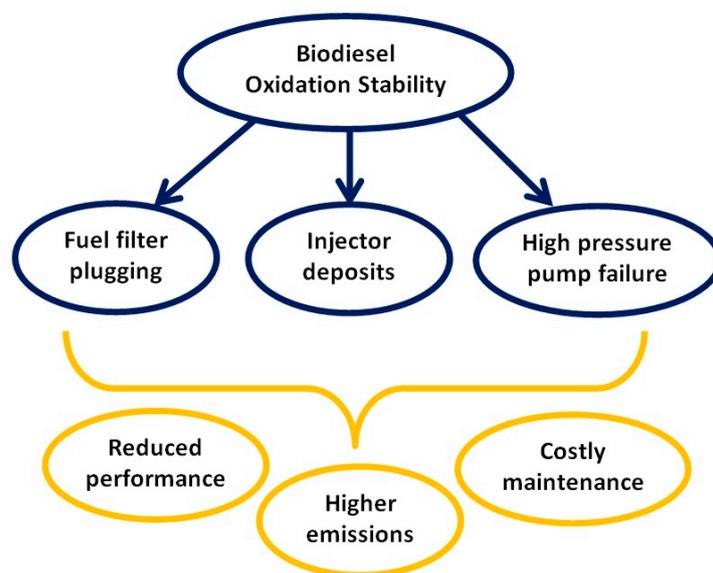
**Figure 1.** Effects of biodiesel oxidation stability problems on engine operation.

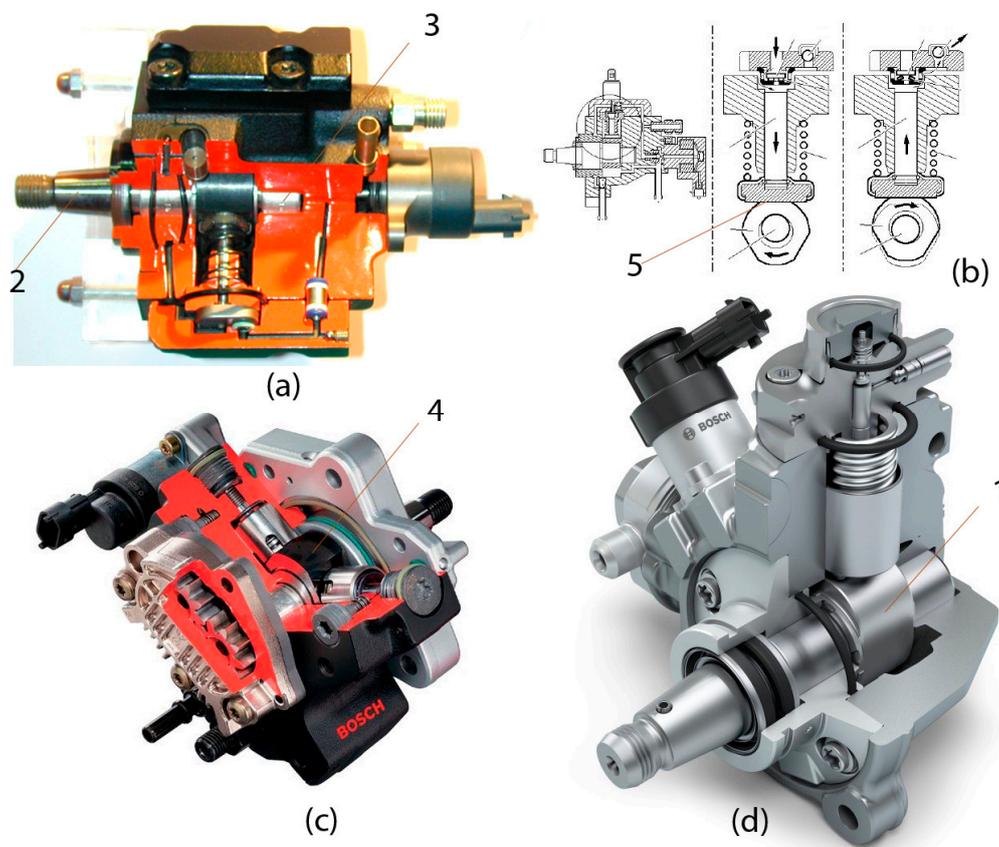
First generation common-rail systems utilize high-pressure pumps with eccentric shaft drives and three radially-arranged plungers. There are three types of CP1 high-pressure pumps: CP1S (standard), CP1K (compact), and CP1H (reinforced). Compared to CP1K/S, CP1H is designed for higher pressures up to 1600 bar. This is achieved by reinforcing the drive mechanism, modifying the valve units, and introducing measures to increase the strength of the pump housing.

Bosch CP3 is a monoblock-housing three-plunger radial high-pressure pump with suction throttle control and an external gear pump for fuel delivery, which is flange-mounted directly on the pump. This construction of housing reduces the potential of leakage in the high-pressure section, and permits a higher delivery rate. The low-pressure ports are mainly located in the aluminum pump flange, which is bolted with the forged steel housing. This pump can withstand pressures up to 1600 bar. Unlike the CP1 pump series, the polygon's movement is not directly transferred to the plunger but rather to the bucket tappet placed in between. This keeps the lateral forces induced by friction away from plunger and conducts them to the pump housing, improving the pump's stability under load [28,30].

CP4 is the latest Bosch common-rail radial high-pressure pump which consists of one (CP4.1) or two (CP4.2) radial arrayed plungers and a drive shaft with a double cam, as shown in Figure 2d (1). The CP4 handles pressure levels from 1800 to 2700 bar and is used for both on-and off-highway applications from passenger cars, light- and medium-duty vehicles up to small heavy-duty vehicles. Analogous models are produced by Denso corporation, HP2, HP3, HP4 [31].

All the types of high-pressure pumps operate in the same reciprocating mode which consists of suction and delivery strokes. The working pump elements are the plunger, barrel, suction and delivery valve. The drive shaft, Figure 2a (2), is mounted in a central bearing, Figure 2a (3). The pumping elements are arranged radially with respect to the central bearing. The polygon, Figure 2c (4), is fitted to drive the shaft which forces the pump plunger, Figure 2b (5), to move up and down.

**Figure 2.** Comparative cross-section views of the different pump generations: CP1 (a,b), CP3 (c), CP4 (d).

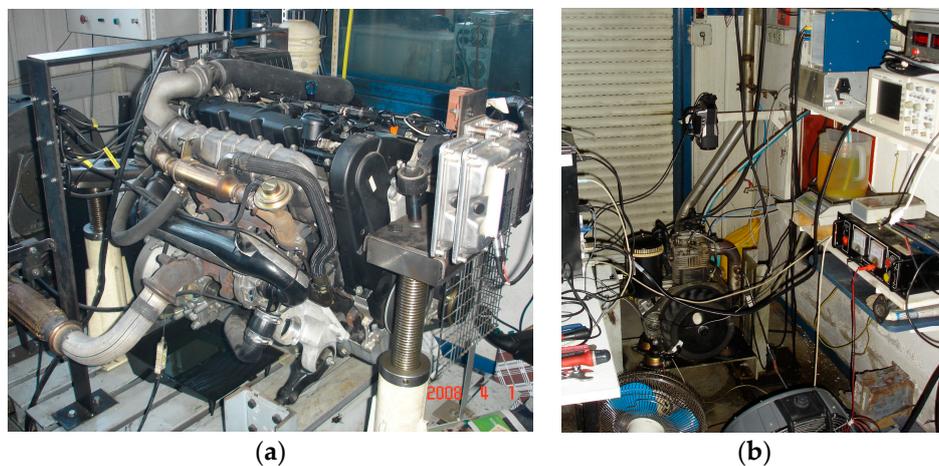
Two different engines were employed in the tests with high-percentage biodiesel blends in the Laboratory of Thermodynamics and Thermal Engines: (a) a PSA DW10 ATED 2.0 L, four stroke, four cylinder, turbocharged, equipped with Bosch first generation common-rail, ECU (Electronic Control Unit)-controlled injection system (Figure 3a, Table 2); and (b) a Ruggerini RF91 0.5 L, four stroke, single cylinder, naturally aspirated, equipped with a pump-in-line injection system (Figure 3b, Table 3).

**Figure 3.** Engine test beds: (a) PSA DW10 ATED, (b) Ruggerini RF91.**Table 2.** PSA DW10 ATED engine specifications.

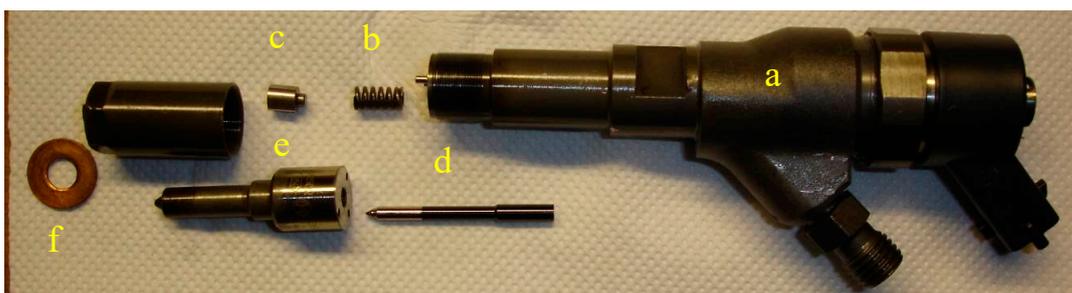
The common-rail injector consists of two parts: injector body and nozzle body. The most easily affected parts, besides the nozzle holes, are the injector’s moving components, like needle, plunger, and spring. An exploded view of this injector is presented in Figure 4.

**Figure 4.** Common-rail injector components. From right to left: (a) Injector body including supply and return fuel line, (b) spring, (c) plunger and nozzle body including (d) needle, (e) nozzle house, and (f) washer.

The next step was to disassemble and clean the injectors according to the official repair manual, as shown in Figure 4. The cleaning process included the removal of the brownish lacquer deposit via an ultrasonic bath in an aggressive detergent, at temperature of 60  $^{\circ}$ C. After the cleaning procedure, the surfaces of each part were carefully investigated for wear by means of the optical microscope. Figure 12 presents photos of the clean nozzle plungers. It was obvious that the prolonged operation with biodiesel led to further corrosion of the plungers, as indicated by the red circles.

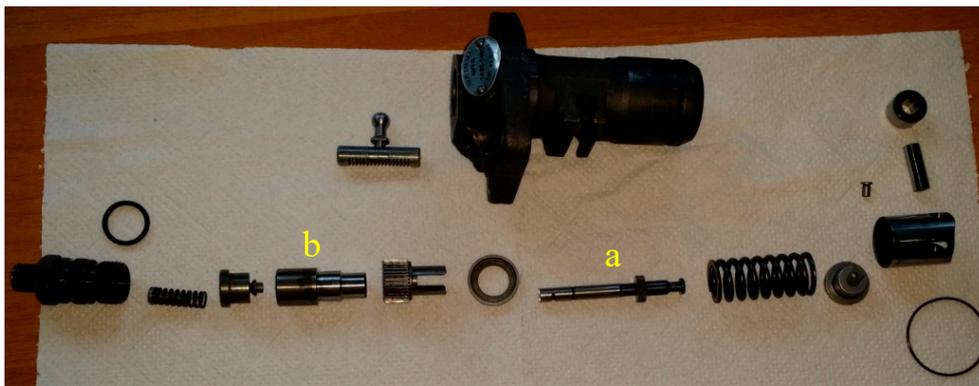
An exploded view of the inline pump of the RF91 engine is shown in Figure 5. There is only one pump element (single cylinder engine) and the components are arranged inline. The most critical components of the high-pressure pump are the plunger, Figure 5a, and the barrel, Figure 5b. The plunger is driven by the pump camshaft and reset by the plunger spring, and the plunger stroke is constant. The plunger compresses fuel as it moves upward and delivers it to the nozzle.

**Figure 5.** Exploded view of New Diesel pump. (a) plunger; (b) barrel.

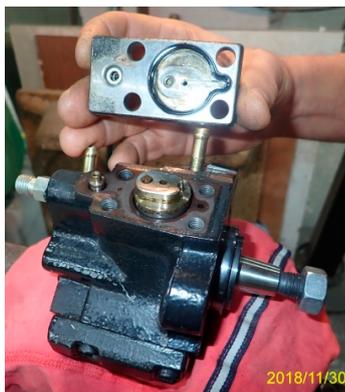
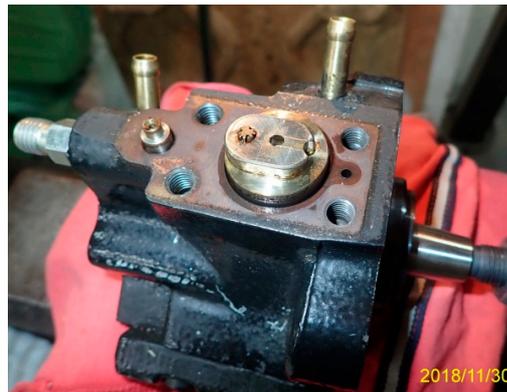
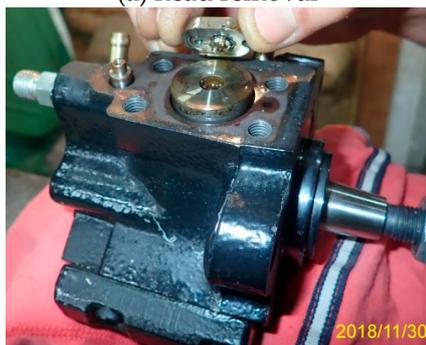
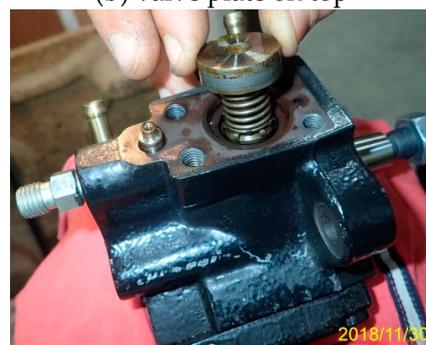
The disassembly procedure of each pumping cylinder of the CP1S pump consisted of three stages, as shown in Figure 6. At the beginning, the four overhead torx screws are removed, allowing the removal of the cast steel pump valve head, as presented in Figure 6a,b. In the second stage, as shown in Figure 6c, the steel valve plate, which includes suction and delivery valves, is removed. Finally, the pumping element is removed, which consists of plunger, barrel, and spring.

(a) head removal

(b) valve plate on top

(c) valve plate removal

(d) pumping element removal

**Figure 6.** Disassembly steps of the common-rail high-pressure pump: removal of head, valve plate, and pumping element.

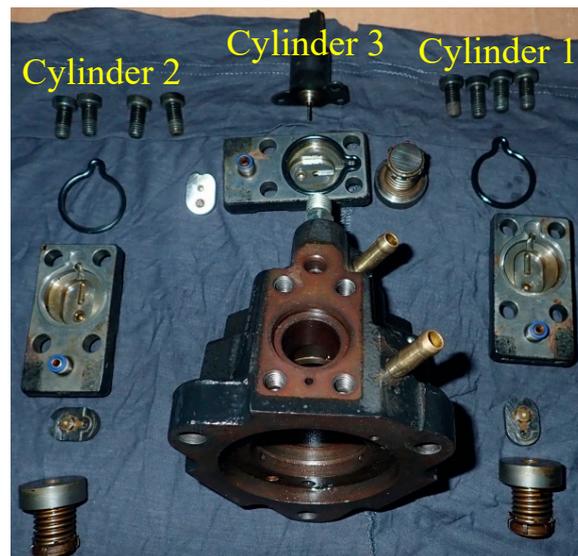
An exploded view of the dismantled pump is presented in Figure 7. The pump consists of three pumping cylinders, as described below.

**Figure 7.** Disassembly view of the Bosch CP1S high-pressure pump, showing components assessed for wear.

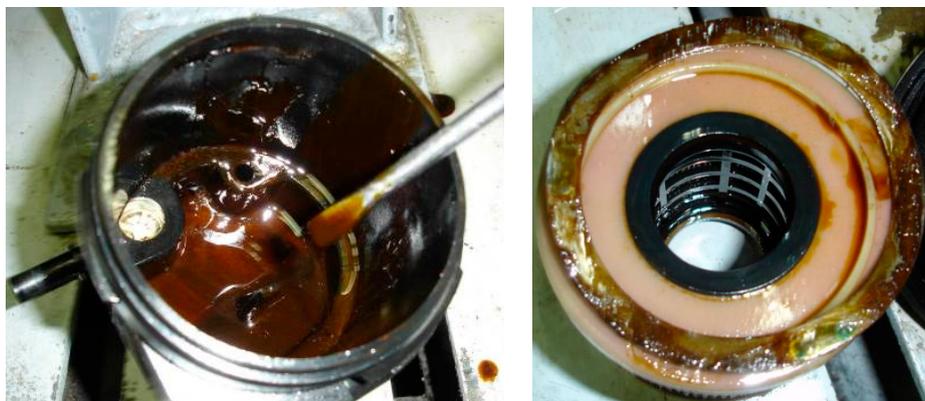
Following the fuel line, the first component of the injection system is the fuel filter, which consists of the box and the filter. Figure 8 illustrates fuel filter's condition after 150 h operation with B70 blend. It is obvious that the filter was totally plugged by sticky slurry, causing problems in the fuel flow from the filter to the high-pressure pump. A significant quantity of brown dense slurry was also found at the bottom of the filter box. This finding is in accordance with the reported results of other researchers and associations [42].

**Figure 8.** Fuel filter holder (left) and the filter cartridge (right) of the DW10 engine after 100 h operation with B70 and 50 h operation with B20 (see Table 7).

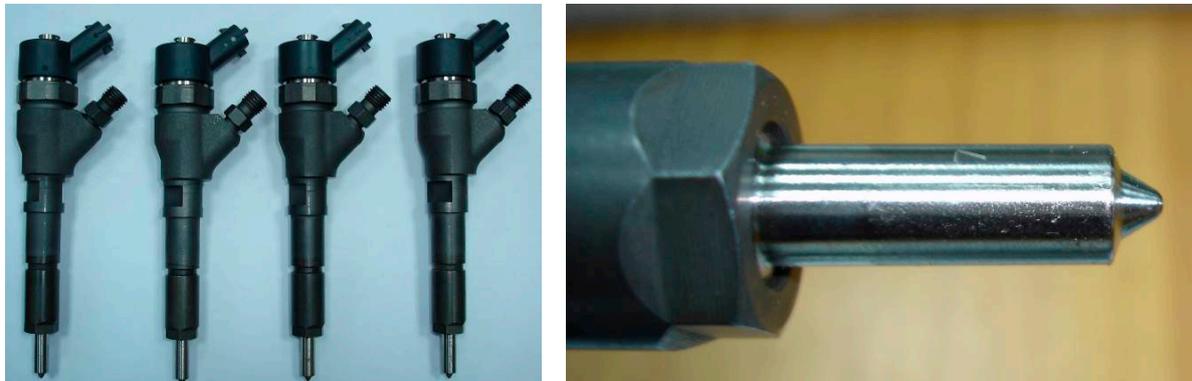
The next affected component of the injection system is the injectors. The effect of biodiesel fuel on the long-term durability of fuel pumps or injectors is an important subject for all biodiesel fleet users, since fuel injectors and especially high-pressure pumps are costly parts. A new set of DW10 common-rail injectors is shown in Figure 9.

**Figure 9.** New set of common-rail injectors (left) and injector nozzle (right).

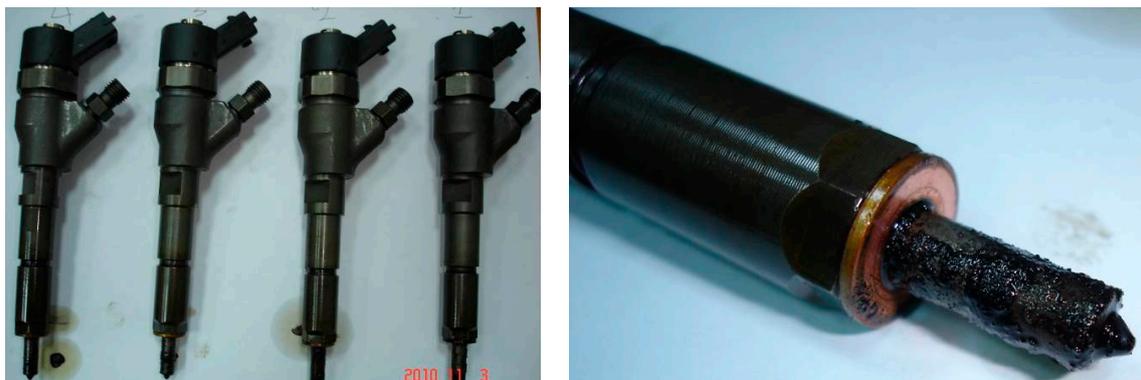
On the other hand, Figure 10 presents the condition of injectors after the prolonged testing with B70 fuel. It is obvious that the nozzle body and the holes were totally covered by a dense slurry.

**Figure 10.** Used common-rail injectors (left) and closer view of the deposits (right).

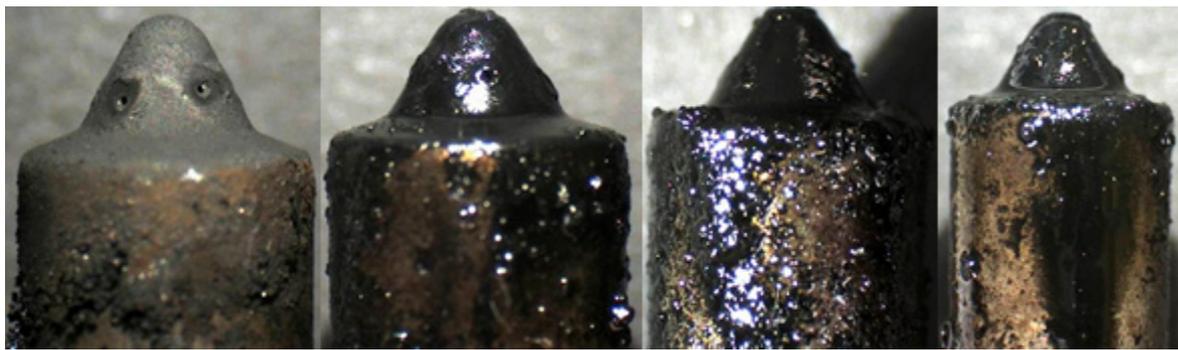
In order to better understand the impact of biodiesel, each injector was analyzed by means of low magnification optical microscopy. Several photos, magnification 10 $\times$ , of the nozzle body, tip of the nozzle, and the nozzle holes area were taken. Figure 11 shows heavy oily deposits on the injector nozzle that disturbed the flow pattern of the injected fuel. Nozzle holes were totally covered except for the first injector, whereby the holes remained open. Based on these figures, the third and fourth injectors seem to have serious operation problems.

**Figure 11.** Common-rail injectors magnified view (10×) after 100 h operation with B70 fuel.

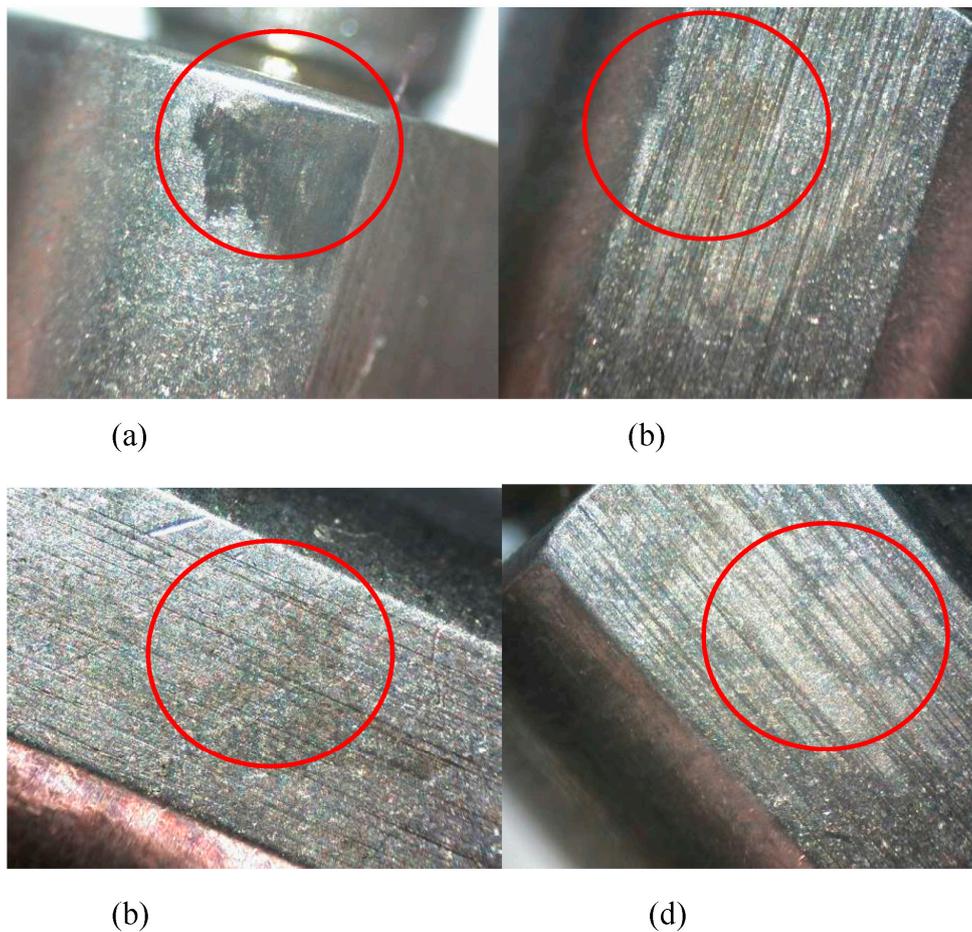
**Figure 12.** Magnified view (10×) of the injector plungers.

Even though biodiesel provides better lubricity than diesel, corrosive wear and friction increase due to absorbing moisture. Biodiesel is more hygroscopic than diesel fuel and it attracts moisture, causing hydrolysis and the formation of organic acids and bacteria.

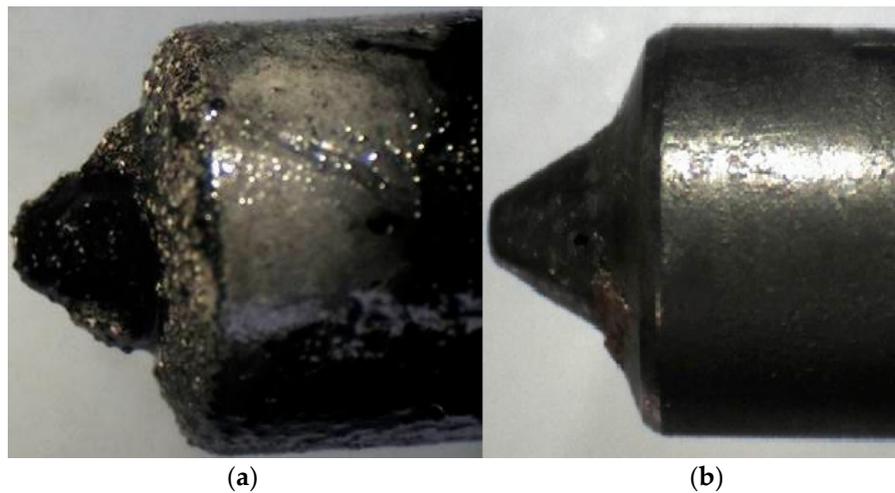
Taking into account the previous findings, the same procedure was applied to the RF91 mechanical injector. Figure 13 presents a comparative view of the injector after 100 h operation with biodiesel blends. The nozzle holes area and the nozzle body were covered by oily deposits and white additive ash, influencing injection and combustion efficiency.

**Figure 13.** RF91 nozzle tip magnified (a) after 100 h operation with B20 and B50, including 50 ppm cerium-doped fuel additive; and (b) after ultrasonic cleaning.

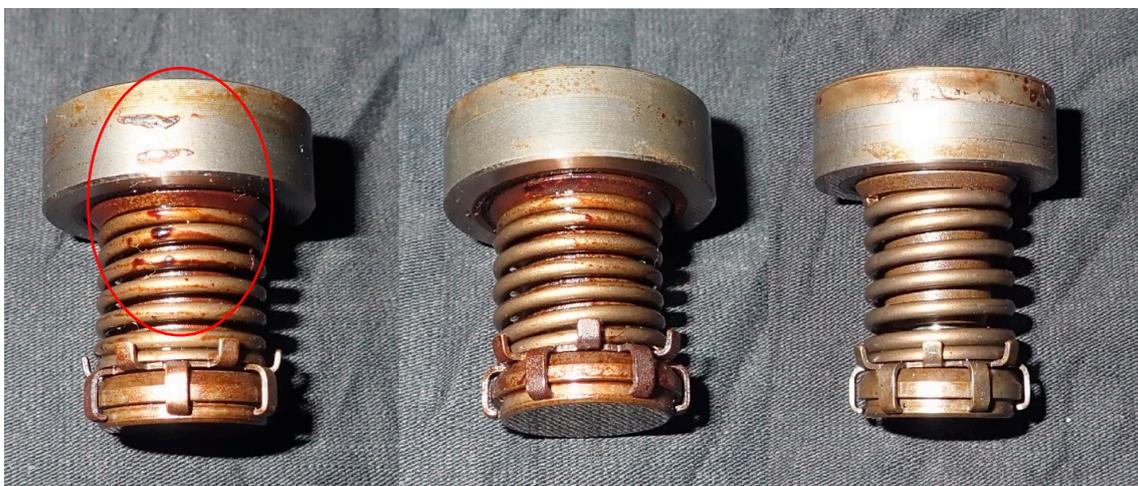
As reported above, the critical failure was that of the high-pressure pump. A summary of the diagnosis procedure is presented below. As reported in [43], in October 2010, after repeated failures to start, a thorough inspection of the fuel lines and injection system was carried out. The findings were presented above. Starting from the fuel filter, a significant quantity of dense slurry rich in fatty esters was observed. After cleaning the fuel filter, the fuel injectors were removed. The injector's nozzle and holes were found covered by heavy, oily carbon deposits. Proceeding with disassembling the set of injectors, a certain quantity of the same oily deposit was found in the needle tip. After installing a new set of fuel injectors, the engine still could not start and the indication from the ETAS-INCA [44] interface was zero rail pressure. Inspection continued with the high-pressure fuel lines and the common-rail without any important findings. Finally, the high-pressure fuel pump was examined and it was found that all fuel was diverted to the return line. Dismantled dirty components of CP1S pump are presented in Figures 14–17. Examination of the fuel pump parts revealed a thin brownish lacquer coating on the barrel and the internal cavities of the valve head. The lacquer was hard, dry, and could be removed by way of an ultrasonic bath. In addition, there were sticky dark brown and black particles on the barrel, spring, and valve chamber, as indicated by the red circles in Figures 14 and 16, respectively.

**Figure 14.** Pumping elements of the CP1S pump cylinders (barrel, plunger, spring). Two out of the three elements were stuck in the Top Dead Center position (end of delivery stroke).

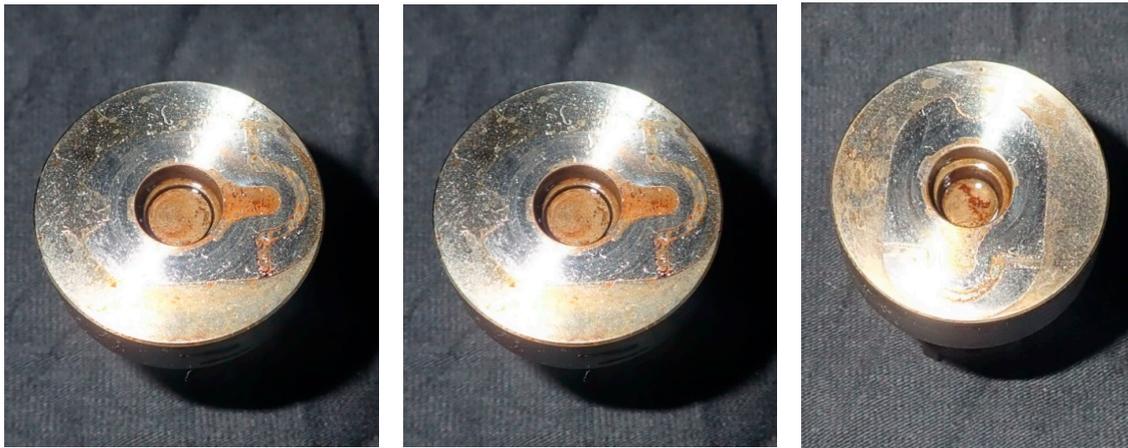
**Figure 15.** Top view of pumping elements covered by gummy deposits.

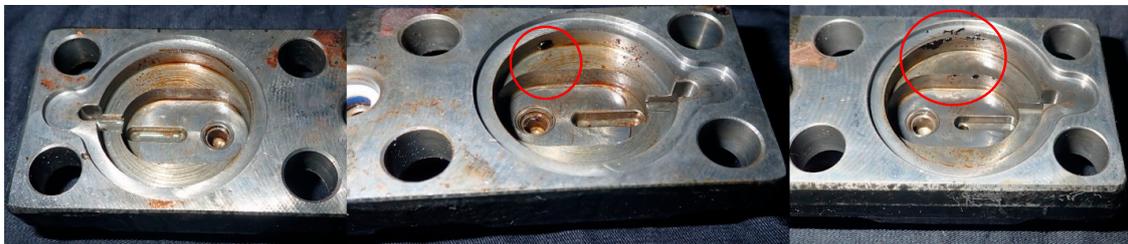
**Figure 16.** Affected valve heads. Black sticky particles were observed in two of them.

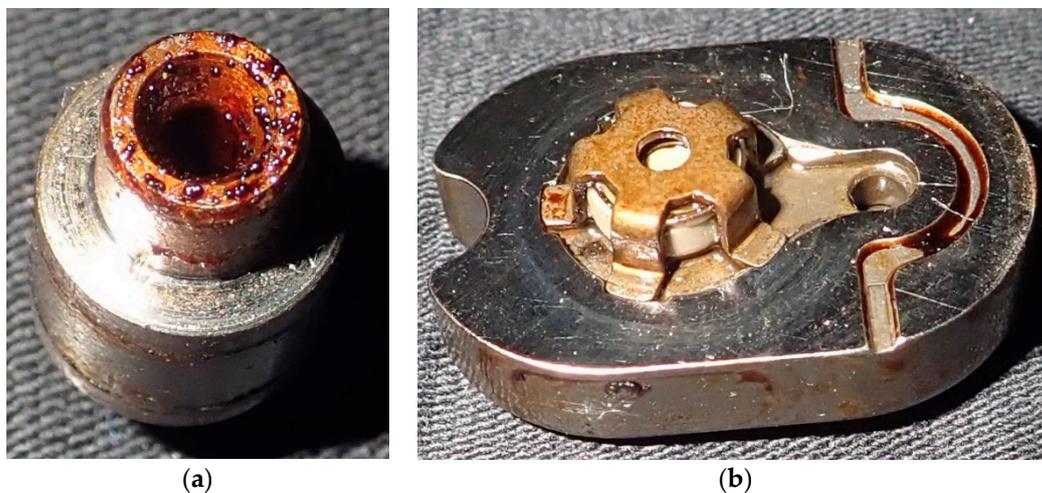
**Figure 17.** High-pressure delivery tube (a) and delivery valve (b) of the third cylinder, which were totally covered by sticky deposits.

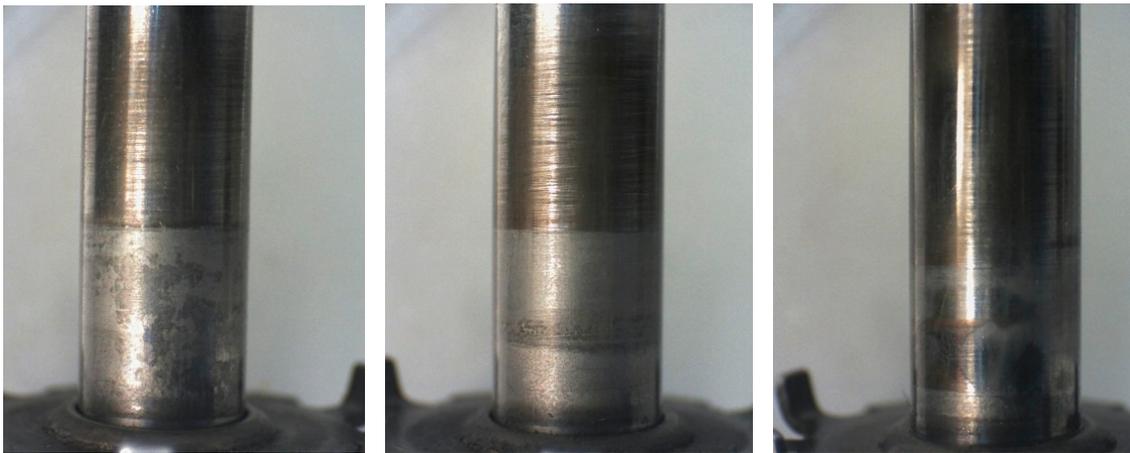
It should be noted that in this type of pump (CP1S) the plunger is not subjected to a purely axial load. Thus, a certain degree of surface wear may be present, which is enhanced by the presence of biofuel, as shown in Figure 18. The most important parameter when one deals with fuel-injection system parts is the surface roughness of the high-pressure mating components. It is important to investigate if any deterioration is present. The surface areas positioned close to the bottom of the pump plungers and to the top of barrels were examined with optical microscopy.

**Figure 18.** Magnified view (10×) of the clean pump plungers.

It can be clearly seen that first plunger (to the left) was found in the worst condition. Only the third one (Figure 18, right) shows the characteristic bright appearance of the chromium plating (20  $\mu\text{m}$ ). Furthermore, the wear on barrels was localized in the fuel flow line and appeared in the form of brown imprints that should be attributed to the corrosive behavior of biodiesel, as presented in Figure 19.

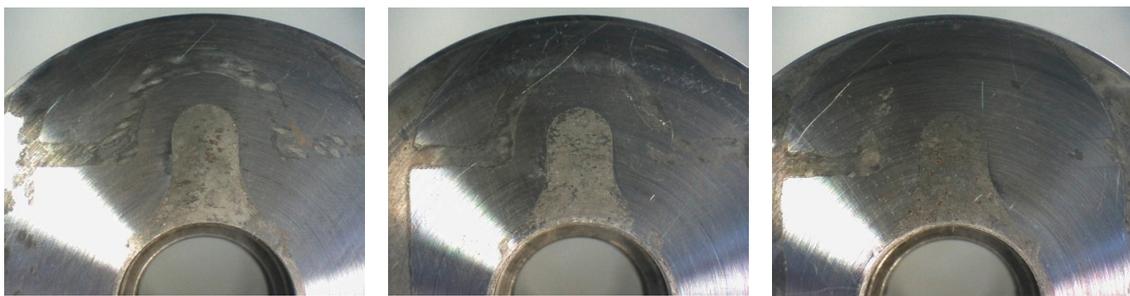
**Figure 19.** Magnified top view (10×) of the clean pump barrels.

As shown in Figure 19, the first pump barrel was, again, in the worst condition in regards to surface corrosion, and the third one was in the best condition.

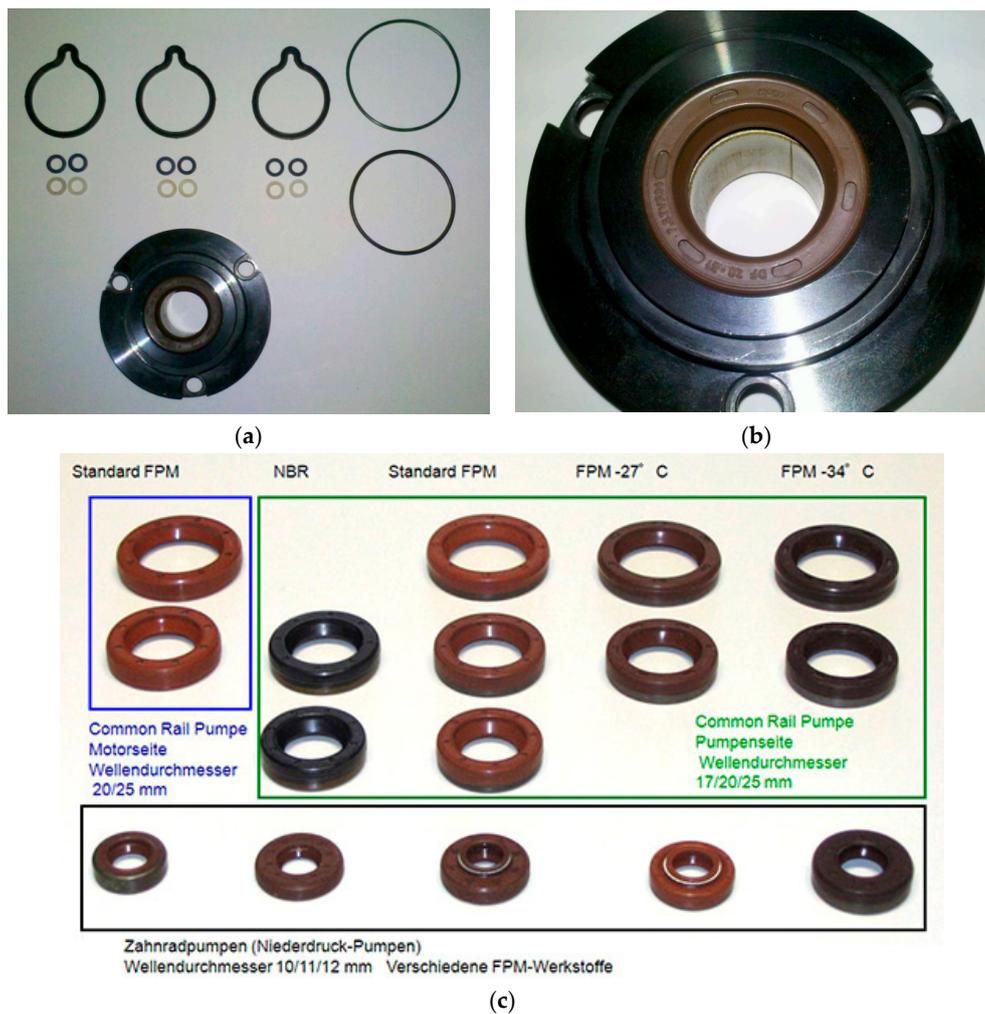
After careful inspection of the pump head gaskets, delivery ports gaskets, teflon washers, camshaft housing, O-rings, and the drive shaft seal, it was concluded that no significant wear from oxidation or swelling were present, and no visible leaks were observed (Figure 20a,b).

Gaskets and O-rings are made by Nitrile and Fluorocarbon elastomer compounds, which are compatible with biodiesel. Taking into account the seal manufacturer's technical notes [45], it becomes obvious that their sealing compound is fluorocarbon. The drive shaft seal type is indicated with red boxes. According to the specialized literature [19,46], these compounds would be expected to deteriorate after prolonged use and/or high-percentage biodiesel blends. However, in our case, no significant deterioration or swelling was observed, which is expected due to the limited hours of testing. Thus, the main damage to the pump remains the sticking of two out of the three unit-pump plungers on their barrels, close to their TDC positions, and the additional sticking of the suction and delivery valves for all three pump units.

**Figure 20.** Elastomer parts of CP1S pump (gaskets, O-rings, washers, and seal). (a) pump gaskets and o-rings; (b) pump drive shaft seal; (c) materials employed in diesel fuel pump shaft seals [44].

Based on the above findings, which agree with experience from other researchers [27,47,48], it would not be wise to exploit the full range of biodiesel blending with these types of engines until the required fuel system modifications are decided by the manufacturers. A maximum blending of 20% on average would be a more conservative approach.

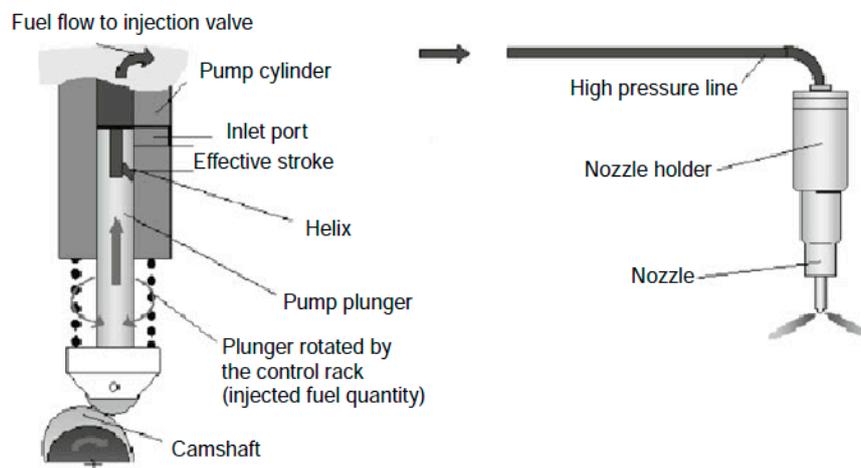
The design and principle of the operation of the pump-in-line system employed in the RF91 single cylinder engine is shown in Figure 21.

**Figure 21.** Design and functional principle of the inline pump injection system.

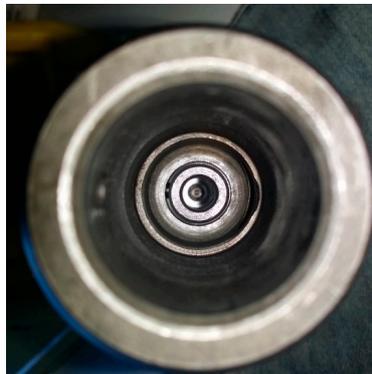
Analogous findings with the previous case were observed in the unit pump of the single cylinder engine. The pump plunger was stuck at the top dead center position (see Figure 22, view from the top, and Figure 23, right, after the dismantling of the plunger). Deposits were found also on the inside of the pump housing (Figure 23). Signs of wear were also visible on the pump cylinder (Figure 24) and the plunger's surface (Figure 25).

Figure 22. Closer view of the New Diesel pump's stuck plunger.

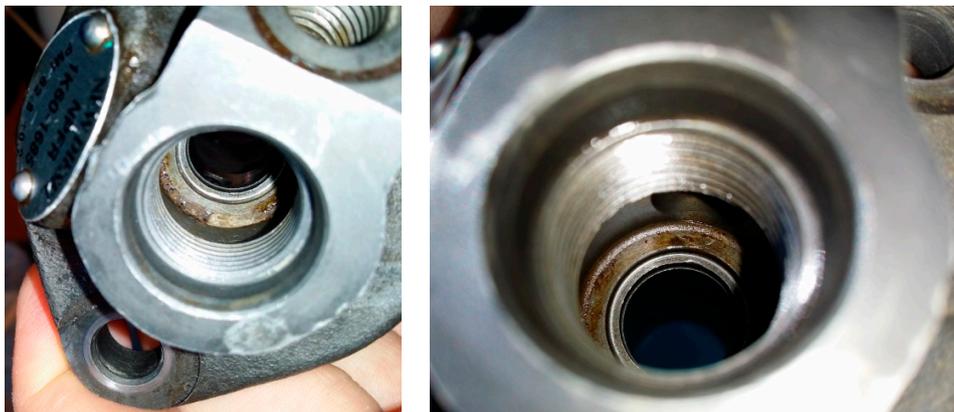
Figure 23. Inside view of the pump housing. Gummy deposits are present.

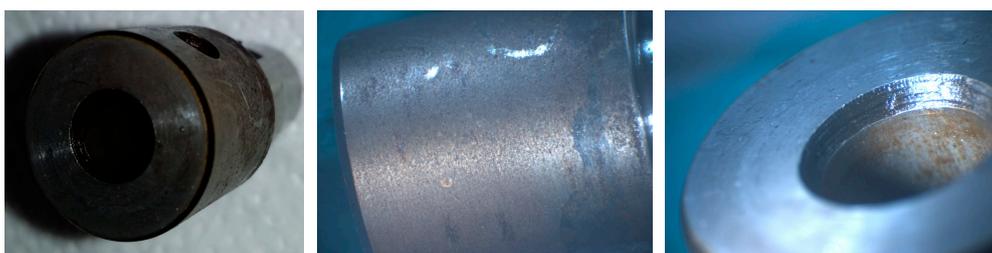
As reported above, the surface quality of precision assemblies in the injection pump has a large impact on the proper operation of the engine. Both the plunger and the barrel of the pumping section are adjusted, so that the gap between the side surface of the plunger and the inner surface of the barrel is approximately 2–5  $\mu\text{m}$ . This clearance provides sufficient lubrication of the side surfaces of the plunger and barrel, while still providing enough sealing to maintain the high-pressure of fuel. The penetration of slurry deposits between the surface of the plunger and the barrel can cause the sticking of the pumping elements, as was the case with the reported findings. The sticking of pumping elements was repeatedly observed after operation with high-percentage biodiesel blends and the shutdown of the engines for a period of two months or more. Moreover, this damage happened in two fuel pumps of different technologies and injection pressures.

Figure 24. Details of wear on the pump cylinder.

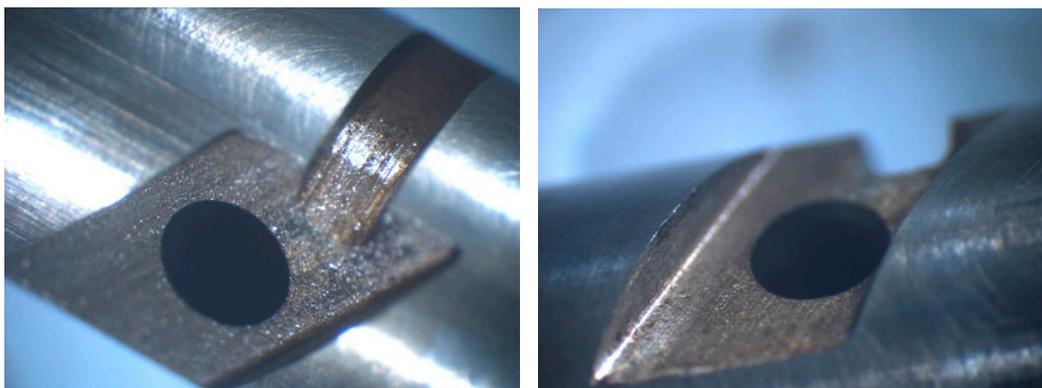
Figure 25. Details of wear on the plunger.
