Article

Internal Cracks and Non-Metallic Inclusions as Root Causes of Casting Failure in Sugar Mill Roller Shafts

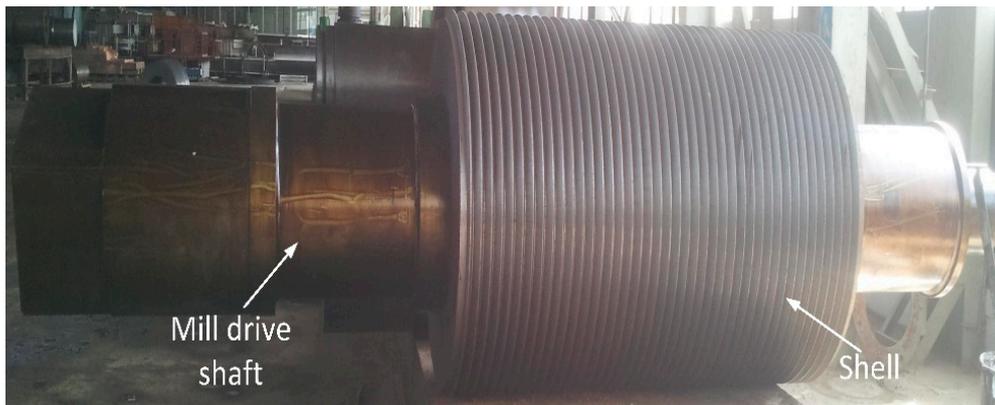
Figure 1. Sugar mill roller shaft with final groove ready for shipment.

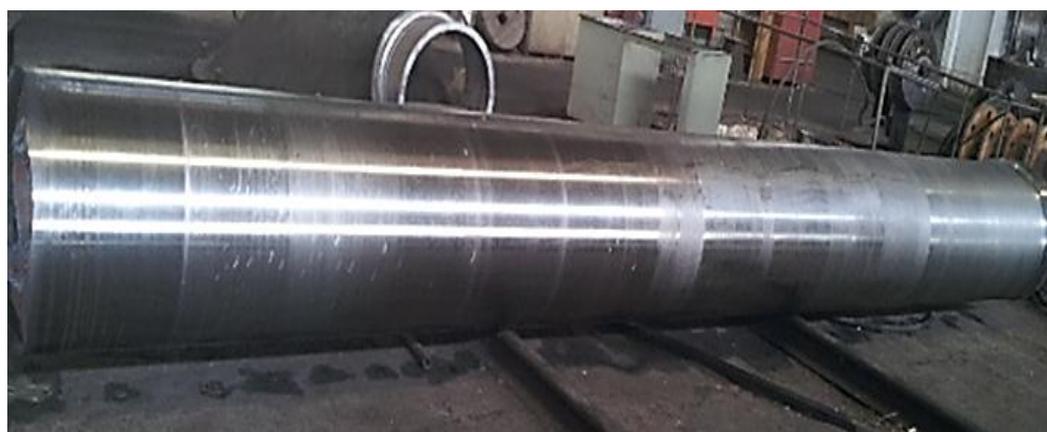
During the scanning of the component, a few indications were found to be above the DAC curve, within 12.7 mm. Based on the indication pattern, the scanned component on the DAC curve showed an indication of flaw. Ultrasonic testing precisely indicates subsurface cracks/discontinuities and the possibility of nonmetallic inclusions [36]. UT measurement was performed twice to validate the presence of cracks and inclusions. The presence of cracks was observed under the supervision of the local industry quality control department non-destructive testing (NDT-64). The NDT-64 reports of the shaft under observation showed non-metallic inclusions and deep internal cracks at a depth of 95~230 mm, randomly distributed throughout the shaft length of 2695 mm (details in Figure 7). For further clarification, UT testing was performed under the supervision of a multi-national quality control department (NDT-65). So, rejection was ensured with the identification of a flaw with its position. NDT-65 depicted internal cracks within the depth of 125~270 mm, randomly distributed through the length of 2710 mm. Based on the detection of cracks and foreign particles, the rough machined ingot was rejected.

Figure 7. (a) A rough machined shaft that was rejected after UT inspection; (b) UT report locating internal cracks and foreign particle inclusions under duplicate measurements.
