Article

GFRP Bars Anchorage Resistance in a GFRP-Reinforced Concrete Bridge Barrier

Abstract: In the present paper, experimental and numerical investigations were conducted on concrete bridge barriers utilizing glass fiber reinforced polymer (GFRP) bars with a hook at their ends. Implementation of these hooked bars instead of the bent bars or headed-end bars in the bridge barriers presented in the Canadian Highway Bridge Design Code (CHBDC) was investigated on American Association for State Highway and Transportation Officials (AASHTO) test level 5 (TL-5) concrete bridge barriers. This research aimed to reach a cost effective and safe anchorage method for GFRP bars at the barrier–deck junction, compared to the conventional bend bars or headed-end bars. Therefore, an experimental program was developed and performed to qualify the use of the recently-developed, small radius hooked bars at the barrier–deck junction. The experimental findings were compared with the design factored applied transverse load specified in CHBDC for the design of the barrier–deck junction as well as factored applied bending moment obtained at the barrier–deck junction using a recently-conducted finite-elem

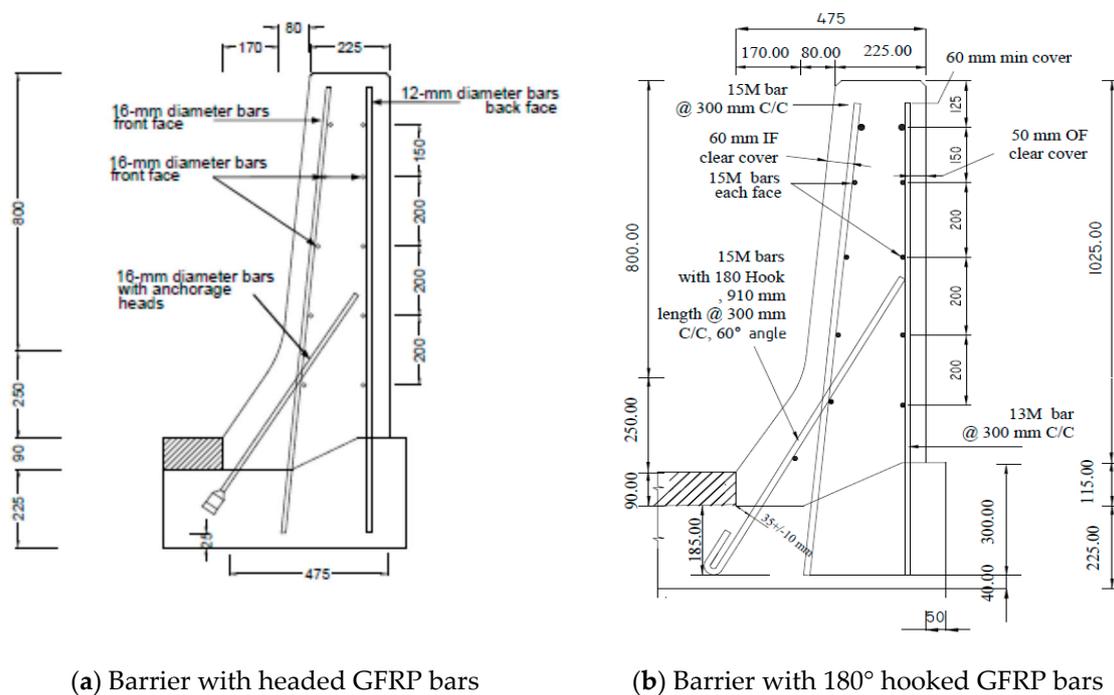
Figure 1. Reinforcement details of AASHTO test level 5 (TL-5) barrier reinforced with glass fiber reinforced polymer (GFRP) bars with headed ends and 180° hooks. (a) Barrier with headed GFRP bars; (b) Barrier with 180° hooked GFRP bars.

Figure 1a shows the sand-coated GFRP bar details of the crash tested barrier utilizing headed-end bars at the barrier–deck junction [1]. The manufacturer of the headed-end bars has recently used a twisted roving method to develop a GFRP bar with a 180° hook with reduced radius, to reduce the cost associated with the use of the headed-end bars at the barrier–deck junction. An alternative design for the barrier wall is presented in Figure 1b, showing the revised details of the TL-5 barrier by replacing the headed bar shown in Figure 1a with a hooked bar. The developed hook shown in Figure 2 has an inner radius of 22.5 mm and a length of 100 mm. Table 1 summarizes the material properties of the GFRP bars used in the present study, as obtained from the manufacturer [16]. The 185 mm vertical embedment length into the deck slab cantilever was considered given the fact that the typical slab thickness used by Ontario Ministry of Transportation in Ontario bridges is 225 mm, with the difference between then representing the proper concrete cover between the bottom of the bar and the bottom surface of the deck slab.

To qualify the revised barrier design in Figure 1b, experimental tests were conducted to ensure that the capacity of barrier–deck junction satisfied Canadian Highway Bridge Design Code (4) requirements. CHBDC specifies transverse, longitudinal, and vertical loads of 210, 70 and 90 kN, respectively, for design of a TL-5 barrier–deck anchorage. By inspection, the transverse load simulating vehicle impact is the only load out of these three load components that affects the barrier–deck joint design. As such, the factored design transverse load to be compared with the barrier experimental load carrying capacity was 357 kN, considering a 1.7 load factor, distributed over 2400 mm length in the direction of traffic and at a height of 990 mm over the deck slab top surface.

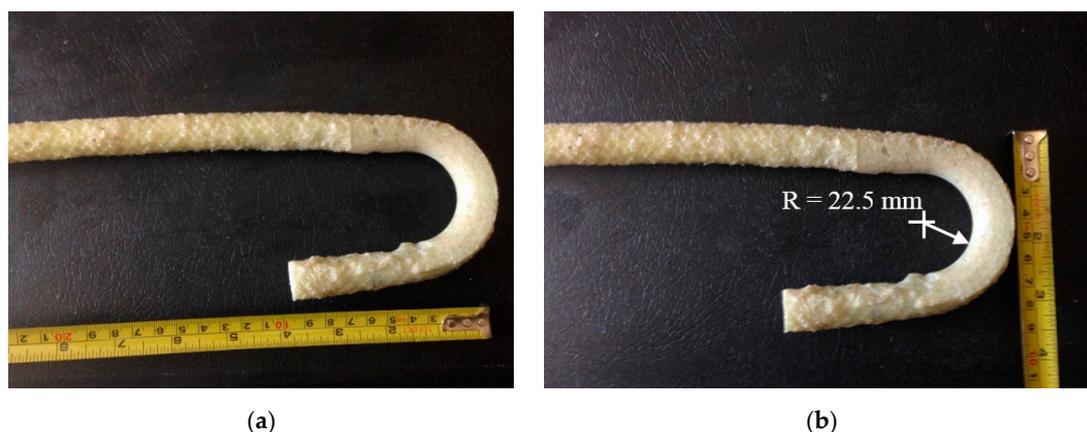
Figure 2. Views of the developed GFRP bar with 180° hook. (a) length of the hook; (b) radius of the hook.

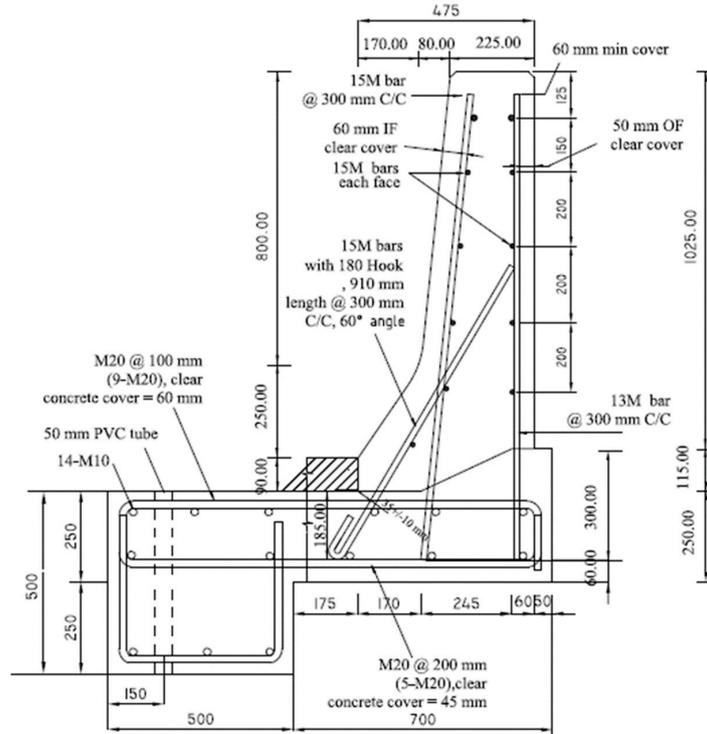
Figure 3. Specimen # 1: Interior location of barrier connected to a cantilever slab (hooks facing the roadway).

Five TL-5 barrier specimens of 900 mm length were constructed and tested by the authors to collapse at Ryerson University’s Structures laboratory to determine their failure patterns and load carrying capacities. Figures 3–7 show cross-section dimensions and GFRP bar arrangement for the five specimens (Specimens # 1 through # 5). The difference between Specimen # 1 and # 2 was the orientation of the 180° hooks embedded in the deck slab, which were towards the roadway and towards the outer face of the barrier in Specimens # 1 and # 2, respectively (both specimens represent the interior location in parapets). In these specimens, the vertical GFRP bars at the front and back faces of the barrier wall were made of 15M and 13M bars at 300 mm spacing, respectively, representing the interior segment of a barrier wall. Specimen # 3 showed the end segment of a barrier, with double vertical reinforcement at the front face only, while bar size and spacing in the barrier wall were otherwise identical to those in Specimens # 1 and 2. It should be noted that Specimens # 1 through 3 rested over a deck slab cantilever of length 700 mm, representing the case of slab-on-girder bridge barrier construction. On the other hand, a barrier wall may be built over a non-deformable slab, which is the case of barrier walls cast over voided slab, solid slab, or side-by-side box beam bridges. Specimen # 4 was similar to Specimen # 1, except that the barrier wall was built integrally over a 500 mm thick slab.

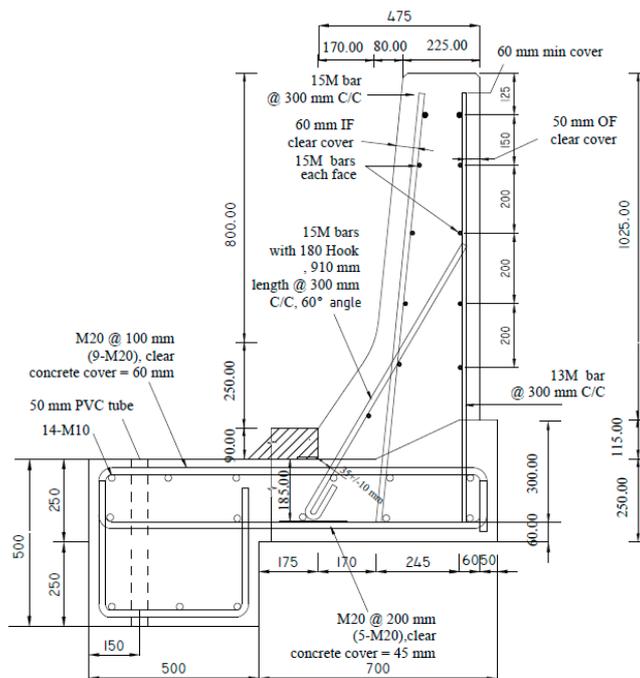
Figure 4. Specimen # 2: Interior location of barrier connected to a thin cantilever slab (hooks not facing roadway).

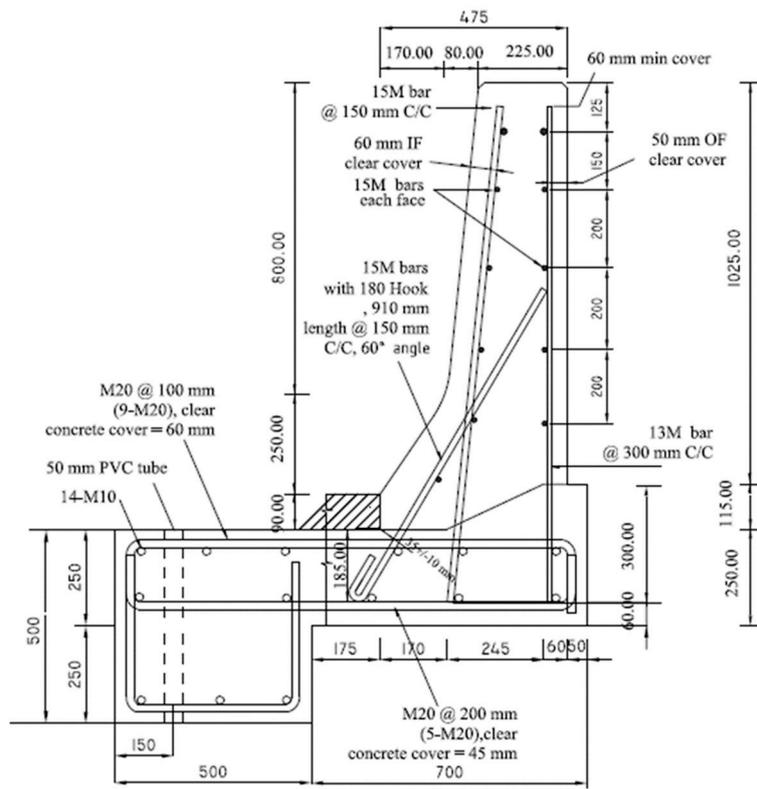
Figure 5. Specimen # 3: End location of barrier connected to a cantilever slab.

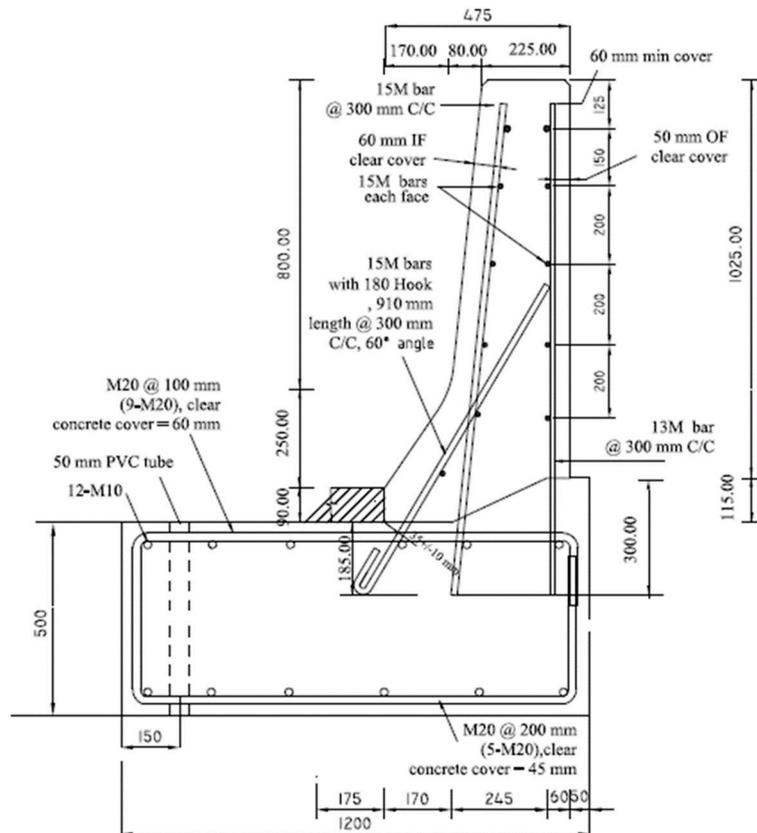
Figure 6. Specimen # 4: Interior location of barrier connected to a non-deformable slab.

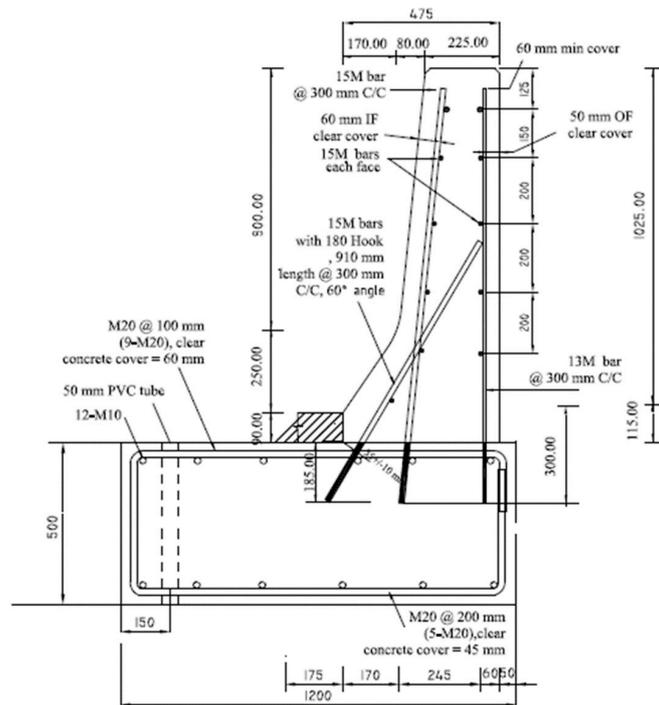
Figure 7. Specimen # 5: Interior location of the barrier connected to a non-deformable slab using post-installed bars.

Specimen # 5 was built to showcase the implementation of replacing the barrier wall in existing bridges with a post-installed barrier wall, using post-installed GFRP bars. HIT RE 500 epoxy was used for post-installation in this case. Figure 8 shows views of the formwork and bar arrangement for each barrier specimen.

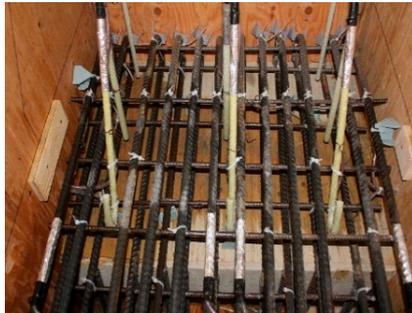
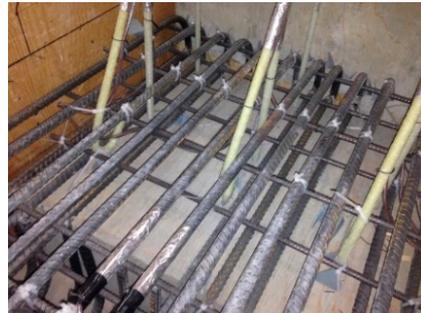
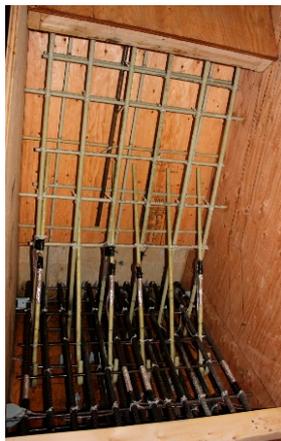
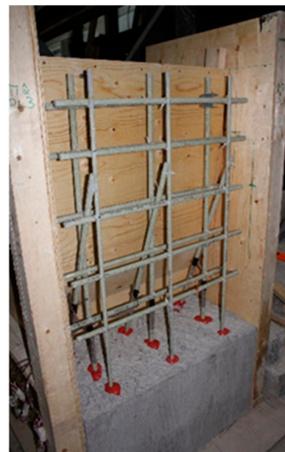
Figure 8. Views of the formwork and reinforcement details. (a) Specimen # 1; (b) Specimen # 2; (c) Specimen # 3; (d) Specimen # 5.

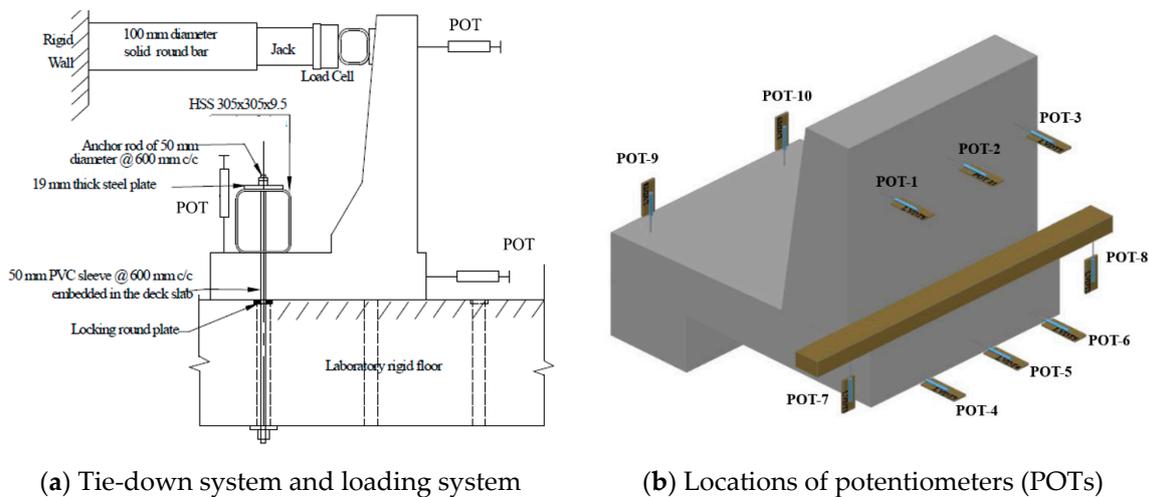
Figure 9. Test setup. (a) Tie-down system and loading system; (b) locations of potentiometers (POTs).

Based on tested concrete cylinders on the day of casting, the average compressive strengths of concrete were 43, 40, 39, 49 and 52 MPa for Specimens # 1 to # 5, respectively, while the characteristic concrete strengths were 37, 35, 38, 45 and 44 MPa, respectively [4]. Each barrier specimen was tied down to the strong floor in the structures lab according to the test setup shown in Figure 9a. Strain gauges were installed in a few GFRP bars and on the concrete surface to record strains at critical locations with increase in applied transverse loading. Figure 9b shows the arrangement of potentiometers (POTs) to record lateral deflection of the barrier wall, vertical deflection of the cantilever slab, specimen uplift at the tie-down location, and transverse movement of the deck slab. The transverse loading was applied in increments at 990 mm from the top surface of the slab until collapse. The specimen was considered failed when it could not take any more load.

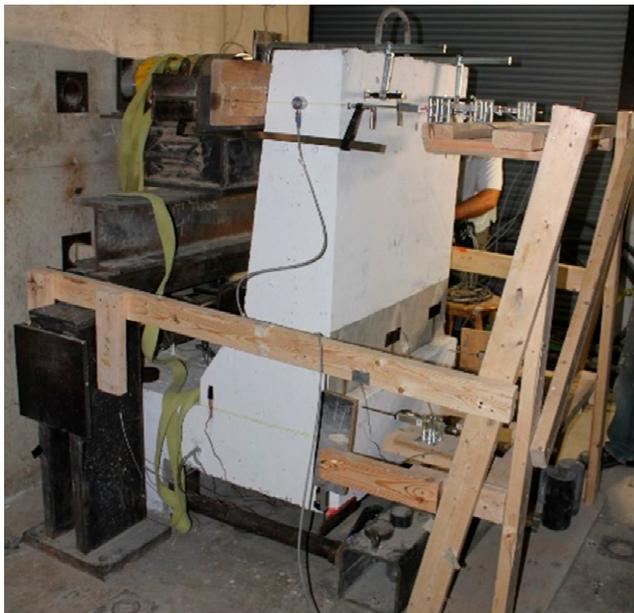
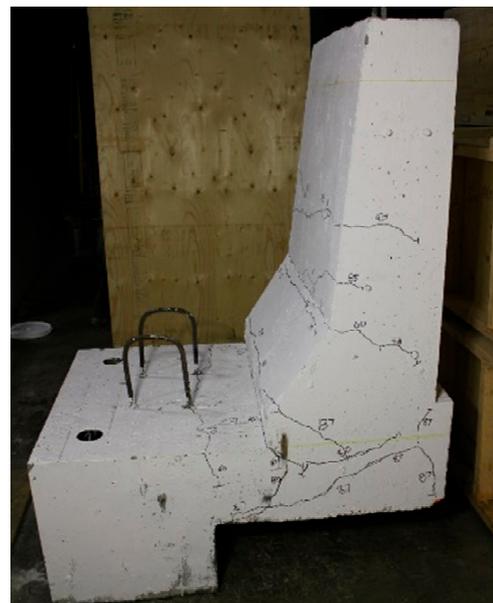
Figure 10. Specimen # 1 before and after testing. (a) Test setup; (b) crack pattern at failure.

The photos of crack patterns at failure and test setups for Specimens # 1 to # 5 are shown in Figure 10, Figure 14, Figure 18, Figure 22 and Figure 26, respectively. Table 3 summarizes the concrete cracking history during the tests. The load–displacement relationship for Specimen # 1 (shown in Figure 10) is depicted in Figure 11. It can be observed that the average deck slab uplift and the horizontal movement at failure were equal to about 7.0 and 13.6 mm, respectively, which was acceptable as they were not affecting the structural behavior of the barrier. The maximum lateral and vertical deflections of the barrier wall at failure were recorded as 50.78 and 19.59 mm, respectively. Tensile strains in the diagonal GFRP bars at the front face are shown in Figure 12, where strain gauges were located at 115 mm above the top surface of the cantilever slab. Average strain in the hooked bars and the adjacent middle bars at failure were recorded as 5487 and 4325 $\mu\epsilon$, compared to ultimate strain of the GFRP bars of 20,000 $\mu\epsilon$ (per the manufacturer’s document). The relationship between load and strain in the concrete is shown in Figure 13, as obtained from strain gauges located 115 mm above the top surface of the cantilever slab and at the front face of the barrier wall. Concrete compressive strain at failure was 1193 $\mu\epsilon$, compared to ultimate concrete strain at failure of 3500 $\mu\epsilon$. The tensile strain at failure in the steel bars at the fixed end of the cantilever deck slab was 1461 $\mu\epsilon$, compared to the steel yield strain of 2000 $\mu\epsilon$. The failure of the barrier–deck junction was due to diagonal tension cracking in the deck slab cantilever just under the barrier wall, as depicted in Figure 10b.

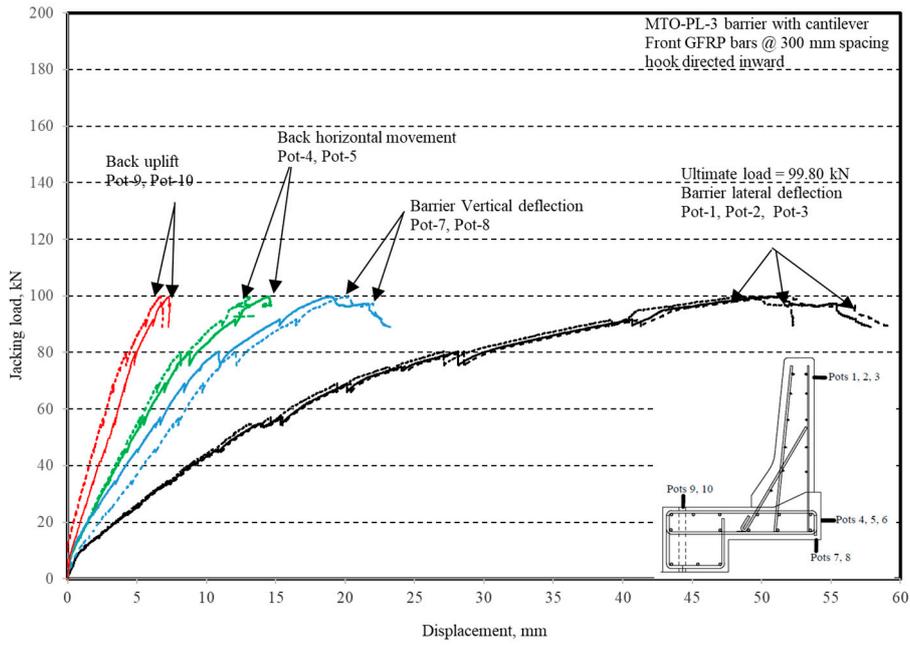
Figure 11. Specimen # 1: Load vs. displacement history.

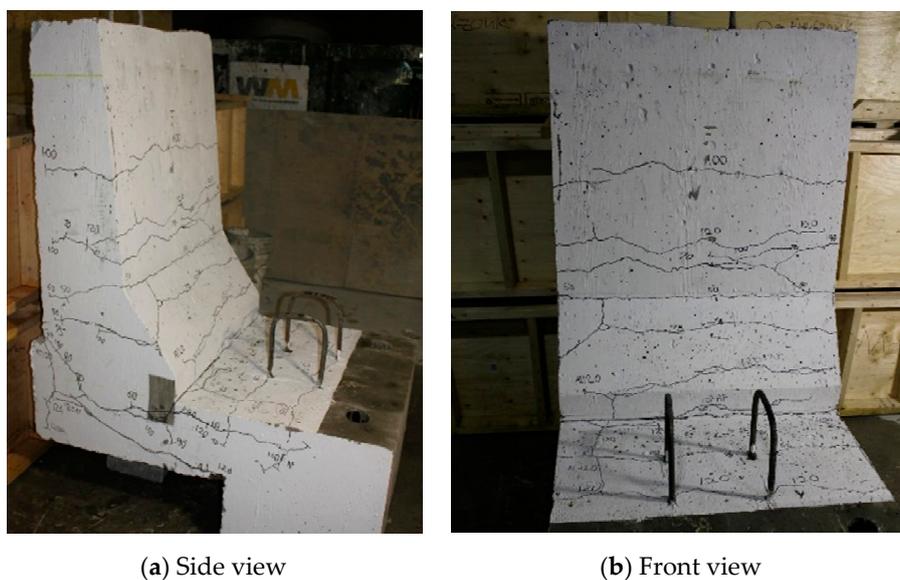
Figure 14. Specimen # 2 crack pattern. (a) Side view; (b) front view.

The load–displacement relationship for Specimen # 2 (shown in Figure 14) is depicted in Figure 15. One may observe that the average deck slab uplift and the horizontal movement at failure were equal to about 5.54 and 9.72 mm, respectively, which was acceptable as they were not affecting the structural behavior of the barrier. Maximum lateral deflection of the barrier wall at failure was 48.80 mm and the

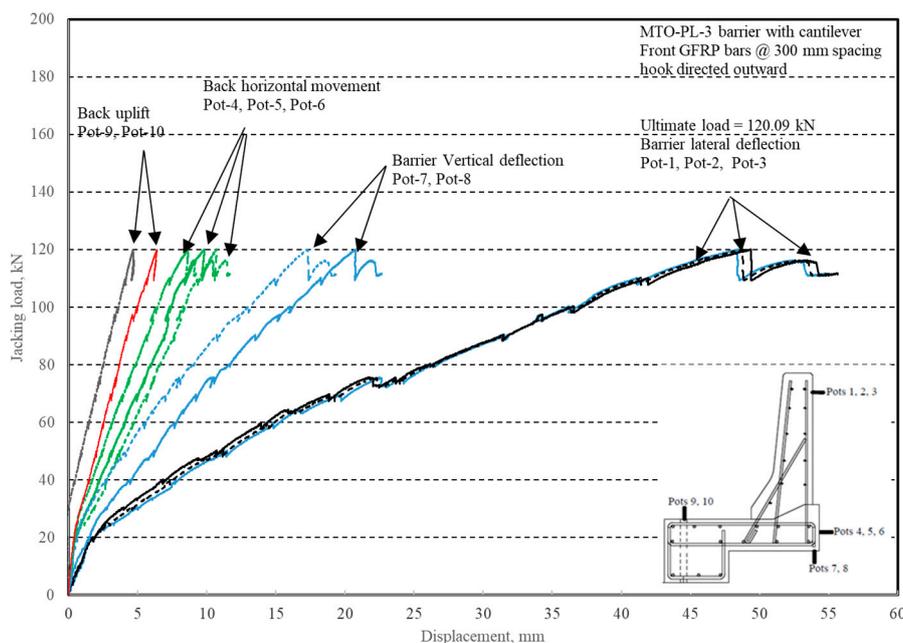
Figure 15. Specimen # 2: Load vs. displacement history.

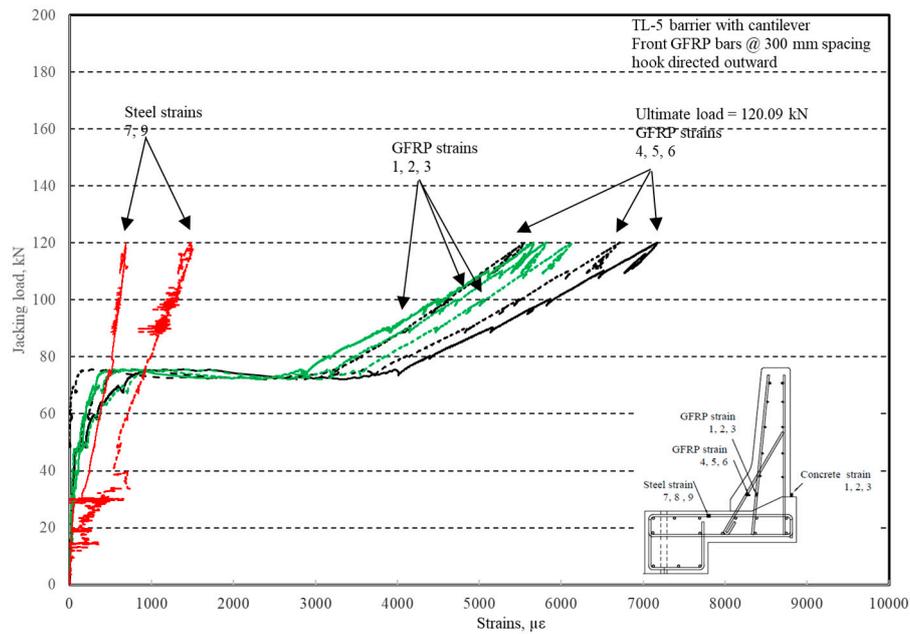
Figure 16. Specimen # 2: Load vs. bar strain history.

barrier vertical deflection was 19.02 mm. Tensile strains in the diagonal GFRP bars at the front face are shown in Figure 16. Average strains in the hooked bars and the adjacent middle bars at failure were 6564.6 and 5780.3 $\mu\epsilon$, compared to ultimate strain of the GFRP bars of 20,000 $\mu\epsilon$. The relationship between load and strain in the concrete is shown in Figure 17. Concrete compressive strain at failure was recorded as 1524 $\mu\epsilon$, compared to ultimate concrete strain at failure of 3500 $\mu\epsilon$. The tensile strain at failure in the steel bars at the fixed end of the cantilever deck slab was 1001.5 $\mu\epsilon$, compared to the steel yield strain of 2000 $\mu\epsilon$. Failure of the barrier–deck junction was due to diagonal tension in the deck slab cantilever just under the barrier wall. One may observe that the barrier–deck anchorage capacity increased by 20% only when the hooks faced the outer face of the barrier, compared to the arrangement on which the hooks faced towards the traffic side in Specimen # 1. This may be attributed to greater confinement to the concrete in the deck slab under the barrier wall associated with orienting the hook to the back side of the wall, thus delaying the diagonal tension failure in this region to a higher load.

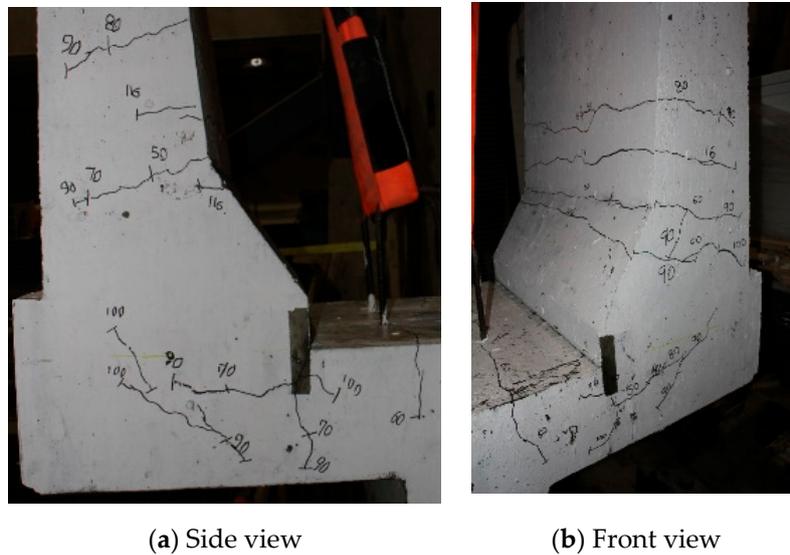
Figure 18. Specimen # 3: crack pattern. (a) Side view; (b) front view.

The load–displacement relationship for Specimen # 3 (shown in Figure 18) is depicted in Figure 19. It was noted that the average deck slab uplift and the horizontal movement at failure were equal to 6.56 and 11.51 mm, respectively, which was acceptable as they were not affecting the structural behavior of the barrier. Maximum lateral deflection of the barrier wall at failure was 49.06 mm and the barrier vertical deflection was 21.97 mm. Tensile strains in the diagonal GFRP bars at the front face are shown in Figure 20. It was observed that the average strains in the hooked bars and the adjacent middle bars at failure were 3459 and 1874 $\mu\epsilon$, compared to ultimate strain of the GFRP bars of 20,000 $\mu\epsilon$. The relationship between load and strain in the concrete is shown in Figure 21. Concrete compressive strain at failure was recorded as 1238 $\mu\epsilon$, compared to ultimate concrete strain at failure of 3500 $\mu\epsilon$. Failure of the barrier–deck junction was due to diagonal tension cracking in the deck slab cantilever

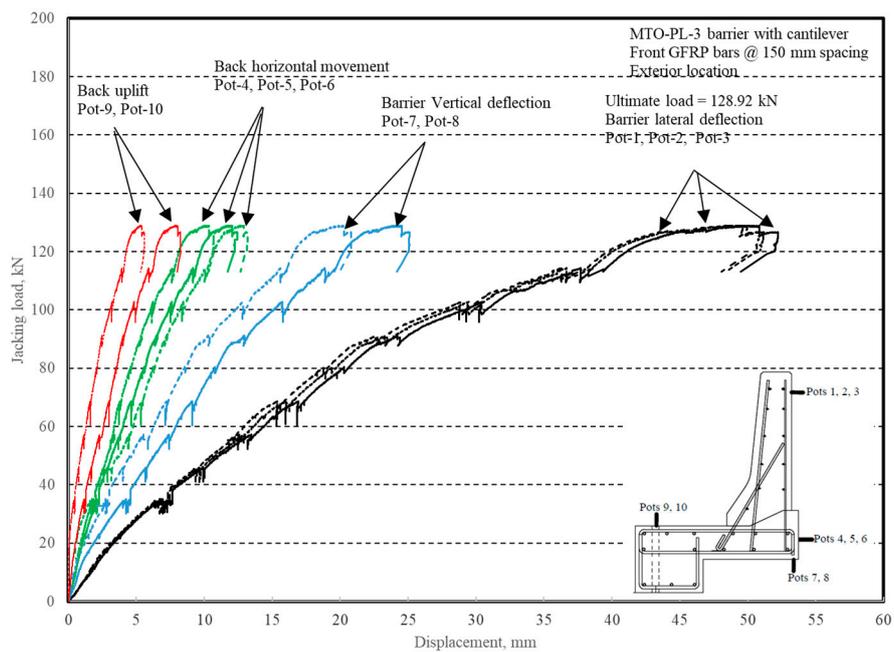
Figure 19. Specimen # 3: Load vs. displacement history.

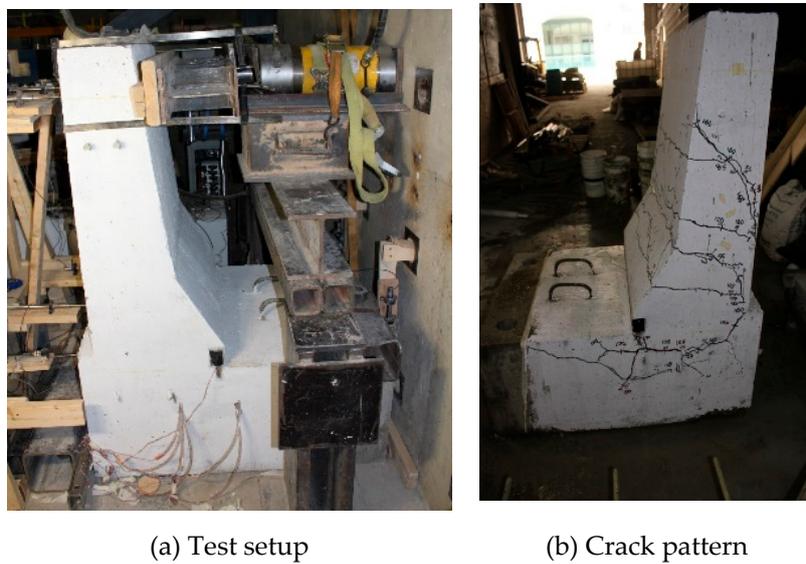
Figure 22. Specimen # 4 before and after testing. (a) Test setup; (b) crack pattern.

The load–displacement relationship for Specimen # 4 (shown in Figure 22), with a 500 mm thick deck slab, is depicted in Figure 23. The average deck slab uplift and the horizontal movement at failure were recorded as 1.40 and 3.42 mm, respectively, which was acceptable as they were not affecting the structural behavior of the barrier. Maximum lateral deflection of the barrier wall at failure was 30.50 mm, which was very much smaller than that for Specimen # 1 with a cantilever deck slab. Tensile strains in the diagonal GFRP bars at the front face are shown in Figure 24. Average strains in the hooked bars and the adjacent middle bars at failure were 6558 and 3477 $\mu\epsilon$, compared to ultimate strain of the GFRP bars of 20,000 $\mu\epsilon$. The relationship between load and strain in the concrete is shown in Figure 25. Concrete compressive strain at failure was 1647 $\mu\epsilon$, compared to ultimate concrete strain

at failure of 3500 $\mu\epsilon$. Failure of the barrier–deck junction was due to sudden concrete breakout at the location of the embedded GFRP bars in the deck, as depicted in Figure 22b.

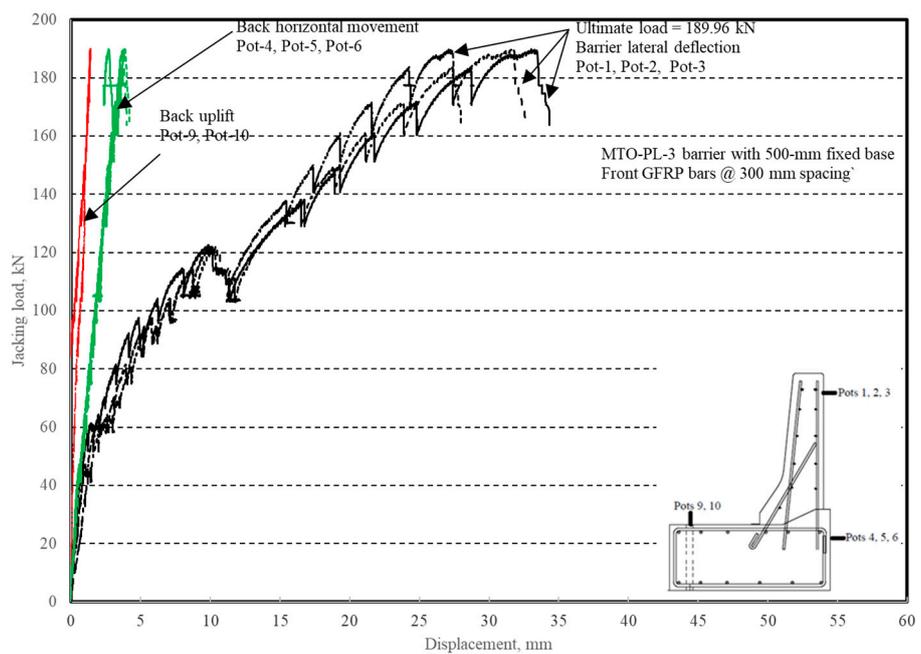
Figure 23. Specimen # 4: Load vs. displacement history.

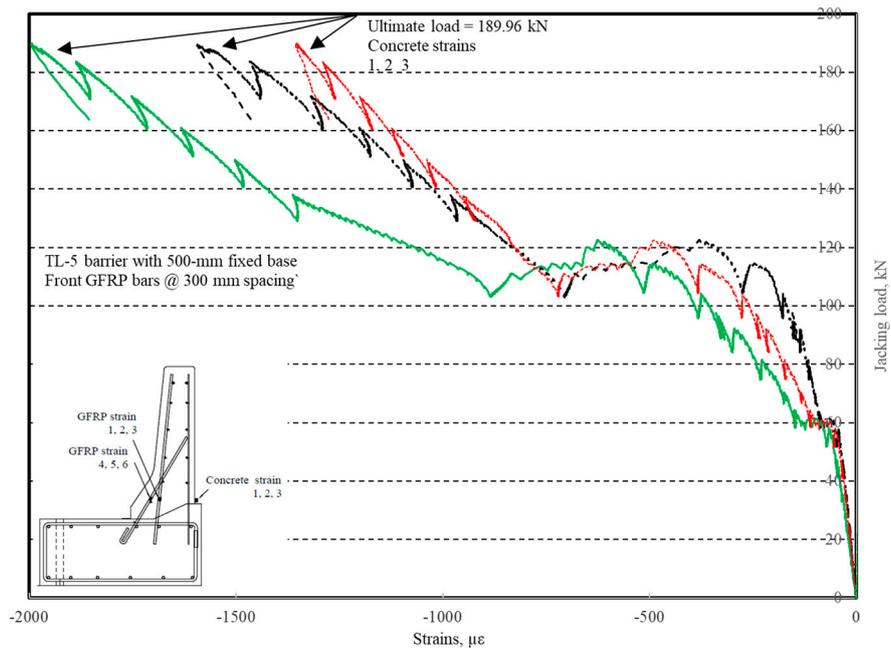
Figure 25. Specimen # 4: Load vs. concrete strain history.

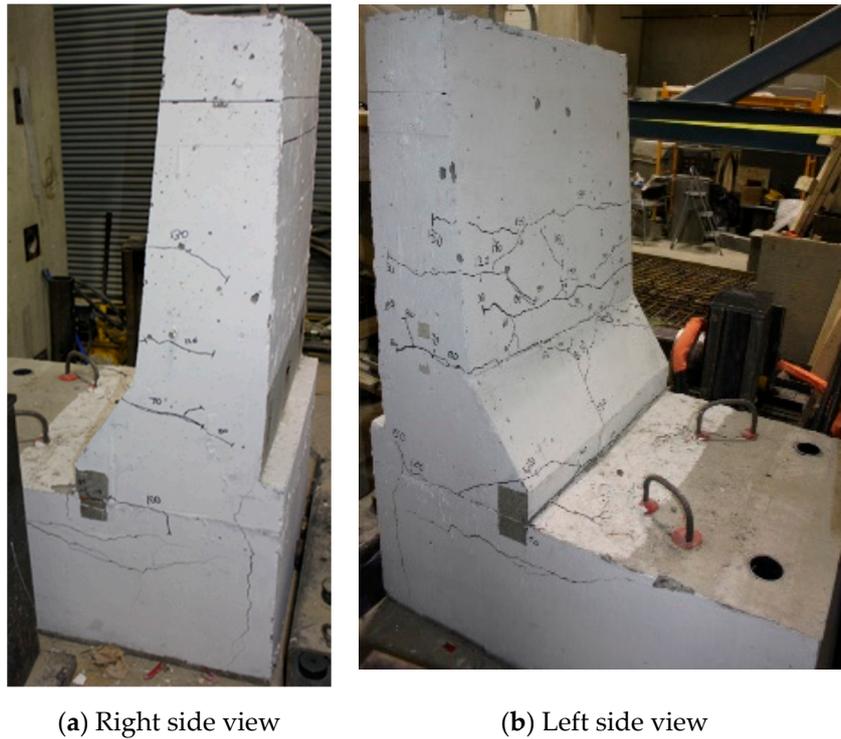
Figure 26. Specimen # 5: crack pattern. (a) Right side view; (b) left side view.

The load–displacement relationship for Specimen # 5 (shown in Figure 26) is depicted in Figure 27. It was observed that the average deck slab uplift and the horizontal movement at failure were equal to 1.71 and 4.18 mm, respectively. Maximum lateral deflection of the barrier wall at failure was 19.38 mm. Tensile strains in the diagonal GFRP bars at the front face are shown in Figure 28. Average strains in the hooked bars and the adjacent middle bars at failure were 4387 and 4113 $\mu\epsilon$, compared to ultimate strain of the GFRP bars of 20,000 $\mu\epsilon$. The relationship between load and strain in the concrete is showcased in Figure 29. Concrete compressive strain at failure was 981 $\mu\epsilon$, compared to ultimate concrete strain at failure of 3500 $\mu\epsilon$. Failure of the barrier–deck junction was sudden concrete breakout at the location of the embedded GFRP bars in the deck, as depicted in Figure 26.

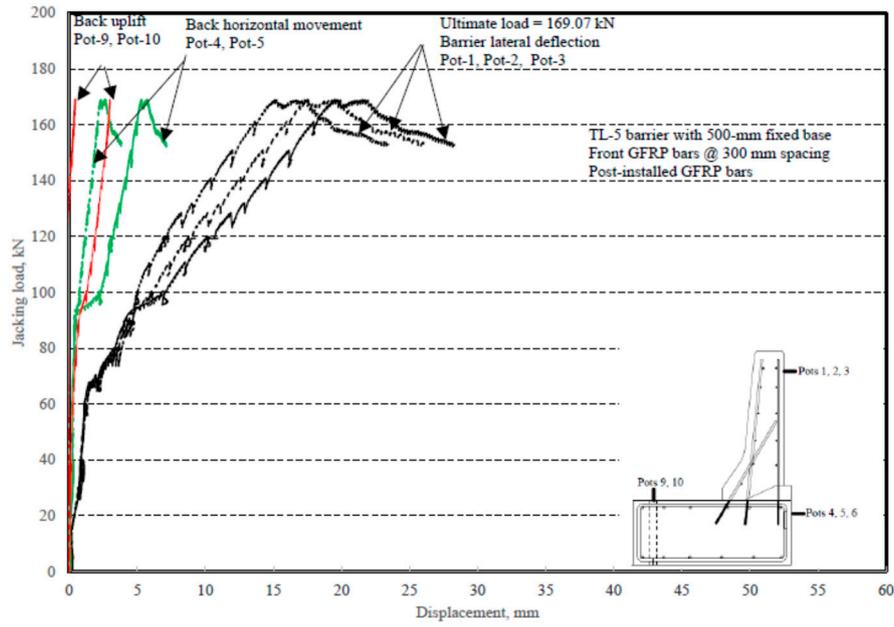
Figure 27. Specimen # 5: Load vs. displacement history.

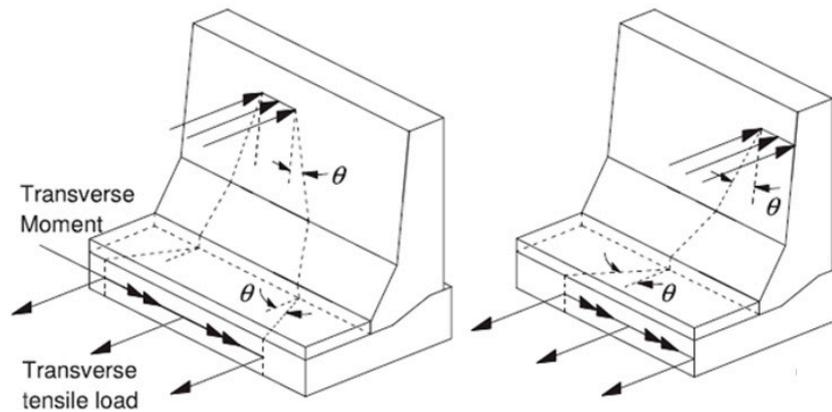
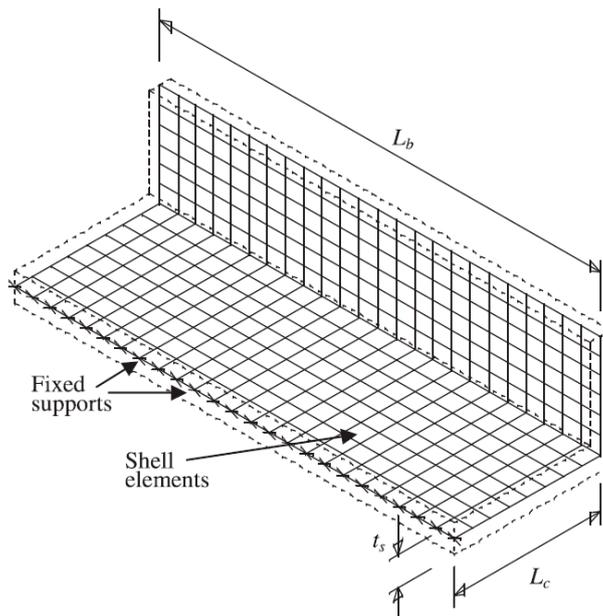
Figure 30. Finite element model and applied transverse loading. (a) Transverse load distribution on interior location (left) and end location (right). (b) Typical finite element model and notations used for the parametric study [18].

When an errant vehicle collides with a bridge barrier, the lateral impact force is distributed in the barrier wall and the deck slab with dispersal angles, leading to the design forces at the barrier–deck junction specified in CHBDC commentaries [18]. Figure 30a shows the distribution of a vehicle transverse impact load on the concrete barriers [18]. Design shear forces and bending moment at the barrier–deck interface can be calculated by finite element modeling for a 1000 mm barrier length. The length of cantilever slabs of bridges can also be different, as in slab-on-girder or non-deformable bases. Therefore, the change in the support condition for barriers should be studied. Barrier length is the distance between two free ends of the barrier or between expansion joints. The length of the barrier affects the dispersion angle of applied forces (Figure 30a). Finite element analysis (FEA) was conducted by Azimi et al. [17] to examine the effects of barrier length, deck slab thickness, and cantilever length on the factored applied moment at the barrier–deck junction of TL-5 barriers, as affected by the barrier length, deck slab cantilever length, and deck slab thickness.

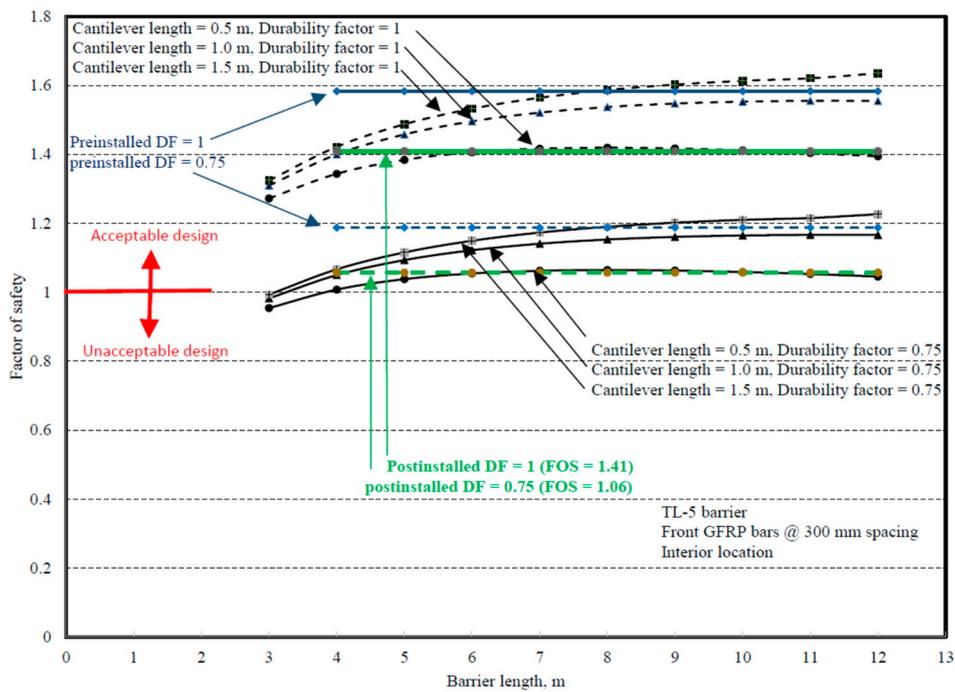
Figure 31. Design factors of safety for TL-5 barrier in Figure 1b at an interior location.

Comparisons between experimental and numerical results for the interior and end locations are shown in Figures 31 and 32. Chapter 2 of the CHBDC [4] specifies that the designer shall consider the environmental conditions and deterioration mechanisms for FRP reinforcement, and recommends that a 0.75 durability factor be applied to the results, which was followed by authors in this paper. To be able to qualify the proposed GFRP bar detailing in Figure 1b, the factor of safety was considered at least 1 to ensure that the experimental capacity was at least equal to the factored applied moment at the barrier deck junction specified in CHBDC or obtained by FEA modeling. Figures 31 and 32 present the factors of safety in design of the proposed barrier when a material durability factor of 0.75 was applied.

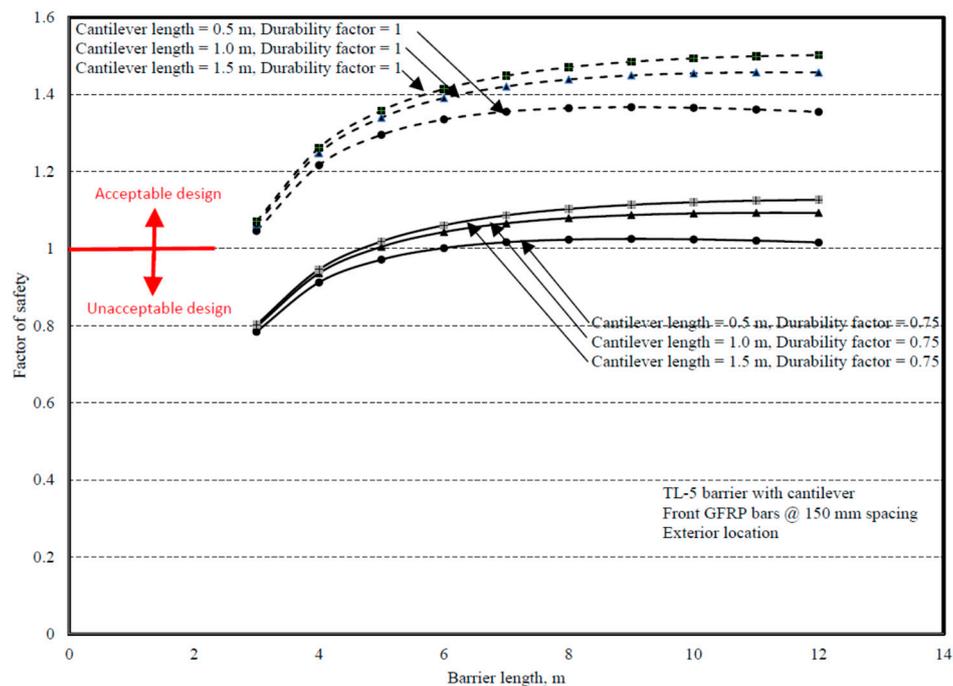
Figure 32. Design factors of safety for TL-5 barrier in Figure 1b at end location.
