# Effectiveness of Nanolime as a Stone Consolidant: A 4-Year Study of Six Common UK Limestones

**Keywords:** nanolime; limestone; drilling resistance; consolidation

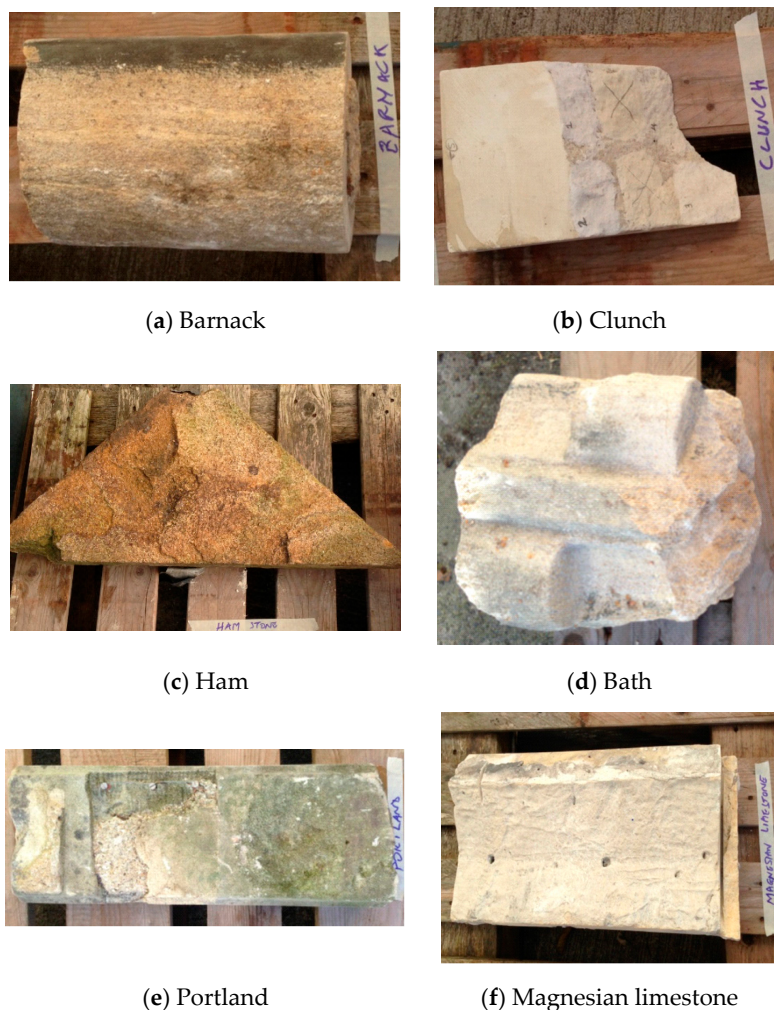
**Figure 1.** Images of the 6 different stone types used during the tests. In this image, the Barnack stone is represented only by the column used during the tests (a) whereas the Bath stone is represented only by one of the samples tested (d). The Magnesian limestone in the image (f) was split after the treatment. Sizes of stones can be estimated from the wooden slats of pallet in the background which are approximately 80 mm.

For each stone, only the exposed surface (weathered) was used during the tests. Since each stone was different (i.e., ashlar, pieces of column), the tested surfaces had different characteristics (e.g., some surfaces were flat whereas others were curved), however, since all stones were sourced from various buildings, all surfaces were finely worked. Often the geometry of the stone dictated the location and direction of the tests such as the location and direction of the holes for the drilling resistance measurements. Testing locations were selected which exhibited visually similar weathering and stone surface texture. The dimensions, shape, colour and texture of the stones is shown in Figure 1.

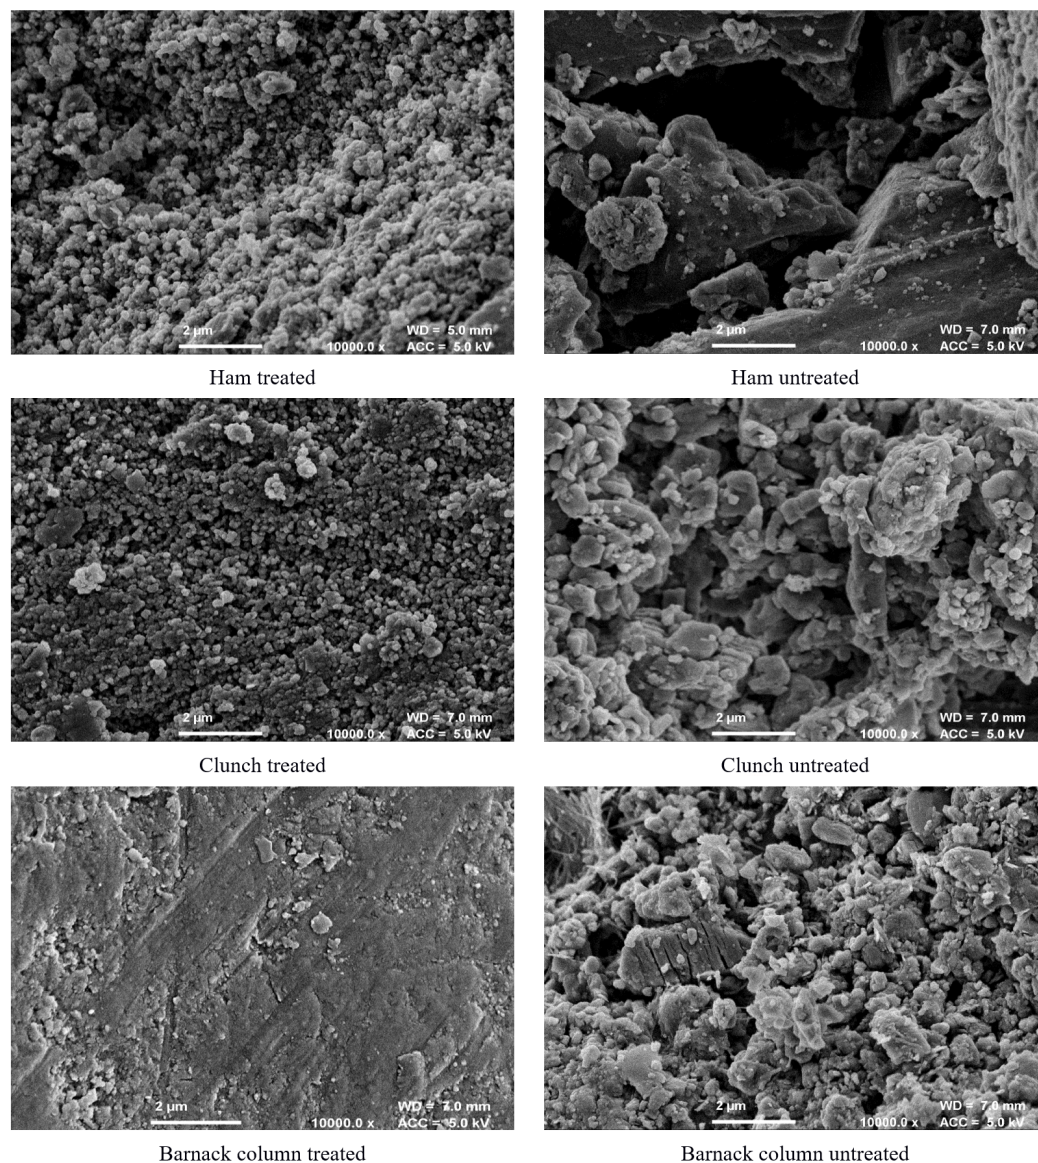
**Figure 3.** FESEM images of the Ham, Clunch and Barnack column stone specimens.

Figure 3 shows the FESEM images of untreated and treated surfaces of Ham, Clunch and Barnack column after 12 weeks from the treatment. The images highlight changes in the porosity of the stone specimens 4 years after the beginning of the test.

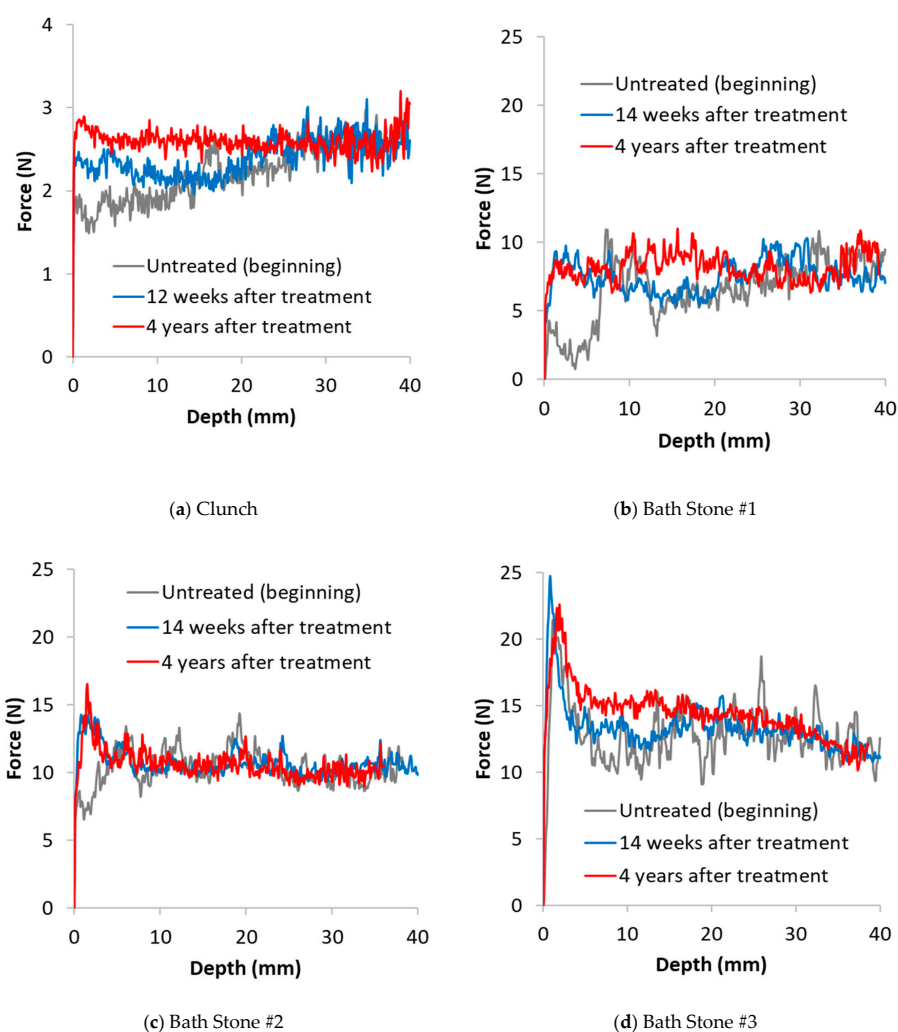
**Figure 4.** Drilling resistance vs. Drilling depth untreated (beginning), 12 weeks after treatment and 4 years after treatment of stone specimens where nanolime had a positive consolidating effect. (a) Clunch; (b) Bath Stone #1; (c) Bath Stone #2; (d) Bath Stone #3.

Results of the drilling resistance measurements are reported in Figures 4–6. In these images, the DR curves of the treated and untreated specimens were aligned to correspond with the resistance at a depth unaffected by the treatment, typically 30 to 40 mm [2]. Each line is an average of the best 3 tests carried out on each surface. This allowed a meaningful comparison between treated and non-treated samples to be made. For a clearer comparison of the results, the tests are divided into 3 groups: (i) stones exhibiting behaviour consistent with the expected results of a consolidation treatment (i.e., positive effect) such as strengthening (Clunch and Bath stones; Figure 4a,b); (ii) stones where the application of nanolime had a negative effect (i.e., Ham stone; Figure 5a); (iii) stones where the application of nanolime had neither a positive nor a negative effect (i.e., Barnack, Portland and magnesian limestone; Figures 5b and 6a–d).

Results of the DRMS on the untreated stones allowed identification of a crust of altered material on the surface of four lithotypes namely Bath (Figure 4c,d), Portland, Magnesian limestone (both samples) and Barnack stone (both samples; Figure 6a–d). Results related to Bath and Portland stones are supported by the observations of the polished sections in Figure 2. Results of the investigation on the porosity change suggest that for Portland stone this crust is connected to a reduction in porosity and, in particular, to the precipitation of exogenous material within the pores of the surface.

DRMS results corresponding to 12 weeks and 4 years for Clunch stone (Figure 4a) highlight an increase in drilling resistance over the time, which is visible up to a depth of about 20 mm from the surface. An increase in drilling resistance is also visible in 2 of the 3 specimens of Bath stone, although in this case the effects of nanolime are not always very clear and also the penetration depth is variable with the sample reaching a maximum of approximately 16 mm in sample #3.

In the case of Clunch and Bath stone, the application of nanolime not only increased the drilling resistance after 12 weeks from the treatment, but also had a long-lasting effect (Figure 4a,b). The result suggests that in both cases, the time for achieving a full consolidation effect was within the initial 12 weeks and that the increase in drilling resistance is not proportional to the time that passed by.

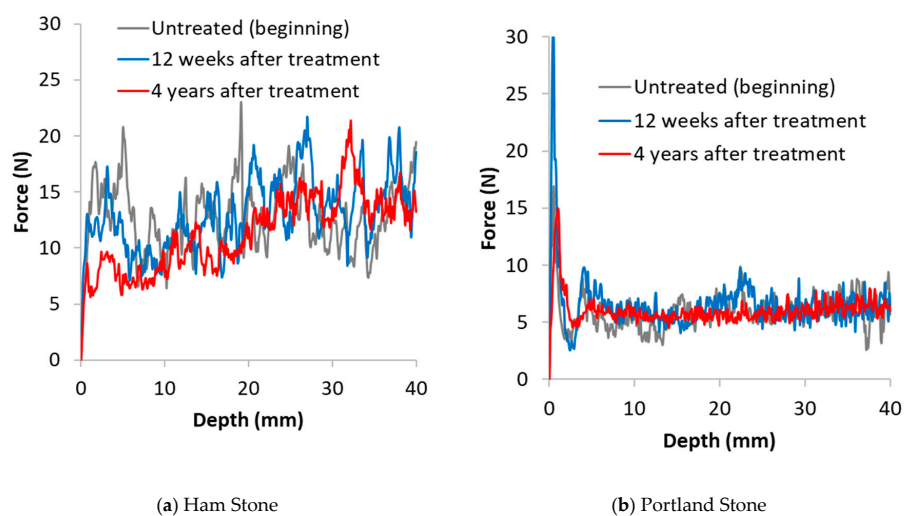
**Figure 5.** Drilling resistance vs. drilling depth for (a) the Ham stone and (b) Portland stone, untreated (beginning), 12 weeks and 4 years after treatment.

Ham stone (Figure 5a) shows a continuous reduction in drilling resistance over the 4 years of the tests with effects visible up to a depth of 6 mm.

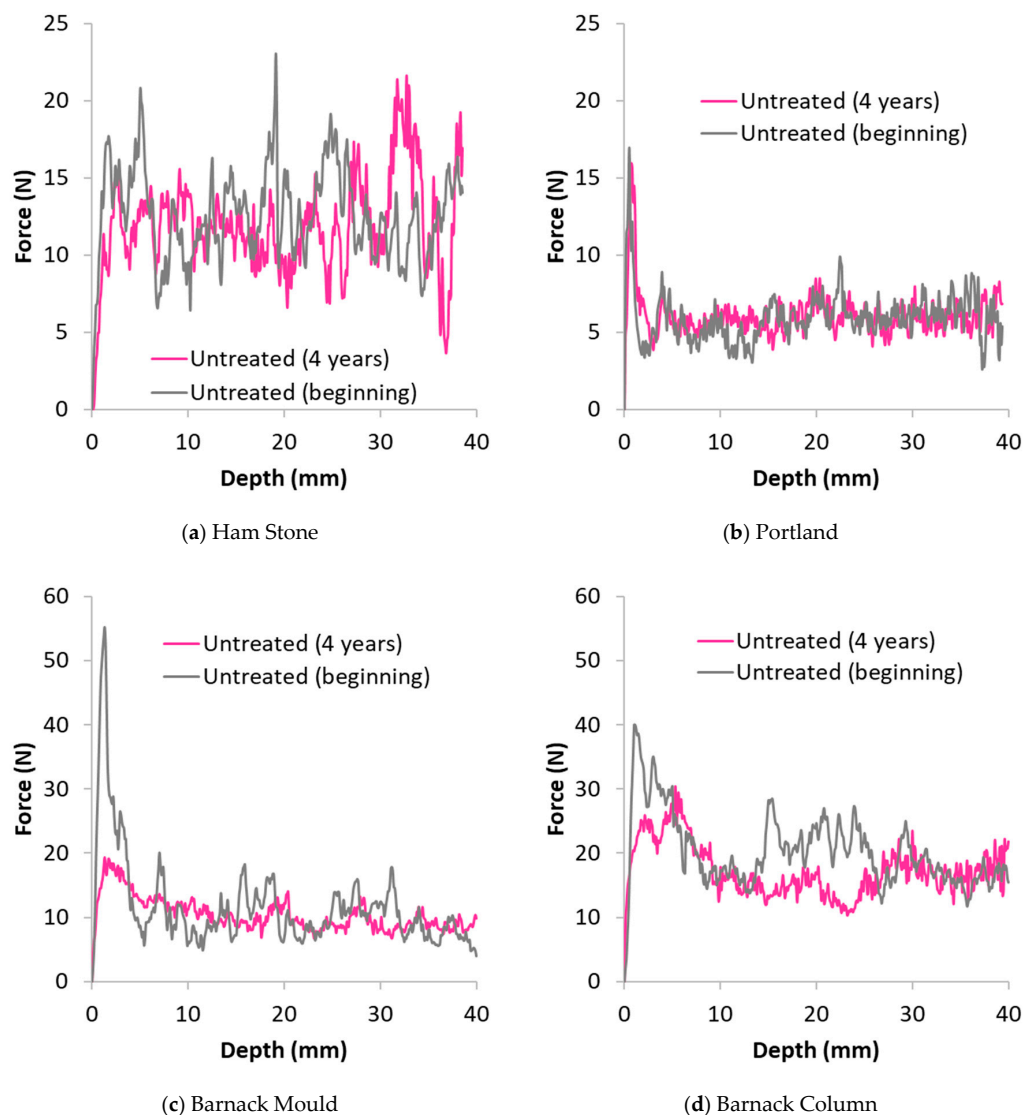
**Figure 7.** Drilling resistance vs. drilling depth of untreated stone specimens tested at the beginning and at the end of the test. (a) Ham Stone; (b) Portland; (c) Barnack Mould; (d) Barnack Column.

Figure 7 shows the DR of the untreated areas of the same stone at the beginning and at the end of the testing period for Ham, Portland and Barnack (mould and column) stones. Drilling resistance of the untreated area of the same stones at the beginning and end of the test show that only Barnack stone (both samples, Figure 7c,d) was affected by the weathering during the 4 years of the test whereas Ham and Portland stone do not show any effect of the weathering.

Ham stone is the only stone that showed a decrease in drilling resistance of the treated area over the 4 years of the test. However, examination of Figure 7a reveals a decrease in the drilling resistance in the untreated areas of the stone that could be explained by a natural weathering. Therefore, caution must be exercised as the decrease observed in the nanolime-treated areas may have been a consequence of the natural weathering and occurred irrespective of the presence of the consolidant. Figure 8b shows the sorptivity of the treated and untreated parts of the stone 4 years after the treatment where an increase in the ease by which the water is absorbed is highlighted. Consideration of the stone porosity as shown in Table 2 indicates a very large difference between region #1 and region #2.

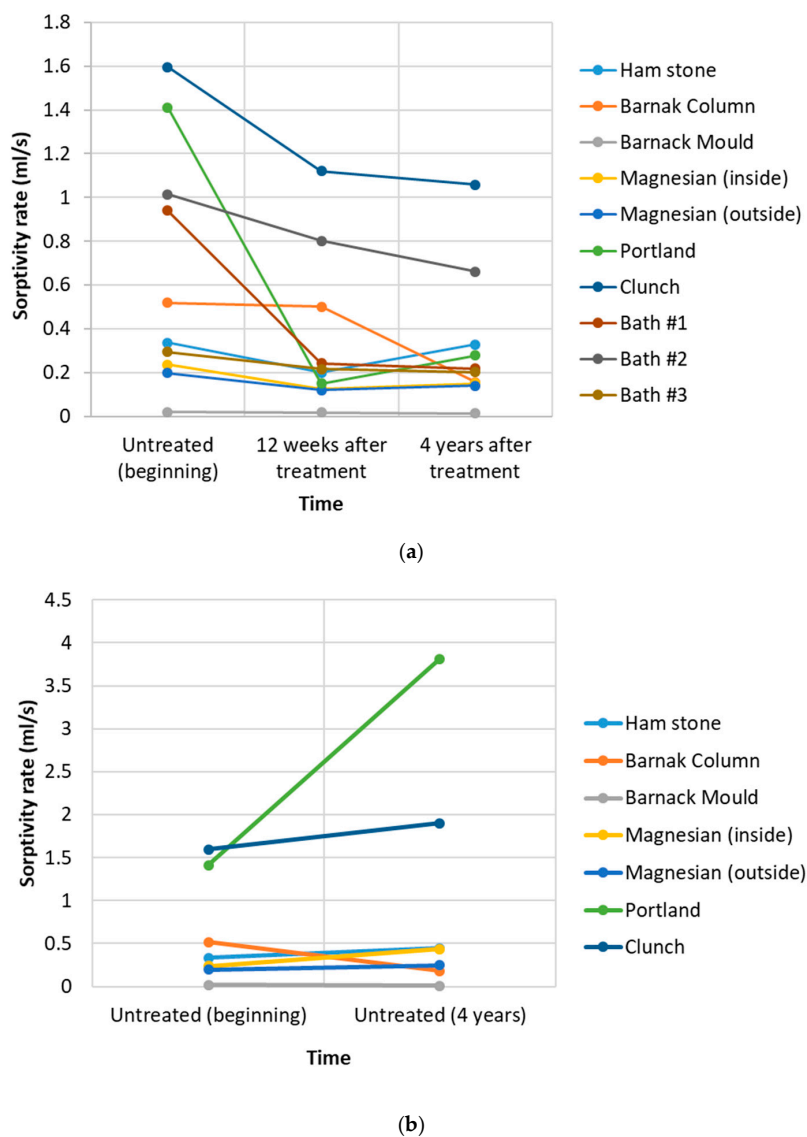
**Figure 8.** (a) Sorptivity rates of the various stone specimens untreated (beginning) and after 12 weeks and 4 years. (b) Comparison of the sorptivity rate of the untreated stone at the beginning and the end of the testing period (4 years).

Figure 8a shows the sorption rate of the untreated and treated samples at 12 weeks and 4 years following treatment. Results of the sorptivity on untreated areas at the beginning and at the end of the test (Figure 8b) suggest a small increase of sorptivity in Ham, Magnesian limestone (both samples) and Clunch, whereas Portland stone shows a dramatic increase. The only specimen showing a reduction in sorptivity was Barnack stone (both samples). Sorptivity of the Bath stone untreated material after 4 years is omitted because the specimens had an uneven surface that did not allow effective sealing of the Karsten tube.
