Wire Ropes and CFRP Strips to Provide Masonry Walls with Out-Of-Plane Strengthening

Elena Ferretti

Department of Civil, Environmental and Materials Engineering—DICAM, Alma Mater Studiorum Università di Bologna, 40136 Bologna, Italy; elena.ferretti2@unibo.it; Tel.: +39-051-209-35-15

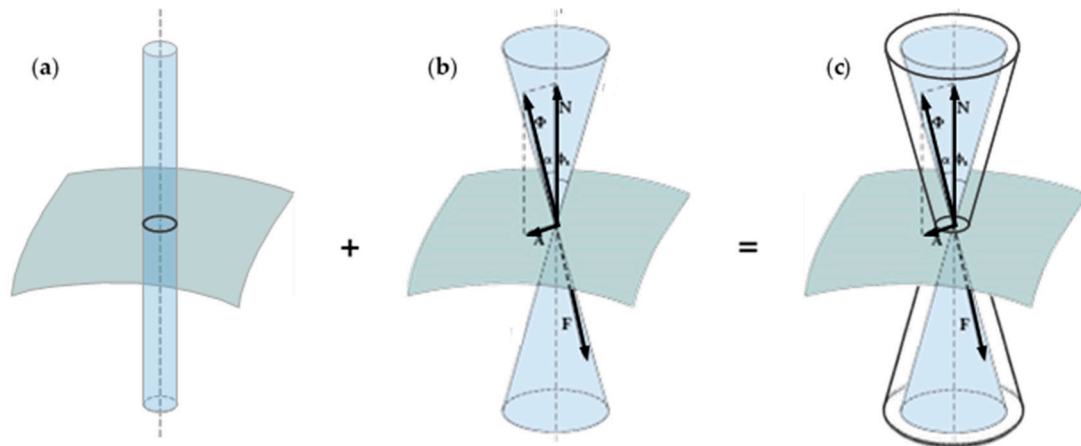
Figure 1. How the addition of a physical bond—represented by (b) the conical limit surface of static friction—changes the limit surface in static conditions from (a) the cylindrical surface of the chemical bond to (c) the double truncated cone of the cohesive static friction [1].

masonry walls provides a physical bond that overlaps with the chemical bond given by the resin alone. As shown in Figure 1, this modifies the limit surface of the interface bond—which becomes a cohesive physical bond—allowing the FRP strips to withstand higher shear forces before delaminating from the masonry wall under bending loads. This increases the delamination load of the FRP strip on the tensioned side of the bent wall.

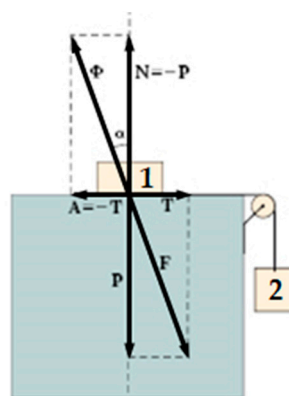
Figure 2. Body 1 at rest under the combined action of its weight force and the shear force provided by body 2: Active and reactive forces developed on the support plane.

- N is the normal force that develops as a reaction to the weight force P , exerted by the body at rest in Figure 2 (body 1): N is equal and opposite to P ;
- A is the frictional force that develops as a reaction to the shear force T , exerted by the hanging body in Figure 2 (body 2): A is equal and opposite to T as long as body 1 is at rest;
- Φ is the resultant of the active forces, N and A , and is applied to body 1;
- F is the resultant of the reactive forces, P and T , and is applied to the support plane.

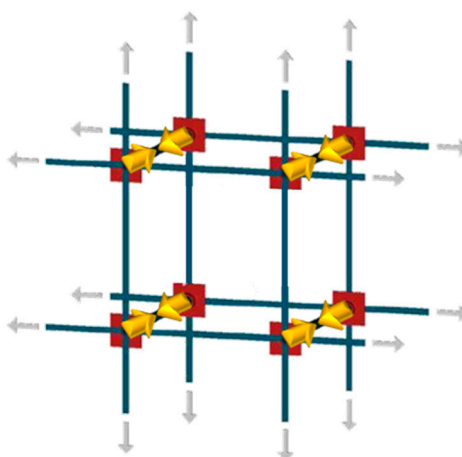
Figure 3. Nodal forces transferred by the CAM straps: Balanced forces in gray and not balanced forces in yellow [1].

The main target of the CAM system, patented in 1999 by Dolce and Marnetto, is to provide the wrapped masonry with an additional state of hydrostatic stress, which increases the safety factor of the masonry building. Nevertheless, a more accurate analysis of the actual mechanism for transferring stresses from the straps to the nodes of the masonry units [2,3] showed that the CAM system does not actually provide a hydrostatic state of stress. In the specific case of a rectangular CAM net, for instance, the straps act in the plane of the wall with pairs of equal and opposite nodal forces, while the nodal forces in the wall thickness are not counteracted (Figure 3). Consequently, the rectangular retrofitting system does not transfer any in-plane force, while it provides an out-of-plane compression to the nodes.

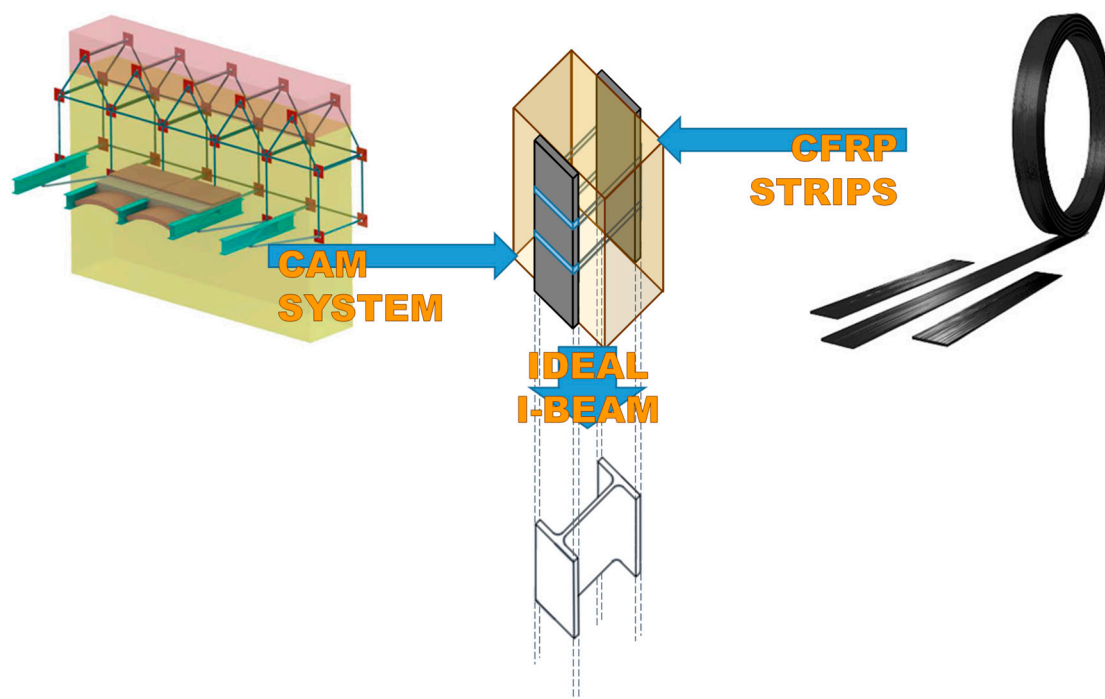
Figure 4. The transverse connections between the FRP strips give rise to an I-beam behavior [1].

A useful application of the straps/strips combined technique consists in placing the FRP strips vertically, one in front of the other on the two faces of a masonry wall (Figure 4). In this case, an additional advantage in terms of reinforcement overlaps with the benefits of the cohesive physical bond on the stretched side: When tied by the CAM straps as in Figure 4, the two FRP strips work together due to the transverse connection established by the CAM system (Figure 5). The resulting strengthening effect under bending loads is the same as that provided by a bracing FRP I-beam, which acts as an embedded buttress without having to cut the masonry wall to insert it.

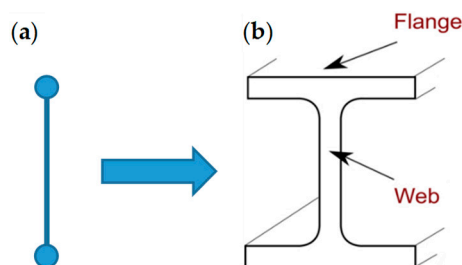
Figure 5. Concept of the straps/strips combined technique: Two FRP strips tied by CAM ribbons behave as (a) two mass points connected by a stiffness constraint, which is the ideal scheme of behavior of (b) a bent I-beam in its cross-section.

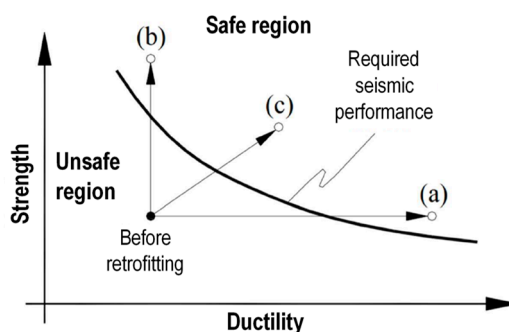
Figure 7. Comparison between retrofitting systems: An FRP reinforcement leads the structure to point (b), increasing strength but not ductility; a three dimensional reinforcement with steel ribbons leads the structure to point (a), increasing ductility but not strength; the combined technique leads the structure to point (c), increasing both strength and ductility.

- It continues to wrap the wall even after masonry crushing, allowing the damaged building not to collapse. This high degree of ductility (Figure 7) allows the combined technique to survive structural damage, acting as both a reinforcement system and a protection device.

The load/deflection diagrams in Figure 10 clearly show that both strength and ductility increase with the combined technique (Figure 7). In particular, for Specimens W3 and W4, the delamination loads are comparable to that of Specimen W2 (given only by the CFRP strips) and the post-peak ductility is comparable to that of Specimen W1 (given only by the steel straps). Actually, due to the high ductility, Specimens W1, W3, and W4 did not undergo a real collapse until the end of the test, which was necessary to avoid damage to the instrumentation. This means that the resilience of these specimens is extremely high: It recalls the resilience of FRP wrapped columns [38–41].

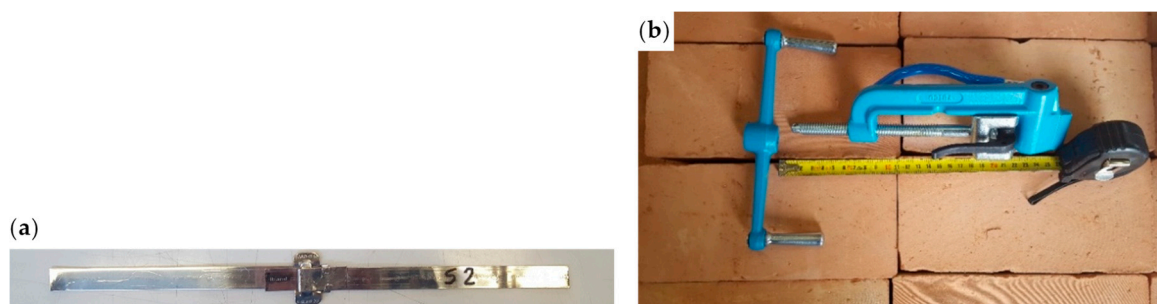
Figure 8. The fastening system of Reference [1]: (a) one fastened specimen for the characterization of the junctions and (b) the manual strapping tool used to fasten the steel ribbons.

Figure 8 shows a sealed ribbon and the manual device used to pre-tension the ribbons during strapping.

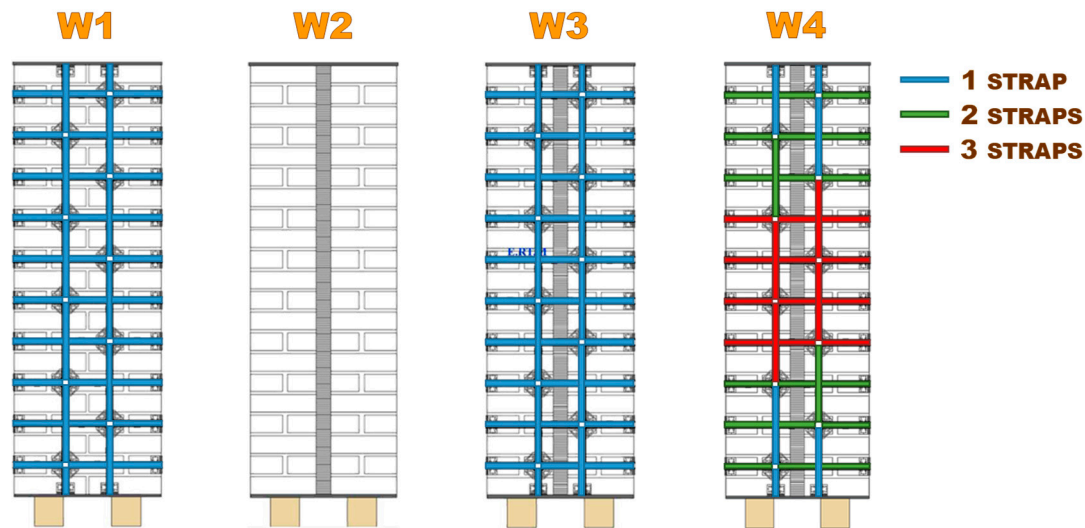
Figure 9. Arrangement of the straps for Specimens W1, W2, W3, and W4.

W3). Although the CAM system allows the use of up to four straps per loop, in specimens W1 and W3 there was only one strap per loop (Figure 9). After testing, the experimenters restored Specimen W3, modified the number of straps per loop as shown in Figure 9, and performed a further three-point bending flexural test on the restored specimen (Specimen W4). For details on the reason for the diversified number of straps per loop of Specimen W4, see [1].

The increased number of longitudinal and transverse straps near to the middle cross-section of Specimen W4 (Figure 9) also decreases the load drop at delamination (Figure 10). This improves the overall behavior in real applications, since excessive load drops in the strengthened structural element can cause serious overloads in adjacent structural elements, which can collapse.

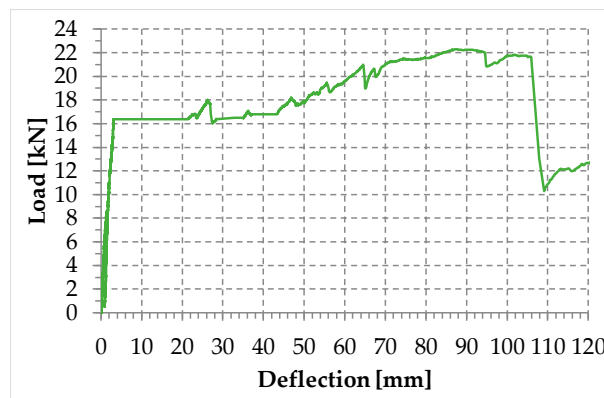
Figure 11. Load/deflection diagram for the first combined technique, in a hypothetical flexural test performed in the load control.

Since the post-delamination load of Specimen W4 increases up to recover and exceed the delamination load, the load/deflection diagram in the load control follows the horizontal path between the delamination load and the recovered load (Figure 11). The increase in load after the horizontal path of Figure 11 is of fundamental importance for the overall stability in real applications. In fact, as long as the increase in the displacement along the horizontal path is compatible with the resilience of the structure, the increase in the load beyond the recovered load avoids the redistribution of the load on the adjacent structural elements, which are no longer in danger of overloading.

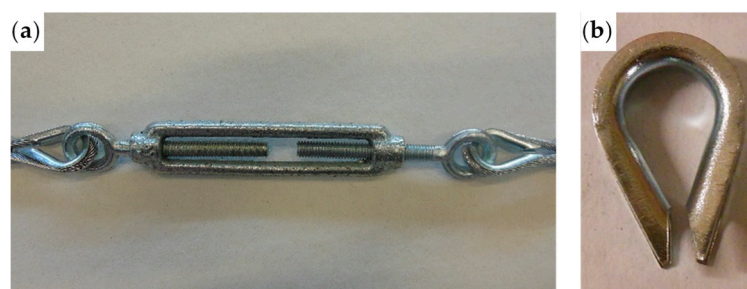
Figure 12. The fastening system of the second combined technique: (a) Two Flemish eyes connected by an eye-eye turnbuckle and (b) detail of the thimble placed inside a Flemish eye.

In the fastening system of the second combined technique, both loose ends of each steel wire rope form a Flemish eye (Figure 12a), which is a loop-shaped end, fixed back on the steel wire rope. A thimble installed inside the loop (Figure 12b) prevents the steel wire rope from bending too tightly when a device connected to the loop concentrates the load on a small contact area. Furthermore, the thimble protects the steel wires on the inside of the loop from abrading and pinching.

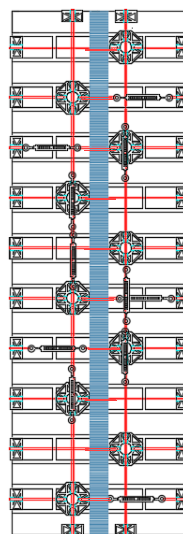
Figure 13. Layout scheme of the straps for the second combined technique.

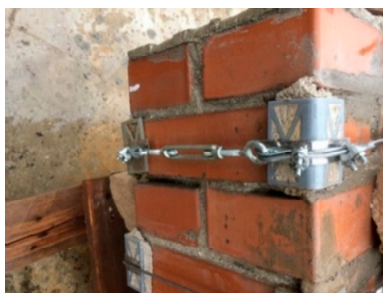
Figure 14. The fastening system along the lateral face of the brick wall (23 cm).

The eye–eye turnbuckles of the shorter horizontal straps are too long to lie on the two main faces. However, they find an optimal positioning on the lateral faces of the masonry wall, which is a two-headed wall (Figure 14), with Bolognese type bricks ($24.5 \times 5.5 \times 11$ cm). As the dimensions of the brick wall are $50 \times 146 \times 23$ cm, the Bolognese bricks do not exactly fit the length of the wall. Therefore, it was necessary to shorten the end bricks of Figure 15a to obtain the desired length.

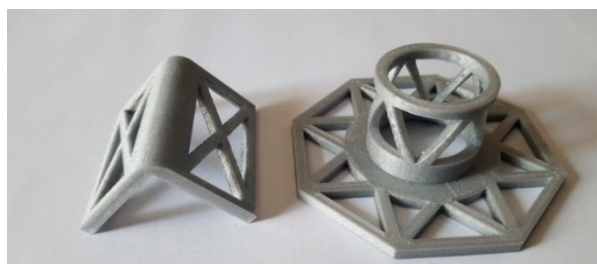
Figure 16. 3D printed rounded angle (on the left) and funnel-shaped plate (on the right) [1].

At the corners of the straps, the second combined technique uses the same protective elements as those of the first combined technique (Figure 16), that is, funnel-shaped plates and rounded angles printed with FDM (Fused Deposition Modeling), a technology that allows us to fix some intrinsic geometrical limits of hot forming. The choice of the material and the optimization of the shape of the 3D printed protective elements are part of the experimental program. For both the 3D printed plates and angles, the corners in contact with the straps are rounded, while those in contact with the edges of the wall are at 90° . Moreover, the truss shape of the flat parts increases the contact area between mortar and protective elements, improving adherence (Figure 17).

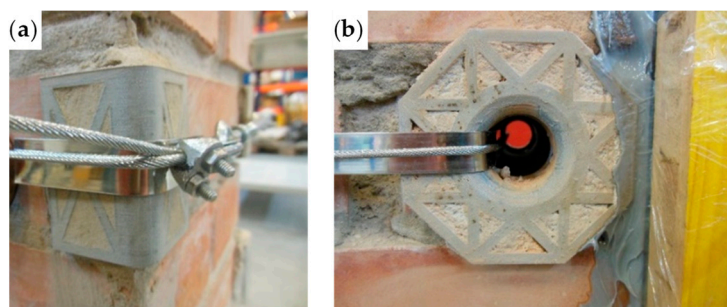
Figure 17. The pieces of steel ribbons positioned under the straps at the corners of the protective elements: details of (a) a rounded angle and (b) a funnel-shaped plate.

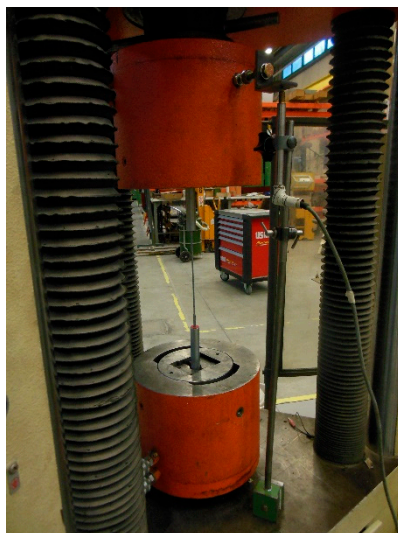
Figure 19. Positioning the LVDT (Linear Variable Differential Transformer) to measure the displacement of the crosshead.

ASTM A931 [46] covers the tensile testing of steel wire ropes and strands at room temperature. Figure 19 shows the experimental set-up of the tensile test performed on one spiral strand rope of the experimentation. As usual for steel ropes, an LVDT measured the crosshead displacement to obtain the extension of the specimen (Figure 19). In fact, due to high-energy specimen failures, using a traditional contacting extensometer means there is a risk of damaging and/or transforming the extensometer into a projectile. To avoid this, it is necessary to remove the extensometer prior to specimen failure. However, since the specimen will be under load, this entails a significant risk for the operator, as there is the possibility that the specimen will break during the removal of the extensometer. Furthermore, if the extensometer remains attached to the sample, reduction in rope diameter (Poisson effect) and twisting can cause the contact points to slip or the device to fall off. It could also happen that the edges of the knife cause stress concentrations, leading to premature failure.

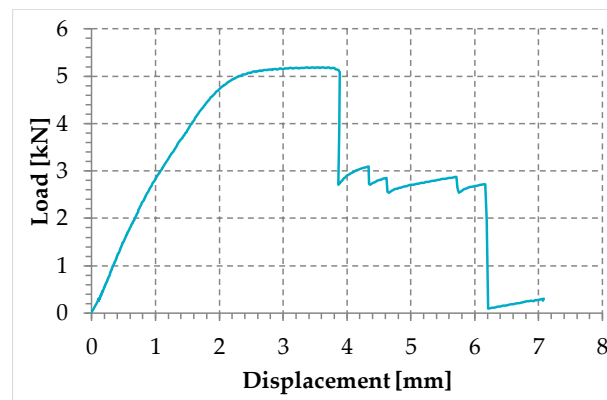
Figure 20. Load/displacement diagram of the steel wire rope used in the experimentation.

Figure 20 shows the load/displacement diagram of the tested specimen, while Figure 21 shows the specimen after failure. The load drop in Figure 20 for a displacement of almost 3.9 mm corresponds to the moment in which the steel wire rope began to fray. The fraying occurred at one end of the specimen (right end in Figure 21a,c), while on the other end the individual steel wires of the specimen twisted (left end in Figure 21a,b). Each load drop in Figure 20 occurred due to the failure of one or more fraying steel wires. The first load drop did not immediately bring the sample to failure and further load increases were possible after it, as the remaining steel wires took up the load. A similar load redistribution occurred after each steel wire failure. This allowed the specimen to reach a final displacement equal to about 182% of the displacement of first fraying, with an average residual load during the fraying that is about 52% of the maximum load.

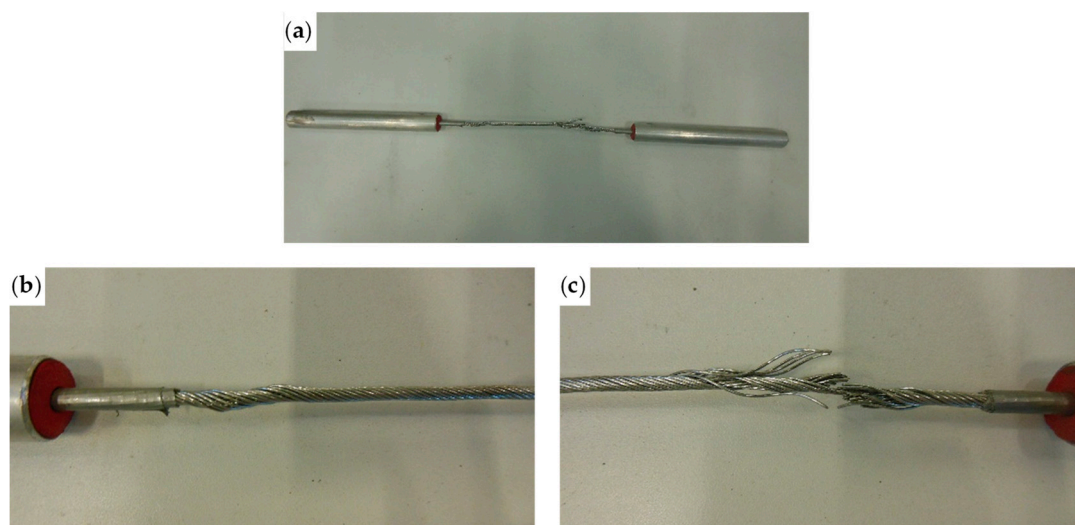
Figure 21. The spiral strand rope after the test: (a) general overview; (b) detail of wire twisting at the left end; and (c) detail of the failure due to fraying, at the right end.

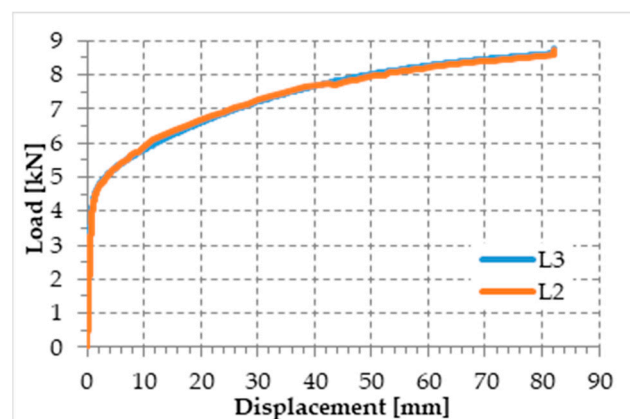
Figure 22. Load/displacement diagrams for the steel ribbons used in [1].

For comparison purposes, the selection criterion for the cross-section of the steel wire rope was to choose a steel wire rope with the same yield load as that of the steel ribbons used in the experimental program on the first combined technique [1]. The yield load in Figure 20 is actually comparable to the yield load of the steel ribbons of [1] (Figure 22). The specimen failure took place at the frayed end, with a final displacement equal to about 8.6% of the final displacement for the steel ribbons of [1] (Figure 22).

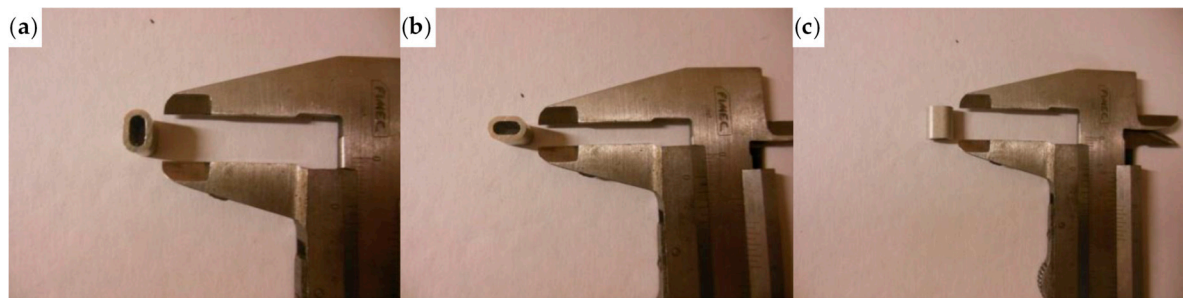
Figure 23. The ferrules of the experimentation: (a) longitudinal dimension; (b) transversal dimension; and (c) thickness.

As already mentioned in Section 2.2, the most common devices for fixing a Flemish eye are ferrules and clips. Ferrules—also often referred to as eyelets or grommets—are narrow circular clamps made from metal (Figure 23). They are useful to hold together and connect steel wires, generally by crimping, swaging, or otherwise deforming the ferrule to tighten it permanently on the parts it holds. A clip is a steel wire rope clamp consisting of a U-shaped bolt, a forged saddle with two holes to fit into the U-bolt, and two nuts to fix the arrangement in place (Figure 24).

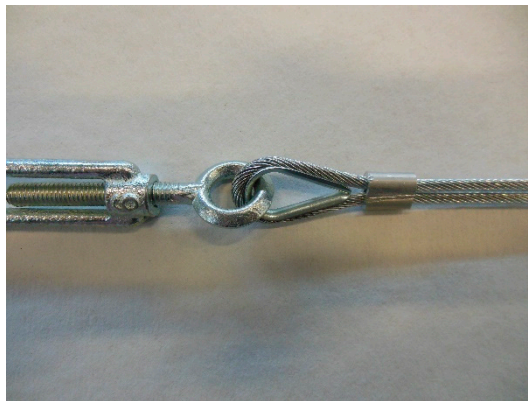
Figure 26. Specimen 1: Flemish eye closed by 1 ferrule.

Specimens 1 and 2 had a very bad behavior, because they failed for a load value much lower than the maximum load of the steel wire rope without a joint (Table 3). Moreover, both specimens showed an excessive deformation of the Flemish eyes, which squashed despite the use of the thimble. However, since the maximum load of Specimen 2 was more than double the maximum load of Specimen 1 (Table 3), the use of a second ferrule helps the joint to withstand higher loads.

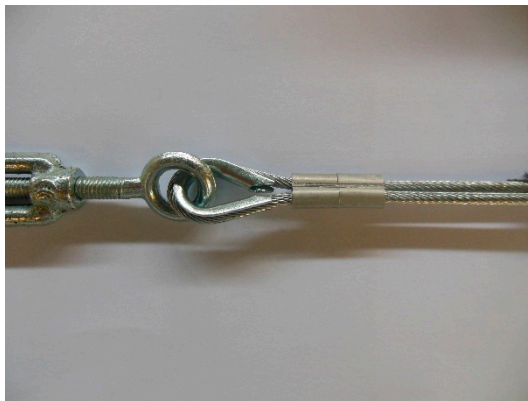
Figure 27. Specimen 2: Flemish eye closed by 2 ferrules.

- 2 ferrules in succession (Specimen 2, Figure 27);
- 1 clip (Specimen 3, Figure 28);
- 2 clips in succession (Specimen 4, Figure 29);
- 1 ferrule and 2 clips, in succession, starting from the Flemish eye (Specimen 5, Figure 30);
- 1 ferrule, 1 clip, a second ferrule, and a second clip, in succession, starting from the Flemish eye (Specimen 6, Figure 31);

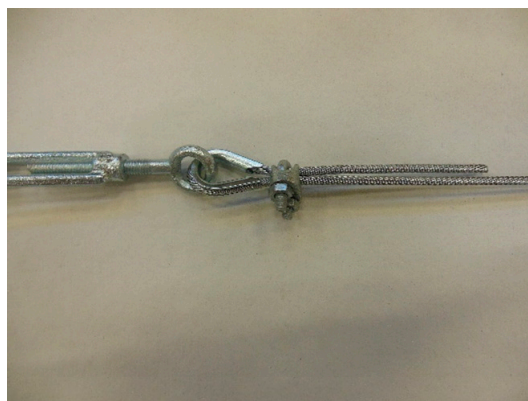
Figure 28. Specimen 3: Flemish eye closed by 1 clip.

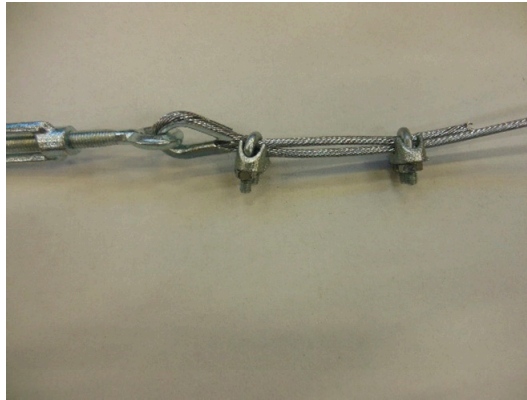
Figure 29. Specimen 4: Flemish eye closed by 2 clips.

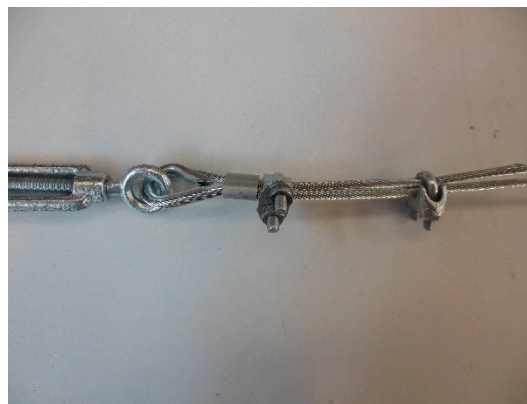
Figure 30. Specimen 5: Flemish eye closed by 1 ferrule and 2 clips, in succession.

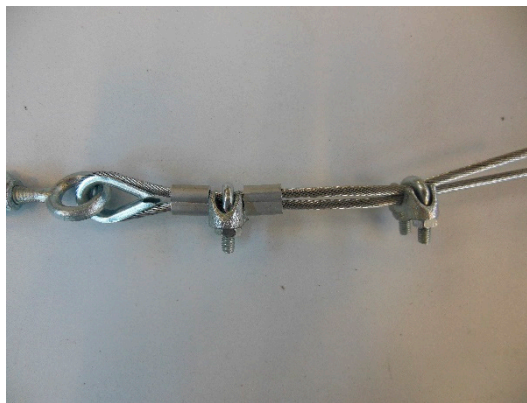
Figure 31. Specimen 6: Flemish eye closed by 1 ferrule, 1 clip, 1 ferrule, and 1 clip, in succession.

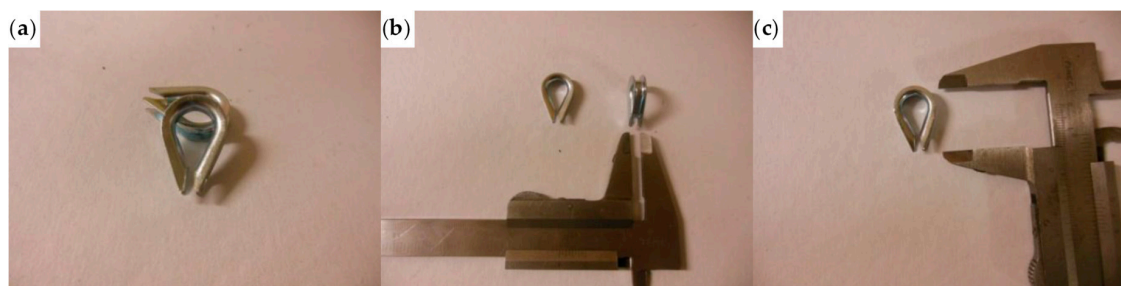
Figure 32. The thimbles of the experimentation: (a) overview; (b) thickness; and (c) longitudinal dimension.

The thimbles used to shape the Flemish eyes for the specimens listed above have the geometrical characteristics shown in Figure 32.

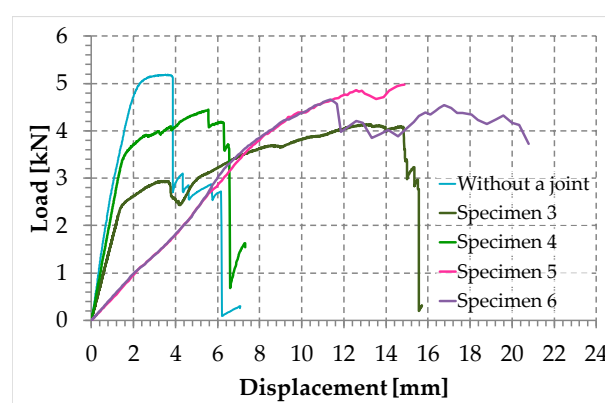
Figure 33. Load/displacement diagrams for 5 of the 7 specimens used for the mechanical characterization of the joints.

Figure 33 shows the comparison between the load/displacement diagrams of the steel wire rope without a joint and the four specimens with Flemish eyes closed by means of clips or combinations between clips and ferrules.

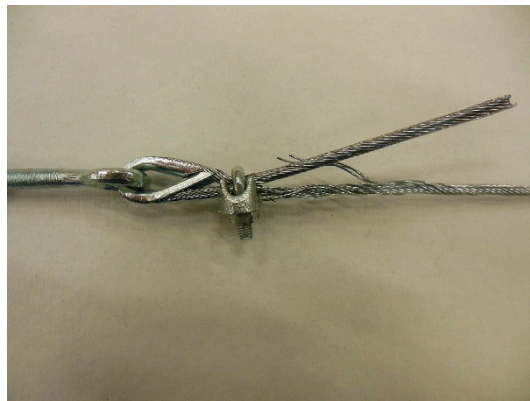
Figure 34. Failure mechanism of Specimen 3.

suffered a load drop due to the squashing of the Flemish eyes. Once the squashing of the Flemish eyes was over, the load started to rise again, up to its maximum value. Afterwards, the fraying of the steel wires quickly led the specimen to failure. It is worth noting that the fraying started from one of the two clips used to close the Flemish eyes (Figure 34). In fact, the eccentricity of the load supplied to the steel wire rope—due to the non-perfect coaxiality between the turnbuckle and the “live” side—caused the flat bearing seat of the clip to rotate, until its edge came into direct contact with the steel wires. This caused the pinching and abrading of the steel wires and, consequently, their failures in rapid succession.

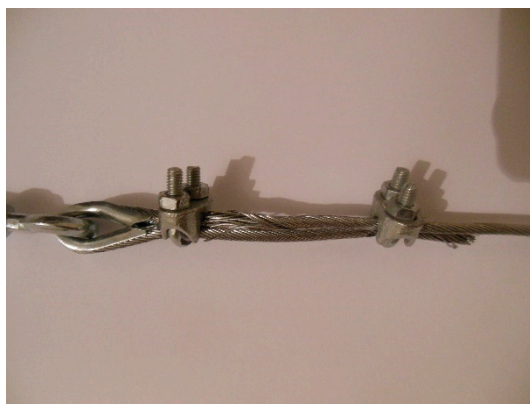
Figure 35. Failure mechanism of Specimen 4.

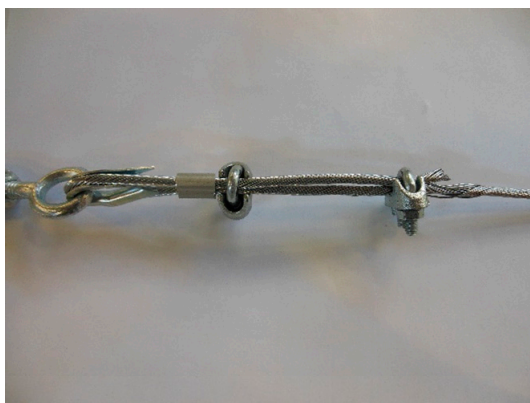
Figure 37. Failure mechanism of Specimen 5.

- The purpose of the fifth fastening scheme was to eliminate the torsion of the first clip of the fourth fastening scheme, that is, the clip closest to the Flemish eye. In other words, the function of the ferrule was to center the load on the two clips (Figure 36). Specimen 5 did not actually fray near the first clip (Figure 37): It frayed near the second clip. The improved load centering allowed the specimen to withstand a higher ultimate load, comparable to the ultimate load of the steel wire rope without a joint. However, the ferrule caused an excessive deformation of the Flemish eyes, as for Specimens 1 and 2. This greatly reduced the stiffness of the specimen.

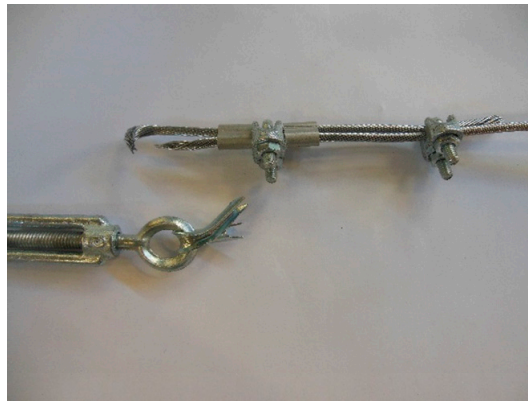
Figure 38. Failure mechanism of Specimen 6.

- The sixth fastening scheme introduces an additional ferrule between the two clips to eliminate even the rotation of the second clip, with the aim of preventing the specimen from fraying near both clips. The second ferrule actually further improved the load centering, eliminating fraying near both clips. However, this concentrated the deformation phenomena on the thimble that twisted, cutting off the steel wires (Figure 38). The twisting of the thimble occurred due to the excessive squashing of the Flemish eye. In fact, once the two ends of the thimble come into contact, the further squashing of the Flemish eye is possible only by forcing the two ends of the thimble to slide one over the other in the direction orthogonal to the load. This causes the twisting borders of the thimble to cut the steel wires. Even in Specimen 5 the excessive deformation of the Flemish eye caused a twist of the thimble (Figure 35), but this did not lead to damage to the steel wires. Lastly, the concentration of the deformations on the Flemish eyes greatly reduced the stiffness of Specimen 6, as for Specimen 5.

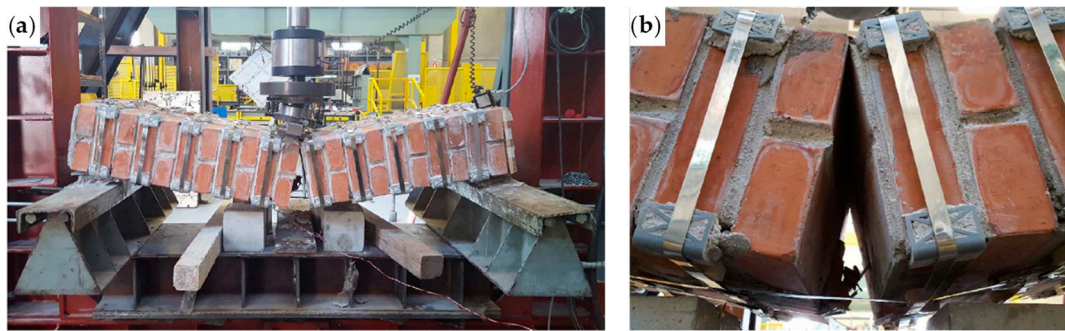
Figure 39. Specimen W1 shortly before the interruption of the test [1]: (a) disconnection mechanism and (b) detail of the disconnected cross-section (brick tear in the background).

During the three-point bending test on Specimen W1, an inner hinge opened near the middle cross-section (10th mortar bed joint from the right, in Figure 39a). The disconnection along the failed mortar bed joint led the two parts of the specimen to rotate around the inner hinge in a controlled manner, because the high ductility of the steel ribbons (Figure 22) allowed the disconnection to open up considerably (Figure 39), without ever causing loss of equilibrium. No straps broke during the opening of the disconnection. However, of the two longitudinal straps that crossed the disconnection, the one that passed through the hole closest to the inner hinge broke the protective funnel-shaped element and ripped off the thin layer of brick located between the disconnection and the cavity for the passage of the straps (Figure 39b).

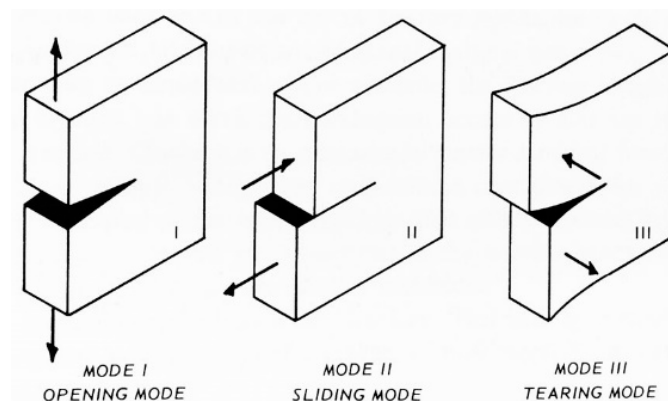
Figure 40. Modes of fracture.

Since the delamination of the upper CFRP strip occurs due to buckling, the detachment of the upper CFRP strip was in Mode I (Figure 40), near the disconnected cross-section. As usual for detachments in Mode I between CFRP strips and masonry [55], delamination caused the tearing of a thin layer composed by brick and mortar (Figure 51b), since the substrate is the element with the lower tensile strength in the system consisting of CFRP, resin, and masonry.

Even on the lower side, the delamination caused the tearing of a thin layer of substrate (Figure 48b), although the failure mode on the lower face of a bended specimen occurs in Mode II (Figure 40). Actually, the substrate is the weakest element also for shear sliding on mortar bed joints reinforced with CFRP strips [56–58], since the substrate is the component with the lower shear strength in the CFRP/resin/masonry system.

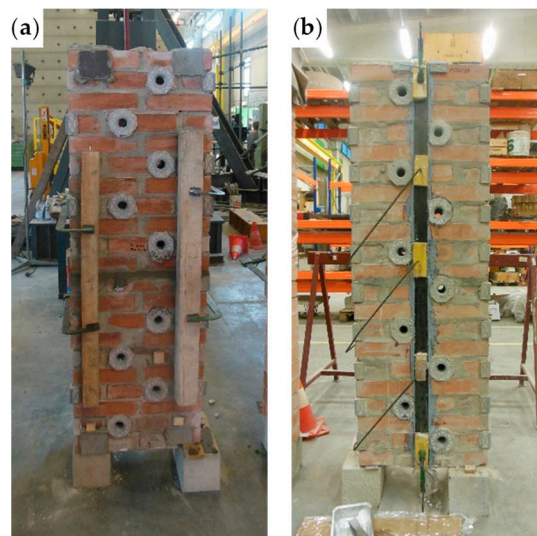
Figure 41. Preparation of the specimen: (a) restoration of the 10th mortar bed joint from below (front view) and (b) application of the CFRP strips after the maturing period (back view).

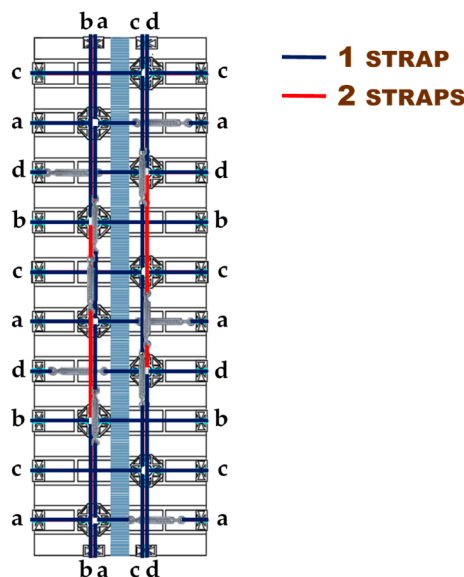
Figure 42. The four staggered meshes to strap the restored specimen (Specimen W5).

- Application of the straps on the restored specimen (Figure 42).

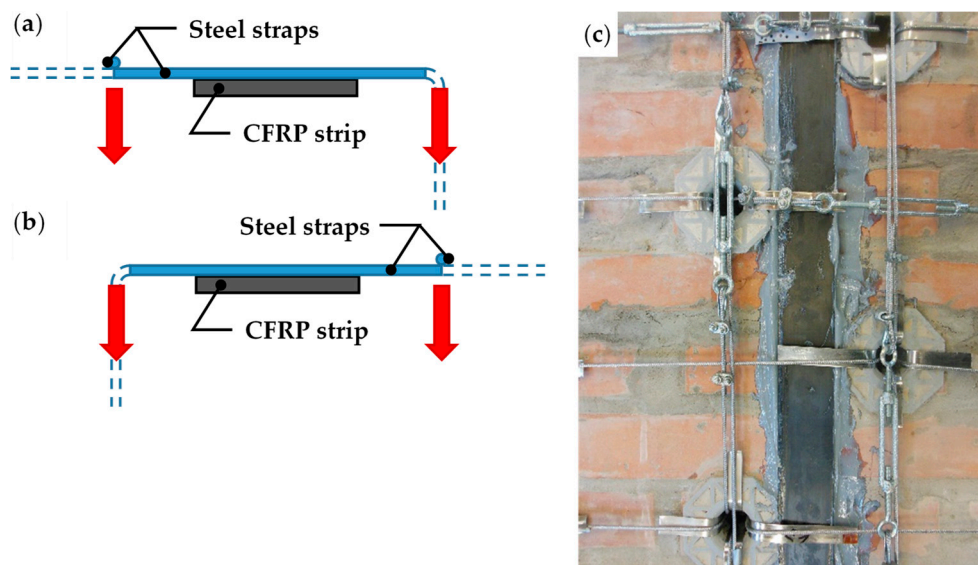
Figure 43. Load patterns of the CFRP strips: (a) cross-section view of the longitudinal strap on the left of the CFRP strip (not to scale); (b) cross-section view of the longitudinal strap on the right of the CFRP strip (not to scale); and (c) scheme sequence a, b, a, b on the strapped specimen.

As already done for the first combined technique, the strapping took place in two phases, arranging the transverse straps (parallel to the shorter sides), first, and the longitudinal straps (parallel to the longer sides), subsequently. As a result, the longitudinal straps pass over and press the transverse straps against the wall (Figure 43). This gives rise to the alternate patterns (a) and (b) of Figure 43, which allow the transverse straps to act on the CFRP strips with symmetric loads. The frictional forces caused by contact then couple the transverse straps and the CFRP strips mechanically, establishing the I-beam behavior described in Section 1.

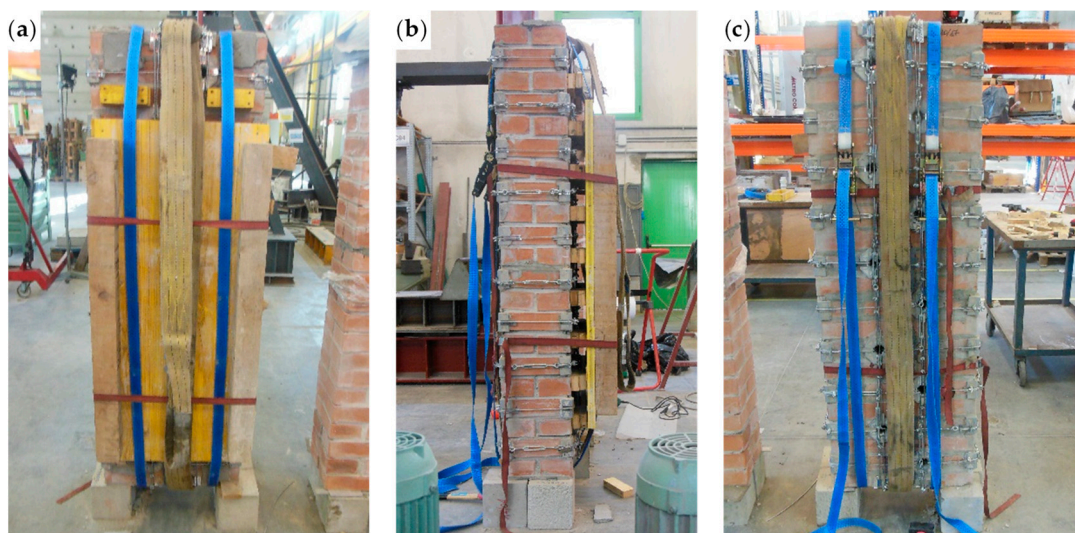
Figure 44. Slinging of Specimen W5, used to allow handling and overturning of the specimen by means of the girder crane: (a) front view; (b) viewed from the left; and (c) back view.

The slings also had the function of tying a wooden “stretcher” on the front side of the masonry wall (Figure 44a), to avoid damage to the specimen during the subsequent handling phase. Some wooden spacers between the wooden “stretcher” and the masonry wall (Figure 44b) prevented the wooden “stretcher” from touching the straps. In the absence of spacers, the wooden “stretcher” could have crushed the straps when the slings pushed it against the wall, damaging the tying system.

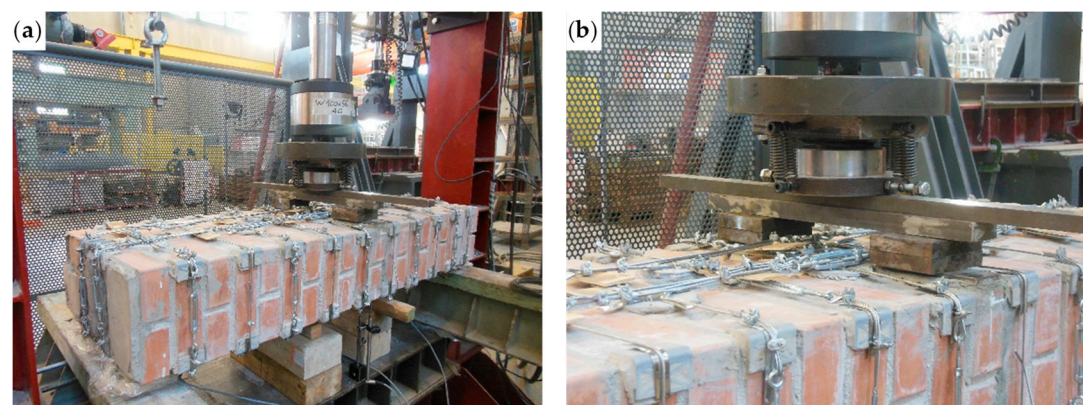
Figure 46. The flat steel bars for load distribution on the middle cross-section: (a) overview of the loading system and (b) detail of the passage of the steel wire ropes under the loading piston.

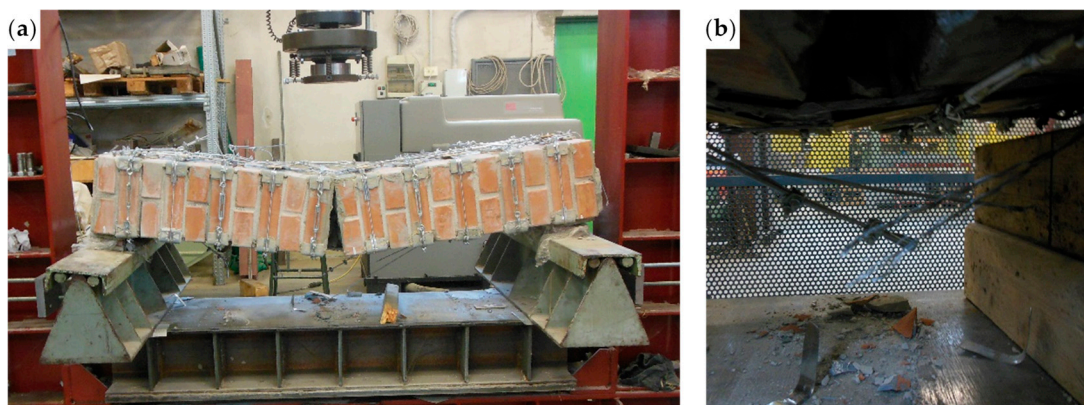
Figure 47. The specimen on the testing machine after the test: (a) front view and (b) detail of the broken straps under the middle cross-section (back view).

The bending test took place under displacement control. The behavior of the specimen was highly ductile, as for the specimens strengthened with the first combined technique (Sections 2.1 and 3.5.1). In fact, even in this latter case the specimen did not undergo an actual collapse because the steel wire ropes allowed the inner hinge to provide relative rotations in a controlled manner, preventing the specimen from falling (Figure 47a). However, contrary to what happened with the first combined technique (Section 3.5.1), several longitudinal straps suffered fraying and failure during the test, in particular those positioned on the middle cross-section (Figure 47b). This occurred due to the lower ductility of the steel wire ropes compared to the steel ribbons of the first combined technique (Section 3.3). In addition, one of the two threaded eyebolts of a defective turnbuckle positioned near the middle cross-section opened, due to the high load supplied by the steel wire rope. This led the Flemish eye to come out of the threaded eyebolt, interrupting the continuity of the strap (Figures 47b and 48b).

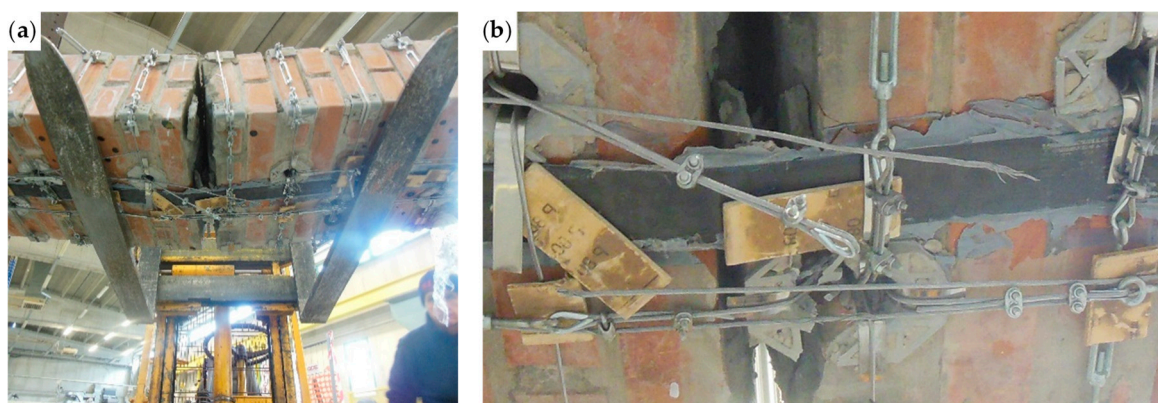
Figure 48. The specimen on the forklift after the test: (a) bottom/back view (the vertical white marks indicate the middle cross-section) and (b) detail of the disconnected cross-section viewed from below, with the Flemish eye that came out of the threaded eyebolt in the foreground.

The view from below in Figure 48b also shows a broken funnel-shaped plate near the middle cross-section. Since the internal disconnection of Specimen W5 opened in the same position as for Specimen W1 (Specimen W5 before the restoration), for Specimen W1 the funnel-shaped plate near the middle cross-section also broke into two parts. In Specimen W5, however, the failure of the funnel-shaped plate did not entail the interruption of the chain made by the longitudinal straps

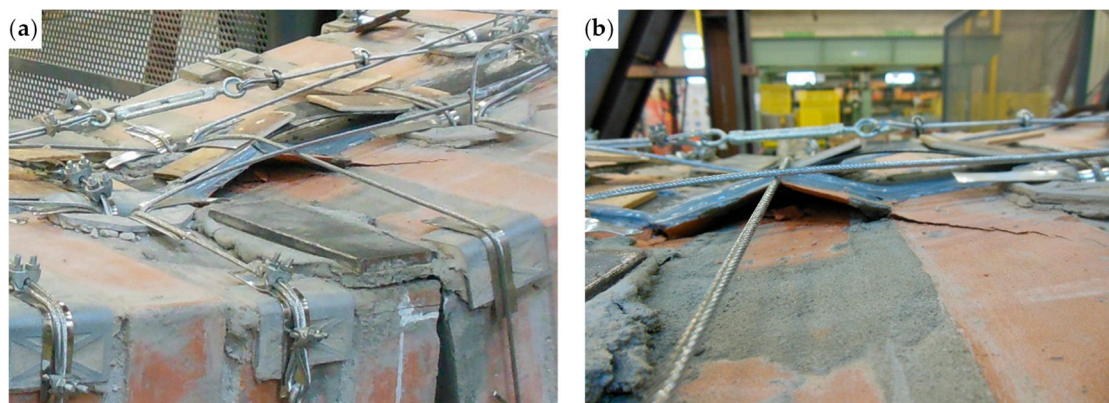
Figure 51. Buckling of the upper CFRP strip: (a) how the transverse and longitudinal steel wire ropes hold back the upper CFRP strip, counteracting delamination on the middle cross-section and (b) detail of the brick peeling caused by delamination.
