# Study on the Restoration of a Masonry Arch Viaduct: Numerical Analysis and Lab Tests

**Abstract:** This article presents an analysis of the load-carrying capacity of a historic masonry arch viaduct. The vault was made of bricks and lime-cement mortar. It was built in 1886 and, therefore, its historical character had to be included in the restoration project. The main task of the restoration was to bring the viaduct to a technical condition corresponding to the current requirements to allow normal (or limited) service. The strength of the brickwork and joints (mortar) was examined experimentally in the laboratory and on the viaduct. This paper presents numerical calculations for the masonry viaduct that were performed using two programs based on the finite element method. As the project documentation was unknown, two- and three-hinged models of the masonry arch were analyzed. The axial forces, shear forces, bending moments, displacement, normal stresses, and shear stresses generated from the numerical analysis have been discussed. The conditions of the load capacity of the arch viaduct due to compression and shearing have been met. The safety of a masonry arch of the viaduct was

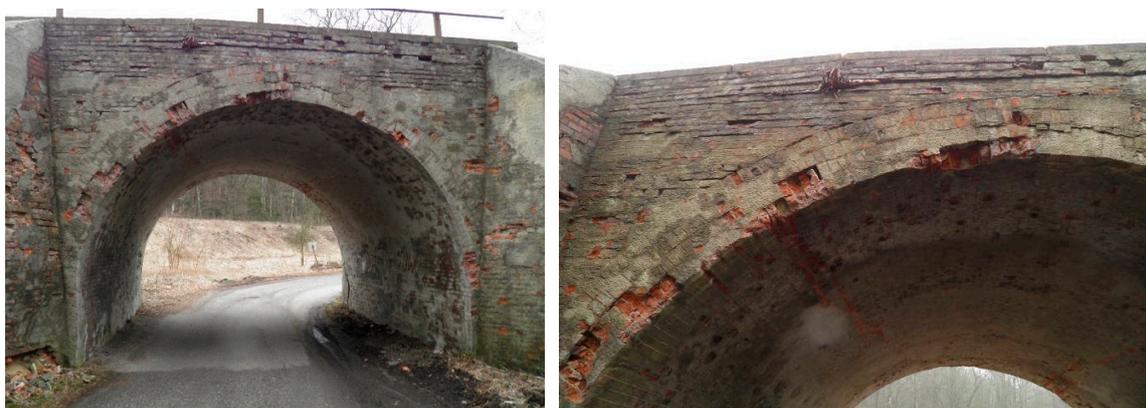
**Figure 1.** Side view of masonry arch viaduct before restoration: (a) Overview, (b) visible damage (deflection from the vertical) of the parapet (upper part of the headwall), which was caused by the root.

At the inlet and outlet of the viaduct, there were brick wings with a variable thickness of 0.60–1.20 m and a length of about 4.50 m. The lack of ongoing maintenance and regular repair works to the viaduct over the past 30 years has led to its poor technical condition, mainly in the field of the aesthetic perception (Figure 1a).

headwall was rated as satisfactory. A root was noted growing on the parapet (top part of the headwall), which caused its slight local deviation (<5 cm) from the vertical position (Figure 1a,b). The deviation was located in the upper part of the headwall (outside the area of backfill pressure on the headwall) and did not affect the load-carrying capacity of the masonry arch. There was weeping and blooming from the bottom of the span, which indicates insulation leakage. In addition, leaching of the joints between bricks and the brick surface destruction were visible. However, in general, the lime-cement mortar was in fairly good condition. Superficial damage to the masonry arch structure caused by impacts from non-standard vehicles was noted. The insulation condition of the viaduct was bad; the drainage was in a slightly better condition.

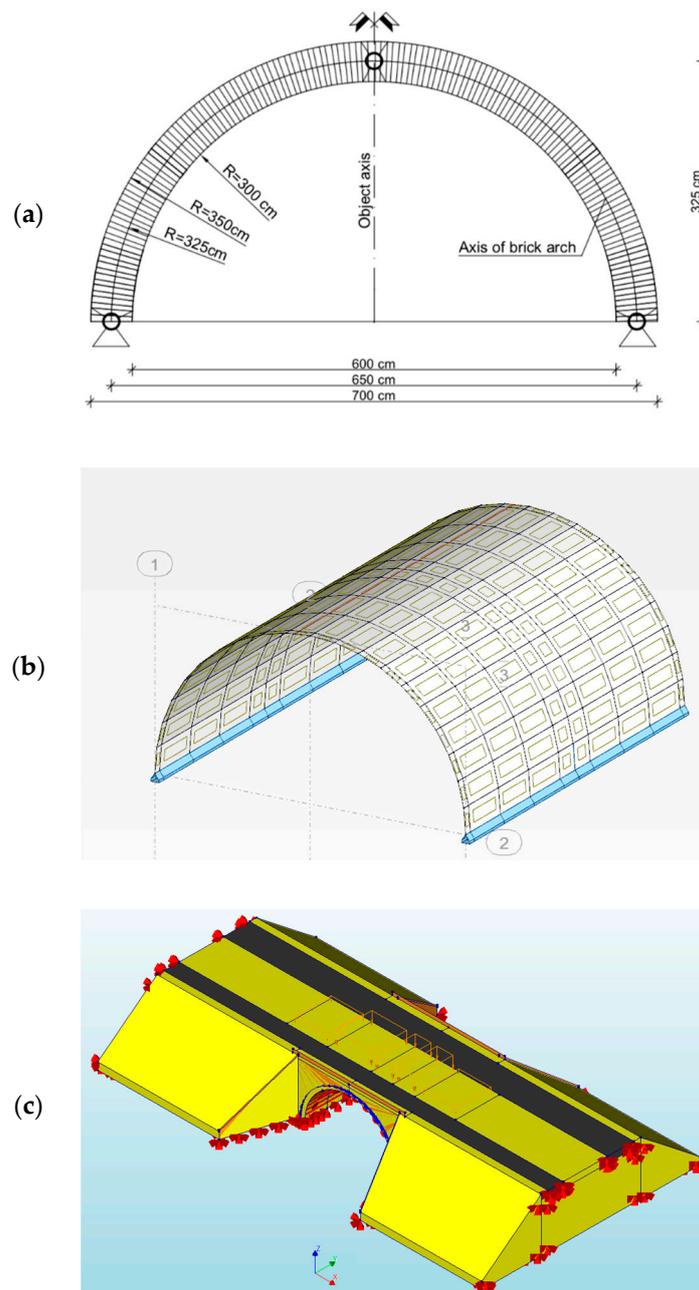
**Figure 2.** Viaduct with three-hinged arch: (a) Static scheme, (b) program #1, (c) program #2.

The arch in the shape of a cylindrical shell with a span edge in its crown and two-hinged supports on its lower edges was subjected to analysis (Figure 2b). Additionally, in the next numerical model, an additional hinge was introduced at the arch crown, forming a three-hinged arch (Figure 2a). The shell structure was modelled with a constant 0.5 m thickness and strength parameters of the brick wall and curvature consistent with the neutral axis of the actual arch. In program #1, the arch shell structure was divided into 2369 FE of rectangular shape, while in program #2, the arch had 2580 FE, but in the whole numerical model, there were 243251 FE.

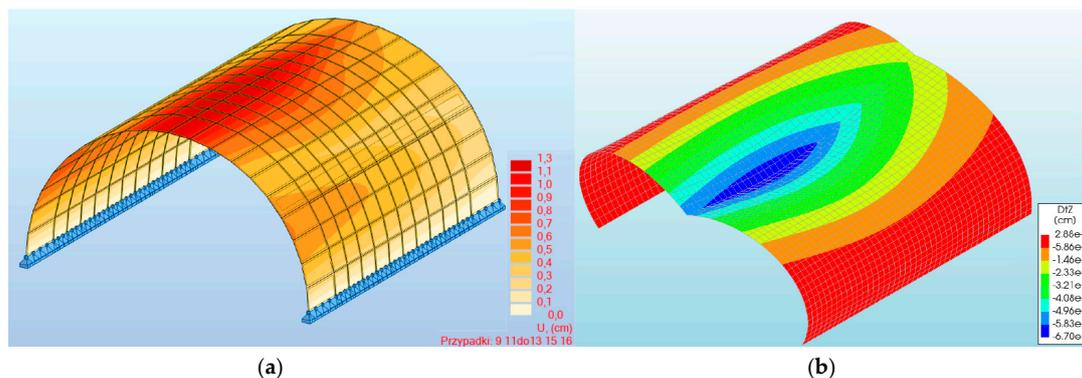
Figure 3. Maximal displacements of the three-hinged arch for program: (a) #1, (b) #2.

For the results from programs #1 and #2, the maximum vertical displacements of the structure at the arch crown (Figure 3a,b) from the standard load were minor and were about 13.10 and 6.7 mm, respectively (for the three-hinged arch). In the case of the two-hinged arch, the maximum displacement at the crown of the viaduct amounted to 7.31 mm. Thus, the largest differences between the maximal displacements of program #1 and #2 did not exceed 47%. Smaller differences were observed in the case of the two-hinged arch model (Figure 4). In all the numerical models, the maximal vertical displacements were observed in the arch crown of the structure.

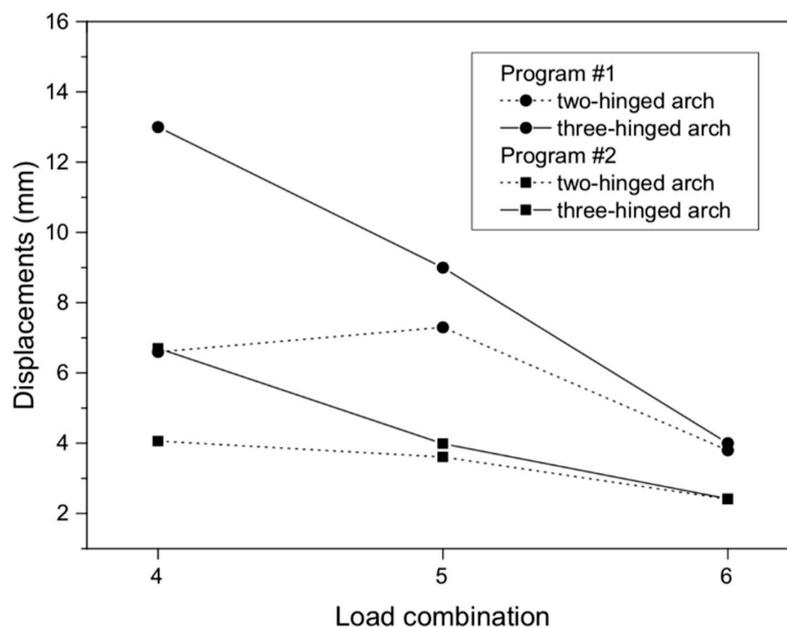
Figure 4. Displacements of masonry arch for various load combinations.

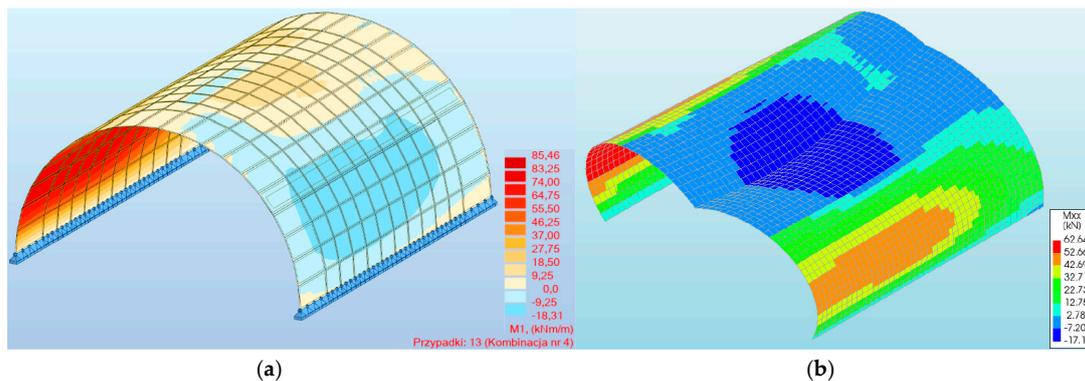
Figure 5. Maximum bending moments of a three-hinged arch for program: (a) #1, (b) #2.

In the case of bending moments, the maximum values did not exceed 85.46 and 62.64 kNm/m (in the three-hinged arch model) for program #1 and #2, respectively (Figure 5a,b). From Figure 5, for the three-hinged arch, the maximum bending moments were observed in the same places, i.e., between 1/3 and 2/3 of the arch height. In addition, the absolute results in program #1 and #2 for both the two- and three-hinged arch models were relatively close to each other, with the largest differences being 21% and 12%, respectively (Figure 6). In addition, in program #2 for combination #4, the maximum moment was obtained for both the two- and three-hinged bridge models.

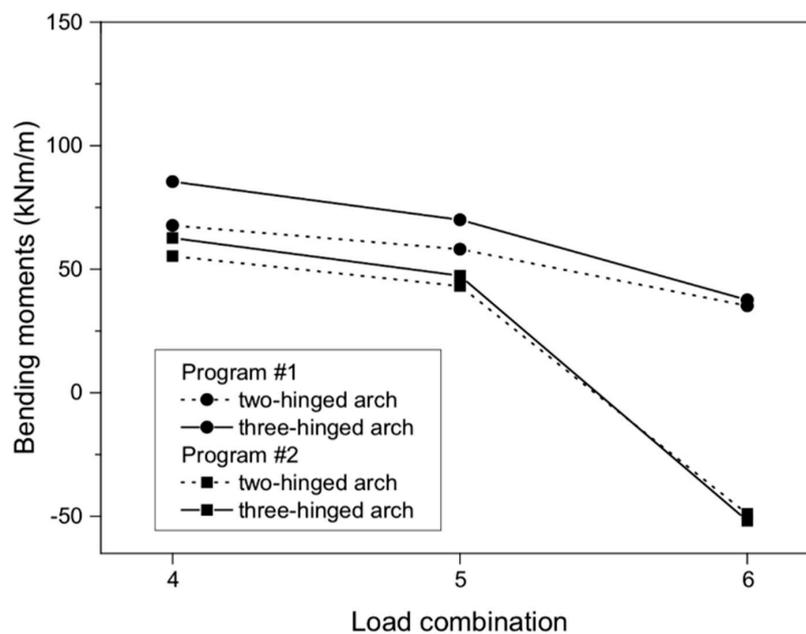
Figure 6. Bending moments of masonry arch viaduct for load combinations.

As can be seen in Figure 6, the character of the maximum bending moments in program #2 varied. By contrast, program #1 provided maximum bending moments with a uniform character, i.e., positive.

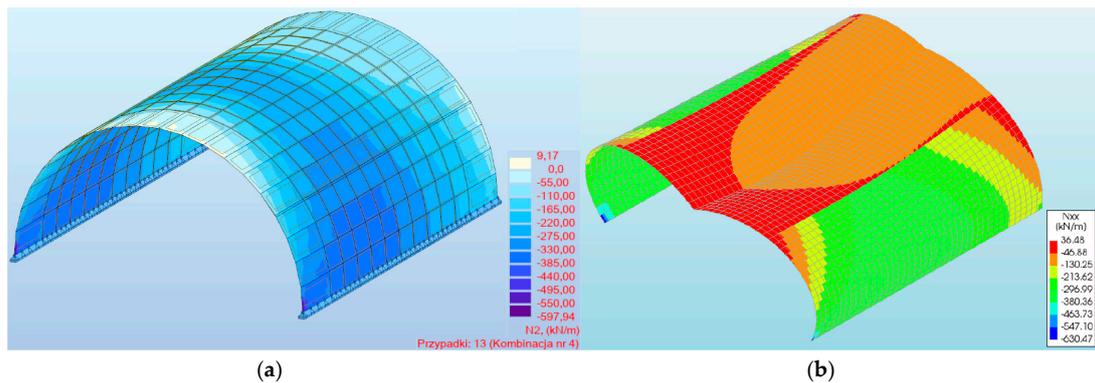
Figure 7. Maximum axial forces of a three-hinged arch obtained in the program: (a) #1, (b) #2.

When analyzing the axial forces, it was noted that their maximum values (in three-hinged arch) were almost  $-630$  kN/m in program #2 (Figure 7b) and  $-597.94$  kN/m in program #1 (Figure 7a), and these appeared near the foundations of the arch viaduct. Thus, the difference between them was 5%. Meanwhile, for the models with a two-hinged arch, the axial forces were smaller than for the three-hinged arch. For the two-hinged models, the axial forces were  $-592.10$  and  $-616.15$  kN/m for program #1 and #2, respectively. In addition, the results obtained were very similar to each other (Figure 8).

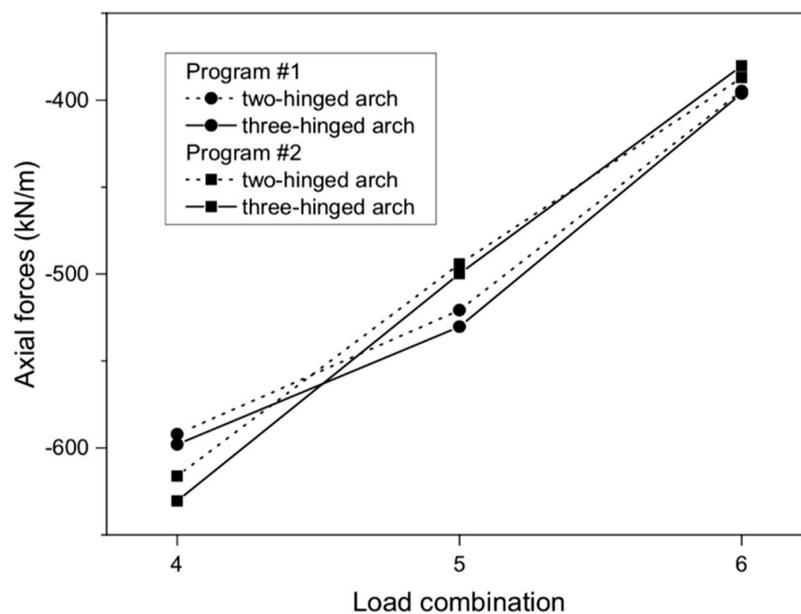
Figure 8. Axial forces of arch viaduct vs. load combinations.

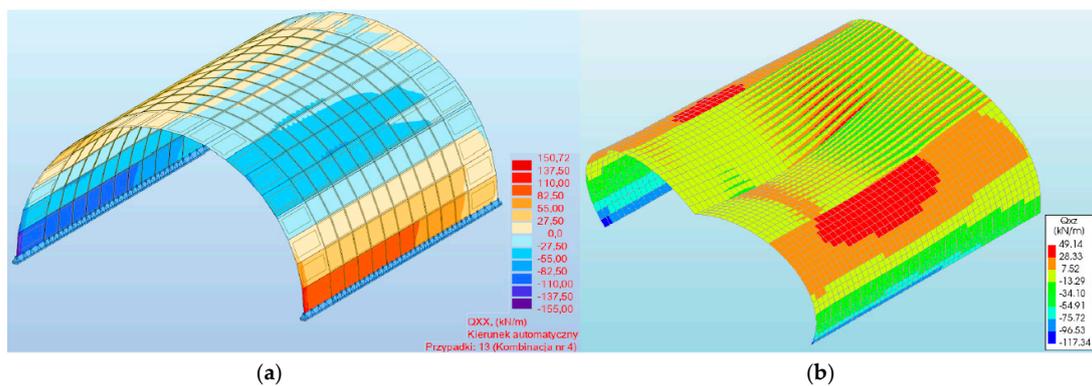
Figure 9. Maximum shearing forces of a three-hinged arch viaduct obtained in the program: (a) #1, (b) #2.

In the case of maximum shear forces, the largest value ( $-155.00$  Kn/m) was also obtained in the numerical model with a three-hinged arch in program #1 (Figure 9a). Using program #2, a 24% lower value was obtained, which was  $117.34$  Kn/m (Figure 9b). The shear forces obtained in both programs (#1 and #2) appeared around the supports of the numerical models analyzed. In models with a two-hinged arch, shear forces of  $-127.00$  and  $-109.85$  Kn/m were obtained, respectively. Thus, the difference between the programs used for the two-hinged models was 14%. For both axial and shear forces, their character was the same for all the numerical models analyzed (Figure 10). In addition, in programs #1 and #2, the differences between the two- and three-hinged models were 6% and 18%, respectively.

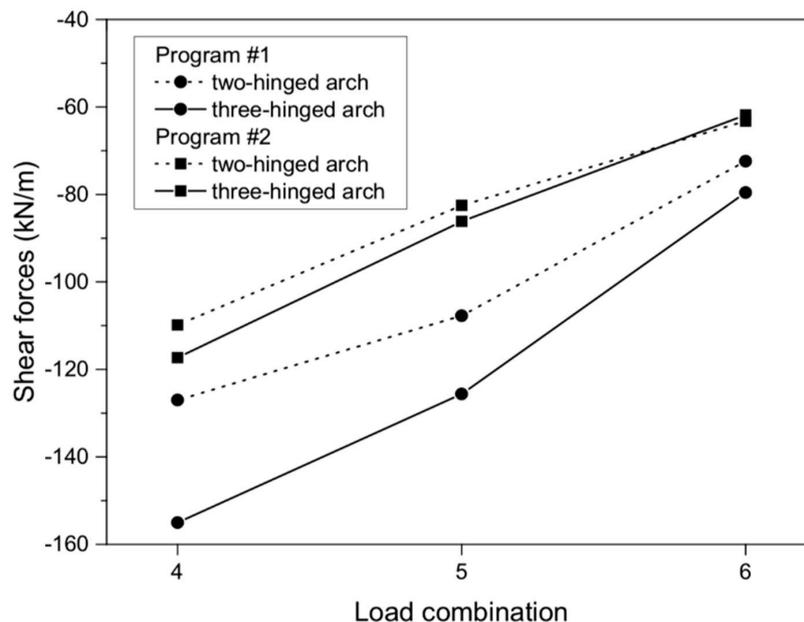
Figure 10. Shearing forces of masonry arch for load combinations.

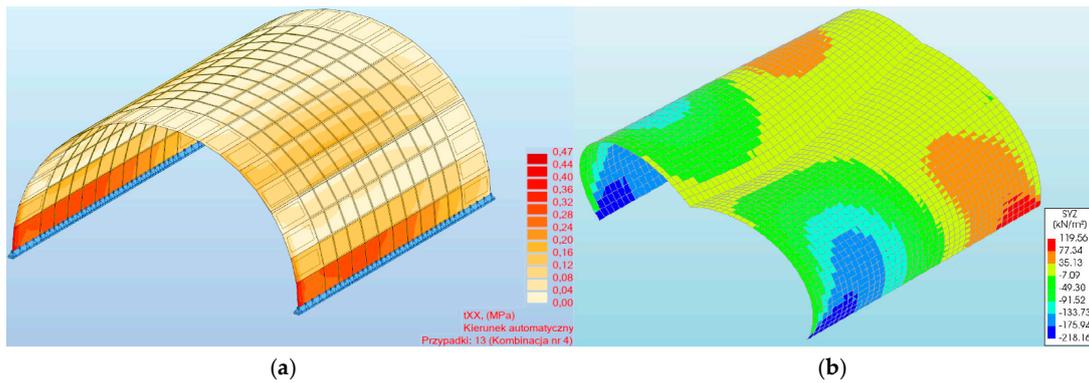
Figure 11. Maximum normal stresses of a three-hinged arch obtained in the program: (a) #1, (b) #2.

The maximum normal stresses (2.71 MPa (program #1) and  $-1.01$  MPa (program #2)) were recorded in the three-hinged arch model (Figure 11a,b). These stresses were recorded between 1/3 and 2/3 of the viaduct arch height. Thus, the difference between them was 63%. In addition, a different distribution of normal stresses was noted in both programs for the three-hinged arch model (Figure 12). In program #1, the maximum normal stresses were symmetrical relative to the shell crown (Figure 11a). By contrast, in program #2, it was asymmetrical (Figure 11b). A similar tendency was observed in models with the two-hinged arch, but the maximum normal stress obtained was smaller (Figure 12), i.e., 2.25 (for program #1) and 0.89 MPa (for program #2). One can also observe a good agreement in the results obtained in programs #1 and #2, where the difference between the two- and three-hinged arch viaducts reached 17% and 12%, respectively.

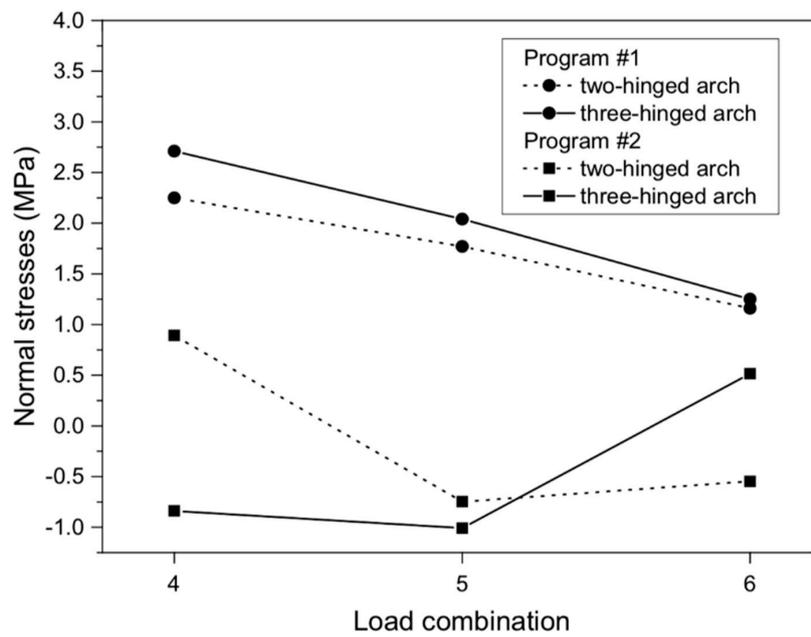
Figure 12. Maximum normal stresses of masonry arch viaduct for various load combinations.

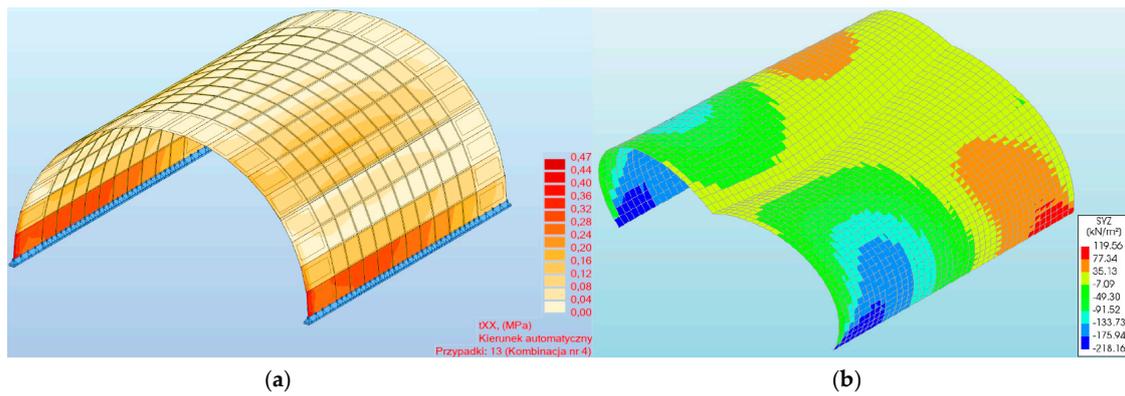
Figure 13. Maximum shear stresses of a three-hinged arch viaduct for the program: (a) #1, (b) #2.

For shear stresses in the analyzed arch viaduct models, the maximum values were obtained in the three-hinged model and did not exceed 0.47 (program #1, Figure 13a) and  $-0.22$  MPa (program #2, Figure 13b). Thus, the difference between the results of program #1 and #2 was 53%. Shear stresses were observed in the same places, i.e., near the supports of the arch viaduct models. The character of the shear stresses varied (Figure 14). Generally, the differences between the individual arch viaduct models (two- or three-hinged model) in programs #1 and #2 were small (Figure 14) and did not exceed 19% and 5%, respectively (for load combination #4).

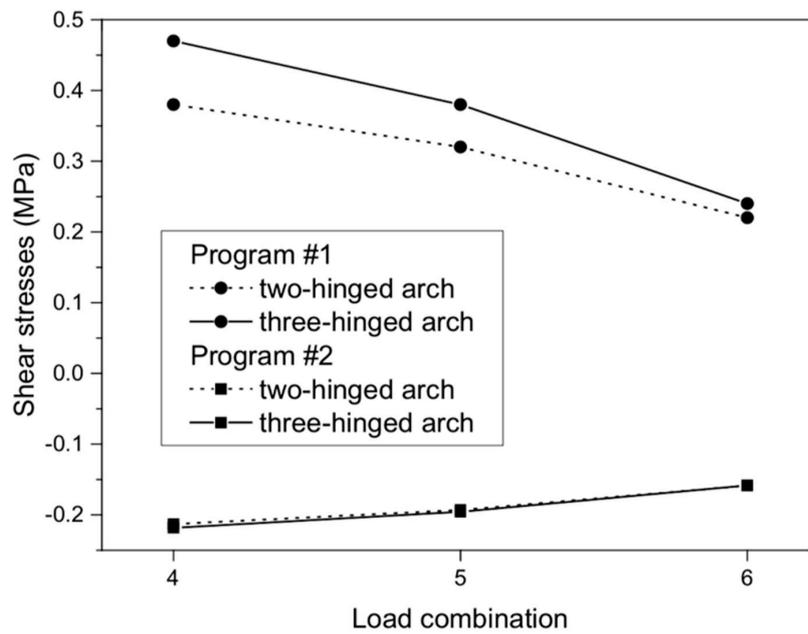
Figure 14. Shear stresses of masonry arch for load combinations.

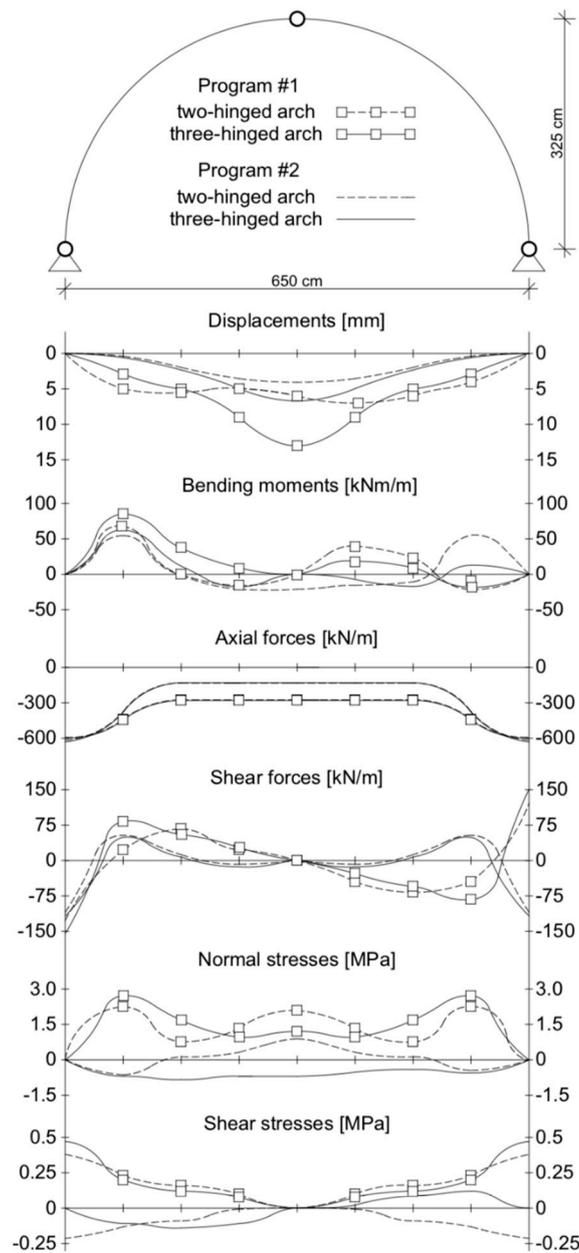
**Figure 15.** Distribution of analyzed maximum values in the cross-section of the two- and three-hinged arch viaduct in both programs (#1 and #2).

Figure 15 shows the distribution of the analyzed values in the cross-section of the two- and three-hinged arch models. It shows that the maximum displacements were obtained in the arch crown, while the bending moments and normal stresses were at the quarter points of the arch. Meanwhile, the maximum axial forces, shear forces, and shear stresses occurred near the support of the arch viaduct. In almost all cases, the viaduct was symmetrically strained (except for bending moments).

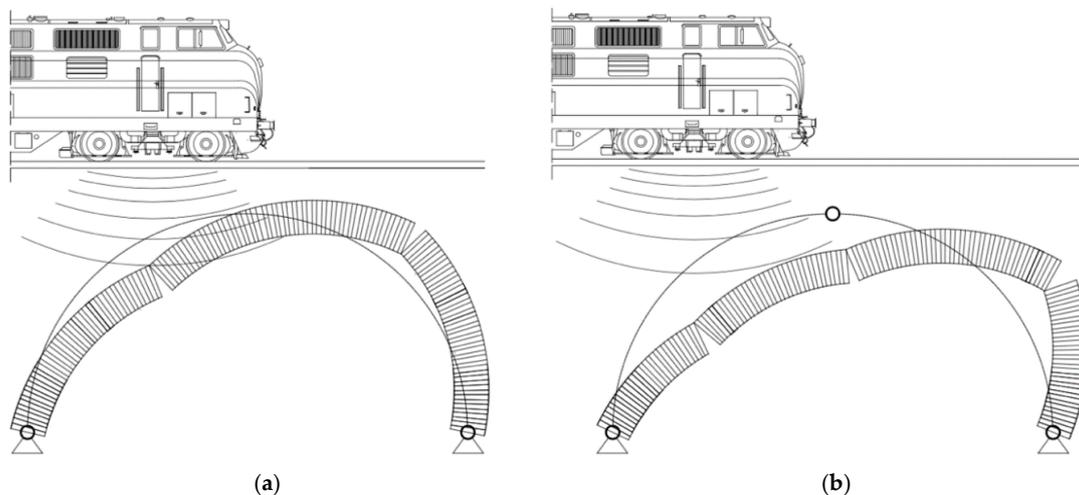
**Figure 16.** The potential collapse mechanisms for: (a) The two- and (b) three-hinged arches.

In addition, the potential collapse mechanisms for the two- and three-hinged arches are schematically presented in Figure 16. Potential damage to the arch can occur in the places where the maximum compressive and shear stresses appear. They can appear in the near foundation and quarter points of the arch (for the two-hinged arch), and additionally in the crown for the three-hinged arch. The simplified arch schemes are also presented in [60–62], and the influence of failure hinge locations on arch stability is presented in [63]. The authors provided an interactive tool to simplify and aid in understanding the mechanized failure of masonry arches.

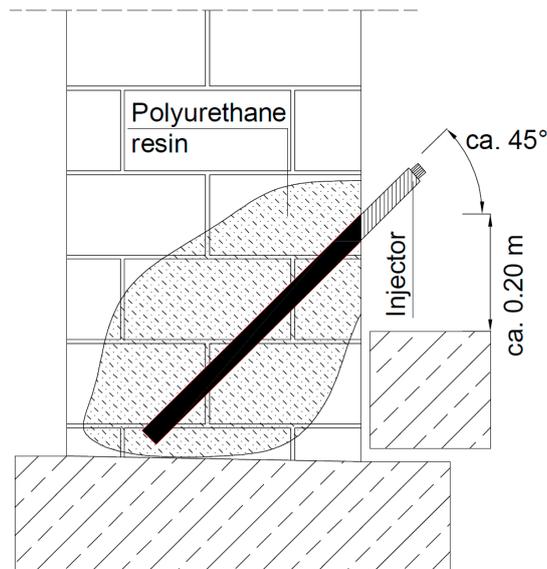
Figure 17. The injection system in the wall.

- (b) then, the polyurethane resin had to be injected (characterized by high tensile and flexural strength intended for closing and sealing cracks). Before injection, heavily damaged parts of the wall (mainly joints) had to be sealed with lime-cement mortar, preventing resin from flowing out. After the arch injection, the injectors were removed, and the holes were sealed with the lime-cement mortar.

- After 48 h, the curtain injection waterproofing on the arch and walls began, protecting the wall from exposure to water and moisture. Waterproofing was conducted after strengthening the masonry arch using the injection system. Horizontal insulation of the vault should be made in holes with a  $30 \times 30$  cm spacing drilled through the entire thickness of the walls. A low-viscosity acrylic gel was used to perform the surface insulation.

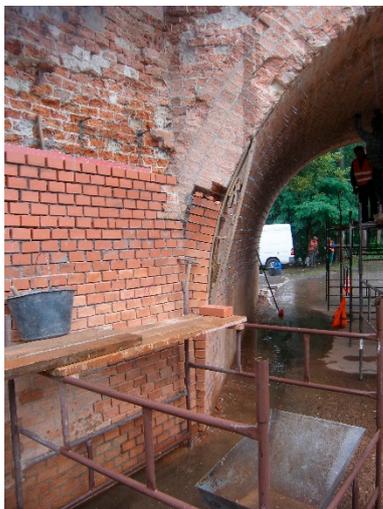
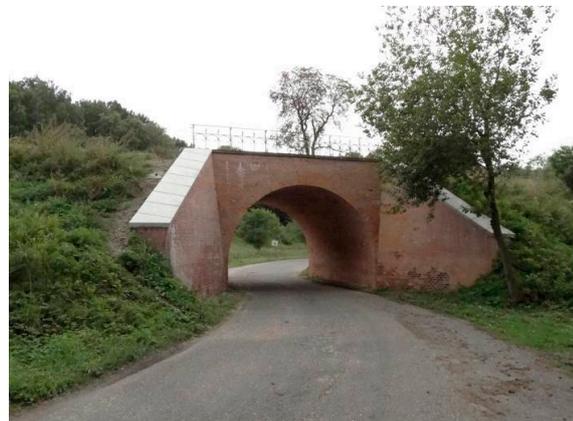
Figure 18. Side view of the masonry viaduct: (a) During restoration works (arch injection and rebuilding of the wings), (b) after renovation.

was performed on all brick parts of the viaduct. Figure 18b shows a view of the masonry viaduct after renovation.
