Influence of the Chloride Attack on the Post-Cracking Behavior of Recycled Steel Fiber Reinforced Concrete

Cristina Frazão ^{1,*}

, Joaquim Barros ¹ and José Alexandre Bogas ²

Citation: Frazão, C.; Barros, J.; Bogas, J.A. Influence of the Chloride Attack on the Post-Cracking Behavior of Recycled Steel Fiber Reinforced Concrete. *Materials* **2021**, *14*, 1279. <https://doi.org/10.3390/ma14051279>

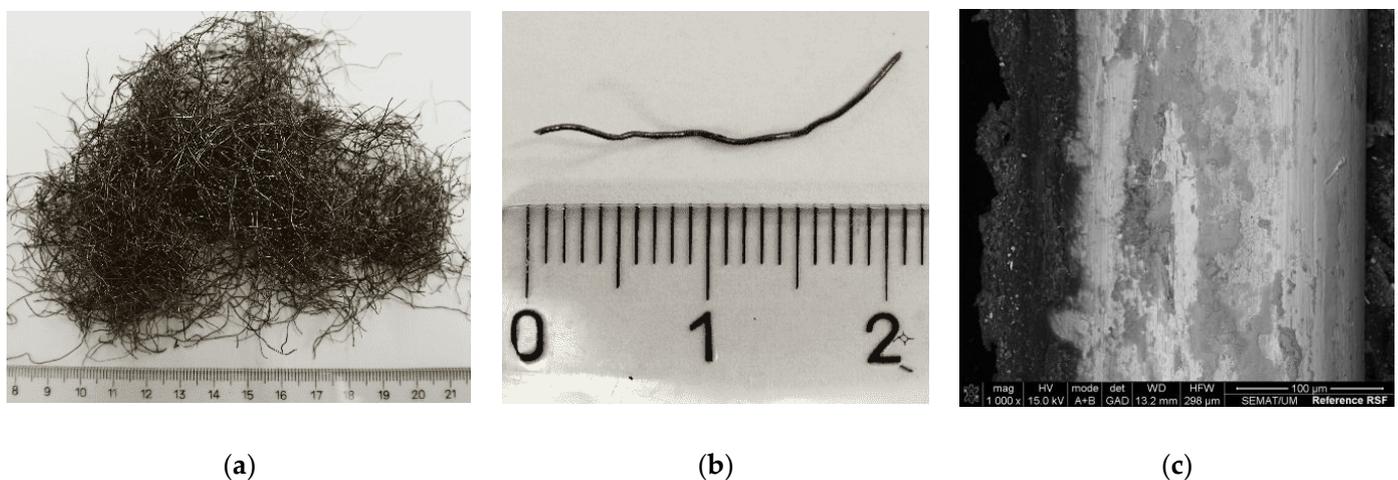
Figure 1. Recycled steel fibers (RSFs): (a) general view of multi RSFs; (b) general view of the geometry of a single RSF; and (c) SEM micrograph of the surface of a single reference RSF (magnification: 1000×) [3].

The recycled steel fibers (RSFs) used in this research were recovered by a shredding process of post-consumed truck tires. These RSFs generally have irregular shapes with various lengths and diameters (Figure 1a,b). The steel was separated from the rubber by an electromagnetic separator, and most of the RSFs still contain some rubber particles attached to their surface due to the shredding process (Figure 1c). According to a detailed characterization performed on a sample of 2000 fibers, on average, the RSFs have 20 mm in length (l_f), defined as the distance between the outer ends of the fiber, 0.25 mm in diameter (d_f), and an aspect ratio (l_f/d_f) of 110. The average tensile strength of RSFs, obtained from five fibers by means of direct tensile tests, was around 2648 MPa (coefficient of variation = 16%). A carbon concentration of 0.77% in the chemical composition of RSFs was determined by X-ray fluorescence spectrometry (XRF, X'Unique II spectrometer, Philips) analysis.

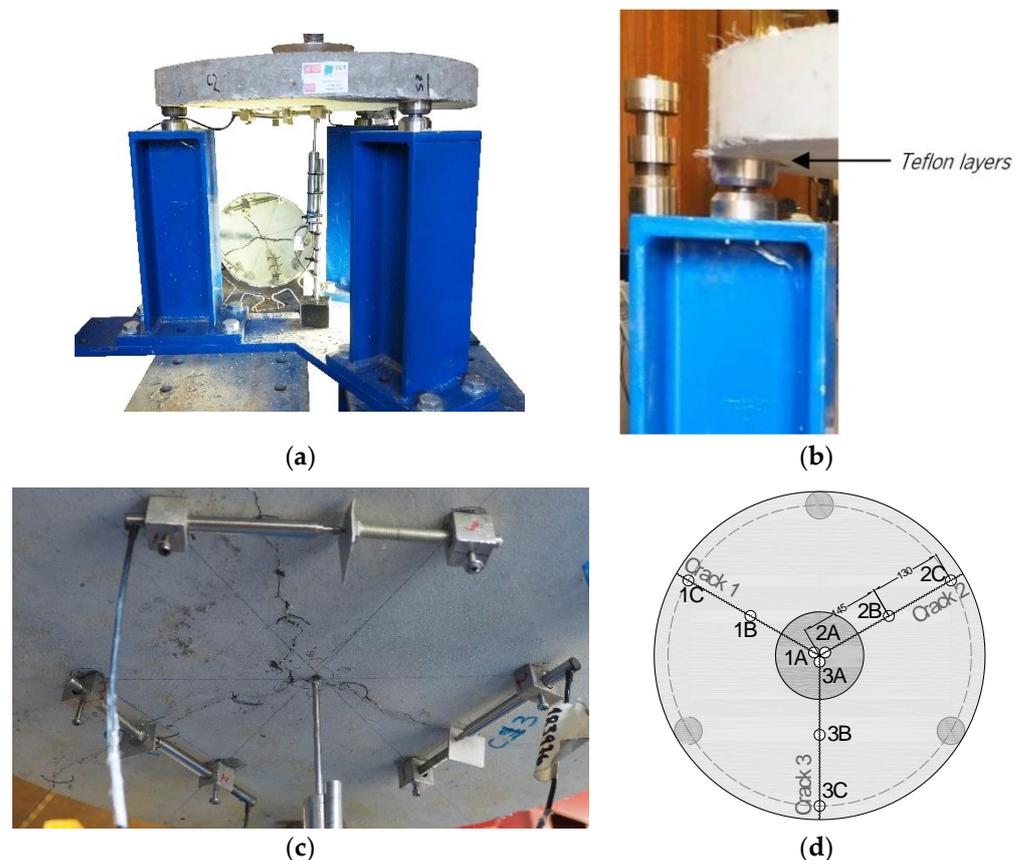
Figure 3. The round panel test supported on three points (RPT-3ps) setup: (a) the three pivots support system [3]; (b) connection between the panel and each pivot; (c) positions of the linear variable displacement transducers (LVDTs) for central deflection measurement and of LVDTs for crack width measurement; and (d) position of the crack width measurement with a USB microscope (“A”—At the center of the panel; “B”—At a distance of 145 mm from the panel center; “C”—At a distance of 275 mm from the panel center).

Round panel tests supported on three symmetrically arranged pivots (RPT-3ps) were conducted, as presented in Figure 3a. The connection between the panel and each pivot was provided by two round steel pieces of 50 mm diameter and 25 mm thickness, with a spherical seat of around 6 mm depth machined into the two surfaces to achieve the ball connection recommended by ASTM C1550-08 [27], as represented in Figure 3b. Two Teflon sheets were used between the concrete panel and each round steel plate to reduce friction (Figure 3b). The load was applied to the panel's center through a hemispherical-ended steel piston at a constant displacement rate. The central deflection of the panel was measured by an LVDT installed at the bottom surface of the panel (Figure 3a). Three LVDTs were also used in the bottom face of the panel to measure the width of the three developed cracks (Figure 3c,d).

Figure 3c, is close to the intended one; (3) if not, impose successive increments of 0.25 mm to the installed central displacement, at the same deflection rate, until the intended pre-crack width is achieved. At the end, and before submitting the panels to the environmental exposure, the ω_{cr} was measured with a USB microscope in the nine points indicated in Figure 3d (three points at each crack).

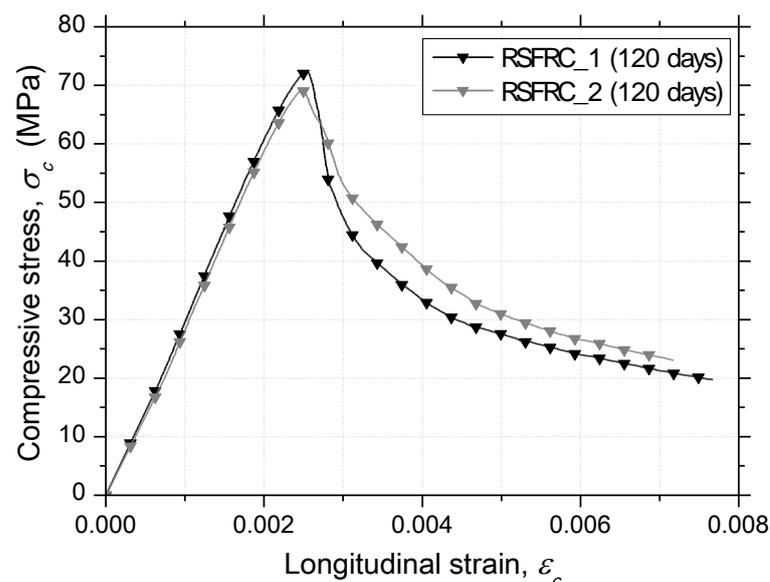
Figure 4. Average compressive stress–longitudinal strain curves obtained in compression tests of RSFRC_1 and RSFRC_2 batches (120 days).

The average $\sigma_c - \varepsilon_c$ curves determined at the same age of round panel tests (120 days) from a set of four concrete specimens of each RSFRC batch (RSFRC_1 and RSFRC_2) are depicted in Figure 4. Table 3 includes the average values and the corresponding coefficients of variation (CoV) of the hardened density, the elasticity modulus, E_{cm} , the compressive strength, f_{cm} , the strain at peak load, ε_{c1} , and the energy dissipated under compression, G_c , calculated as the area under the stress–strain curve, $\sigma_c - \varepsilon_c$, until an ultimate deformation, ε_u , of 0.005, where the residual strength was less than 50% of the corresponding f_{cm} . The maximum compressive strength was slightly higher in RSFRC_1 than in RSFRC_2, although this last batch showed a lower residual strength drop after the peak load.

Immediately after the peak load, a high gradient of stress decay was observed in the RSFRC since fibers were not able to sustain the relatively high release of energy in the RSFRC at this stage. The average values of E_{cm} and f_{cm} were also slightly lower for batch RSFRC_2 (Table 3). In general, low CoV values were obtained for all the evaluated parameters in the compression tests, which attests to the adequate homogeneity of produced concrete.

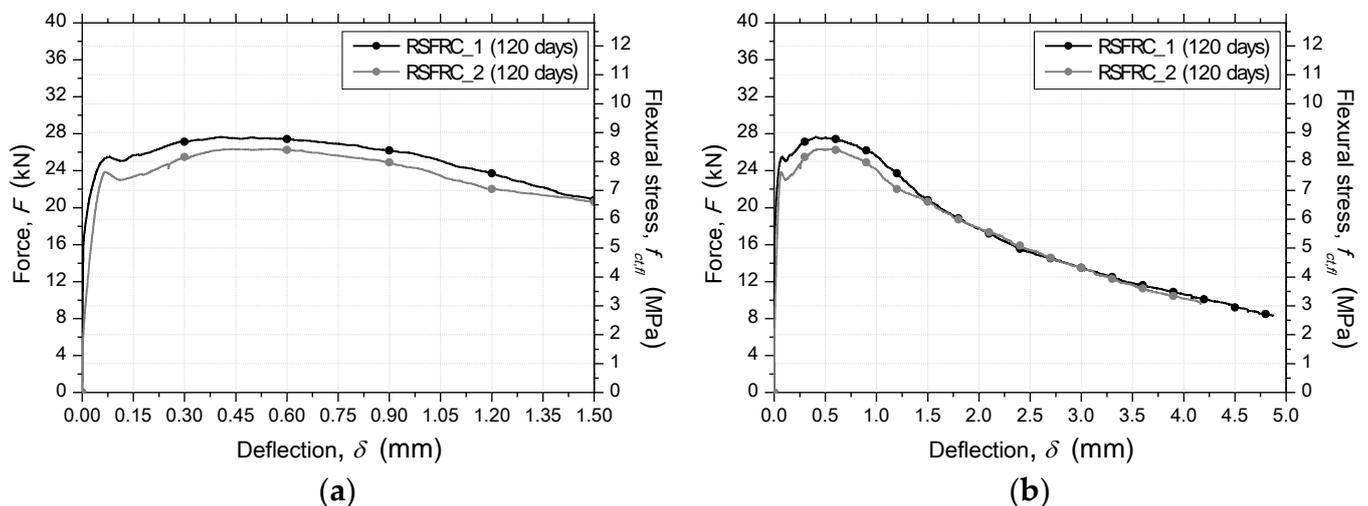
Figure 5. Average force/flexural stress–deflection curves obtained in bending tests of RSFRC_1 and RSFRC_2 batches (120 days). (a) Deflection up to 1.5 mm (b) Deflection up to 5 mm.

Figure 5 presents the average 120 days force/flexural stress–deflection ($F/f_{ct,fl} - \delta$) relationship, obtained for the notched beams RSFRC_1 and RSFRC_2. Regarding the pre-peak behavior, after the cracking load has been attained, the RSFRC beams presented a small decrease of flexural capacity until a deflection at which the fiber reinforcement mechanisms started being mobilized and controlling the crack opening process (Figure 5).

Table 4 shows the average values and the corresponding coefficients of variation (CoV) of the flexural tensile strength parameters, $f_{R,1}$, $f_{R,2}$, $f_{R,3}$ and $f_{R,4}$, considering the two concrete batches. From the data presented in Table 4, in general, no significant differences were observed between the residual strengths of RSFRC_1 and RSFRC_2. On average, the peak load was about 5% higher in RSFRC_2 than in RSFRC_1, corroborating the slightly higher mechanical strength of this batch.

During the pre-cracking stage of the panels (Figure 17a,c), the determined parameters corroborate with the flexural tensile strength parameters obtained in the 3PNBBT of the corresponding RSFRC beams (Table 4 and Figure 5).

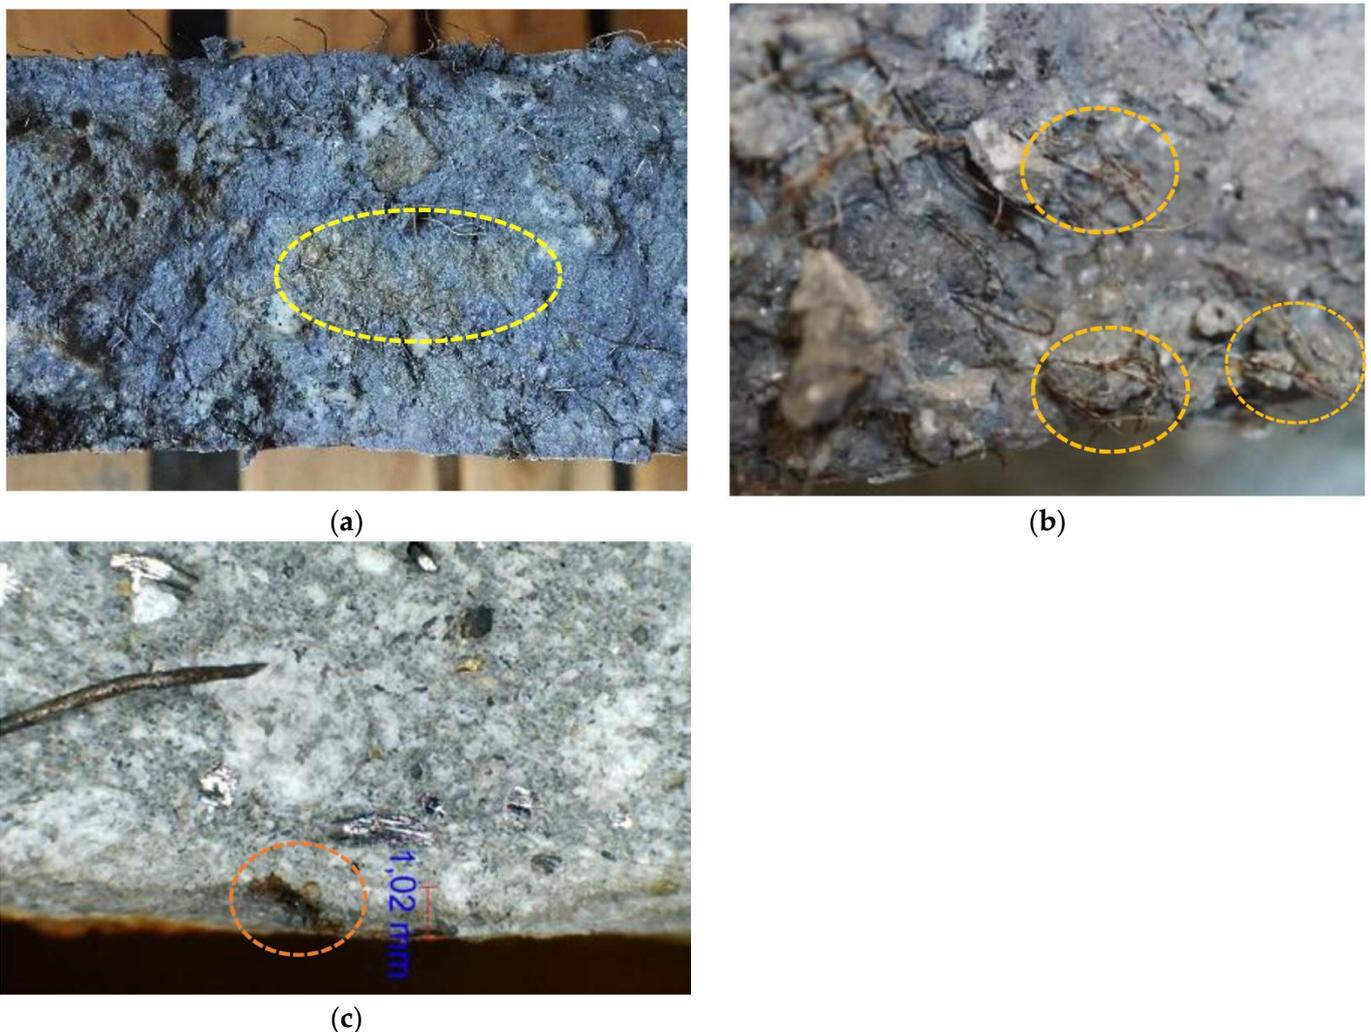
Figure 6. (a) Inspection of recycled steel fibers' (RSFs) corrosion at the crack surface; (b) chloride penetration depth at the cracked surface; and (c) corrosion signs on RSFs located on an orthogonal cut plane to a crack surface (uncracked region), after the exposure period of 90 days of dry–wet cycles.

After 90 days of dry–wet cycles in chloride solution, a significant increase of corrosion spots occurred on the surface of pre-cracked RSFRC panels. At the end of RPT-3ps, the cracked surfaces of the RSFRC panels submitted to chloride exposure were visually observed. To assess the chloride penetration depth, the crack surfaces of these panels were sprayed with silver nitrate solution. The cracked surfaces were almost completely penetrated by chlorides during the immersion period, only a few irregular areas inside the panels showed no signs of chloride penetration (Figure 6a).

As shown in Figure 6b, some RSFs at cracked surfaces presented corrosion products, mainly near the bottom of the exposed face of the panels, where the crack width was higher and closer to the chloride solution. It seems that the RSFs' corrosion occurred mainly at the fiber length crossing the crack width (in direct contact with the chloride solution) (Figure 6b). However, few corrosion spots were detected by microscopic inspection on RSFs up to 1–3 mm deep, located on a cut surface orthogonal to a crack, as observed in Figure 6c.

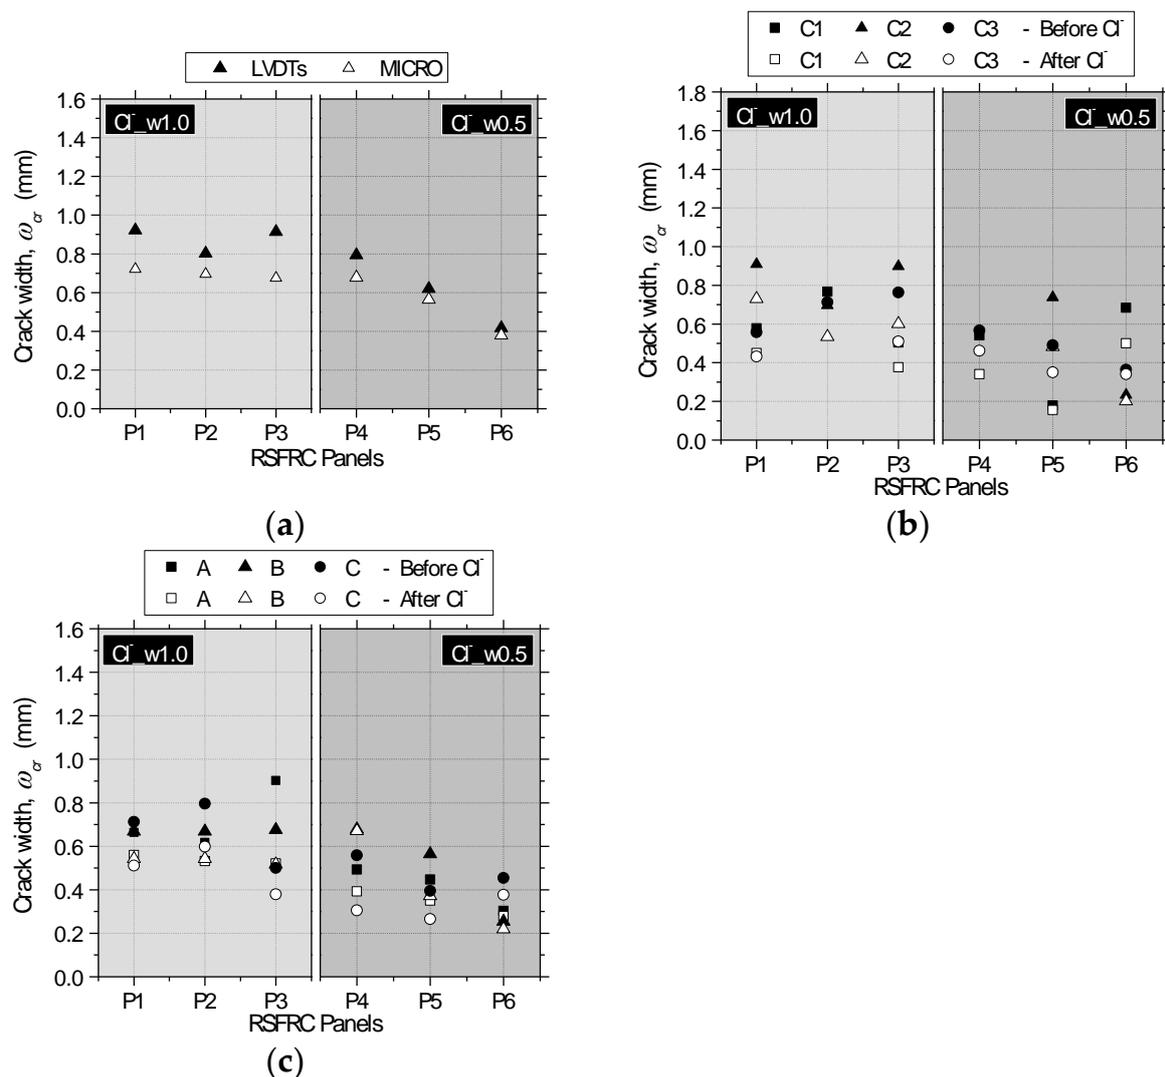
Figure 7. Crack width measurements performed with (a) the LVDTs and the microscope; (b) the microscope at each crack C1, C2, and C3 (Figure 3d); and (c) the microscope at each position A, B, and C (Figure 3d).

As mentioned in Section 2.3.2.1, the crack widths were also measured with a USB microscope before and after submitting the panels to immersion. The measurements were performed at three points of each crack in the bottom surface of the panel, as schematically represented in Figure 3d (points A, B, and C). In some of these positions, it was not possible to measure the crack width due to the difficulty in capturing a sharp image with well-defined crack boundaries. For this reason, only reliable results of crack width measured with the microscope are presented. Since the observations in terms of crack width measurement were similar between the series subjected to different environmental exposure conditions (Cl⁻ and REF), only the results obtained in panels of Series Cl⁻_w0.5 and Cl⁻_w1.0 are graphically presented. Figure 7a shows the comparison between the crack width measurements performed with the LVDTs and with the microscope at position B (Figure 3d) after pre-cracking and before immersion. The results represent the average of the three radial cracks of the panels. According to the results obtained in all test series, the crack widths measured with the microscope were slightly lower than that measured with the LVDTs, with an average difference of 0.14 mm for the panels with the higher pre-crack width level (panels P1, P2, and P3) and 0.11 mm for the panels with the smaller pre-crack width level (panels P4, P5, and P6). The larger crack width values measured by the LVDTs is caused by the elastic deformation included in the registered measures and due to the kinematic mechanism mentioned by Spasojević [33], which owed to the geometry of the measurement device, l_m , in which rotation of the measurement base, θ , caused higher experimental captured deformations, $l_m + \Delta l_{m,device}$, than the real element tensile deformations, $l_m + \Delta l_m$ (Figure 2c).

Figure 7b represents the comparison between the crack width measurements performed with the microscope for each crack, C1, C2, and C3 (average of the three measurements at positions A, B, and C; Figure 3d), before and after continuous immersion/dry-wet cycles, i.e., before introducing the panels into the tanks and after removing them from the tanks and placing in the test setup for the final RPT-3ps. According to the results of Figure 7b, a slight reduction of the crack width occurred in the three cracks of the panels after the chloride exposure (on average, 0.10 mm for the panels with the higher pre-crack width level and 0.07 mm for the panels with the smaller pre-crack width level). High dispersion of the results was observed between the measurements at the three different cracks (CoV ranging from 3% to 60%), probably due to the irregular character of RSFs' geometry crossing the cracks.

Figure 7c shows the comparison between the crack width measurements performed with the microscope at each position, A, B, and C (average of the three measurements at cracks C1, C2, and C3; Figure 3b), before and after continuous immersion/dry-wet cycles. A slight reduction of the crack width was observed at the three crack positions A, B, and C of the panels after performing the environmental exposure (on average, 0.10 mm for the panels with the higher pre-crack width level, and 0.06 mm for the panels with the smaller pre-crack width level). High dispersion of the results was also observed between the crack measurements at the three different positions (CoV ranging from 2% to 42%). Since the difference between the average crack width measured at the center of the panel (position A) and at the edge of the panel (position C) was within the test variability and did not follow a clear trend, the crack width along the crack development length was assumed constant in the theoretical approach for deriving the stress vs. crack width by inverse analysis RPT-3ps (Section 4).

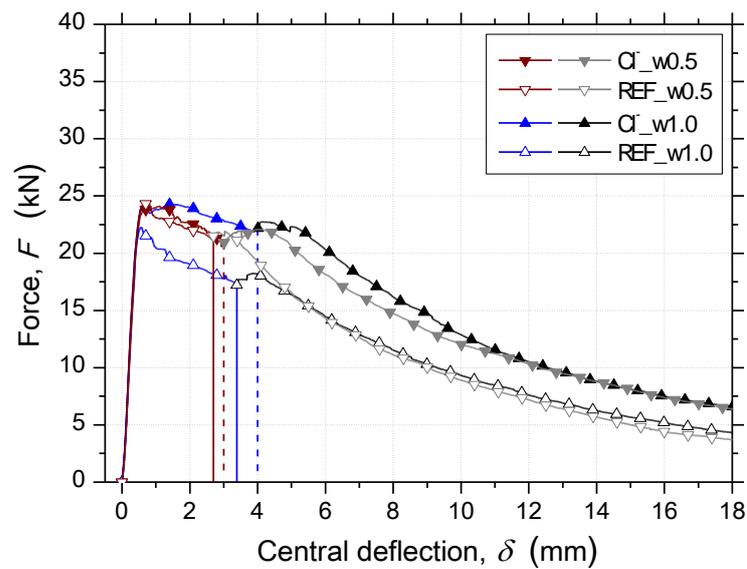
Figure 8. The average force–central deflection ($F - \delta$) relationship for panels from RPT-3ps during the pre-cracking process and after the environmental exposure period of 90 days.

Figure 8 presents the average force–central deflection responses, $F - \delta$, registered in the RSFRC panels, during the pre-cracking process (initial load/unload cycle) and after the environmental exposure period of 90 days of dry–wet cycles/immersion. The average pre-crack widths, ω_{cr} (after unloading), based on microscope measurements, are indicated in Table 5 and were close to the target crack widths of 0.5 mm and 1.0 mm.

The pre- and post-cracking load-carrying capacity observed for the panels submitted to chloride attack for 90 days of dry–wet cycles (RSFRC_1 batch) was higher than that of the corresponding pre-cracked reference panels (Figure 8). This corroborates the 3PNBBT results (Section 3.2) and contributes to the higher post-cracking load-carrying capacity of pre-cracked panels subjected to chloride attack.

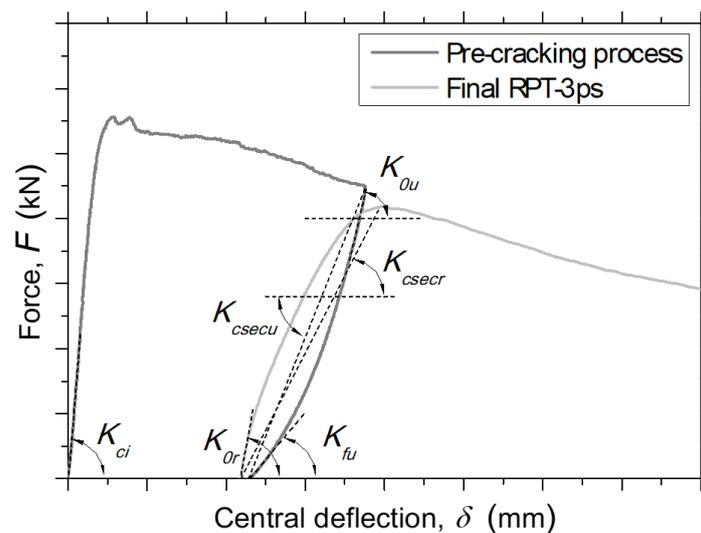
Figure 9. Stiffness parameters determined for each pre-cracked panel using the obtained experimental data.

For the $F - \delta$ relationship obtained in each pre-cracked panel, the parameters of stiffness represented in Figure 9 were determined, namely, the initial stiffness, K_{ci} , initial unloading tangent stiffness, K_{0u} , final unloading tangent stiffness, K_{fu} , initial reloading tangent stiffness, K_{0r} , unloading secant stiffness, K_{csecu} , and reloading secant stiffness, K_{csecl} . The results obtained of the normalized stiffness parameters are presented in Table 5.

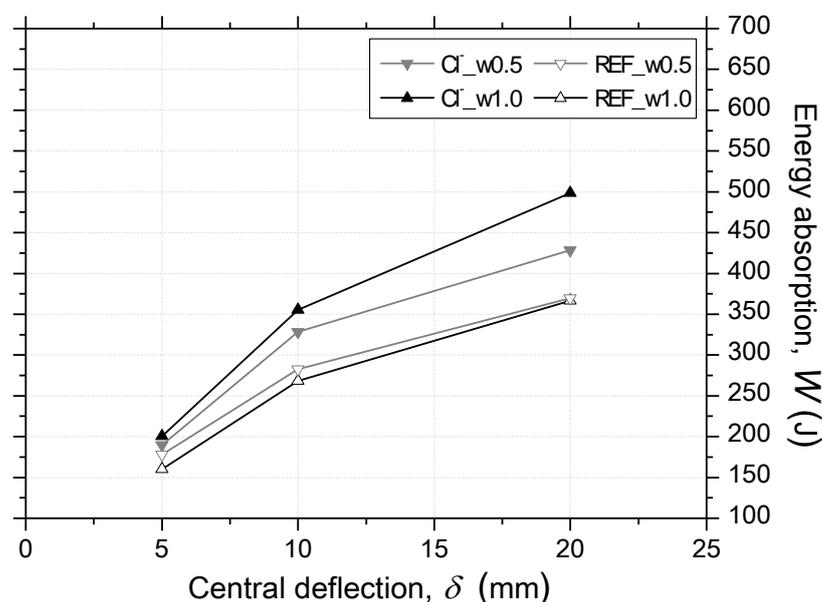
Figure 10. Average energy absorption–central deflection ($W - \delta$) relationships for pre-cracked panels from RPT-3ps after the exposure period of 90 days.

The average values of energy absorbed by the RSFRC panels, W , up to a central deflection, δ , of 5 mm, 10 mm, and 20 mm are presented in Figure 10. These W values were corrected considering the panel thickness by using Equation (4) recommended by ASTM C1550-08 [27], where W is the corrected energy absorption (J), W' is the measured energy absorption (J), t_0 is the nominal thickness of 75 mm, t is the measured panel thickness (mm), d_0 is the nominal diameter of 800 mm, d is the measured panel diameter (mm), and δ is the specified central deflection at which the energy absorption is evaluated (mm).

According to Figure 10, the panels submitted to 90 days of dry–wet cycles in chloride solution showed higher absorbed energy than the corresponding reference ones, and this difference has increased with the pre-crack width. The obtained results may be affected by the fiber distribution and orientation at crack surfaces. This is further discussed in Section 3.3.6.

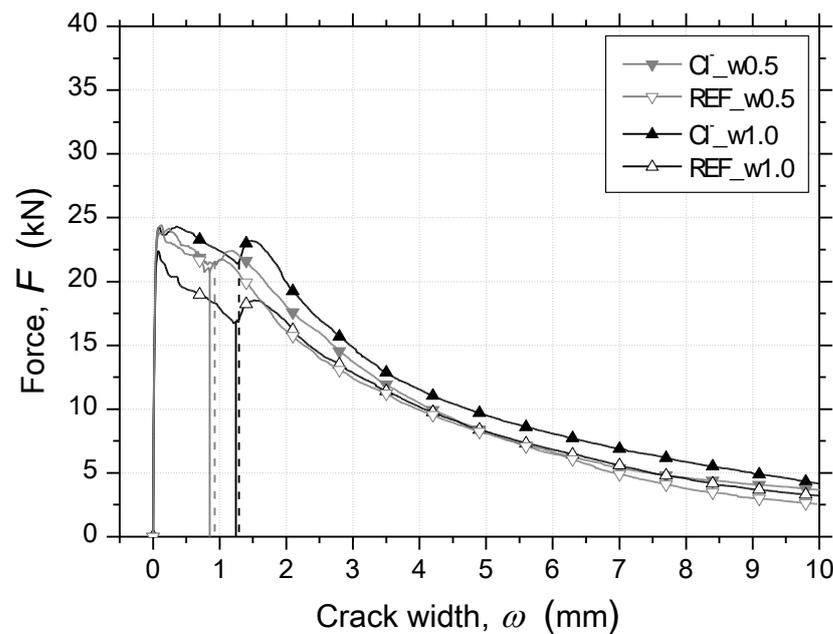
Figure 11. Average force–crack width ($F - \omega$) relationships for panels from RPT-3ps after the exposure period of 90 days.

Figure 11 represents the average force–crack width responses, $F - \omega$, registered on the RSFRC panels. The crack width, ω , corresponds to the mean value measured by the three LVDTs used for measuring the width of the three developed cracks (Figure 3c). Until the occurrence of the first crack in the measuring stroke of the LVDT, the displacement

No significant differences were observed between the average $F - \omega$ relationships of pre-cracked panels with different ω_{cr} submitted to 90 days of environmental exposure. This is indicative of a negligible effect of the chloride attack, and, consequently, of the RSFs' corrosion products on the average progression of crack widths during the RPT-3ps for the predefined conditions of chloride exposure and pre-crack width level.

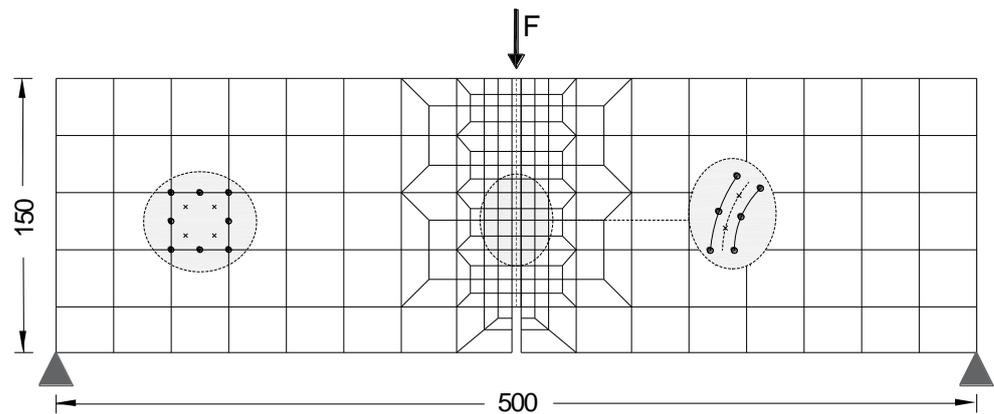
Figure 12. Finite element mesh used in the simulation of the 3PNBBT [36].

The experimental force–crack mouth opening displacement ($F - \text{CMOD}$) curves obtained with RSFRC_1 and RSFRC_2 notched beams at 120 days were simulated using a numerical model developed in previous research [36,40], implemented in the FEMIX, a software based on the finite element method [41]. Due to the geometry, support, and loading conditions used in the 3PNBBT, a plane stress state was assumed in the beam. For the numerical simulation of the crack initiation and propagation, 2D line interface elements of six nodes located on the symmetry axis of the specimen were used. The remaining part of the specimen was modeled with a mesh of eight-node serendipity plane stress finite elements, assuming a linear elastic behavior for the material.

The Gauss–Legendre integration scheme with 2×2 integration points (IP) was used in all elements, with exception of the interface finite elements at the symmetry axis of the specimen, where a 1×2 Gauss–Lobato IP were used in order to assure the crack progress along the symmetry axis. Figure 12 depicts the mesh used in the numerical simulations. The values of the material properties used in the inverse analysis are indicated in Table 7.

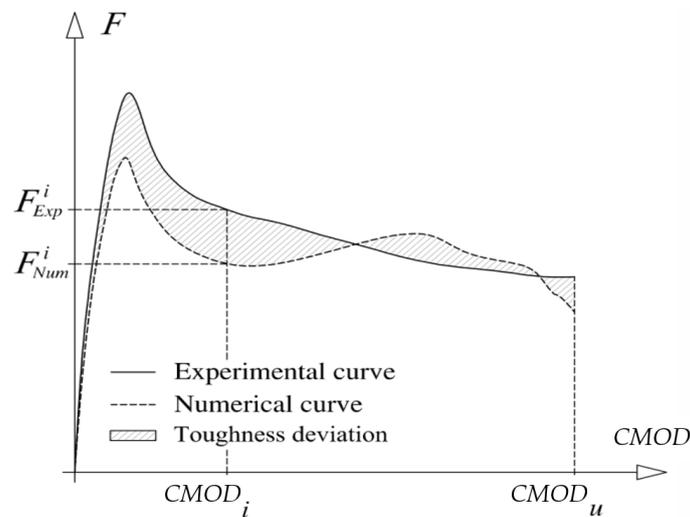
Figure 13. Schematic representation of the force–crack mouth opening displacement ($F - CMOD$) registered experimentally and obtained numerically by the inverse analysis.

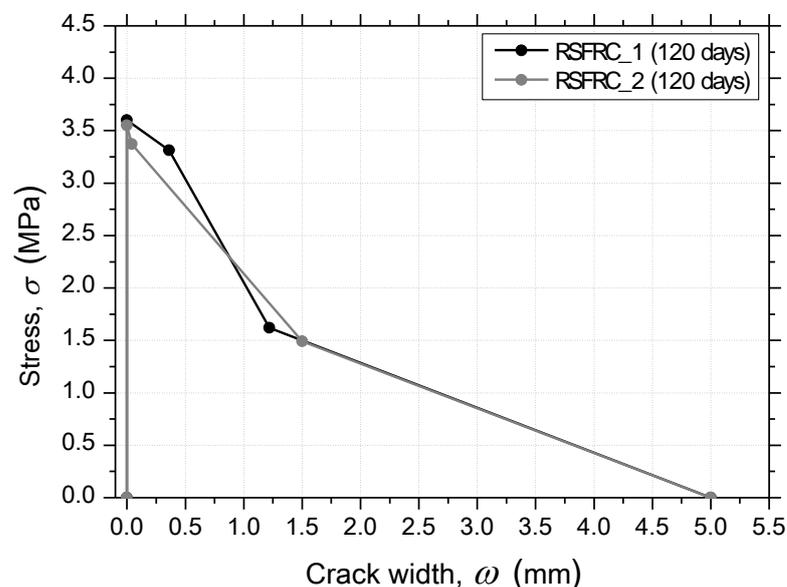
Figure 14. Trilinear tensile–softening ($\sigma - \omega$) relationships obtained by inverse analysis from 3PNBBT.

The obtained parameters defining the $\sigma - \omega$ relationship, and the equivalent fitting error, e , are indicated in Table 8, where f_{ct} is the tensile strength, σ_1 and σ_2 are, respectively, the stress at the first and second post-peak point of the crack opening, ω_1 and ω_2 , and ω_u is the ultimate post-peak point of the crack opening. The graphical representation of these $\sigma - \omega$ laws is presented in Figure 14. For the same crack width level, no significant differences in the parameters were observed (Figure 14).

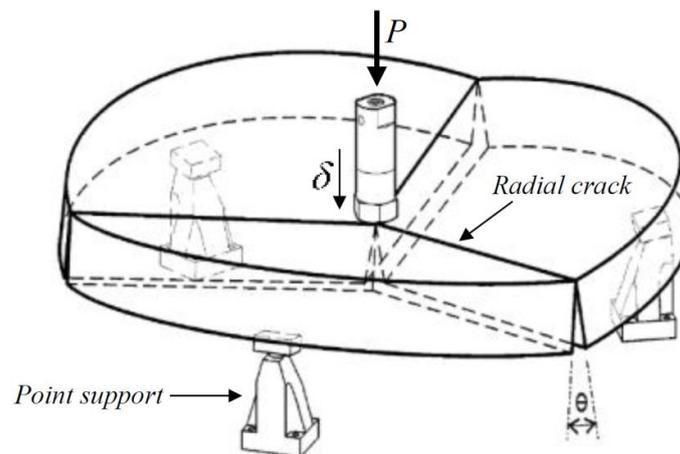
Figure 15. RPT-3ps setup with three-point support and normal failure mode (P and δ represent, respectively, the central load and deflection) [42].

From the inverse analysis, the post-cracking constitutive laws of the RSFRC representative of the RPT-3ps were determined by fitting the experimental curves of the average $F - \delta$ relationships obtained in each test series of RPT-3ps. This strategy allowed to evaluate the influence on the $\sigma - \omega$ relationship of the chloride exposure conditions adopted for the pre-cracked RSFRC round panels. This numerical simulation considers the constitutive laws of RSFRC in tension and in compression to determine the moment–rotation relationship, the loading and support conditions of RPT-3ps (Figure 15), kinematic assumptions, and the principle of virtual work in order to derive the $\sigma - \omega$ law of RSFRC by fitting as much as possible the force–deflection registered in the round panel tests [8,22].

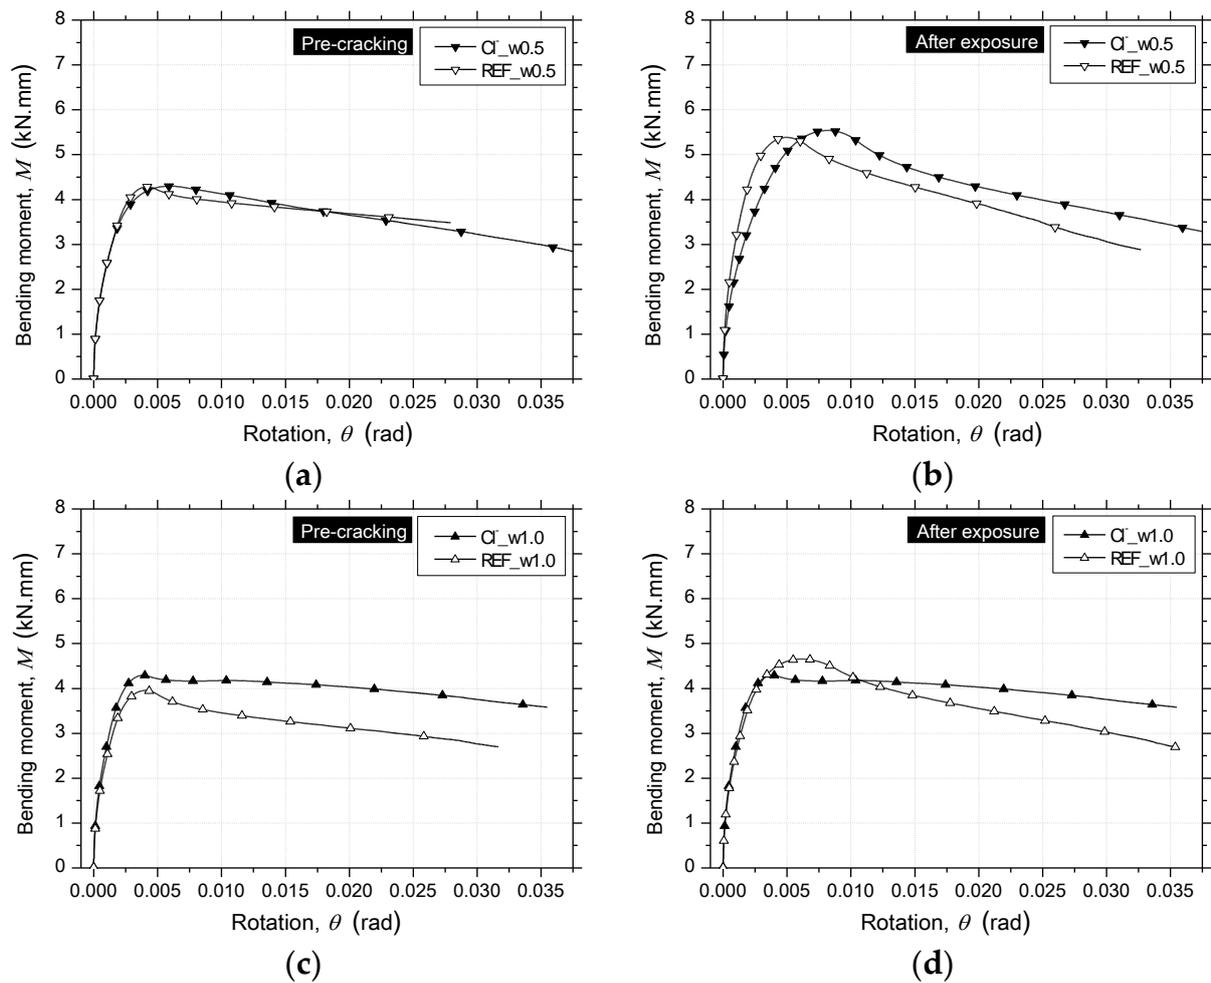
Figure 16. Moment–rotation ($M - \theta$) relationships obtained by inverse analysis from RPT-3ps of RSFRC panels with the target ω_{cr} of 0.5 mm (a) during the pre-cracking stage and (b) after environmental exposure; and the target ω_{cr} of 1.0 mm (c) during the pre-cracking stage and (d) after environmental exposure.

By using a cross-section layer model available in DOCROS computer program (DOCROS—“Design Of CROSS Section”, Guimarães, Portugal [43]), the moment–rotation relationship for the round panel cross section was evaluated, as presented in Figure 16. This layered model in DOCROS allows considering sections of irregular shape and size, composed of different types of materials subjected to an axial force and variable curvature or crack width [43]. The compression and tensile behavior of each material can be simulated by several types of constitutive laws. To obtain the moment–rotation of the RPT-3ps, a round panel’s cross section of 1000 mm wide and a height corresponding to the average thickness of the tested panels was considered, having this height been discretized in 60 layers of equal thickness.

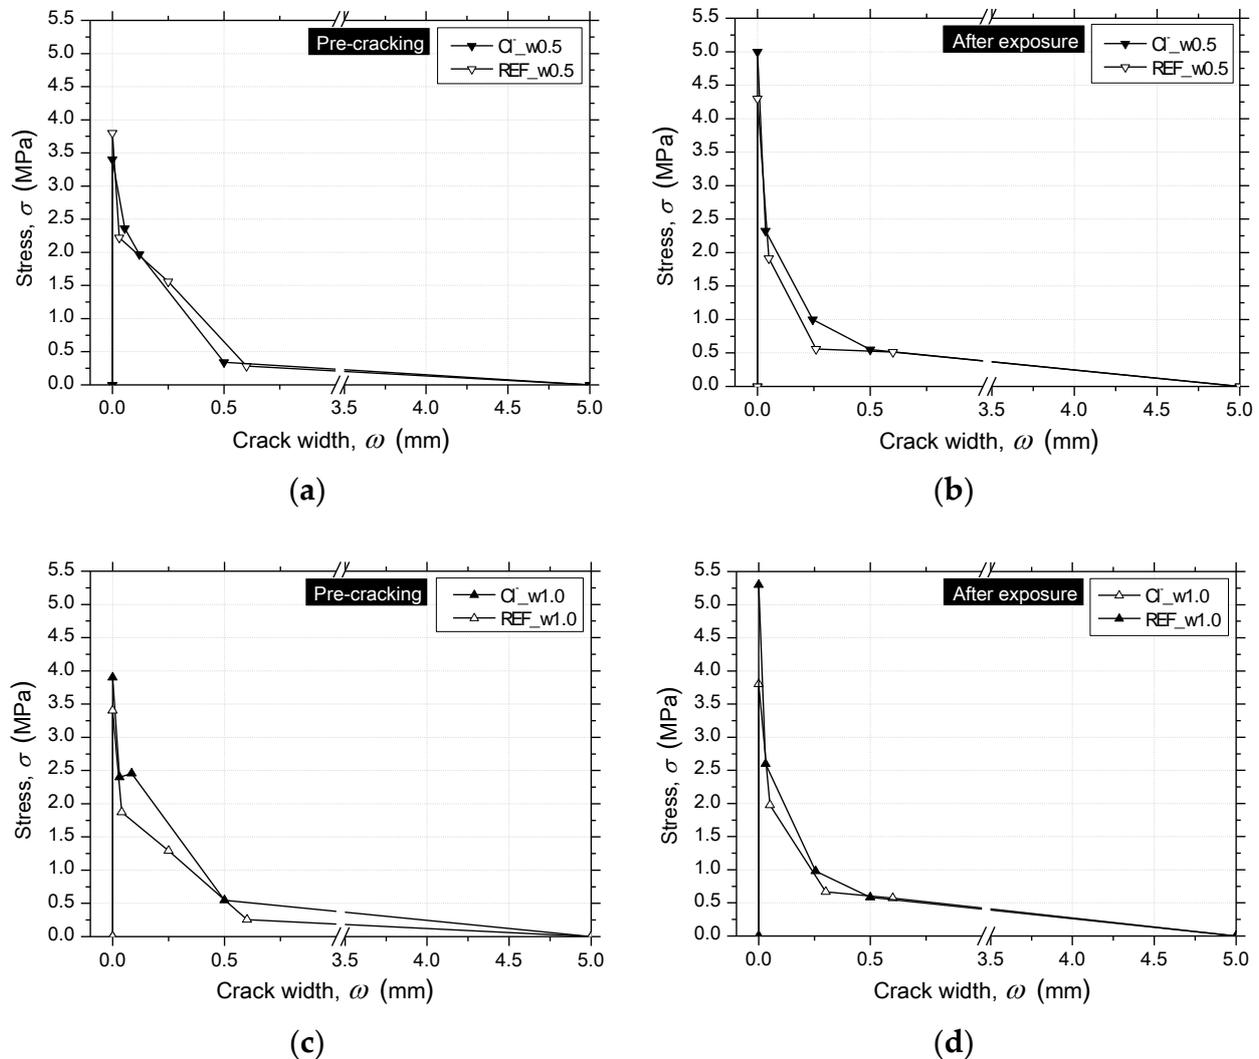
Figure 17. Stress–crack width ($\sigma - \omega$) relationships obtained by inverse analysis from RPT-3ps of RSFRC panels with the target ω_{cr} of 0.5 mm (a) during the pre-cracking stage and (b) after environmental exposure; and the target ω_{cr} of 1.0 mm (c) during the pre-cracking stage and (d) after environmental exposure.

A quadrilinear tensile–softening ($\sigma - \omega$) diagram was used to simulate the fracture mode I propagation of pre-cracked RSFRC, whose parameters were obtained by performing inverse analysis with the average $F - \delta$ relationships obtained for the pre-cracking stage and after the environmental exposure of the pre-cracked panels. The obtained parameters that define the shape of the diagram and the equivalent fitting error, e , are indicated in Table 9. The graphical representation of these $\sigma - \omega$ diagrams is presented in Figure 17a–d.

After the exposure period of 90 days, the differences in the fracture energy obtained during the pre-cracking stage (Figure 17a,c) and after the environmental exposure of pre-cracked panels (Figure 17b,d) were mainly explained by the difference in concrete age. This suggests that the action of RSFs' corrosion was negligible in the post-cracking behavior of cracked RSFRC submitted to these chloride exposure conditions. According to the present study, a longer exposure period for chloride environment (>3 months) should be adopted for a more comprehensive assessment of the long-term effects of chloride attack in cracked RSFRC.

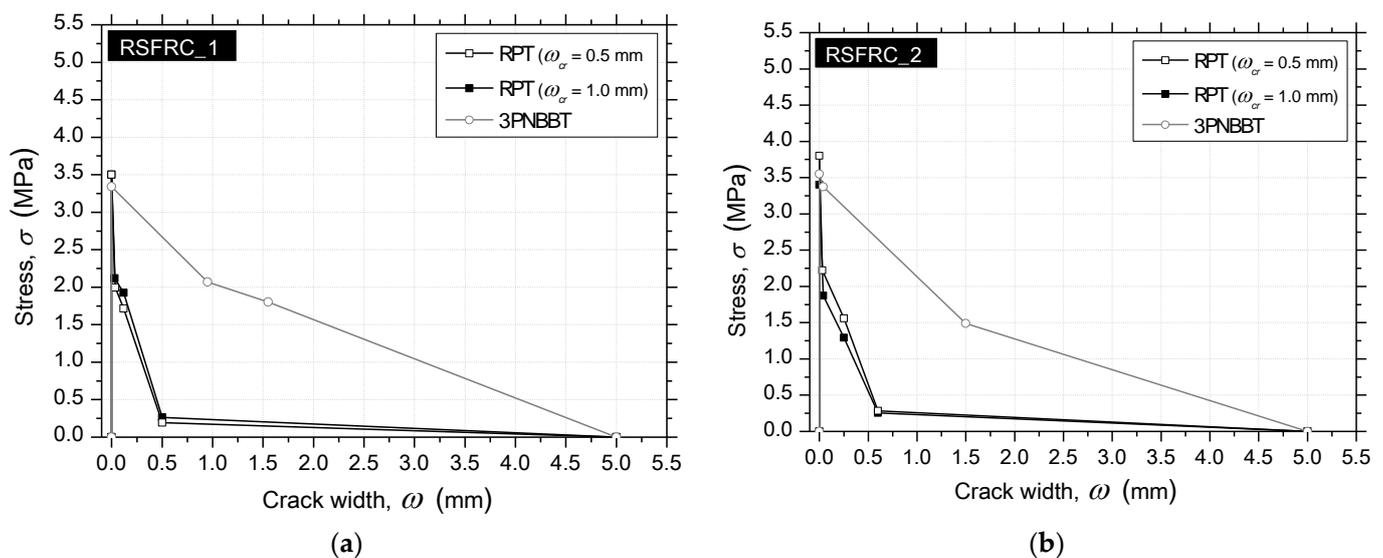
Figure 18. Stress–crack width ($\sigma - \omega$) relationships obtained by inverse analysis from RPT-3ps and 3PNBBT for: (a) RSFRC_1 batch (b) RSFRC_2 batch.

Comparing the $\sigma - \omega$ relationship of RSFRC obtained by inverse analysis from RPT-3ps and 3PNBBT presented in Figure 18 and Tables 8 and 9, it is verified that the constitutive laws obtained from 3PNBBT (prismatic specimens with a localized crack) overestimated the post-cracking behavior of RSFRC compared to the constitutive laws obtained from RPT-3ps, which are more representative of the fiber reinforcement mechanisms developed in thin elements (wall elements, panels, slabs, shotcrete linings).
