# Influence of Temperature on the Mechanical Performance of Unidirectional Carbon Fiber Reinforced Polymer Straps

**Abstract:** The performance of pretensioned, laminated, unidirectional (UD), carbon fiber reinforced polymer (CFRP) straps, that can potentially be used for example as bridge deck suspender cables or prestressed shear reinforcements for reinforced concrete slabs and beams, was investigated at elevated temperatures. This paper aims to elucidate the effects of elevated temperature specifically on the tensile performance of pretensioned, *pin-loaded* straps. Two types of tests are presented: (1) steady state thermal and (2) transient state thermal. Eight steady-state target temperatures in the range of 24 °C to 600 °C were chosen, based on results from dynamic mechanical thermal analysis (DMTA) and thermogravimetric analysis (TGA). Transient state thermal tests were performed at three sustained tensile load levels, namely 10, 15, and 20 kN, corresponding to 25%, 37%, and 50% of the ultimate tensile strength of the pin-loaded straps at ambient temperature. In general, the straps were able to retain about 50% of their ambient temperature ultimate tensile strength (UTS) at

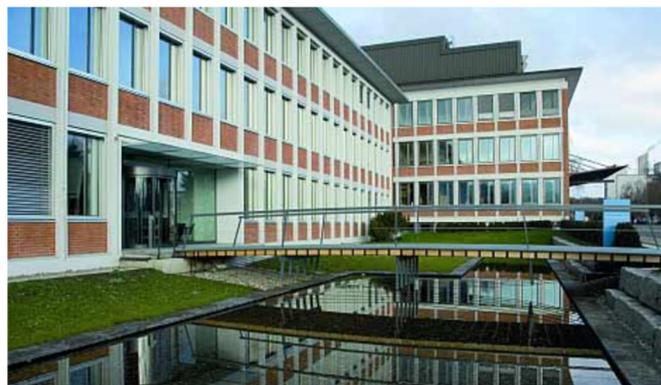
**Figure 1.** Empa bowstring arch footbridge [14]. Reprinted with permission from ref. [14]. Copyright 2009 Empa.

Practical applications and design concepts for pin-loaded non-laminated straps include the bowstring arch footbridge at The Swiss Federal Laboratories for Material Science and Technology (Empa) [14], which represents the application of such a configuration in timber bridge construction (Figure 1). A stress-ribbon bridge has also been realized by Schlaich and Bleicher [15] (Figure 2), wherein non-laminated CFRP straps acted as ribbons; in total six ribbons, prestressed by receiving a 6.5% elongation, were used and were able to carry a tensile force of 530 kN. A further application of non-laminated prestressed CFRP straps used them as prestressed shear reinforcements for concrete beams (Figure 3) [4] in the former Bank Leu premises in Zurich (2019). In total, 1080 non-laminated CFRP straps, pretensioned to 100 kN each, were used.

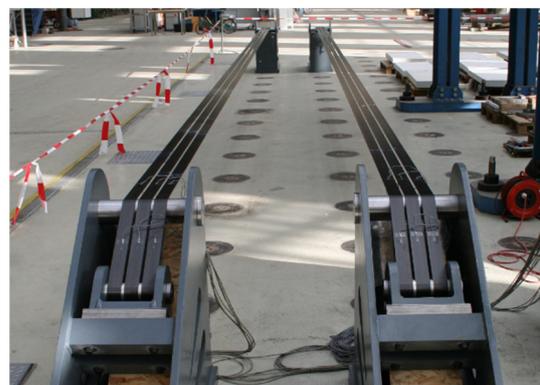
**Figure 2.** Stress-ribbon footbridge [15]. Reprinted with permission from ref. [15]. Copyright 2007 Ernst & Sohn Verlag für Architektur und technische Wissenschaften GmbH & Co. KG, Berlin.

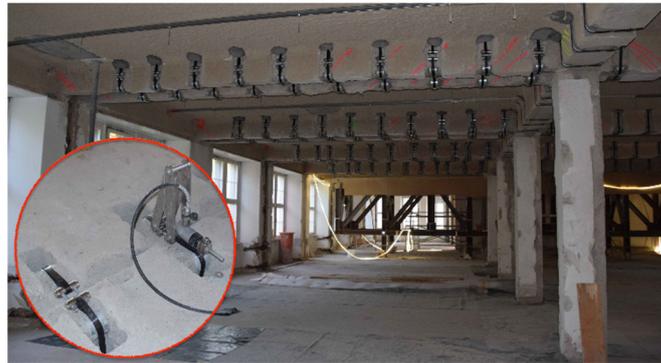
**Figure 3.** Slab reinforcement with prestressed non-laminated pin-loaded Straps (bottom left: prestress detail).

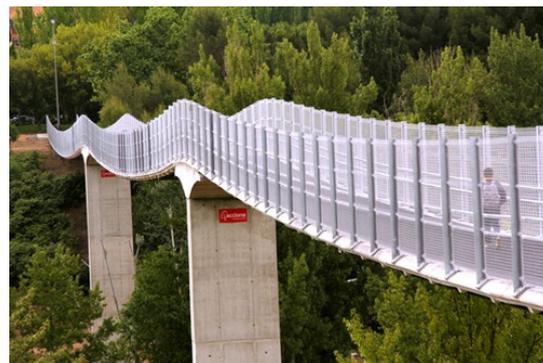
**Figure 4.** Stress ribbon footbridge in Cuenca, Spain (photo by ACCIONA [19]).

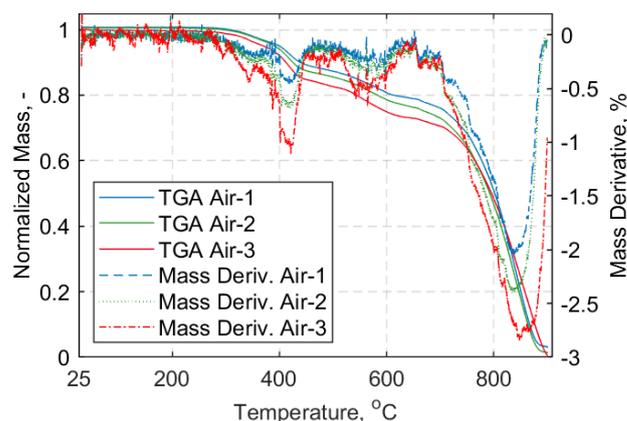
**Figure 5.** (Left): Normalized mass loss curve vs. temperature (°C). (Right): Mass derivative curve (%) vs. temperature (°C); air atmosphere for carbon fiber reinforced polymer (CFRP) straps.

For all samples, a temperature range between 30 °C and 900 °C, with a heating rate of 10 °C/min, was used. The resultant mass loss curves are given in Figures 5 and 6 for the composite material of the straps and the neat epoxy resin, respectively. Subsequently, the fiber volume fraction (FVF) of the cured composite strap material was determined using a standard 'burn-off' procedure. Five samples were cut from the straight shaft of the straps (approximately 1 mm × 20 mm) and tested according to ASTM D3171-15 standard test method [35]. The samples were all weighed using a 0.1 mg precision scale in a stable lab temperature of 22 °C using an Ohaus Adventurer AX324 analytical balance. The density of the composite samples ( $\rho$ ) was obtained, as described in the Ohaus<sup>TM</sup> Density Determination kit manual (Shanghai, China). The 'burn-off' tests were performed using a Nabertherm-L 15/11 muffle furnace at 480 °C for 2 h, and Equations (1)–(5) of the ASTM D3171-15 standard [35] following Test Method I, Procedure G, were used. The results of the weighed Haldenwanger porcelain crucibles (Fisher Scientific, Bishop Meadow Road, Loughborough, Leicestershire, LE11 5RG, UK) and the composite samples prior to and after the burn-off test are presented in Table A1 of Appendix A. The calculated values for FVF ( $V_f$ ), matrix volume fraction ( $V_m$ ) and void volume fraction ( $V_v$ ), as well as the calculated density of each sample, are given in Table 2, alongside the average values and their standard deviations. An average fiber volume fraction of 59.3% was obtained, which is similar to the value of 60% for the carbon fiber reinforced epoxy prepreg material issued by the prepreg's producer, Carbo-Link Ltd (Fehraltorf, Switzerland). It is noteworthy that the burn-off procedure usually carries an error in the range of 2–3% compared with, e.g., a chemical digestion procedure [35].

The degradation mechanisms and the interpretation of the material reactions are complex. In Figure 5, three distinctive stages (peaks) are evident; first, above 340 °C and with a clear peak at about 410 °C, the decomposition of the epoxy resin takes place. This continues up to about 600 °C. Above 700 °C the oxidation of the fibers begins, and peaks at about 840 °C. An average FVF of  $59.33 \pm 2.95\%$  was found from the five burn-off

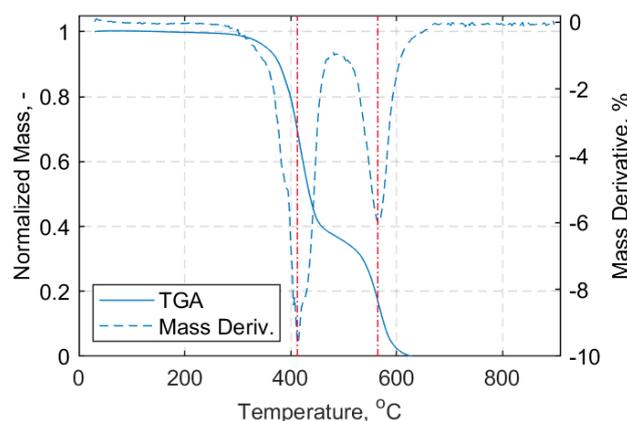
**Figure 6.** (Left): Normalized mass loss curve vs. temperature (°C). (Right): Mass derivative curve (%) vs. temperature (°C); air atmosphere for neat epoxy resin.

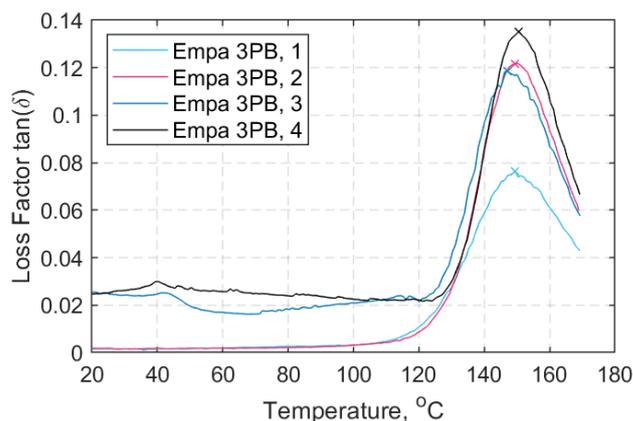
**Figure 7.** Loss factor  $\tan\delta$  over temperature (°C)—all dynamic mechanical thermal analysis (DMTA) samples.

during their manufacturing process (these are described elsewhere). Figure 7 shows the resultant DMTA curves with the  $\tan\delta$  peaks indicated in each case. It is noteworthy that the  $T_g$  values according to a  $\tan\delta$  peak-definition are usually higher than those derived from a peak in the loss modulus curve [36]. It is also evident that the  $T_g$  onset takes place at a lower temperature between 130 and 140 °C, as defined by the intercept of the tangents below  $T_g$  and the slopes of the loss factor curves. A similar behavior of the glass transition of a two-part epoxy adhesive for structural strengthening has previously been reported by Stratford and Bisby [37], who defined  $T_g$  as the  $\tan\delta$ -peak but noted that the stiffness reduction can take place at temperatures of up to 20 °C or more below this  $T_g$ .

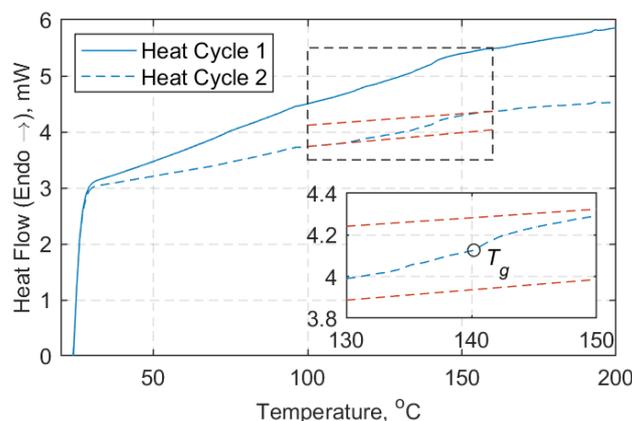
**Figure 8.** Heat flow (mW) over temperature (°C): Representative differential scanning calorimetry (DSC) curve.

Six DSC results were obtained using a DSC 8000 double-furnace by PerkinElmer® (Waltham, MA 002451, USA), for which three samples were extracted from the middle of the straight shaft length of the straps and three from the curved region of the straps. Aluminium pans with lids and a minimum weight of 10 mg per sample were used. A heat-cool-heat cycle was followed, for which each sample was heated from 20 °C to 200 °C, cooled down to 20 °C, and then increased up to 200 °C at a heating rate of 20 °C/min, as described in ASTM D3418-15 [38]. A representative DSC curve is illustrated in Figure 8, where the midpoint temperature ( $T_g$ ) is also shown. The difference observed between the average  $T_g$  values obtained with DMTA and DSC can be attributed to the nature of the tests (see Table 3). Further results are given in Appendix A, Figure A1.

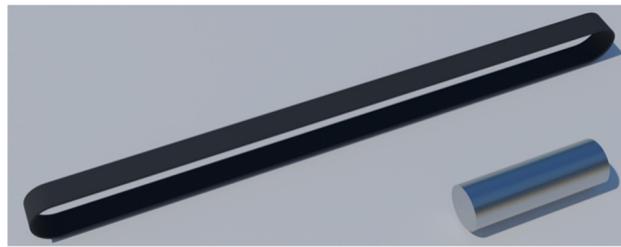
Figure 9. Laminated strap and titanium pin.

The bespoke titanium pins were supplied in specific dimensions (Table 4) and known material characteristics and are shown in Figure 9. The straps were manufactured by winding the continuous UD carbon prepreg tape around a two-piece aluminium mold that was then enclosed by aluminium clamps. Between the prepreg tape and the clamps, a silicon tape was placed to aid in the demolding process. The mold was designed in such a way as to be able to pretension the straps prior to and during curing. Two segments comprise the mold, as illustrated in Figure 10. Initially, the first segment was joined with the second segment and two removable side supports were placed on one side of the assembled mold. Following that, the carbon (prepreg) tape was wound around the two-piece mold; an additional  $\pm 45^\circ$  carbon twill ply was placed at the extremities of the carbon tape (see Figure 11). The dimensions for both the pin and the strap used in the current study are given in Table 4.

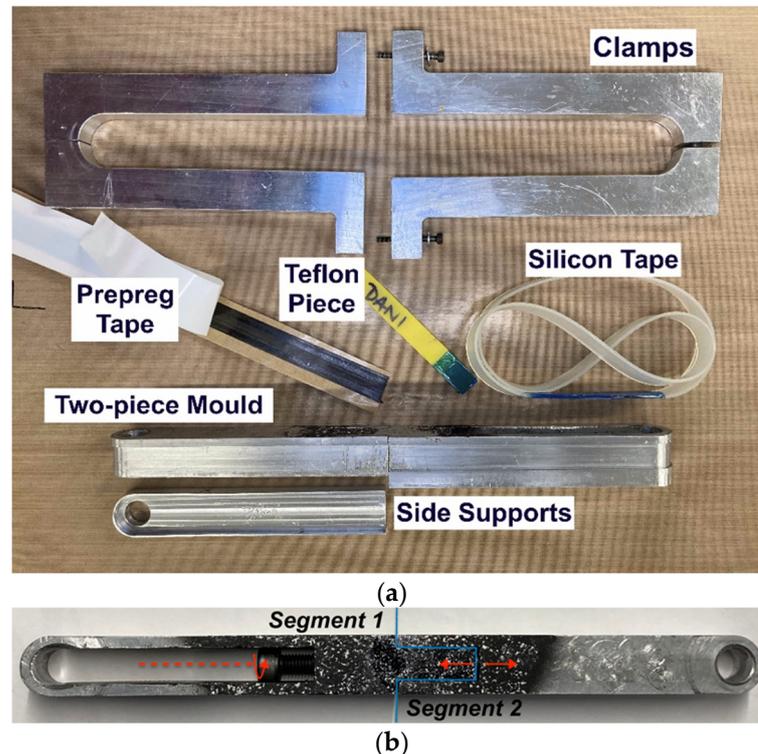
Figure 10. Pretensioning mold: (a) Parts used in manufacturing; (b) side view of two-piece mold.

The next step was to apply an initial axial tensile strain of approximately 0.20% by screwing an M8 bolt within the mold; this drives the two mold segments apart through a pushing cylinder. This corresponds to a preload of about 10% of the average tensile failure load of the straps. The preload level was considered to be active throughout the resin curing—identical measurements of the physical gap generated between the two mold segments were taken prior to and after the curing of the straps and no change was detected. The straps were cured following the guidance given in the prepreg manufacturer's datasheet [34]. The straps first remained at 120 °C for 1 h followed by 2 h at 140 °C, after which the curing cycle ended. The preload approximation is explained in detail in Section 3. Finally, the clamps fully enclosed the mold. A thin silicon cover was placed between the carbon tape and the outer clamps surface. The main intent of using the pretensioning mold—besides resulting in

residual stresses in the cured composite—was that it would allow a better fiber alignment in the finished composite. In addition, the side of the pretensioning mold was spray-painted black and speckled with a random white pattern so that the displacement field could be monitored using image correlation (see Figure 10b).

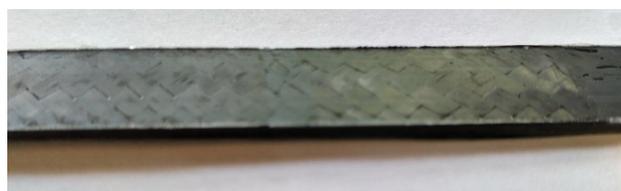
Figure 11.  $\pm 45^\circ$  carbon twill ply.

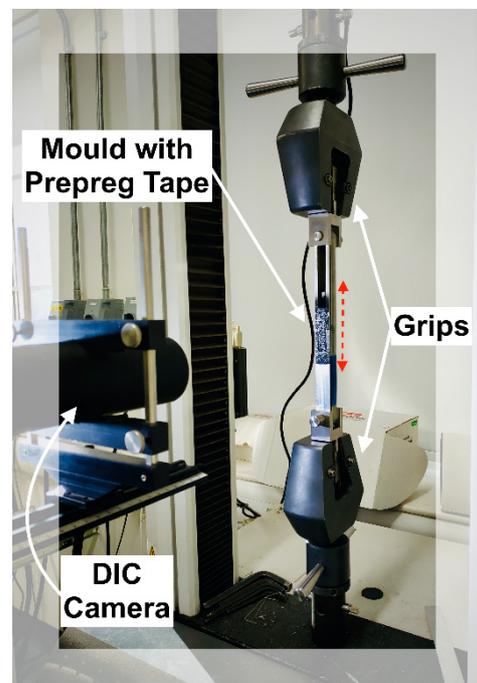
Figure 12. Experimental set-up for preload estimation.

An approximation for the preload (pretension) applied to the uncured straps was measured experimentally, and the set-up is shown in Figure 12. The mold, which was first wrapped with six plies of UD carbon prepreg tape, was placed on an Instron 3369 (Norwood, MA, USA) testing frame with a 10 kN load cell using custom fixtures, and loaded until reaching 10% of the average ambient temperature failure load ( $F_{max}$ ) of the cured straps. A constant crosshead displacement rate of 0.5 mm/min was selected for the test. Throughout the loading cycle, displacement data were acquired using a Canon EOS 600D (Hong Kong, China) camera (indicated as “DIC Camera” in Figure 12) and a remote trigger timer with a consistent sampling rate of 0.2 Hz. Three straps were tested this way and the data were analyzed using Python 3 (pydic, Python Software Foundation [39]) and MATLAB R2019b. The region of interest used in the digital image correlation (DIC) analysis for the computation of displacements is shown in Figure 13 and was maintained consistent for all three tests. Once  $0.1 F_{max}$  was reached, the test was stopped. The M8 bolt was tightened to maintain the preload and the gap that was generated between the two segments of the mold was measured with a Vernier caliper at four different locations. The top left and top right gaps are indicated with arrows and the middle gap is the circled region in Figure 13. Subsequently the mold was removed from the Instron testing frame, enclosed by the clamps and placed in the oven for curing (as described in Section 2.3). It should be noted that the gap(s) generated between the two segments of the mold indicated that the preload remained active (see Figure 13).

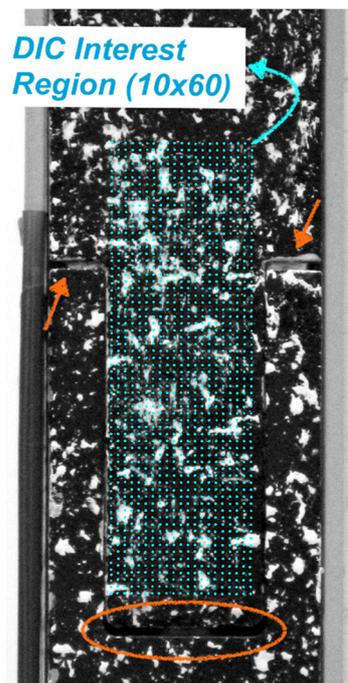
**Figure 13.** Detailed region of interest for digital image correlation (DIC) measurements and gap generation due to preload.

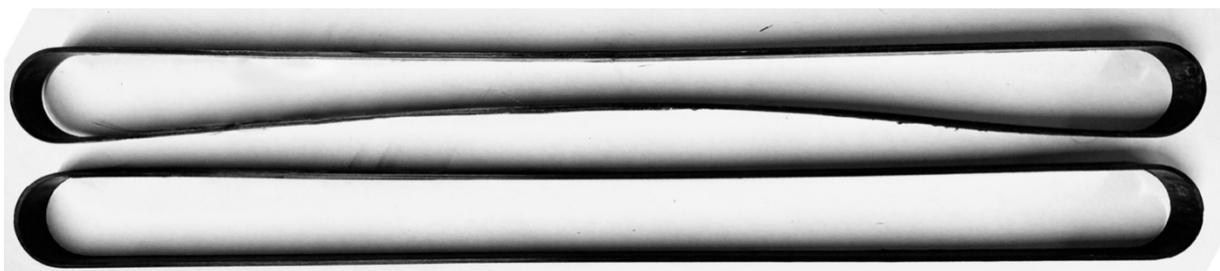
**Figure 14.** Shape change of prestressed straps (top) vs. non-pretressed straps (bottom).

It has been observed that pretensioning the straps resulted in a minor change of geometry in the cured and de-molded samples, as illustrated in Figure 14, where an inwards bowing of the shafts of the straps is evident for those that were prestressed during curing. This behavior was not evident when the straps were made with a non-pretensioning mold. The results obtained from the three uncured straps are illustrated in Figure 15, where the axial load versus displacement plots obtained using DIC are presented. The final displacement values obtained with DIC,  $\delta_{max}$  (gap between the two mold segments), and in-situ measurements with the caliper are presented in Table 5.

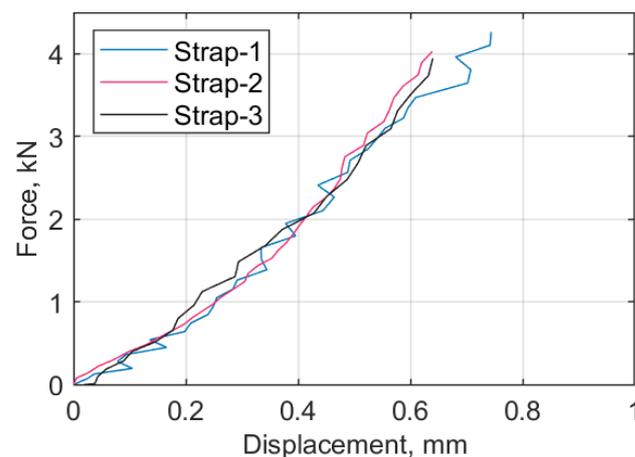
Figure 15. Load vs. (DIC) displacement curves for straps loaded up to  $0.1 F_{max}$ .

The analysis above indicates that 10% of the  $F_{max}$  was equivalent to 0.91 mm (average caliper measurement) spacing between the two mold segments; this was kept constant for all straps in the manufacturing process in order to apply the same preload. In all cases, physical measurements were taken with a caliper rather than utilizing DIC, for simplicity and to increase the rate of specimen manufacture.

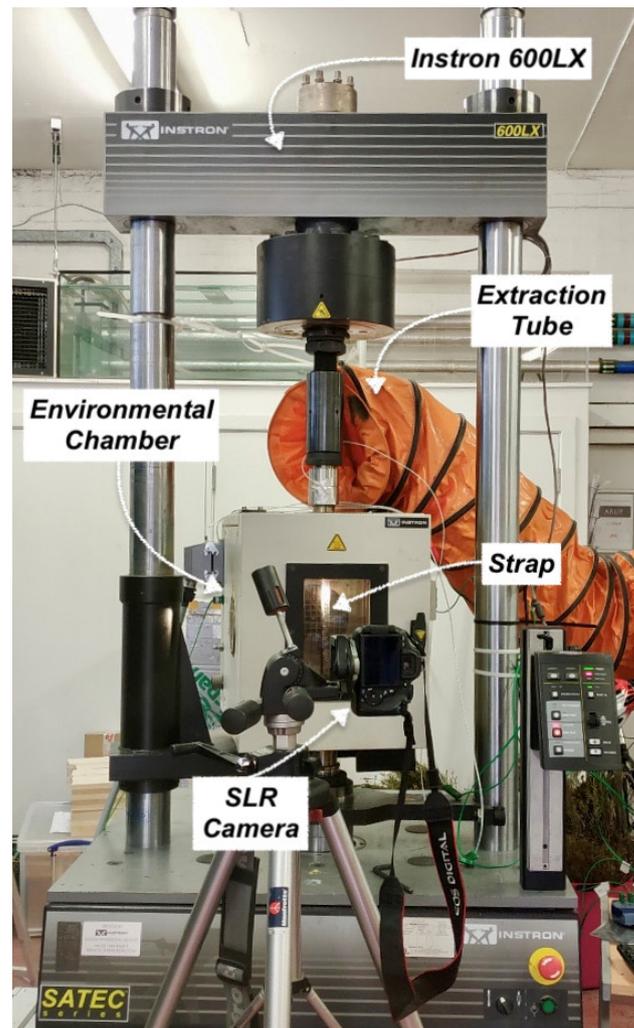
**Figure 16.** Ambient and elevated temperatures test set-up.

The main test set-up is illustrated in Figure 16 and was used for both ambient and elevated temperature experiments. An Instron 600LX hydraulic universal testing machine with an integrated Instron CP103790 environmental chamber was used (High Wycombe, UK). The load capacity of the machine is 600 kN, and the upper temperature limit of the environmental chamber is 600 °C. The strain and deformation fields were monitored using DIC analysis with a Canon EOS 600D camera and a remote trigger timer at a sampling rate of 0.3 Hz. The straps were speckled using high temperature paint to assist with the strain mapping. The image analysis was used to approximate the elastic modulus of the straps at different temperatures. The straps were pin-loaded on custom made stainless steel grips that were screw-fixed to the Instron; the CFRP strap, the titanium pins, and part of the grips were placed inside the environmental chamber, as illustrated in Figures 16 and 17. Four Type-K thermocouples were used in both the steady state thermal (SS) and transient state thermal (TS) tests, the locations of which are shown in Figure 17. Thermocouples 1 (T1) and 2 (T2) were placed inside the chamber at the center of the front straight shaft of the strap and the center of the rear straight shaft of the strap (closer to the heating elements and fan heater), respectively. Thermocouple 3 (T3) was initially placed on the top edge of the top anchorage/loading pin, but, due to disbonding after about 170 °C, it was decided to place it on the vertex of the strap; Thermocouple 4 (T4) was placed outside of the chamber on the top pull rod.

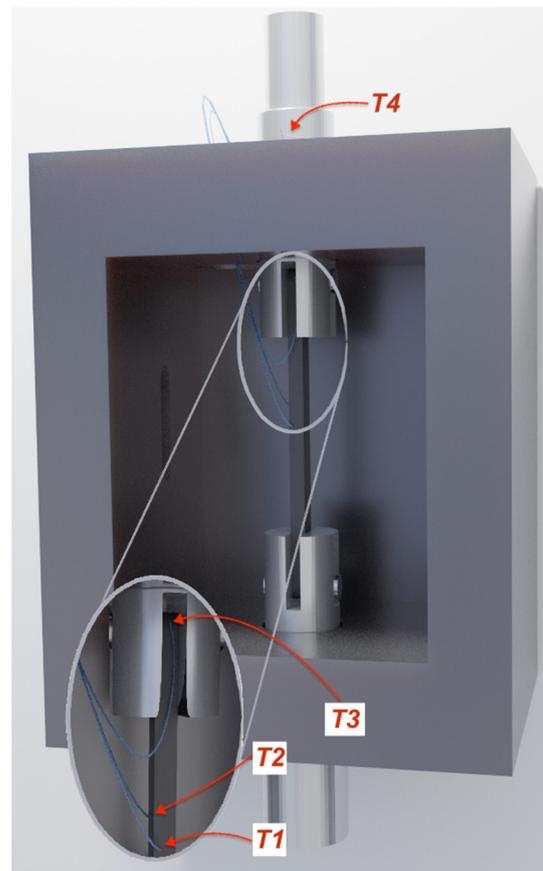
Figure 17. Position of thermocouples in chamber.

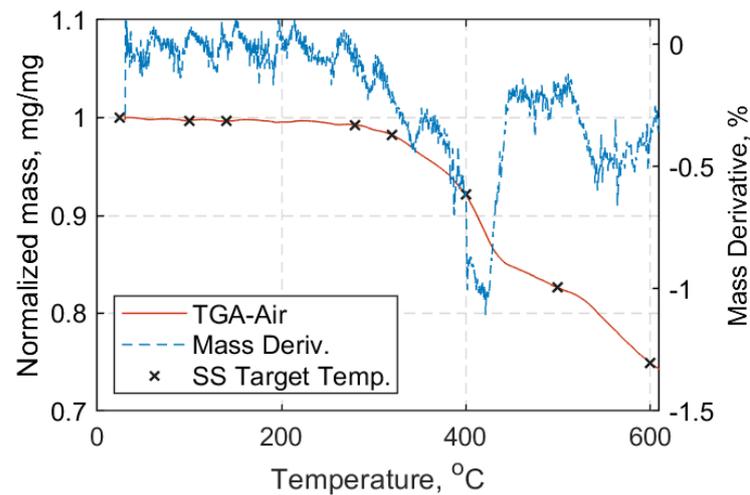
Figure 18. Representative thermogravimetric analysis (TGA) curve in air atmosphere for CFRP Straps with steady state (SS) target temperatures denoted.

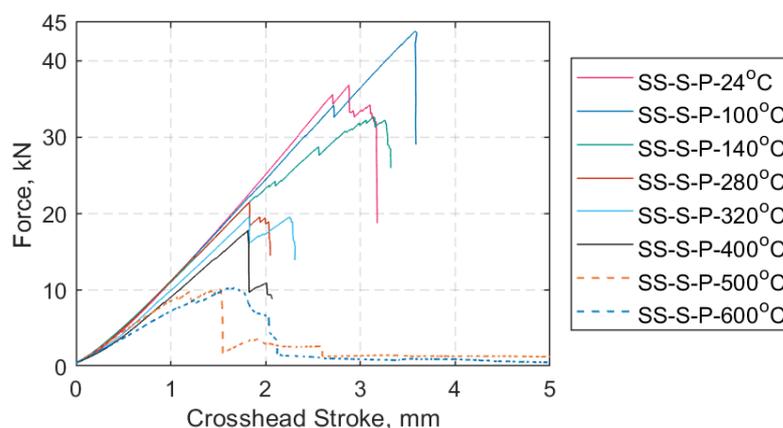
**Figure 19.** Force (kN) vs. crosshead stroke (mm) representative curves for each SS case.

The axial force versus crosshead displacement representative curves for each SS target temperature are given in Figure 19, excluding the hold mode at 0.5 kN. Regarding the SS tests at 500 °C and 600 °C (dashed lines in Figure 19) these tests continued beyond 5 mm of crosshead stroke. They were either stopped manually, to avoid equipment failure, or continued until ultimate tensile failure of the straps. In Figure 20, representative axial stress versus axial strain curves is plotted for each SS case, and the results are used to calculate the elastic moduli at the different target temperatures; the curves shown are representative of the responses of the straps under each test condition. Both Figures 19 and 20 portray the tensile behavior of the prestressed straps after 10 min of exposure at the target temperature. The average values and standard deviations for maximum force, UTS, and tensile elastic modulus in the longitudinal (fiber) direction for each target temperature are given in Table 6.

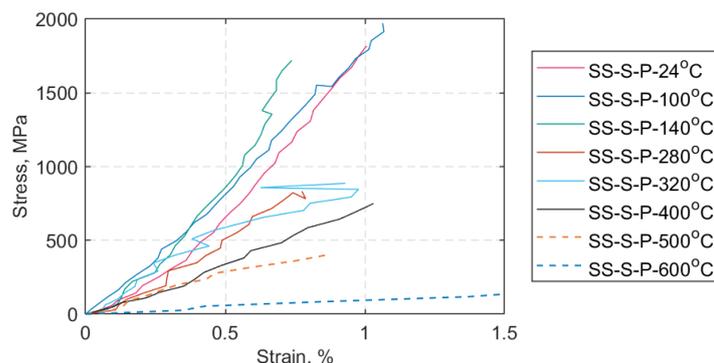
Figure 20. Stress (MPa) vs. strain (%) representative curves for each SS case.

Calculation of the longitudinal elastic modulus followed the ISO 527-5 standard test method [40], i.e., the strain values used were 0.05% and 0.25% with the corresponding stress values, respectively. In all cases the strain values shown are those obtained using DIC. The data were processed in MATLAB 2019Rb. For the SS tests at 600 °C, the strain

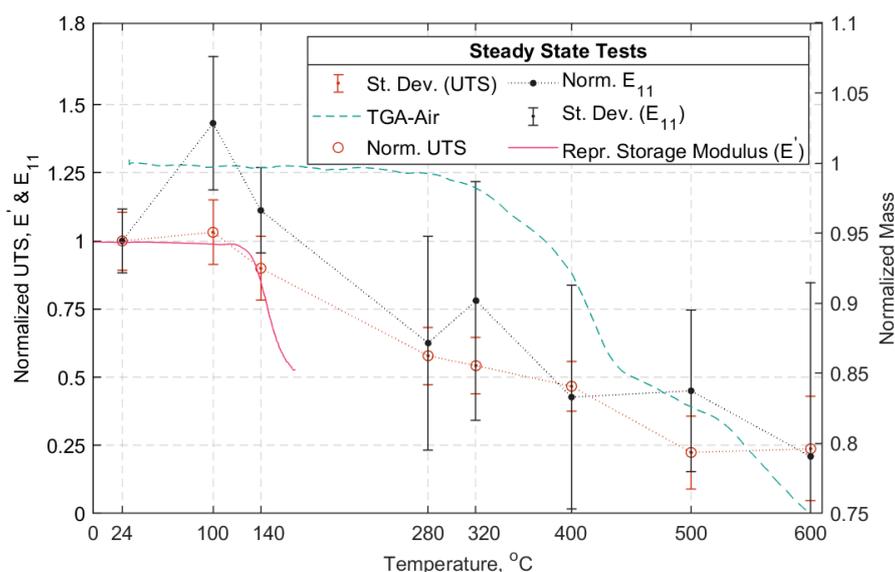
Figure 21. (Left): Normalized UTS, normalized elastic modulus ( $E_{11}$ ), and normalized storage modulus (representative  $E'$ ) vs. temperature (°C). (Right): Normalized mass vs. temperature (°C). SS tests.

Via the SS tests, the influence of temperature on the strength of the straps in the range of 24 to 600 °C was established. This is illustrated in Figure 21, where the average UTS (normalized with respect to the average UTS at ambient temperature) for each temperature is plotted along with its standard deviation. In addition, the impact of temperature on the elastic modulus ( $E_{11}$ ) is presented and follows similar trends.

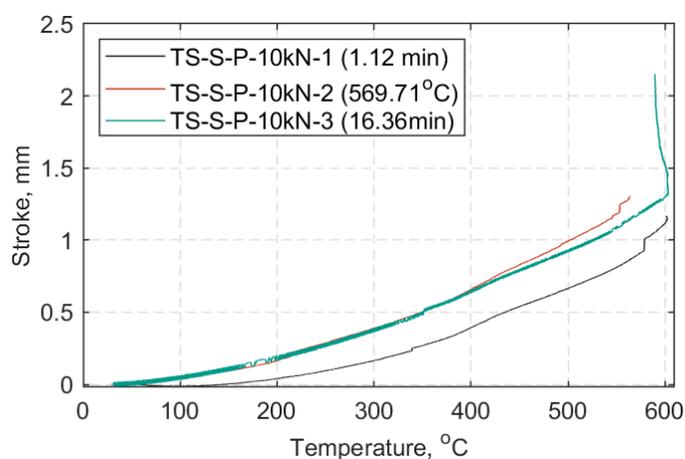
**Figure 22.** Crosshead stroke in hold mode (mm) vs. temperature (°C): All transient state (TS) cases at 10 kN.

In Figures 22–24 each TS load case is presented in a displacement versus temperature plot (once at the target load). The name notation in the legend for the TS tests is similar to that used in the SS tests, with: TS-Transient State, S-Standard Strap Models, P-Prestressed, 10, 15, or 20 as the target load (kN) in each case, and 1/2/3-test number. When a parenthesis is included, this indicates either the duration (in minutes) of the strap's ability to sustain the load at 600 °C, or the temperature (°C) at which the strap failed while sustaining the applied load. Representative curves of the elastic modulus progression over temperature for each TS case are also presented in Figure 25. These data represent an approximation of the elastic modulus, since the DIC pattern was significantly deteriorated after reaching 300 °C and noise in the data was inevitable (e.g., out of plane motion, large deformations); further details can be found in Appendix B.

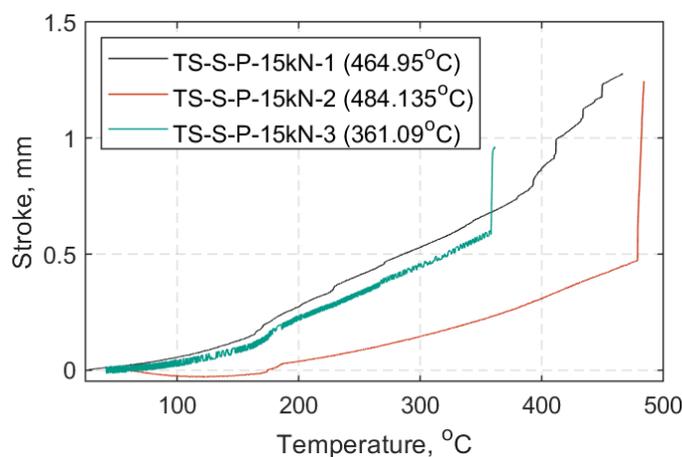
**Figure 23.** Crosshead stroke in hold mode (mm) vs. temperature (°C): All TS cases at 15 kN.

As the load level increased from 15 to 20 kN the straps failed earlier, and at lower temperatures. At a 15 kN load level the average failure temperature was about 435 °C ( $\pm 65$  °C) and at a 20 kN load level, it was around  $350 \pm 21$  °C. This is consistent with the main result of the SS tests that gave a temperature of 365 °C for retention of 50% of the ambient temperature UTS (Figure 21). Failure of the straps became more explosive as the load level increased, especially for those straps tested at 20 kN. This behavior was also reported by Zhou et al. [31], who observed that the time to failure of CFRP tendons tested at elevated temperature increased with a decrease of loading level. Comparing the average failure temperatures of the straps (intermediate modulus carbon fibers of type Tenax IMS60) tested at a 0.5UTS level (350 °C) to that of the ultra-high modulus CFRP tendons (diameter: 5.3 mm) tested at 50% of their design tensile strength (409 °C) by Terrasi et al. [30], the straps in the current study failed at lower temperature. This is expected because pitch-based carbon fibers, with higher modulus and higher degree of graphitization, have superior thermal stability than PAN-based normal/intermediate modulus carbon fibers [42]. Despite the lower failure temperature of the model straps at 0.5 UTS level (20 kN) the straps were still able to carry substantial loads for temperatures well above their  $T_g$ .

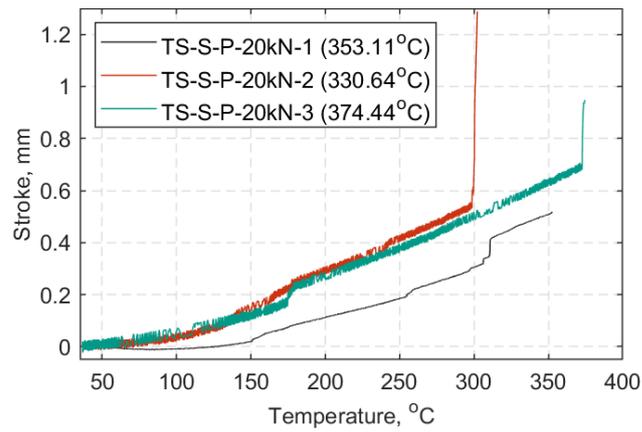
**Figure 24.** Crosshead stroke in hold mode (mm) vs. temperature (°C): All TS cases at 20 kN.

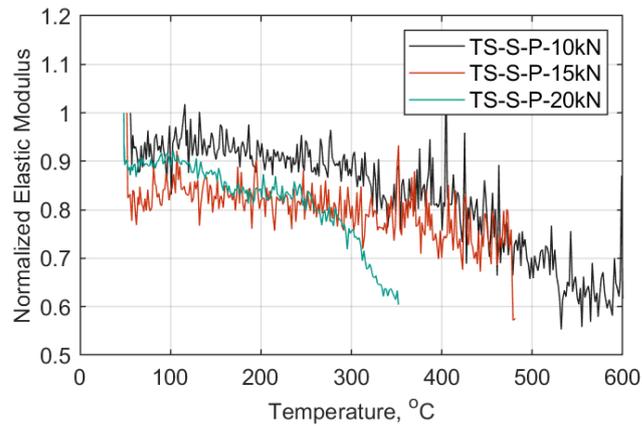
**Figure 25.** Normalized elastic modulus vs. temperature (°C) representative curves, TS cases.

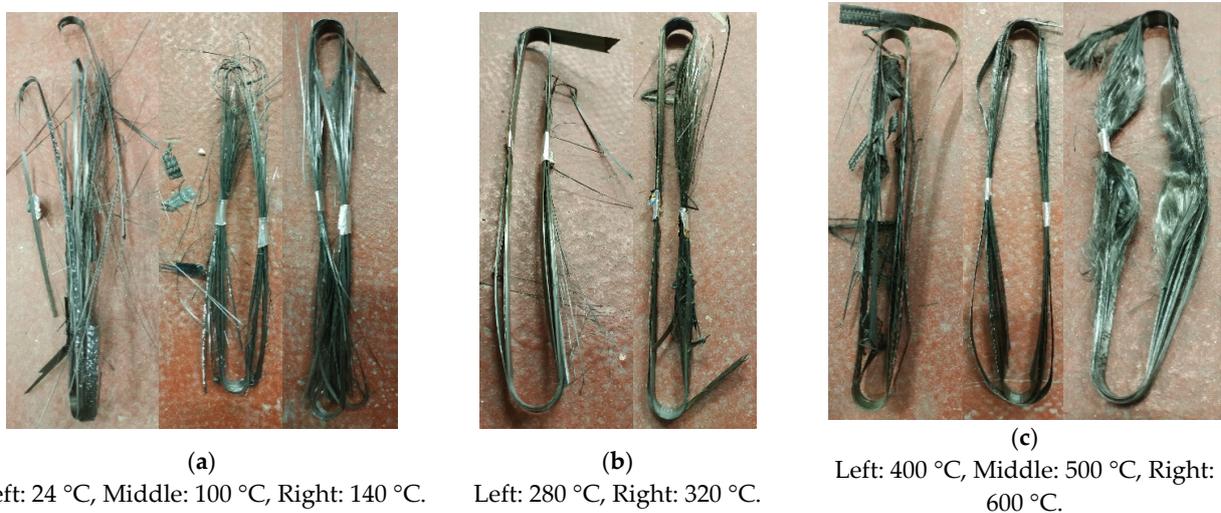
**Figure 26.** Strap failure modes in SS tests at different temperature levels: (a) between 24 and 140 °C, (b) at 280 and 320 °C, and (c) between 400 and 600 °C.

The straps' state after the 10min exposure at the eight different target temperatures is illustrated in Figure 26. In all SS tests, audible crack propagation and/or occasional minor fiber breakages were recorded. The first visible failure mode in all tests was consistently the delamination of the outer ply on the inner side of the wound straps (starting point of the winding). For temperatures up to 320 °C, the final failure of the straps occurred at the vertex area where the straight shaft length met the curvature of the strap around the pin. This was the critical strap region, and is consistent with stress analysis results on tensile loaded straps with pin anchorage [8,20]. At both 24 and 100 °C the straps failed in a

sudden and explosive manner, whereas in the range between 140 and 320 °C the straps failed less explosively; likely due to epoxy matrix softening, lower failure loads, etc. In addition, for temperatures between 280 and 320 °C a partial unwinding of the outer plies was observed. Above 400 °C, initial debonding of the outer plies of the strap, followed by progressive debonding and unwinding of the in-between plies was observed. This behavior was attributed to decomposition of the polymer matrix, which was completely decomposed by about 600 °C and led to larger deformations of the straps. Figure 26 (especially above 500 °C) shows that the straps were in a highly deformed state after the tests.

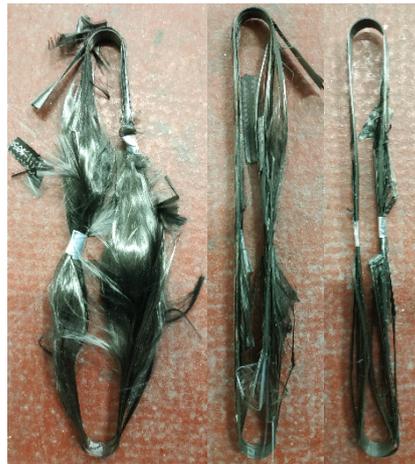
**Figure 27.** Strap state in TS tests when loaded at 10 kN (left), 15 kN (middle), and 20 kN (right).

The failure modes of the straps in the TS tests were strongly dependent on the load level. Figure 27 shows that for a 20 kN load level the straps failed in an explosive manner, however at lower temperatures of around 350 °C. On the other hand, as the load was lowered to 15 and 10 kN, the straps failed in a less explosive manner and exhibited partial debonding and unwinding of the in-between plies, but failed at higher temperatures. The straps tested at 10 kN were soft and malleable after failure.

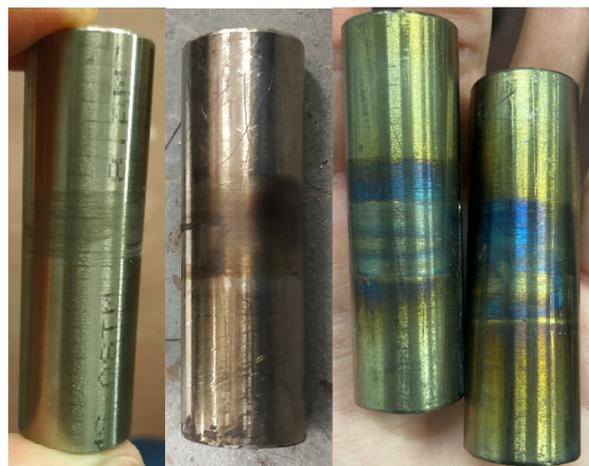
**Figure 28.** Pin state when exposed up to 140 °C (left), up to 500 °C (middle), and at 600 °C (right).

The state of the titanium pins after exposure at the different temperature levels is shown in Figure 28, and it is evident that the titanium pins were not substantially affected by temperature up to 500 °C, as expected.

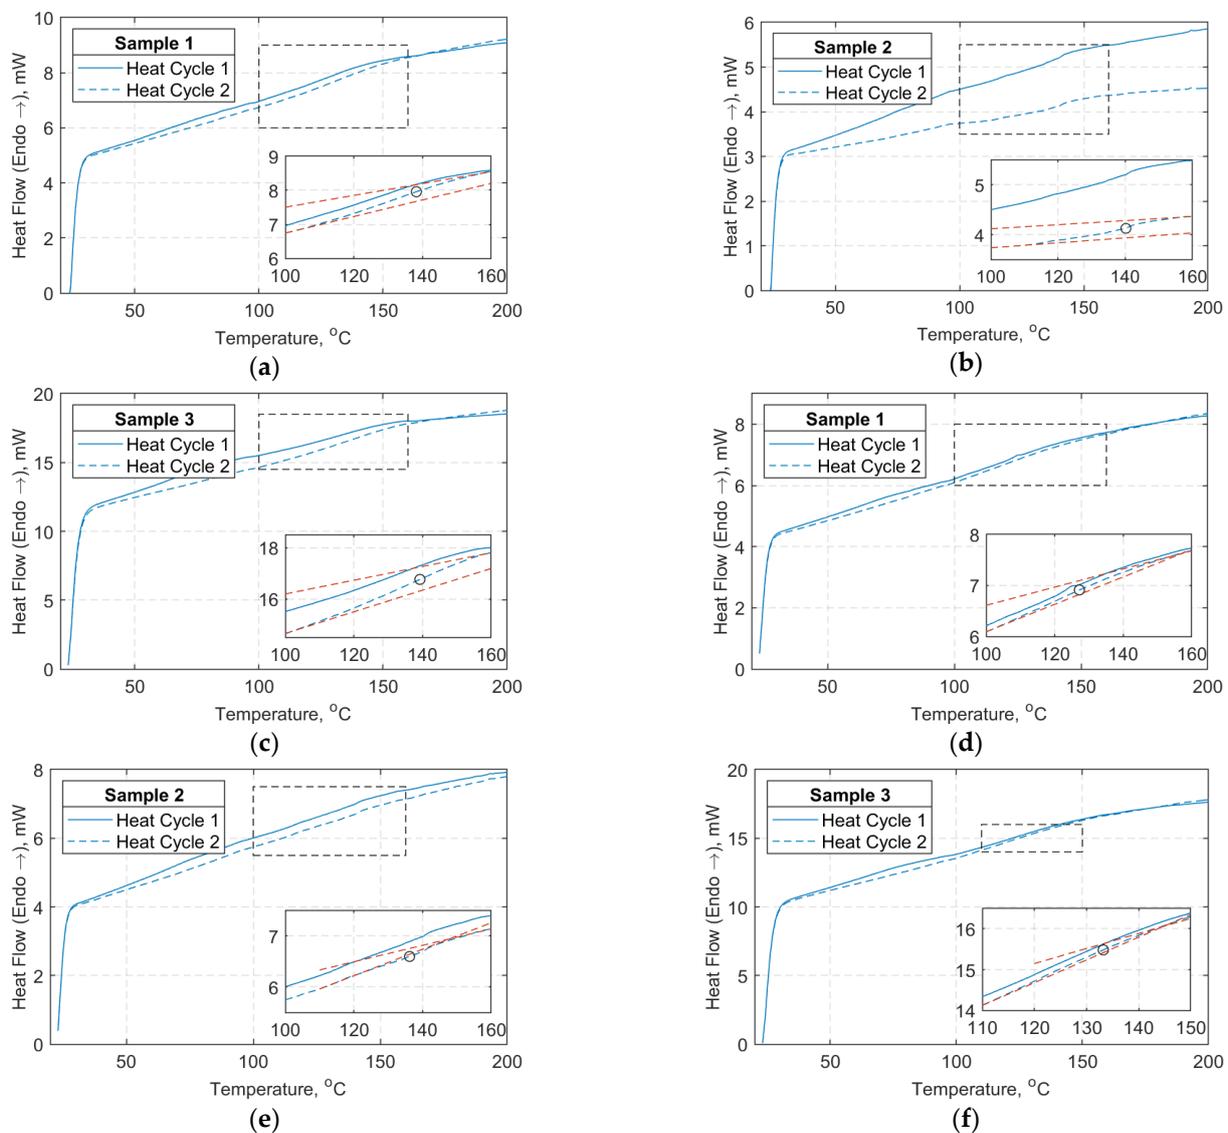
**Figure A1.** DSC plots (heat flow, mW vs. temperature, °C) for composite material of the straps: (a–c) are the samples extracted from the middle shaft length of the straps, while (d–f) are the samples from the curvature region of the straps.

The DSC results were all processed in MATLAB R2019a following ASTM D3418-15 standard [38]. In Figure A1, the extrapolated onset and end temperatures are indicated with dashed (red) lines, and the glass transition (midpoint) temperature is the circled value in the zoomed region on the bottom right corner.

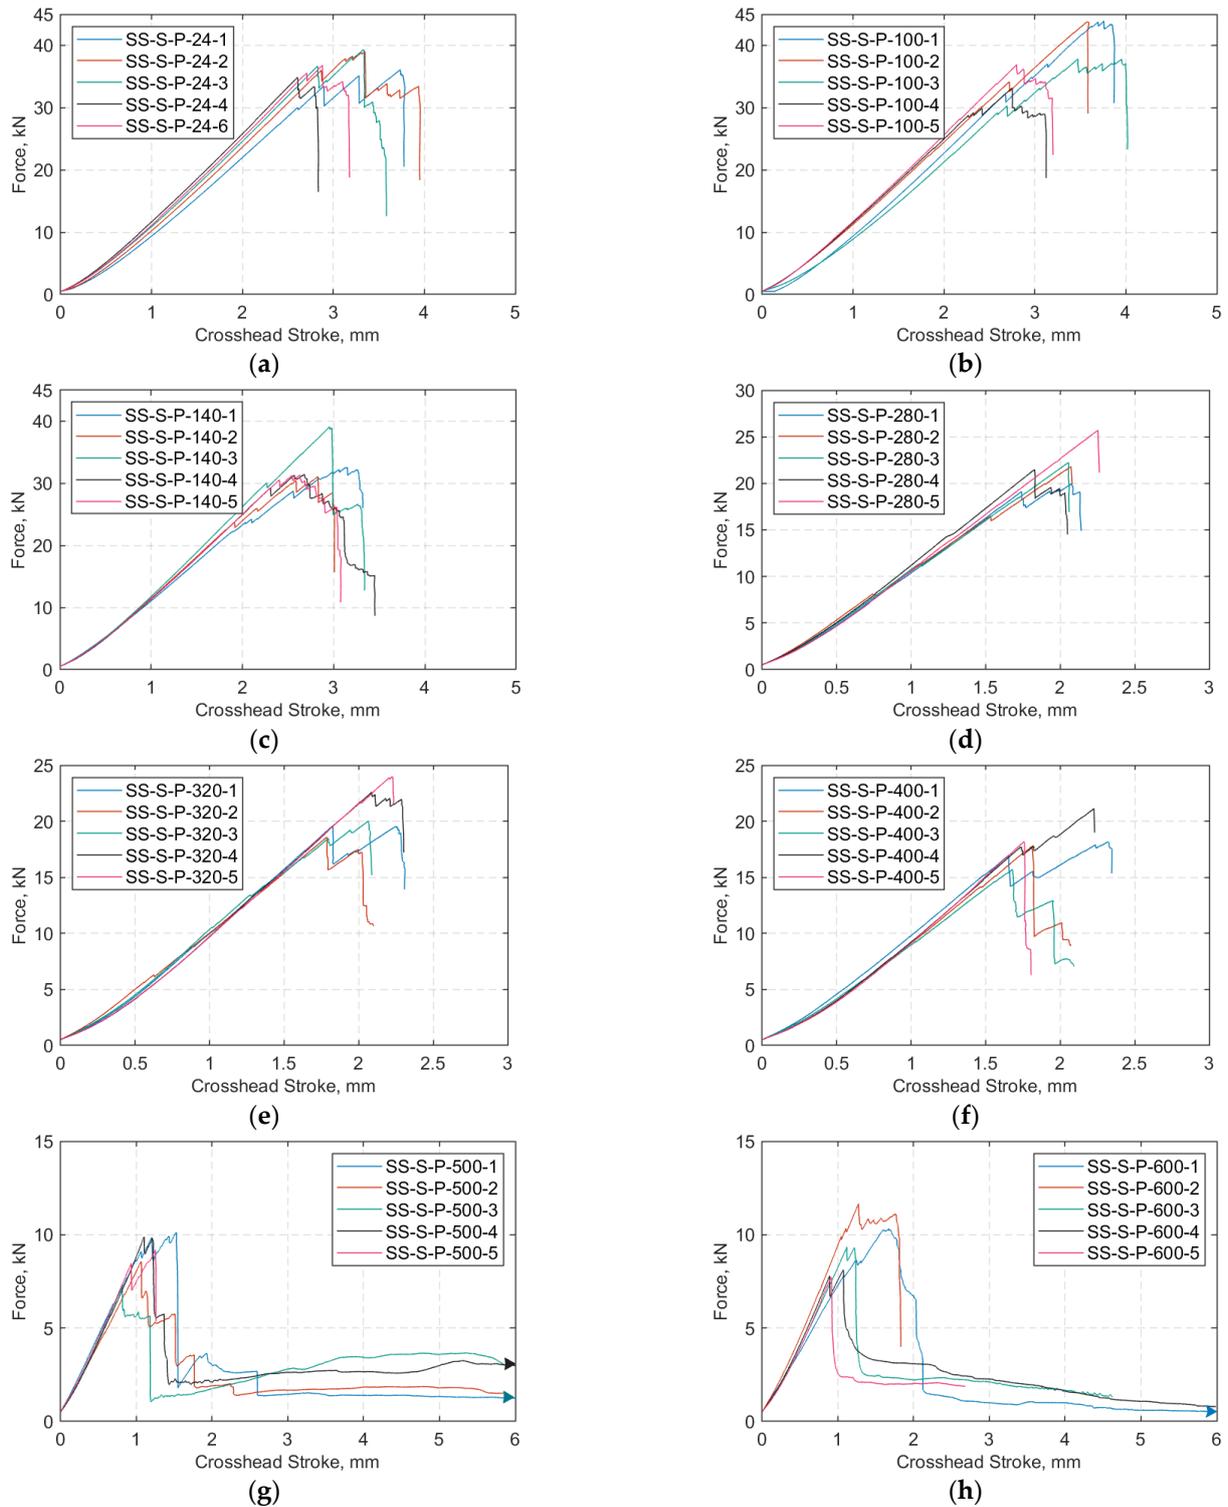
**Figure A2.** Load (kN) vs. crosshead stroke (mm) for all SS cases: (a) 24 °C, (b) 100 °C, (c) 140 °C, (d) 280 °C, (e) 320 °C, (f) 400 °C, (g) 500 °C, and (h) 600 °C.

Detailed figures and a table for all the SS and TS cases can be found here. Figure A2 depicts the load vs. displacement curves for all the SS target temperature cases, while in Figure A3 the normalized elastic modulus vs. temperature curves for all the TS target load cases is presented.

The arrows in Figure A2g,h indicate that the tests continued beyond the 6 mm extension and the test was halted either because the straps could not carry any substantial load due to gradual unwinding of the plies or to avoid equipment damage.

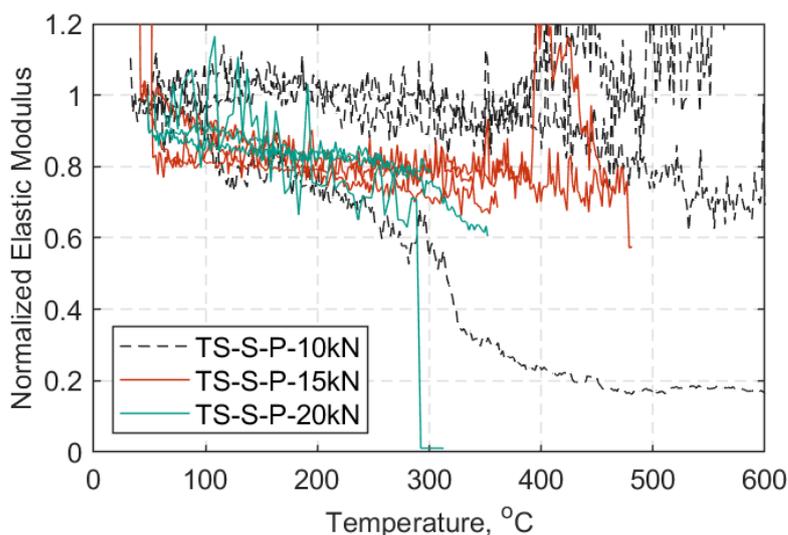
Figure A3. Normalized elastic modulus vs. temperature (°C), TS cases.
