# The Effects of Using Wood Chips and Slash in Reducing Sheet Erosion on Forest Road Slopes

Yilmaz Turk

Department of Forest Engineering, Faculty of Forestry, Duzce University, Duzce 81620, Turkey; yilmazturk@duzce.edu.tr; Tel.: +90-533-5474327

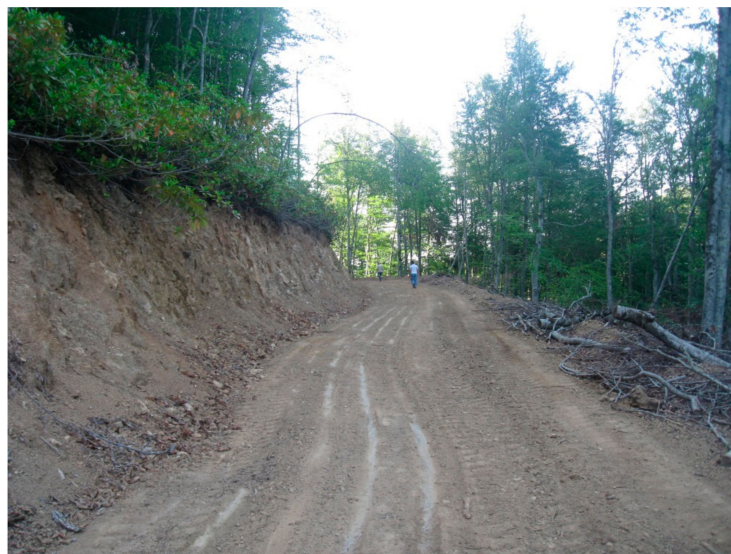
**Figure 1.** Forest road in study area.

The study area has a total of 161.5 km of forest roads. The actual road density value of the working area is 21.89 m/ha and the road distance is 588 m. The investigated road was constructed in 2014. Hydraulic excavators were used in the construction of the forest road in the study. The platform of the forest road in the study area was on average 5.26 m wide with an average road slope of 8%. It was a low-volume, secondary forest road (Figure 1).

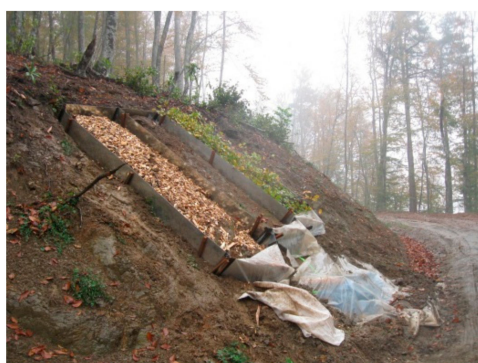
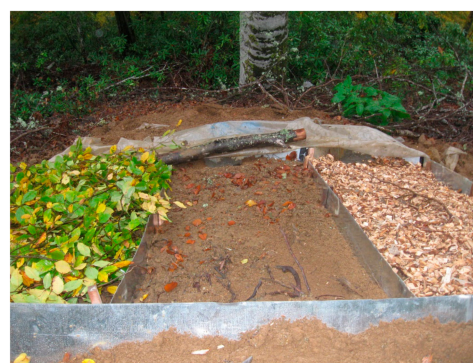
**Figure 2.** Establishment of runoff plots on road slopes: (a) Cutslopes (left—wood chips; center—control; right—slash); (b) fillslopes (left—slash; center—control; right—wood chips).

The field work began after the construction of the forest road. A runoff block (sample field) was established for each of the four designated test sites. Two of the blocks (fillslopes) had gradients of 67% and the other two (cutslopes) of 70%. Two of the blocks were planted facing north and the other two facing south (Table 1). Each block had three runoff plots. One of the runoff plots was left empty for the control (CNT), while wood chips (C) and slash (S), respectively, were deposited in the other two. The wood chips plots were laid with 12 kg ( $4 \text{ kg m}^{-2}$ ) of wood chips at a thickness of 1 cm. The wood chips were obtained from a private workshop in the study area region. In the slash plots, slash (branch/leaf) logging residue obtained from the test area was placed so as to cover the whole of the plot ( $1.5 \text{ kg m}^{-2}$ ). The  $1 \times 3 \text{ m}$  plots were established with the long sides parallel to the direction of the slope. The sides and upper edges of the plots were constrained by 20 cm wide metal sheets, buried in the soil to a depth of 10 cm. The joints of the sheets were suitably connected and sealed with silicone to prevent the leakage of water at the sides. An inlaid structure was formed by inserting a plastic nylon layer at the bottom edge and the runoff water was deposited in a collection tank (Figure 2). The runoff water was measured by scale cylinders in the collection vessel and converted to mm units according to the plot area of  $3 \text{ m}^2$  [27].

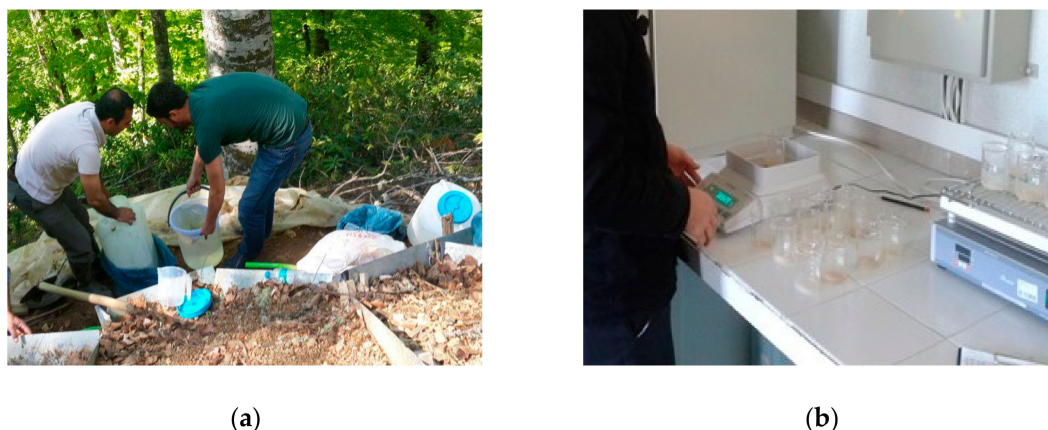
**Figure 3.** (a) Water sample collection; (b) water sample analysis at the laboratory.

The runoff passing through the soil after a rainfall, which accumulated in the collection tank, was measured using scale cylinders and the amount was recorded. When rainfall was not long-term or severe, monthly measurements were taken (excluding areas covered by snow). Nine measurements were taken from the study area throughout the period of October 2014–March 2016. A total of 108 water samples were collected from the test sites, 36 each from the control, wood chips and slash plots. After sediment that had settled at the bottom of the storage tanks was homogenized by shaking the storage tank, the measurement and recording process was completed. After completion, the storage tanks were completely drained.

In order to determine the amount of suspended sediment for each plot, a 0.5 L sample of water taken from the runoff storage tank was brought to the laboratory and put into the heating oven (for 1–2 days at 70 °C). After the runoff water evaporated, the samples of residual suspended sediment were weighed on an electronic precision balance. The specified value was calculated according to the total runoff amount accumulated in the storage tank and the total suspended sediment it carried (Figure 3). The materials coming from the slash plot collecting areas were trapped in a sieve in the collection tank and were not used in determining the amount of suspended sediment [28,29].

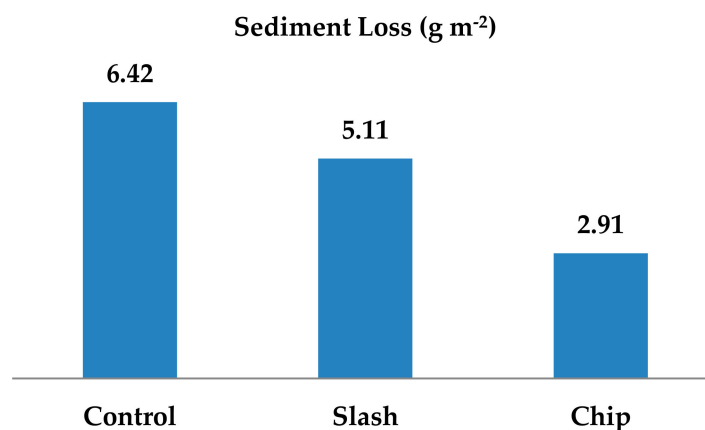
**Figure 4.** Soil loss in the test plots.

According to the results of the 108 water samples taken to determine the soil loss from the plots in the test sites, it was determined that soil loss in the control plots was about 1.26 times higher than that in the slash plots and 2.21 times higher than that in the wood chips plots. In addition, it was determined that soil loss in the slash plots was about 1.76 times higher than that in the wood chips plots (Figure 4).
