# Experimental Study on the Shear Performance of Reinforced Concrete Beams Strengthened with Bolted Side-Plating

**Abstract:** To investigate the residual shear capacity of post-fire bolted side-plated (BSP) reinforced concrete (RC) beams with different depths of steel plate and types of anchor adhesive, i.e., magnesium oxychloride cement (MOC) and HIT-RE500, a control beam and five BSP beams were fabricated, of which two were exposed to fire in accordance with ISO834 temperature curve. Four-point bending shear tests were conducted to investigate the influence of elevated temperature on the failure mode, cracking load, shear capacity, stiffness, ductility and strain development, etc. The shear capacities of RC beams were found to be improved significantly by using the BSP technique. However, the stiffness of BSP beams was seriously degraded after exposed to fire, but the reduction in shear capacity was negligible, whereas the ductility and the strain of longitudinal reinforcement were obviously increased. Thus, the failure-mode was changed from shear failure to flexural failure. Regarding the adhesive mortar used for bolt anchorage, magnesium oxychloride cement (MOC) achieved high

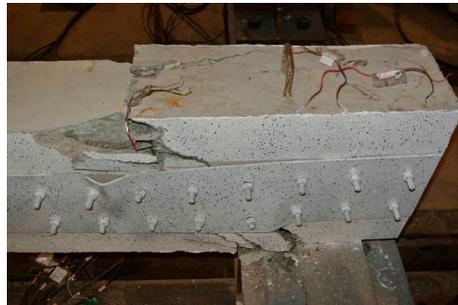
(a) in the left shear span of P2B1-MOCT

**Figure 9.** Buckling of the bolted steel plates.

distribution formed in this region. The phenomenon of the buckling of the bolted steel plates is shown in Figure 9: the bulking of the steel plate for P2B1-MOCT occurred in the shear span, while that for P3B1-MOCT occurred in the mid-span. This indicates that buckling appeared at the place of the maximum compressive stress.

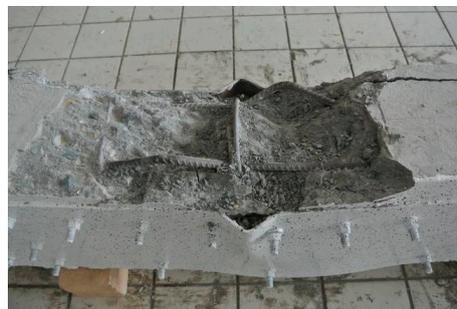
(b) in the mid-span of P3B1-MOCT
