Harmonised Classification of the Causes of Defects in a Global Inspection System: Proposed Methodology and Analysis of Fieldwork Data

Abstract: This research results from the development of a global inspection system based on previous studies about individual expert inspection systems for 12 types of elements/materials of the envelopes of current buildings. The research focuses on the rational harmonisation of the causes of defects in a global classification list, established from 12 individual lists. The process considers predetermined criteria, including guidelines for merging, splitting and combining causes to reach a comprehensive and simple list. The frequency of the prescription of causes of defects is analysed and the causes “C-D12 Dampening of the cladding system” in painted façades and “C-B7 Use of unprescribed, inadequate, incompatible, low-quality, non-certified and/or non-approved materials” in natural stone claddings stand out. Additionally, when analysing the relationship of causes with defects, some causes are highlighted because they are considered direct causes of defects in a broad range of building elements/materials, namely: “C-C9 Accidental collisions with the

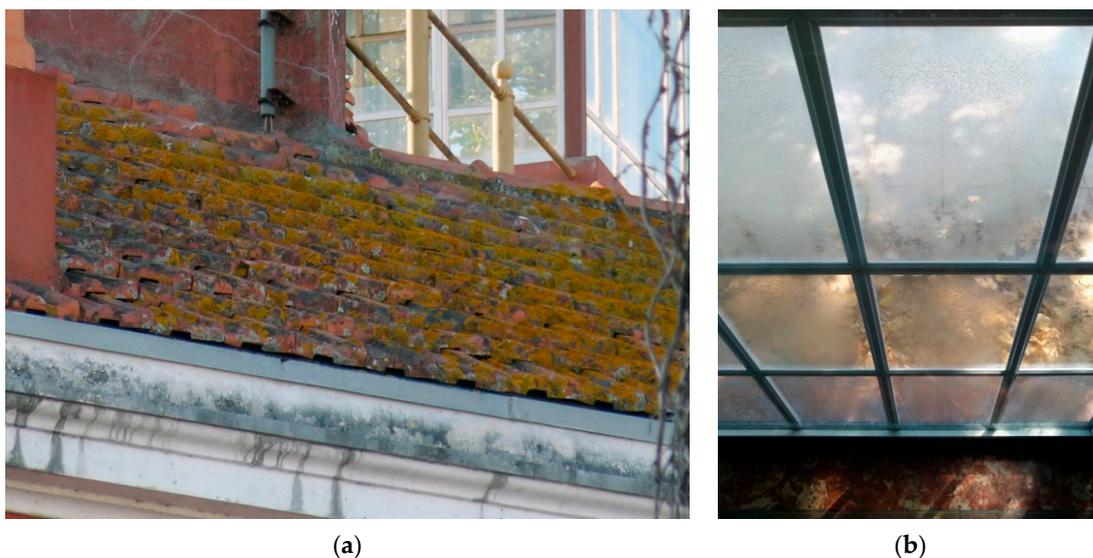
Figure 1. Examples of phenomena associated with faulty ventilation systems (C-A3): (a) biological growth on clay roof tiles of a pitched roof with signs of excessive use of mortar in the top ridge; (b) condensation inside a windowpane in a room with high levels of water vapour production and insufficient ventilation.

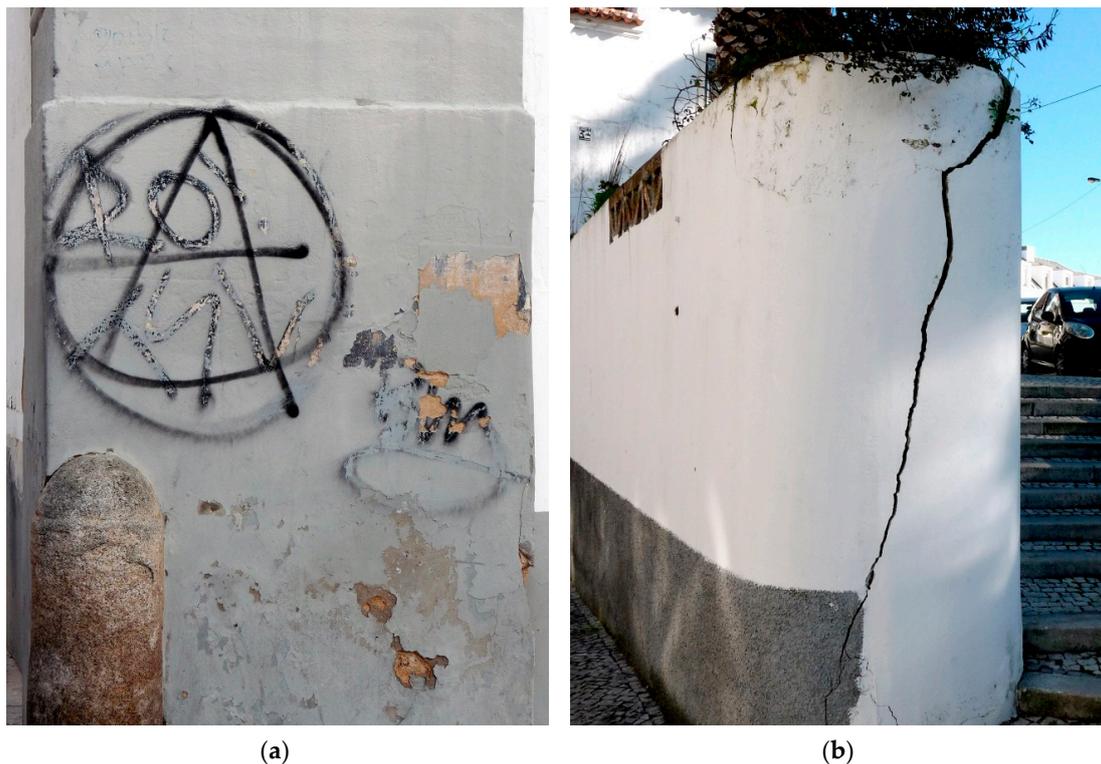
Figure 2. Examples of defects in the building envelope: (a) *graffiti* associated with vandalism and use and maintenance errors; (b) cracked wall due to mechanical actions.

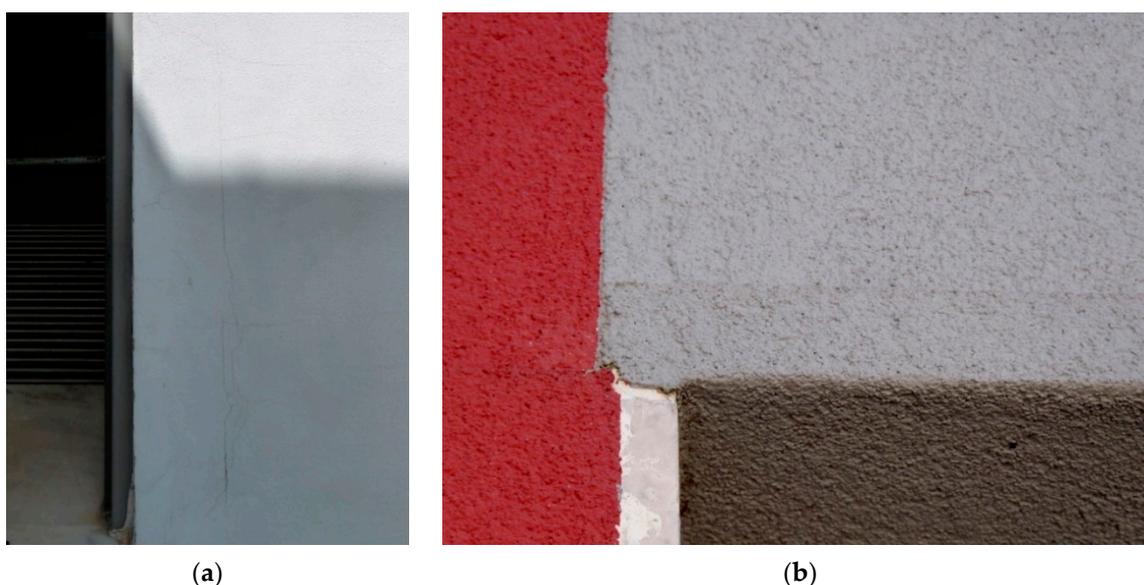
Figure 3. Examples of defect–cause relationships: (a) cracking in an ETICS surface due to insufficient overlapping of the reinforcement splices; (b) protrusion on an ETICS surface due to deficient overlapping of the finishing coat.

Cause “C-B32 Deficient overlap of reinforcement mesh in splices or of the finishing coat in ETICS”, for instance, resulted from the combination of two individual causes from the individual classification list for ETICS (Figure 3), namely: “insufficient overlapping of the reinforcement splices” and “deficient overlapping of the finishing coat” [48]. Both causes, individually, were specific to a cladding system and referred to overlaps, whether on the base or finishing coats of ETICS. By weighing the severity of the effects of such causes, the similarity between them, the overall level of detail and the choice of a shorter global list, C-B32 was created from a combination of two causes of defects.

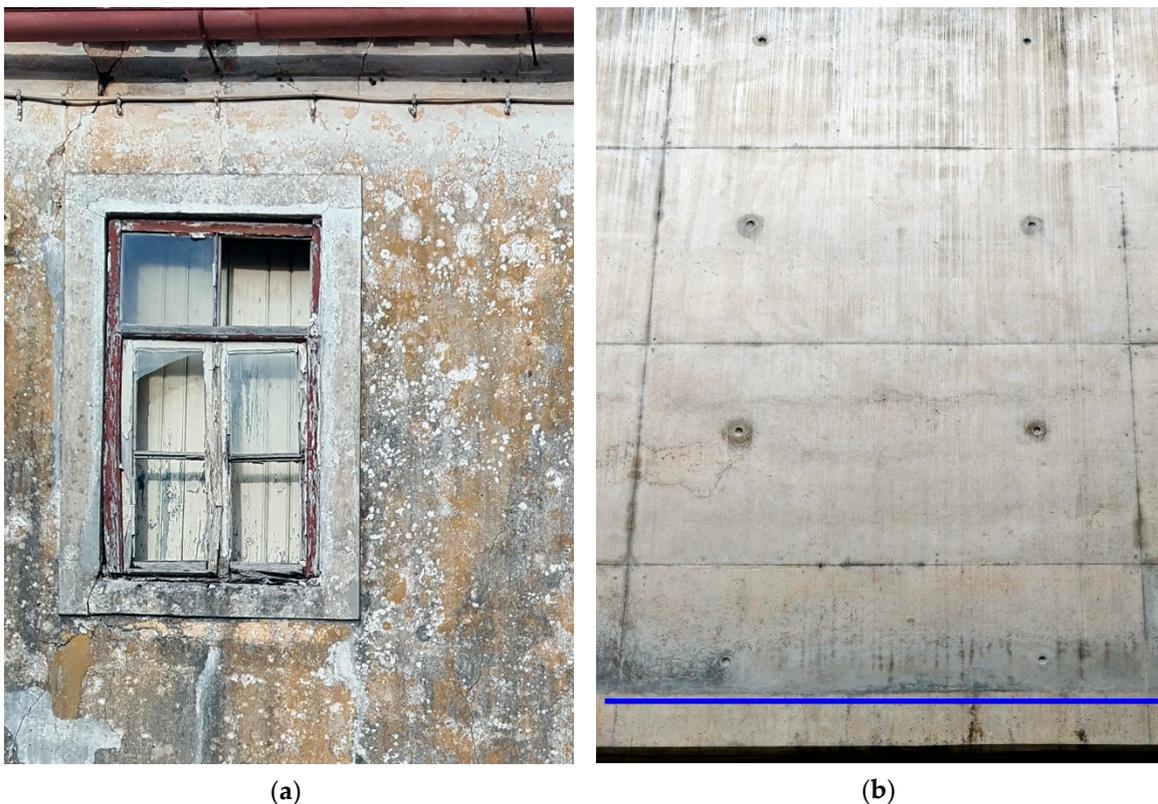
Figure 4. Examples of causes of defects: (a) degradation due to natural ageing in a window frame, a natural stone jamb and a wall render in a vacant house; (b) a deficient architectural concrete surface due to a badly executed casting/panel joint.

Cause “C-B36 Badly executed casting joint in architectural concrete surfaces” was also kept separate, even though it only applies to this type of cladding. In Figure 4b, the highlighted casting joint does not follow the stereotomy pattern of the whole surface, thus it must be considered non-compliant. This type of occurrence is very specific, not allowing for merging the cause with any other type of cause due to the execution specificities of architectural concrete surfaces. The effects of this cause are sufficiently severe to deserve special attention in the classification list of the causes of defects (fourth harmonisation criterion).

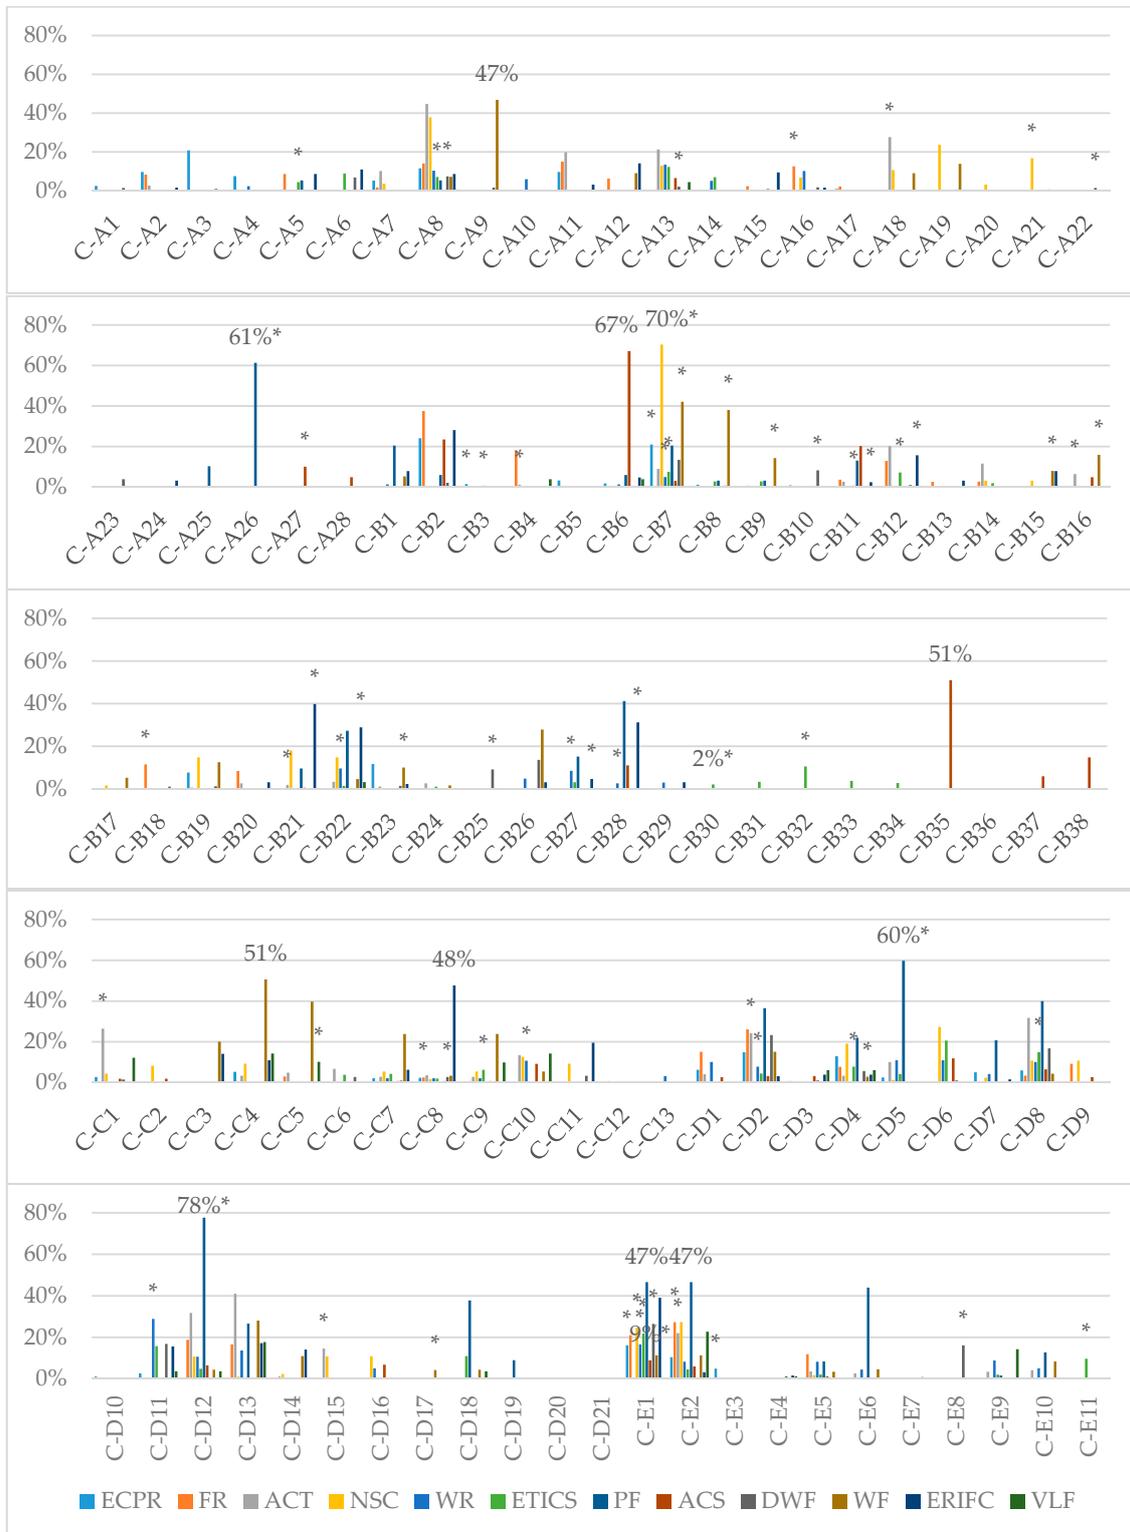
* Resulting from a sum of absolute frequencies.

Figure 6. Relative frequency of the causes of defects identified in each expert inspection system.

absolute frequencies of the individual causes were added up. The results following those sums are marked with an asterisk in Figure 6.

Cause “C-D12 Dampening of the cladding system”, in painted façades, is the one most identified. The 78% relative frequency (Figure 6) is the result of the combination of two individual causes from the inspection system of painted façades (internal moisture and exterior water) [49]. That sample’s numbers were thus summed, but if the highest absolute frequency of those two causes were considered instead, the resulting figure would still be high (40%). Chong and Low [63] identified water seepage as the most recurring latent defect detected in external walls, constituting more than 1/3 of the sample of detected latent defects in external walls. These authors’ result is in line with the findings in Figure 6, although water seepage is different from the causes “dampening of the cladding system”. The research of Barrelas et al. [6], about the degradation of pavilions and prefabricated buildings in secondary schools, also highlights the presence of humidity as the main cause of defects in painting.

“inappropriate use of materials”; and “application of weak or cracked stone slabs” [56]. So, the frequency reported in Figure 6 is the result of the sum of the three frequencies. If, instead of adding up the results associated with these individual causes of defects, the highest frequency of the three was to be considered, a relative frequency of 27% would be found. That logic would correspond to the assumption that the three individual causes were generally identified simultaneously, which is not the assumption inherent in Figure 6.

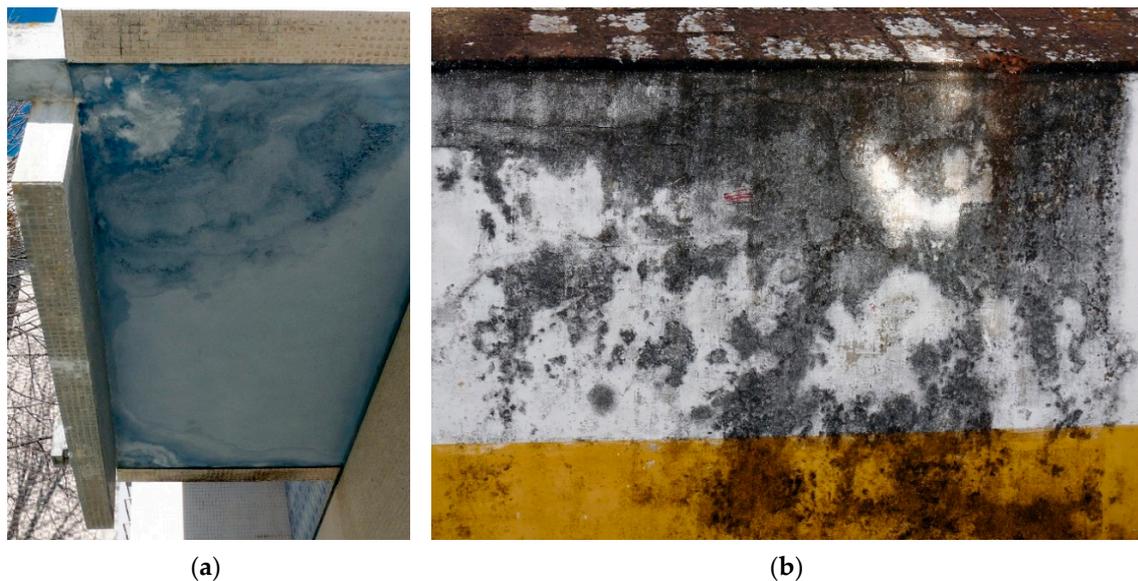
Figure 7. Result of dampening of the cladding system in painted façades: (a) colour changes and efflorescence; (b) dirt and biological growth.

Figure 7 shows two different cases in which painted façades present the effects of such a cause. In Figure 7a, the colour of an outdoor ceiling (below a balcony) shows different tones in two stains that are approximately concentric. In the centre of those quarter circles (one larger than the other), whitish stains are found, giving the impression that efflorescence is occurring, in line with the common appearance of this phenomenon [64–66]. Two phenomena may be occurring, both dampening the surface: (i) the runoff of rainwater through the vertical surfaces of the balcony that then runs off through the lower horizontal surface of the balcony, as no drips to guide the water are observed or (ii) leakages in the waterproofing system of the balcony, reaching the lower surface of the slab. Whichever the case, staining and efflorescence are damaging the appearance of the surface, and more defects may start to occur soon, such as the peeling of the paint coating.

In Figure 7b, blackish stains are observed, associated with the accumulation of dirt and biological growth. The upper sloped surface, above the vertical surface of the façade, promotes the runoff of rainwater through the façade. Dirt accumulated on the sloped surface is dragged by rainwater. Additionally, the lengthy drying period of the vertical surface stimulates the accumulation of dust and pollution particles from the atmosphere. Dirt and favourable moisture and lighting conditions result in the proliferation of mould on the surface.

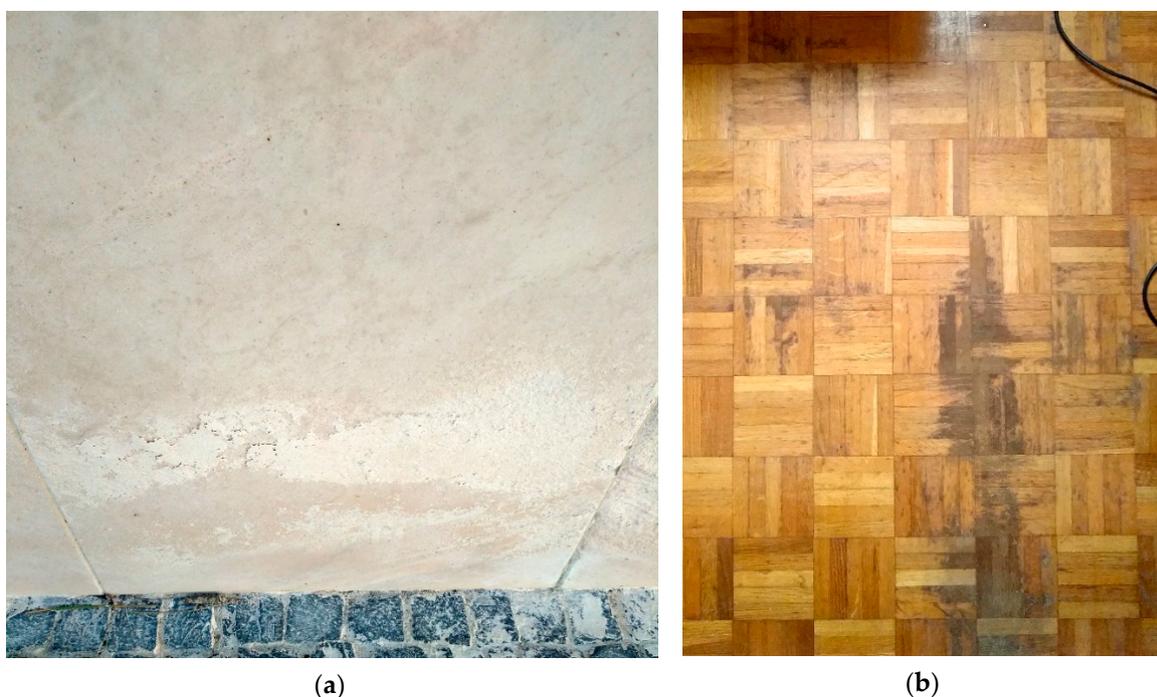
Figure 8. Signs of use of unprescribed, inadequate, incompatible, low-quality, non-certified and/or non-approved materials: (a) in a natural stone cladding in a maritime environment; (b) in a wood flooring.

Figure 8a shows an example of the inadequate use of natural stone materials in the cladding of a façade. In this case, limestone is used in a maritime environment, in a building about 300 m from the sea, resulting in salt crystallisation on the surface and wear associated with erosion. The functional classification of claddings during the design stage would have been a useful tool to guide the specification of this material. That would also have been helpful in the case in Figure 8b, where scratches and wear of the finishing coat occur on a wood flooring. Probably due to situations mostly like this one, the identification of “C-B7 Use of unprescribed, inadequate, incompatible, low-quality, non-certified and/or non-approved materials” in wood floorings is also frequent (42% of defects are associated with this cause).

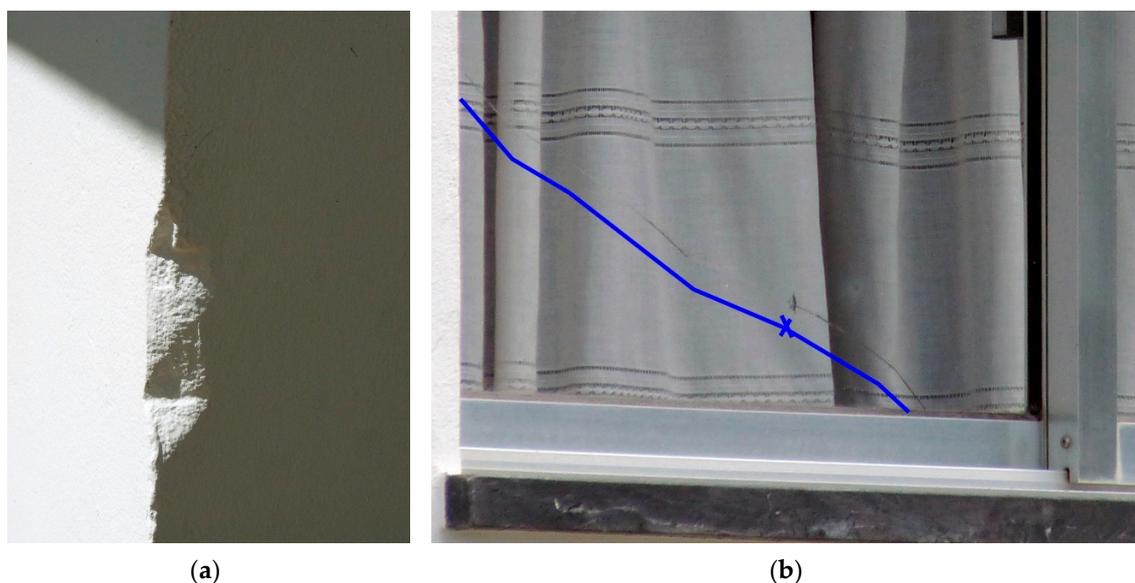
Figure 9. Results of accidental collisions with the cladding in (a) a wall render and (b) the glazing of a window.

An example of deep wear in a wall render is represented in Figure 9a, where the hard manoeuvring of a vehicle resulted in a collision with the wall (C-C9) and subsequent loss of a part of the render. Furthermore, in door and window frames, accidental collisions (C-C9) are a direct cause of “A-C3 Fracture or splintering on the current surface”. In Figure 9b, an example of a defect is illustrated, where the collision of a small stone while the adjacent land was being ploughed, resulted in the fracture and piercing of the glass pane.
