Analysis of Roof Collapse Cases Caused by Snow Loads in Russia (2001–2021)

Valentina Lobkina

Far East Geological Institute, Far Eastern Branch of the Russian Academy of Sciences, Sakhalin Branch, 693023 Yuzhno-Sakhalinsk, Russia; valentina-lobkina@yandex.ru

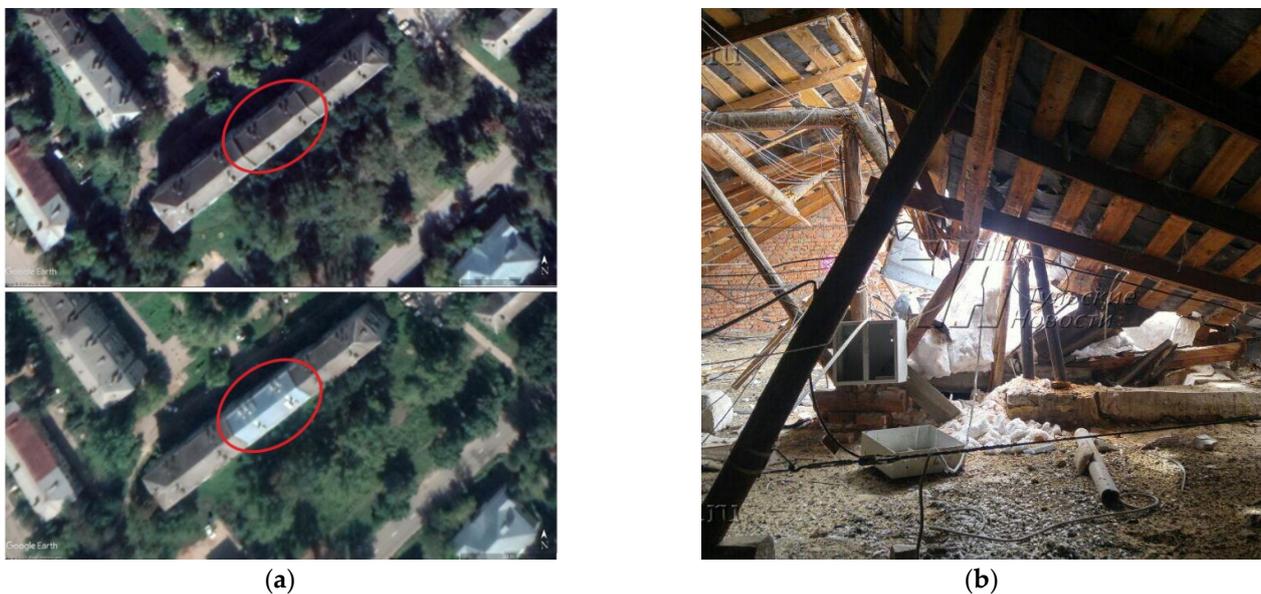
Figure 1. Partial roof collapse of a residential apartment building (15/2 Rihard Sorge Str., Tula) on 23 March 2018: (a) Google snapshot before the collapse on 15 September 2017 (top); snapshot after the collapse and a partial repair of the damaged roof on 24 August 2019 (bottom). The snapshot dated 12 October 2018 has worse quality. The affected part is outlined. (b) General view of the destruction. Photo from the site of IA Tula News (https://newstula.ru/fn_349771.html (accessed on: 24 August 2021)).

The collected collapse data were analyzed according to the following characteristics: collapse date, collapse location (region of Russia), building type, roof shape, roofing material, collapse area, and number of floors (Table 1). The collapse area, when specifying the address of the building location, was checked with Google Images, and it was possible to decode the collapse location via changes in the color and type of coating on the images of different periods (Figure 1).

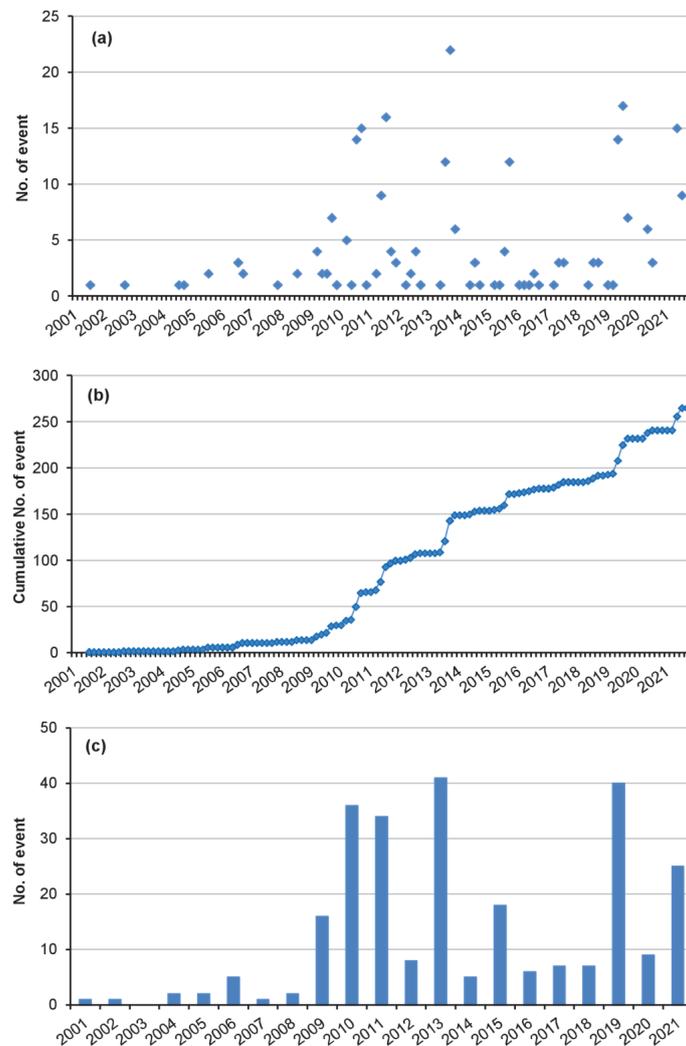
Figure 2. (a) Monthly (November–April) distribution of the cases of roof collapse under snow loads in Russia between 2001 and 2021. (b) Cumulative number of roof collapse. (c) Number of cases by year.

From 2001 to 2021, 266 roof collapses caused by snow loads occurred in Russia. The distribution of the number of cases is shown in Figure 2. Data on 14 collapses only were found for the period from 2001 to 2008, and no data were found in 2003, i.e., 95% of all analyzed cases occurred after 2008. The increase in the number of cases after 2008 could be

The largest number of collapse cases occurred in 2013 (15.4% of the total number of cases), followed by 15% cases that occurred in 2019. On average, 13.3 cases of roof collapse caused by snow loads occurred in Russia per year. Most of the buildings affected were civil, with a predominance of residential buildings in both years.

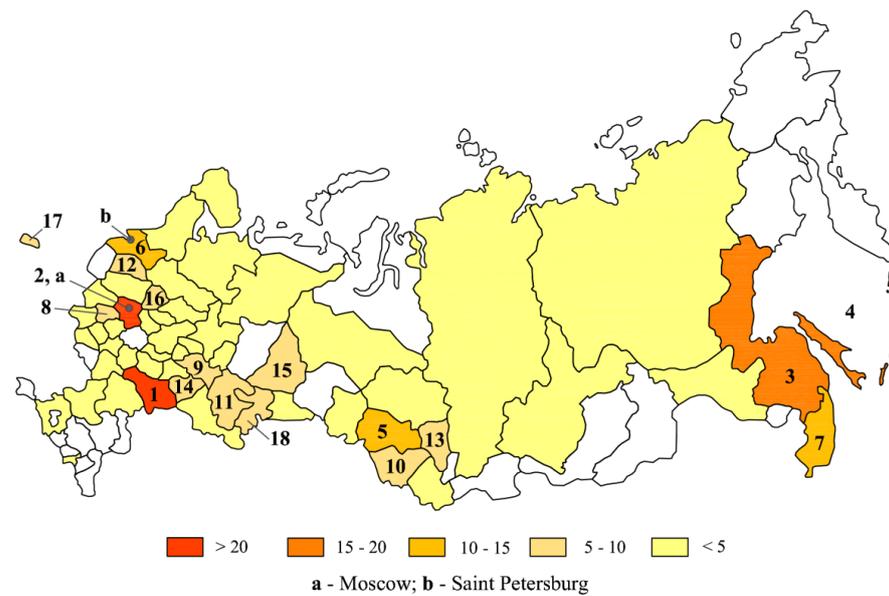
Figure 3. Distribution of collapse cases number over the territory of Russia.

The geography of the collapses included 58 out of 85 regions of Russia (including the federal cities of Moscow and St. Petersburg). Figure 3 shows the ranking of Russian regions by the number of roof collapse cases caused by snow loads over the past 20 years. The intensity of color increases with the number of collapses. The numbers in Figure 3 show the regions where five or more collapses occurred. The number of cases is given in the Table 2. Regions with fewer than five collapses are also listed in the Table 2 without designation in Figure 3. The territories of the regions with no collapse data for the period under consideration remained empty.

The main number of collapses occurred in the Saratov and Moscow regions (including Moscow), with approximately 17% of the total number of cases (Figure 3). The regions with available information on less than five cases of collapse accounted for 28%. Regarding cities, the most affected were Moscow (15 cases), St. Petersburg and Novosibirsk (11 cases each), and Saratov and Yuzhno-Sakhalinsk (eight cases each).

The largest number of collapse cases was observed in February and March (more often in February). From the third 10-day period of February to the first 10-day period of March, the largest winter snow water equivalent (SWE) was observed in the European part of Russia [17,18]. During this period, most of the collapses occurred in Moscow, Saratov, Kaluga, Novgorod, and Leningrad (Figure 3). The largest SWE in the Far East and Siberia fell on the second or third 10-day period of March [17,19]. The most vulnerable here were the Khabarovsk territory and the Sakhalin region (Figure 3).

This article collected and analyzed data on 266 cases of roof collapse under the influence of snow loads in Russia from 2001 to 2021. The average value of the number of cases per year was 13.3. At the same time, this number varied from year to year, from 0 (2003) to 41 (2013). The most affected regions for the period of review were the Saratov and Moscow regions, the Khabarovsk territory, Sakhalin, the Novosibirsk and Leningrad regions, and the Primorsky territory (Figure 3).

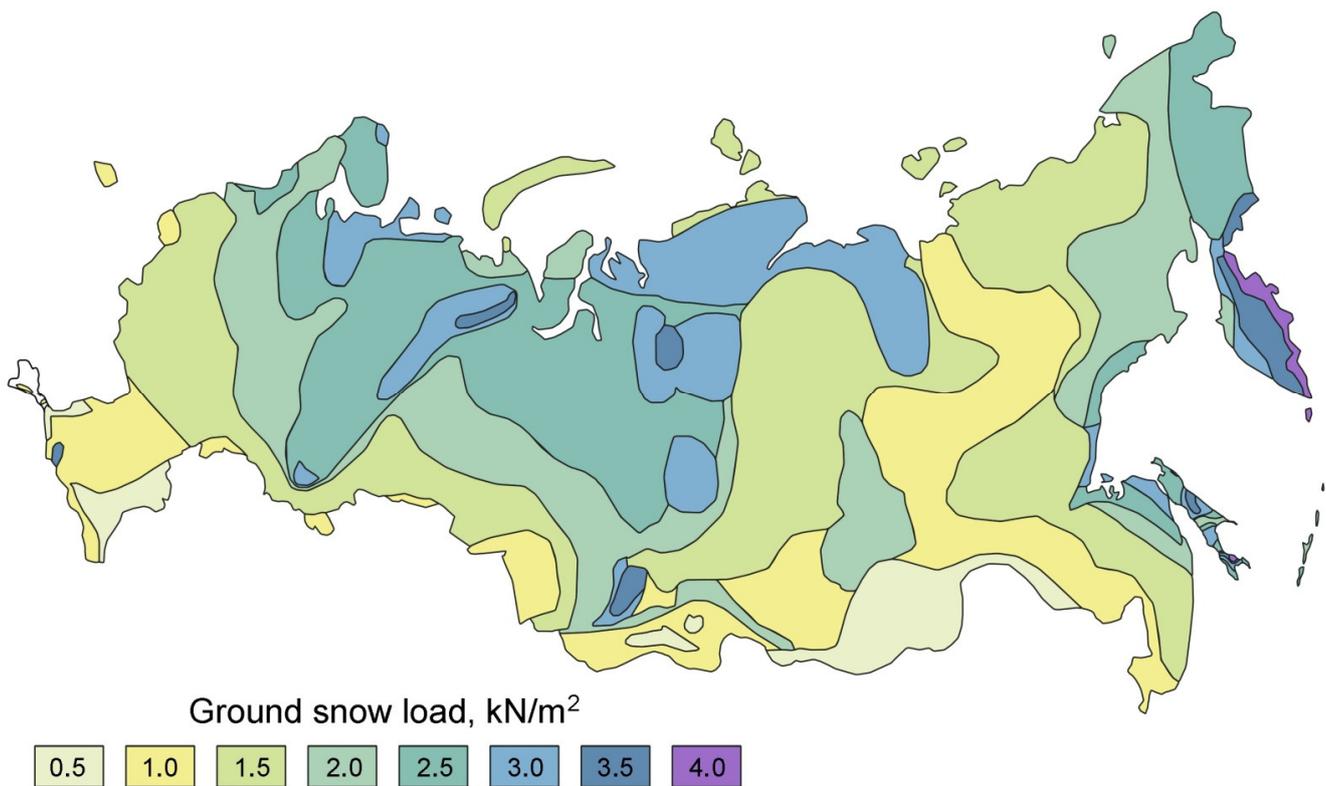
Figure 4. Distribution of the snow loads on the ground in Russia [13].

Figure 4 shows the distribution of snow loads on the ground in Russia, indicating the danger faced by the affected regions. The official edition can be found in [13].

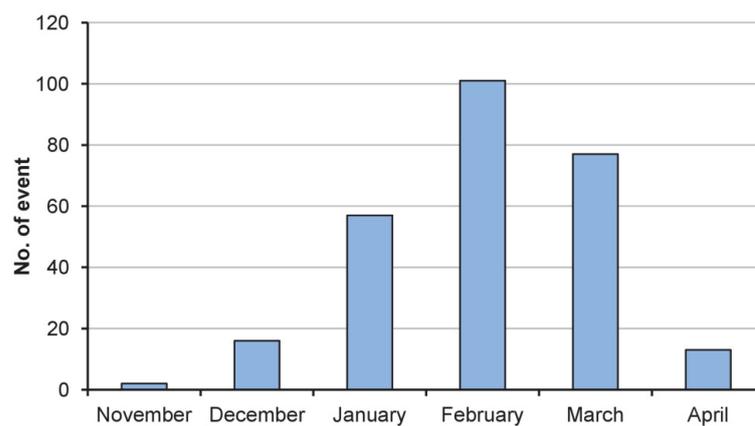
Figure 5. The period of excessive snow load formation with the distribution of the number of cases of collapse by month.

Roof collapses under the influence of snow loads were noted from November to April; this period corresponds to the average dates of snowfall formation over the territory of Russia. Appendix A (Figure A1) contains the monthly average precipitation values related to the studied period of the year when the collapses occurred, according to the site data [16]. The distribution of cases of collapse during winter is shown in Figure 5.

The period of excessive snow load formation coincided with the calendar winter period and lasted from November to April. Moreover, the most dangerous months were February and March. During these months, the largest SWEs were observed across most parts of Russia. The overwhelming number of roof collapses (38%) occurred in February (Figure 5).

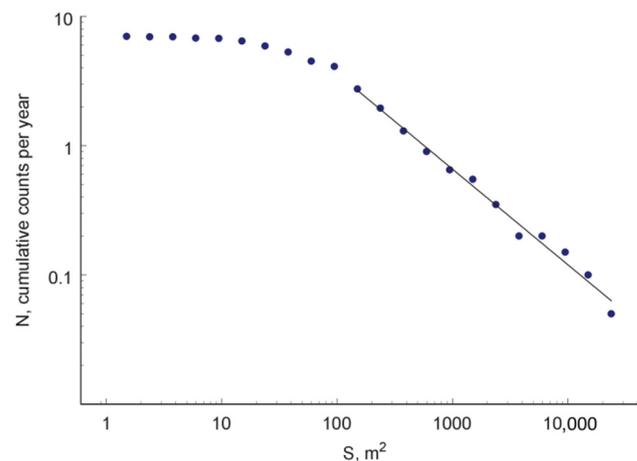
Figure 6. Frequency of a given area of roof collapse.

A frequency graph was constructed based on the available collapse area data (Figure 6), apparently resembling the well-known Gutenberg–Richter magnitude–frequency relation [23], which is actively used in assessing the frequency of earthquakes (e.g., ref. [24]). The observed graph curvature from a collapse area ≤ 150 m² is most likely due to missing data. We assume that collapses with an area of ≤ 150 m² occur much more often; however, data on these cases do not always appear in open publications, so it is impossible to take them into account. The frequency of collapses with an area >150 m² has a linear relationship of the form:

$$\lg N(\geq S) = (-0.74 \pm 0.2) \times \lg S + (2.04 \pm 0.2), \quad (1)$$

where S is the collapse area and N is the cumulative number of cases.

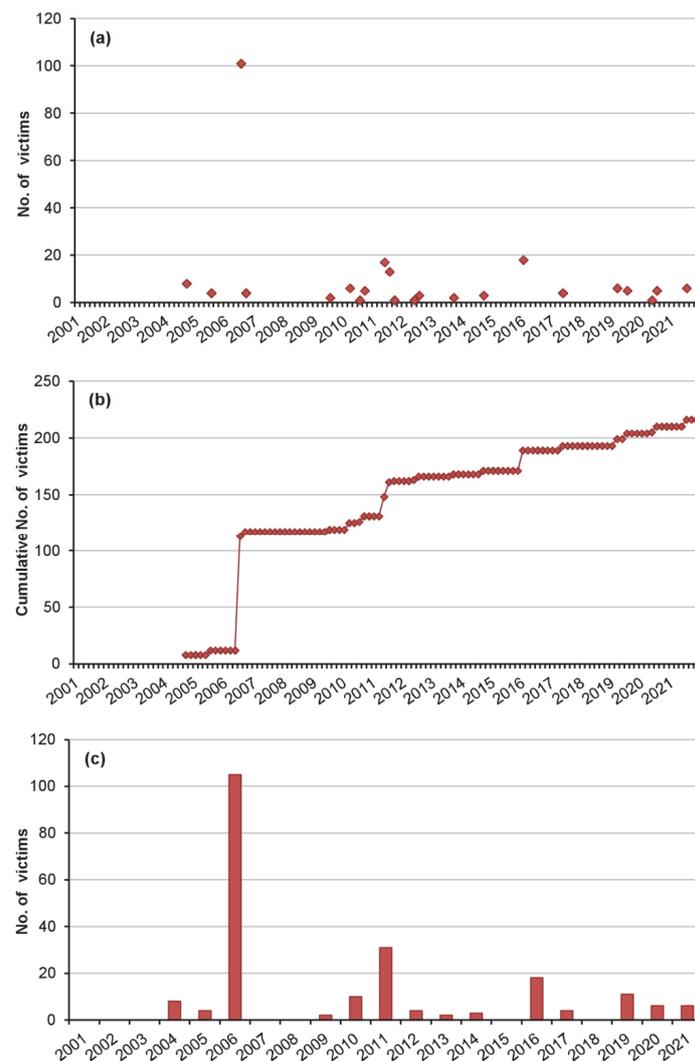
Figure 7. (a) Monthly (November–April) number of victims (injured and fatalities) from roof collapses caused by snow loads in Russia between 2001 and 2021. (b) Total number of victims. (c) Number of victims by year.

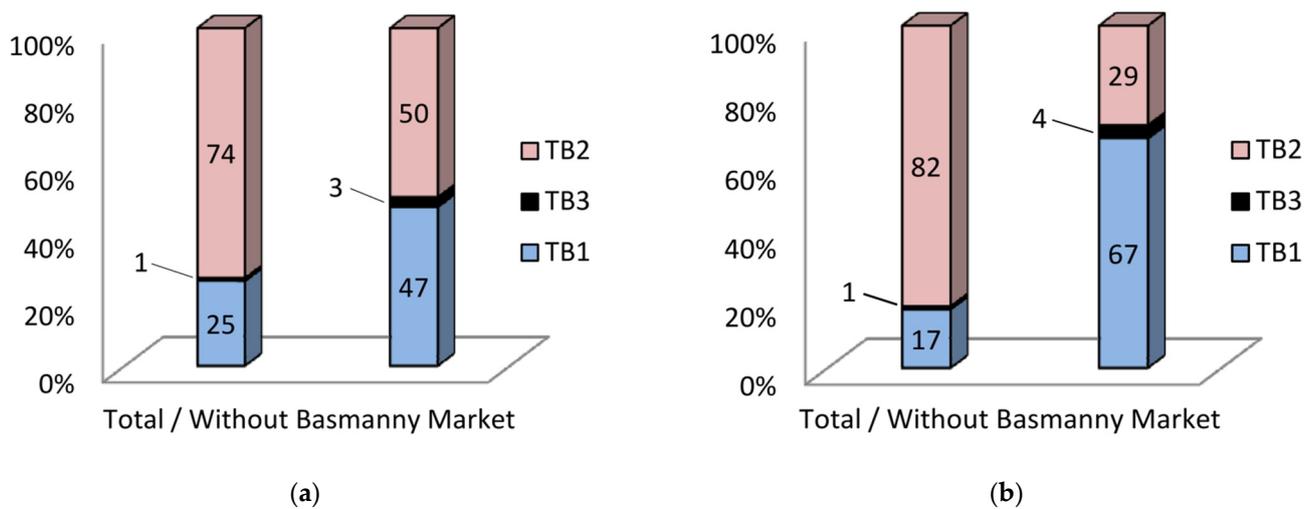
Figure 8. Percentage of victims (a) and fatalities (b) depending on the type of building.

By analyzing all of the victims (Figure 8a), it can be noticed that the majority were harmed by the collapse of civil buildings (74%). If we exclude from consideration the emergency in Basmanny market (Figure 8a), as the only case in the sample with more than 100 people injured, then the distribution of victims between the collapse of civil (50%) and industrial (47%) buildings is almost equal, despite the fact that the number of cases of collapse of civilian buildings is significantly higher than industrial buildings (208 vs. 40). In cases with fatalities (Figure 8b), a strong influence of a single event was also seen; when excluded, it turns out that the largest number of deaths occurred when industrial buildings collapsed (67%). The high mortality rate in industrial buildings can be explained by the fact that, unlike civilian buildings, they do not have an upper technical floor and the roof falls not on the beams of the technical floor, but directly into the working area where the people are.

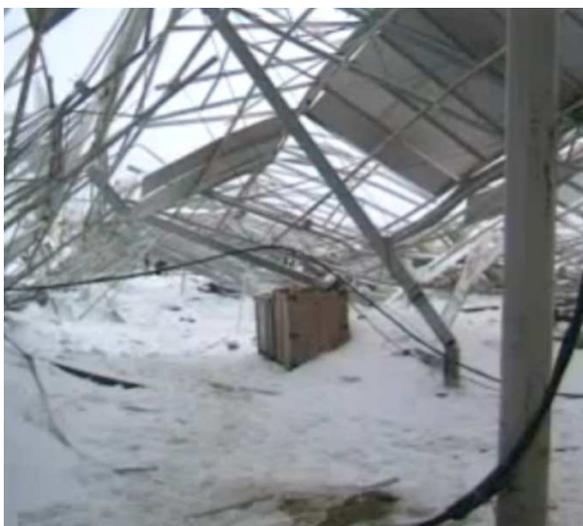
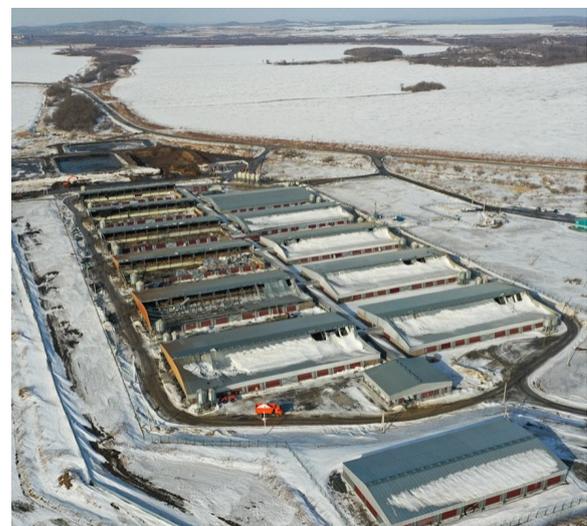
Figure 9. Consequences of the destructive impact of snow load: (a) An agricultural enterprise for growing roses, 2010. Photo from the site of Renzainform (https://www.penzainform.ru/news/incidents/2010/02/02/penzenskaya_oblast_poteryala_150_millionov.html (accessed on: 18 June 2021)). (b) The Mikhailovskoye pig farm, 2021. Photo from the VL News website (<https://www.newsvl.ru/society/2021/03/05/197518/> (accessed on: 11 March 2021)).

The largest building in terms of area, destroyed under the impact of snow loads over the past twenty years in Russia, is the greenhouse of an agricultural enterprise for growing roses (Figure 9a), located in the village of Mokshan (Penza region). A collapse with a total area of 30,000 m² (two greenhouses of 20,000 and 10,000 m² each) occurred on 01 February 2010. In addition to the partial destruction of the greenhouse itself, the specialized equipment and boiler room of the enterprise were damaged. The work covered an area of 75,000 m². The damage to the enterprise amounted to 4.9 million dollars (at the rate of exchange of 2010).

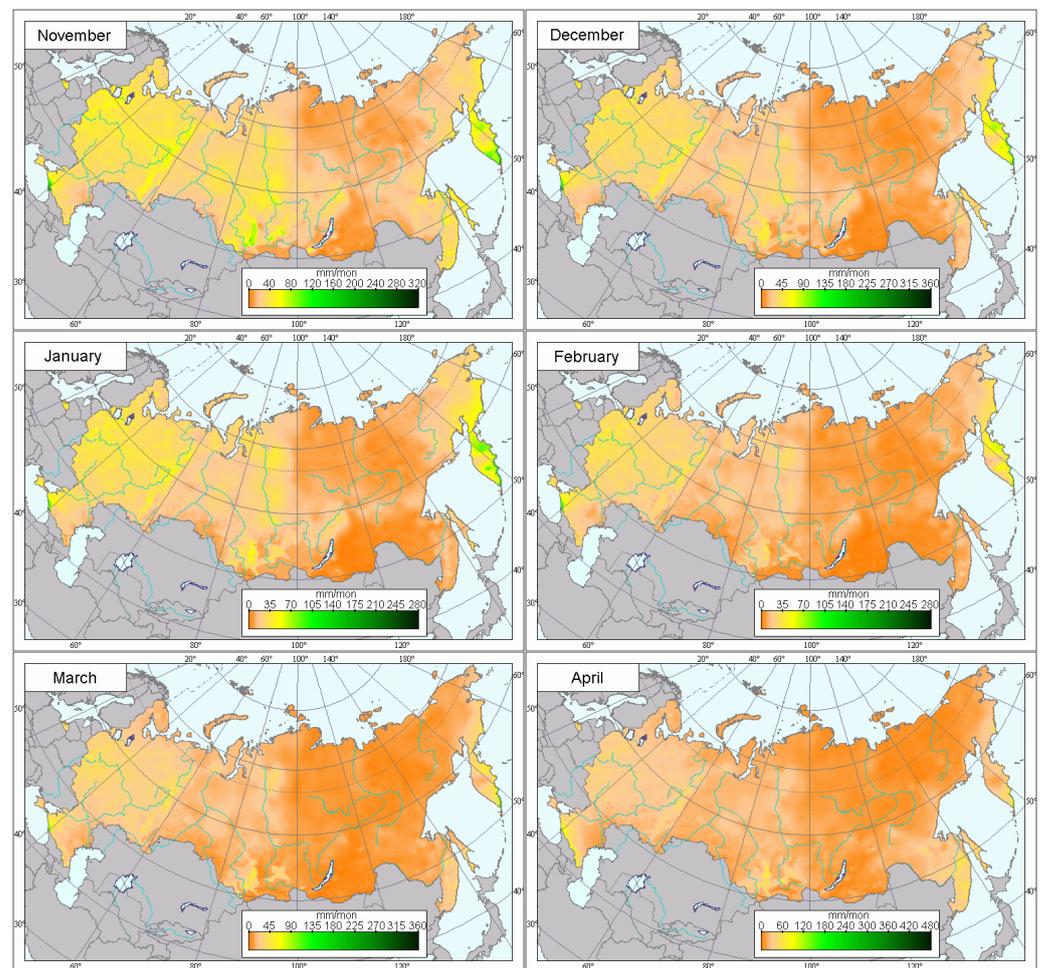
Figure A1. The monthly average precipitation values related to the studied period of the year, according to the data [16]. (The archives of meteorological data can be found in [17]).
