Article

Low Energy Renovation of Social Housing: Recommendations on Monitoring and Renewable Energies Use

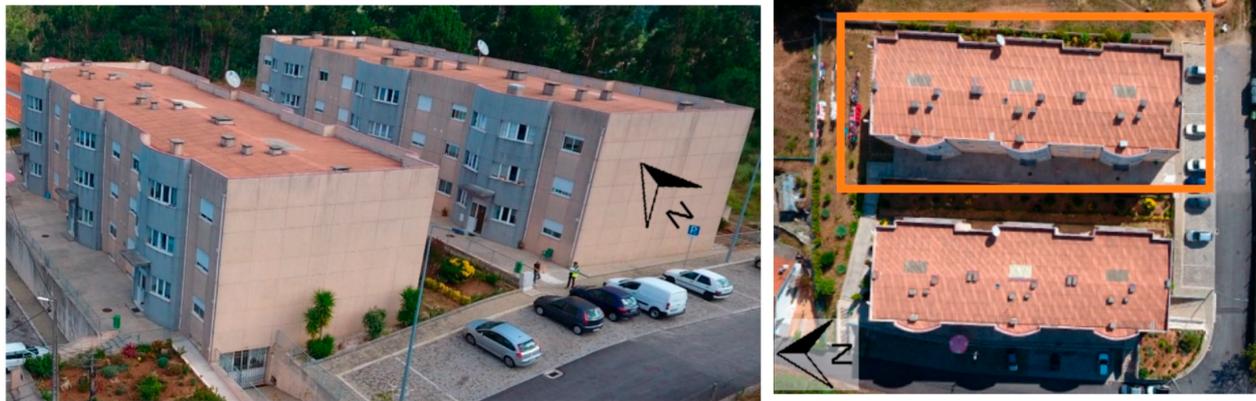
Figure 1. Aerial views of the studied social housing neighborhood.

The case study is a Portuguese small social housing neighborhood in the Municipality of Vila Nova de Gaia (Figure 1). The neighborhood, built in 1997, consists of two parallel buildings with three entrances each. Low-income households occupy all the 35 dwellings. Each building has three floors above the ground. Each entrance gives access to two dwellings per floor (six dwellings per entrance). In each floor, there is a two-bedroom apartment and a three-bedroom apartment.

The first phase of the planned renovation will only cover the building to the east, marked on Figure 1. The intervention covers 18 of the neighborhood dwellings.

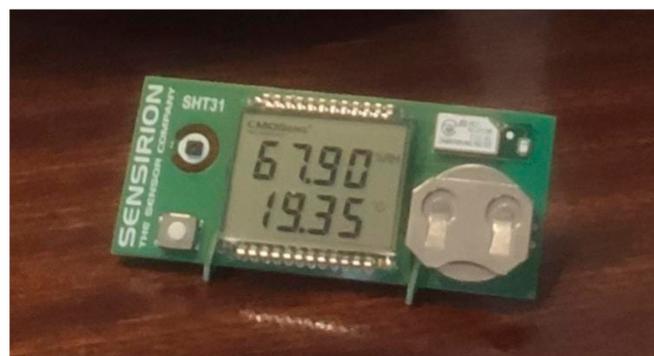
**Figure 2.** Equipment used for monitoring.

The type of sensor used for the monitoring campaign was the “Sensirion-SHT31 Smart Gadget Development Kit” (Figure 2), which is a sensor of relative humidity and temperature inserted in a simple reference circuit board, with approximately $3.3 \times 7.5 \times 0.5$ m³ and unit weight of 20 g. It can also communicate with an iOS or Android smartphone compatible with the available “My Ambience” application, via Bluetooth Low Energy (BLE). The device stores the measured values in the built-in memory and is powered by battery. The stored data can be downloaded to the application and exported. The temperature accuracy is ± 0.3 °C for a range of -40 to 90 °C, and for the relative humidity the accuracy is $\pm 2\%$ for 0% to 100%.

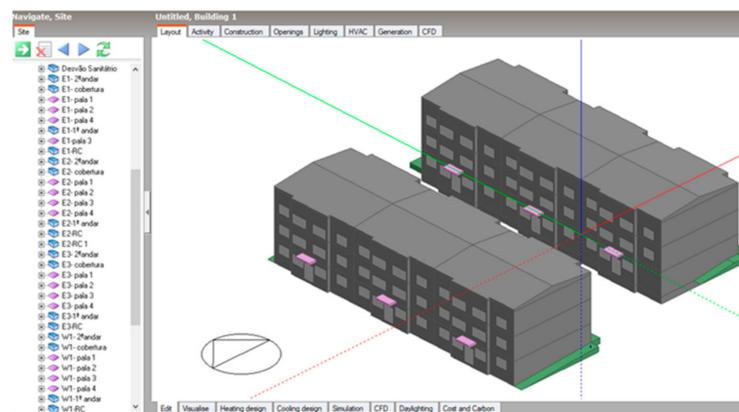
Figure 3. Modelling of the buildings of the studied neighborhood, from Design Builder.

After modelling the buildings, made easy by the software packages (Figure 3), and defining their occupation and type of use, based on the monitoring and survey data, the simulations were performed and validated, comparing their results to the values measured by the sensors.

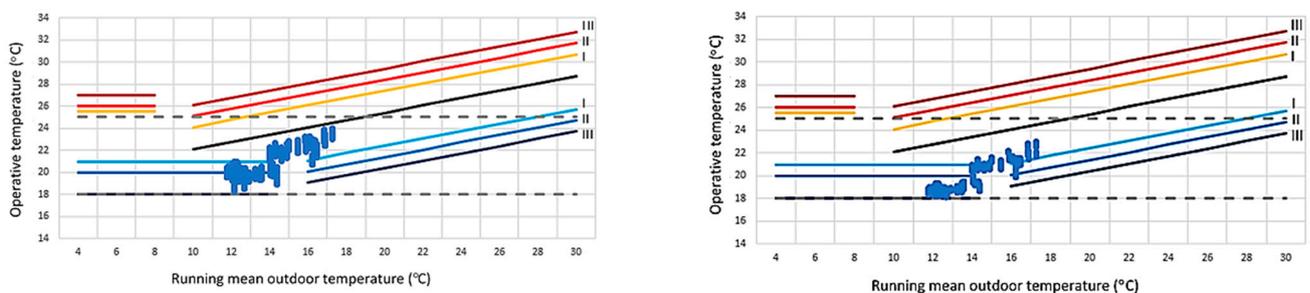
Figure 4. Thermal comfort analysis in dwelling N°5 according to EN-15251 [33]: (a) in the living room; (b) in the main bedroom.

According to Portuguese national regulation in the field of energy efficiency in residential buildings, Decree-Law n° 118 (2013) and subsequent Ordinances and Orders [32], a lower limit of 18 °C and an upper limit of 25 °C are considered as a reference, defining a comfort range of indoor temperatures. In the European Standard EN-16798-1 [30], for the cooling season, an adaptive model is suggested, and for the heating season, an analytical method is suggested, with constant values. In Figures 4 and 5, both approaches are shown.

The comfort analysis focuses on two dwellings, N°5 and N°6. These are interesting dwellings, since one is located beneath the roof and the other is overcrowded. The analyzed indoor spaces are the living room (LR) and the main bedroom (R1). The clouds of points in the graphs of Figures 4 and 5 display the pairs of running mean outdoor temperature and indoor temperature measured by the sensors, for the days from 8 April to 21 May. It should be noted that the data for only two months might not be sufficiently representative of the real comfort conditions of the buildings. However, since in the beginning of the measurement period, there were still a considerable number of cold days, and at its end, there were already several quite warm days, it was possible to identify the main trends.

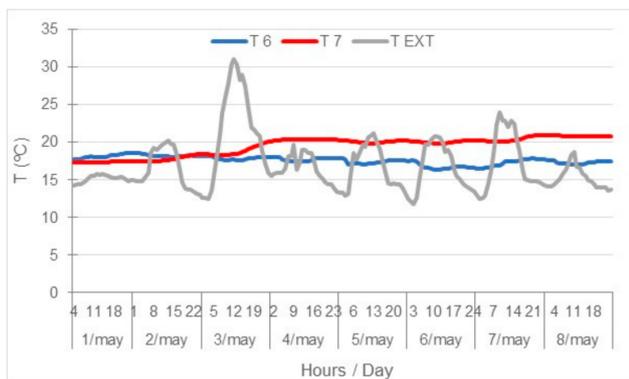
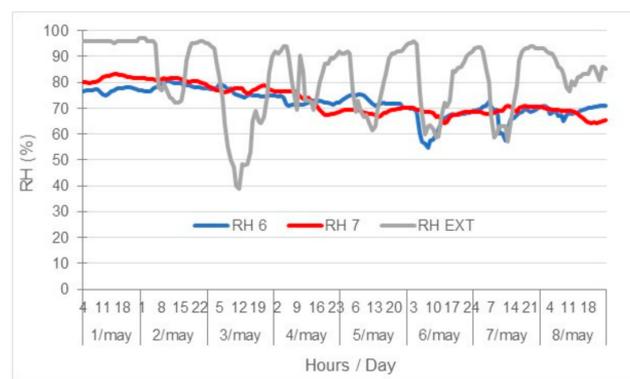
Figure 6. A May week comparison between an occupied dwelling (N°6) (blue curve), and a non-occupied dwelling (N°7) (red curve), concerning the conditions in the living room (LR): (a) temperature; (b) relative humidity.

The graphs of Figures 6 and 7 show the comparisons between the measured values of temperature and relative humidity obtained through the sensors, in the dwelling N°6 (blue curve) and N°7 (red curve), having as reference the outdoor temperature values (grey curve). The graphs for the living rooms (LR) and main bedroom (R1) are presented, with the values for a reference week (May 1 to 8) for better visualization of the results.

As could be expected, the occupied dwelling has a higher variation over time, in temperature and relative humidity, than the vacant dwelling. The presence of some visible peaks suggests moments where there was interference in the indoor climate and, since the biggest difference between the two dwellings is the presence of occupants, these variations can be attributed to their intervention. Another important observation is the considerable temperature difference in the R1 rooms. This difference, especially from the hottest day, May 3, may be attributed to the occupants' action, such as the use of solar protections that prevented the room of dwelling N°6 from heating up as much as N°7's.

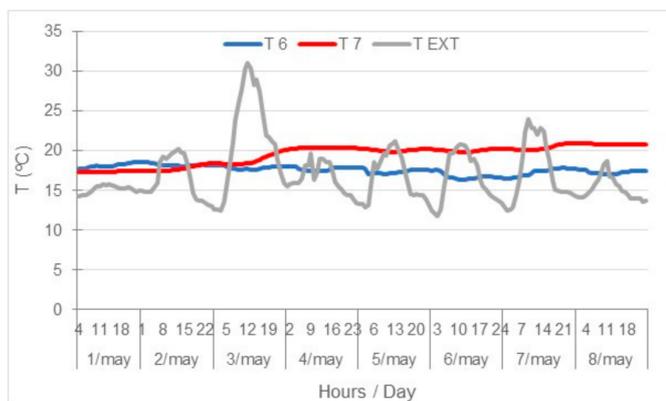
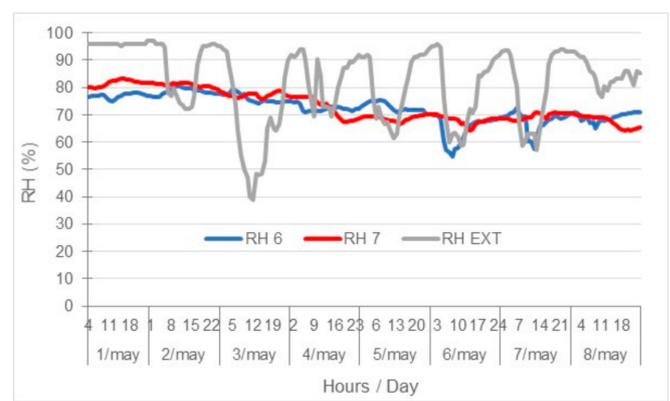
Figure 7. A May week comparison between an occupied dwelling (N°6) (blue curve) and a non-occupied dwelling (N°7) (red curve), concerning the conditions in the main bedroom (R1): (a) temperature; (b) relative humidity.

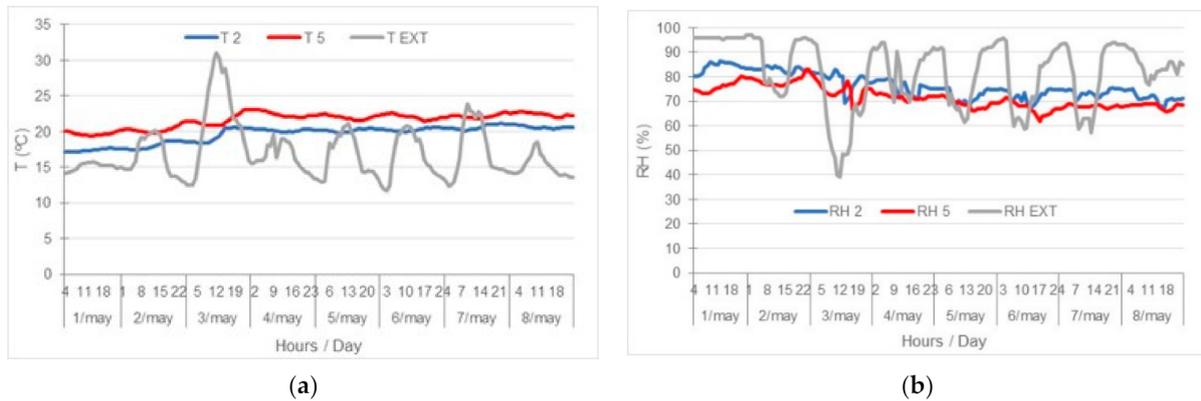
Figure 8. A May week comparison between a dwelling with one occupant (N°2) (blue curve) and a dwelling of the same size with five occupants (N°5) (red curve), concerning the conditions in the living room (LR): (a) temperature; (b) relative humidity.

Two other dwellings of interest are the N°2 and N°5, which, like the previous ones, are in the same position in the building but in parallel buildings. The particularity of these two dwellings refers to their occupancy; both are two-bedroom apartments, but the dwelling N°2 is under-occupied, having only one occupant, while the N°5 has five occupants. The graphs of Figures 8 and 9 show the comparison of the actual temperature and relative humidity, for a reference week (May 1 to 8), between the two dwellings. The overcrowded dwelling has always higher indoor temperatures than the N°2 dwelling, with a maximum difference of 2.9 °C and a minimum difference of 0.7 °C, for the LR, and a maximum difference value of 2.0 °C and minimum of 1.0 °C, for R1. This difference can be attributed to the different ventilation rates and times and occupation density, showing the influence of the different occupation styles.

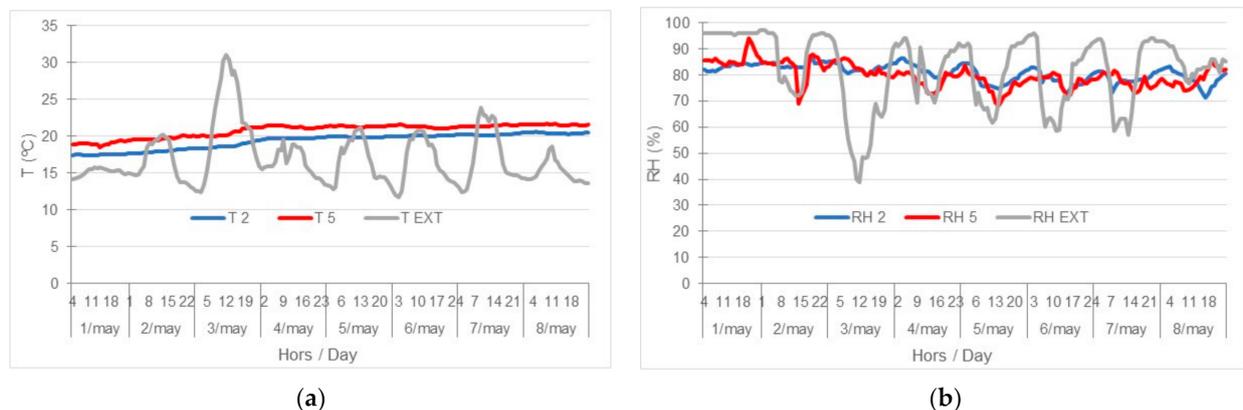
Figure 9. A May week comparison between a dwelling with one occupant (N°2) (blue curve) and a dwelling of the same size with five occupants (N°5) (red curve), concerning the conditions in the main room (R1): (a) temperature; (b) relative humidity.

The two presented cases demonstrate the discrepancy that can occur in the indoor conditions of a dwelling, depending on the type of occupation and use. As such, they justify the importance of simulations that consider the influence of the occupants.

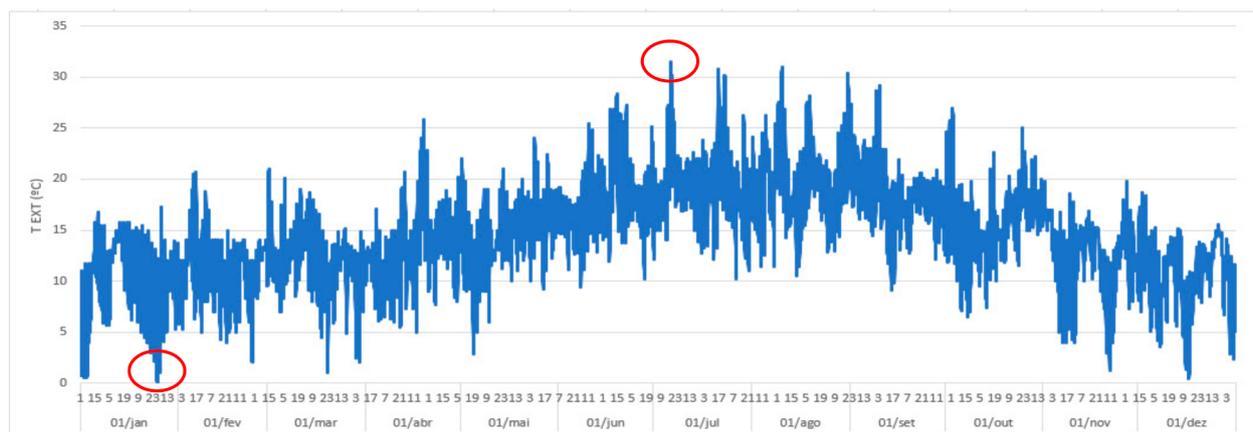
Figure 11. Outdoor temperature for the reference year.

To simplify the presentation of the results, two reference weeks are selected, where the highest and lowest outdoor temperature occur, for the cooling and heating season, respectively. Thus, the days chosen are from 25 January to 1 February and from 6 to 12 July, since they include the two peaks shown in Figure 11.

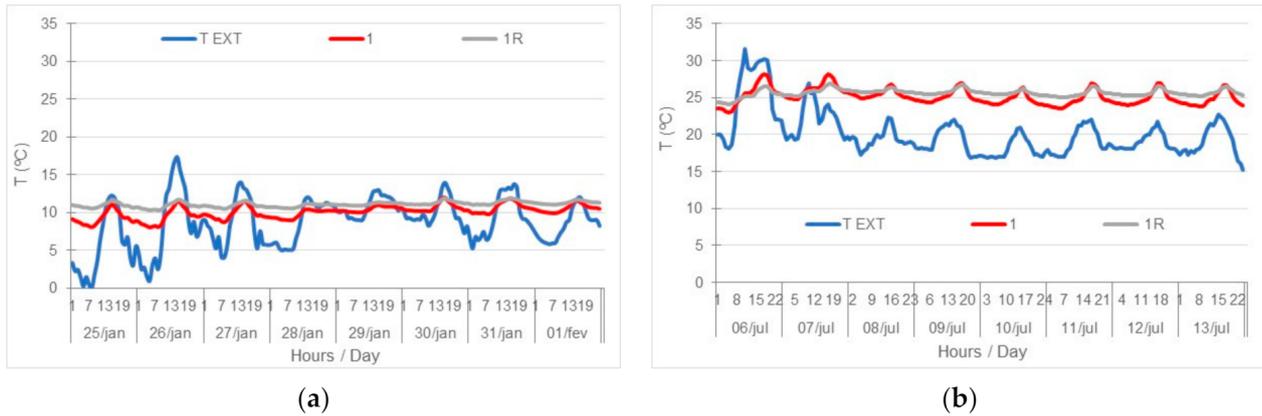
Figure 12. Comparison between temperatures before (red curve) and after (grey curve) renovation in dwelling N°1: (a) January; (b) July.

The graphs with the comparisons for the reference weeks are shown in Figures 12–14. In the reference week of the heating season, there is a significant improvement of the thermal performance of the building. For the dwellings N°1, N°2, and N°6, there is a maximum temperature increase of 2.5, 3.0, and 3.5 °C, and average temperature increase of 1.0, 1.0, and 1.5 °C, respectively. However, in the cooling season, for dwellings N°1 and N°2, there was a slight rise in temperature, which, in this case, is unfavorable, since it increases the risk of overheating. In the cooling season, the increase in maximum temperature recorded before and after renovation is 1.5 °C for the dwelling N°1 and 1.7 °C for the dwelling N°2. Regarding the N°6 dwelling, the planned renovation measures also result in an improvement of its thermal performance in the cooling season, with a maximum temperature reduction of 2 °C. This improvement in the dwelling N°6 was expected, since this dwelling in its original conditions has quite high thermal gains through the roof in summer and, therefore, with the roof insulation, a great reduction of these gains is achieved.

In Figures 12–14, it can be seen that, for the free-floating simulation, post-renovation temperature values do not comply with the upper limit value (25 °C), nor with the lower limit value (18 °C), suggested as reference by the Portuguese regulation [32]. This means that simple renovation measures alone do not guarantee adequate comfort levels, although they improve indoor thermal conditions. It is important to note that the presented results correspond only to two extreme weeks of winter and summer. In many other periods during the year, comfort may be achieved through passive measures. Particular attention needs to be paid to summer comfort, since the application of thermal insulation increases the risk of overheating in some dwellings. However, there are ways of compensating that increase, such as improving night ventilation.

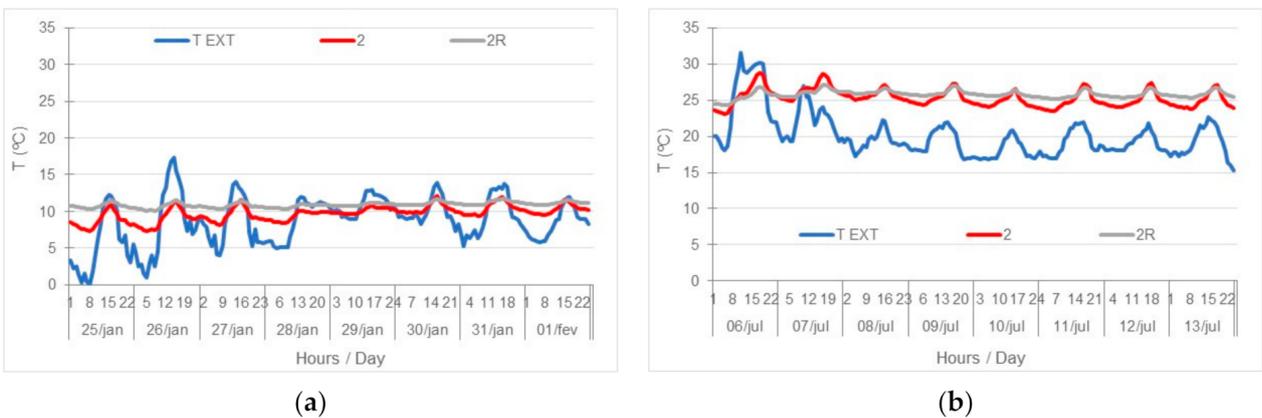
Figure 13. Comparison between temperatures before (red curve) and after (grey curve) renovation in N°2: (a) January; (b) July.

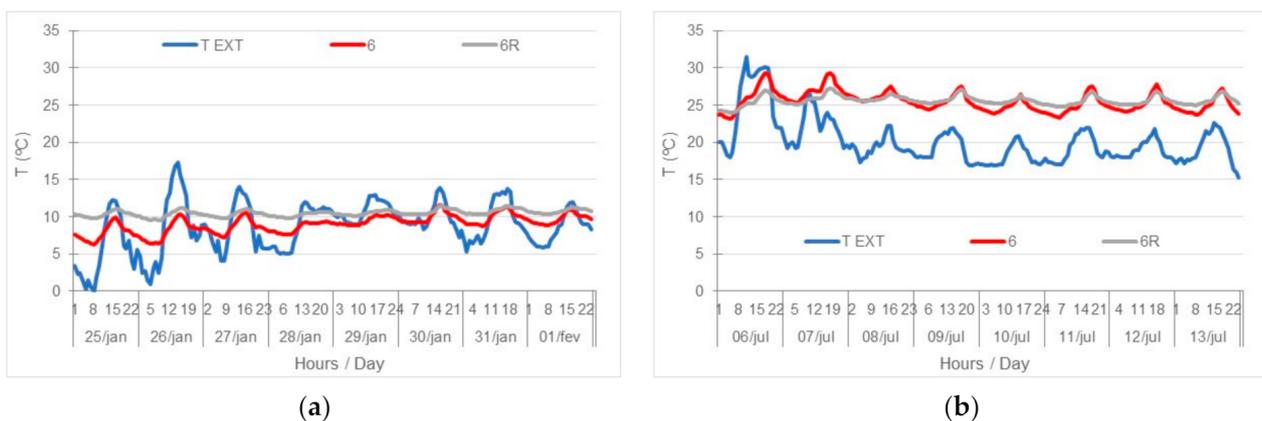
Figure 14. Comparison between temperatures before (red curve) and after (grey curve) renovation in N°6: (a) January; (b) July.

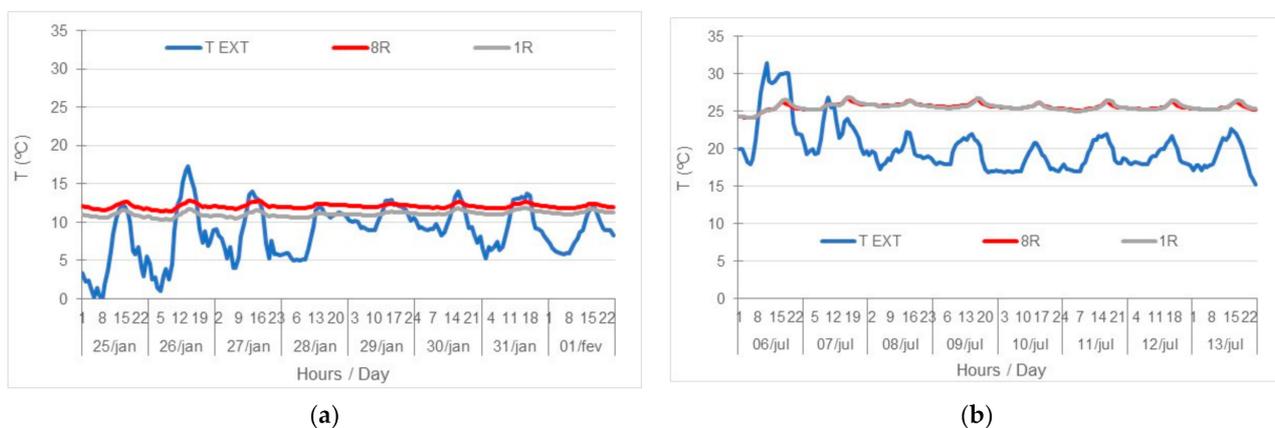
Figure 15. Comparison between temperatures in dwellings N°1 (grey curve) and its opponent (red curve): (a) January; (b) July.

By analyzing the resulting graphs (Figures 15–17), it can be concluded that the most vulnerable entrance is the one with the “blind facade” facing North in winter; this means its dwellings are colder than the ones of the southern entrance, in the heating season. Dwellings N°1, N°2, and N°6 have on average temperatures lower 1.0, 1.2, and 1.3 °C, respectively. In the cooling season, there are no significant differences between the two sets of dwellings, as could be expected.

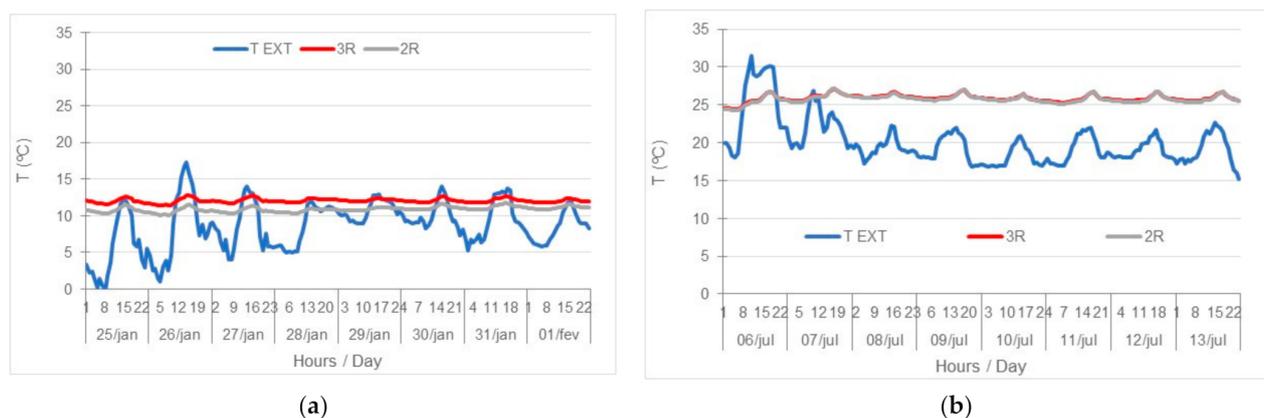
Figure 16. Comparison between temperatures in dwellings N°3 (red curve) and N°2 (grey curve): (a) January; (b) July.

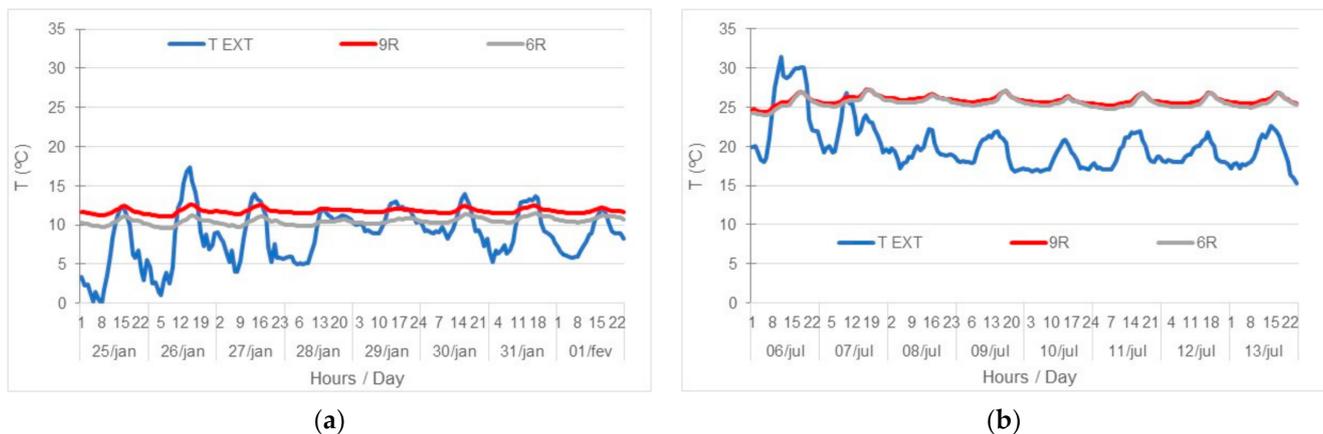
Figure 17. Comparison between temperatures in dwellings N°6 (grey curve) and its opponent (red curve): (a) January; (b) July.

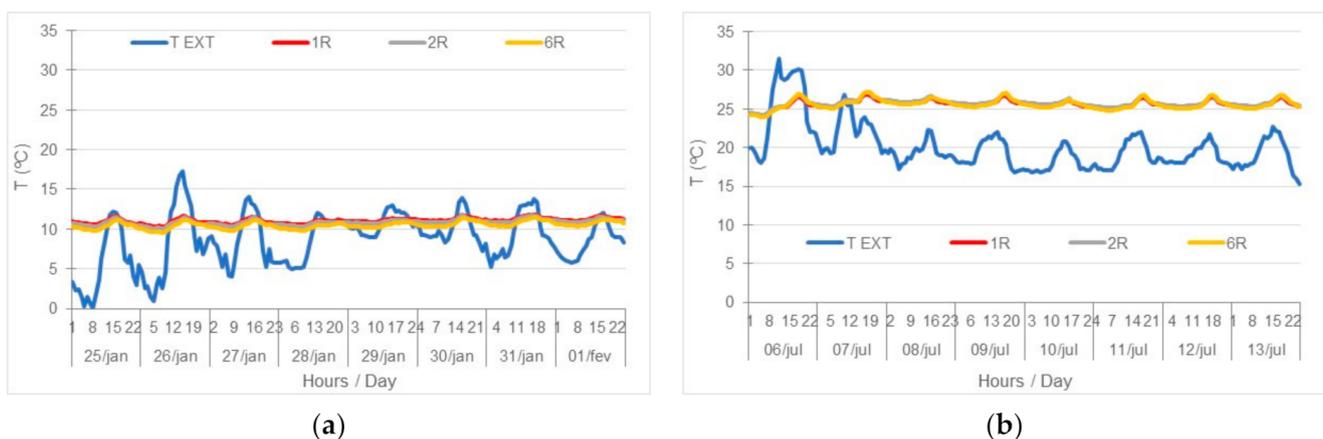
Figure 18. Comparison between temperatures in dwellings N°1 (red curve), N°2 (grey curve), and N°6 (yellow curve): (a) January; (b) July.

Examining the graphs, in the heating season, the N°6 dwelling is the most critical, having the lowest temperatures, and this can be explained by the higher thermal losses through the roof, since this dwelling is located immediately beneath the roof. Regarding the cooling season, all dwellings behave similarly, in spite of the heat gains through the roof in N°6, because, after renovation, those gains are very much reduced (Figure 18).

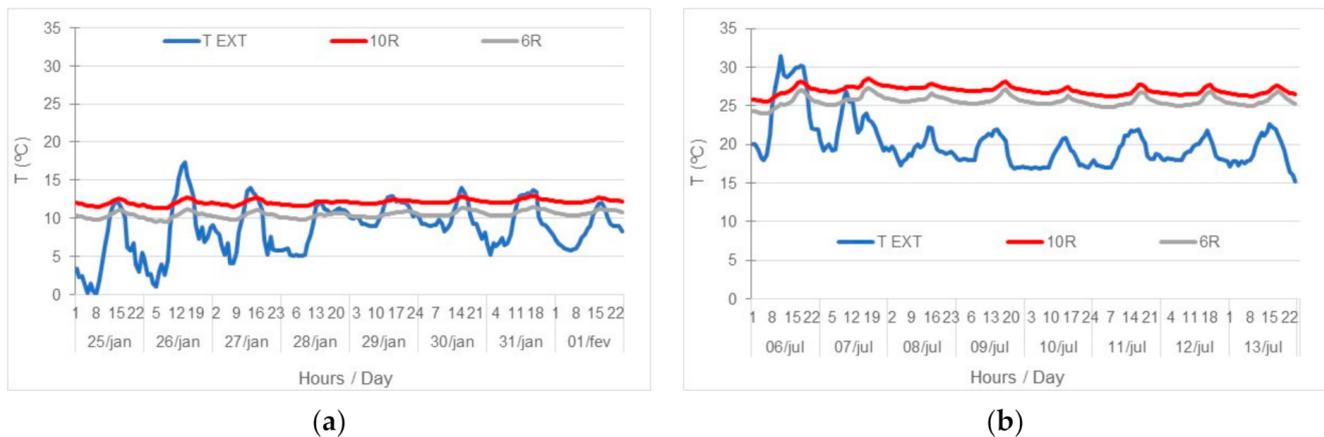
Figure 19. Comparison between temperatures in dwelling N°6 (grey curve) and the least exposed dwelling (red curve): (a) January; (b) July.

The graphs of Figure 19 show that the least exposed dwelling is warmer in both seasons, with a maximum temperature difference of 1.8 °C and an average difference of 1.6 °C in the heating season and 1.7 and 1.4 °C, respectively, in the cooling season, being a dwelling with a higher risk of overheating in the post-renovation. Since overheating is

In the post-renovation period, the dwelling N°6 will be the most critical dwelling in the heating season, and the least exposed one (N°10) will be the least critical one in the heating season but somehow problematic in the cooling season.

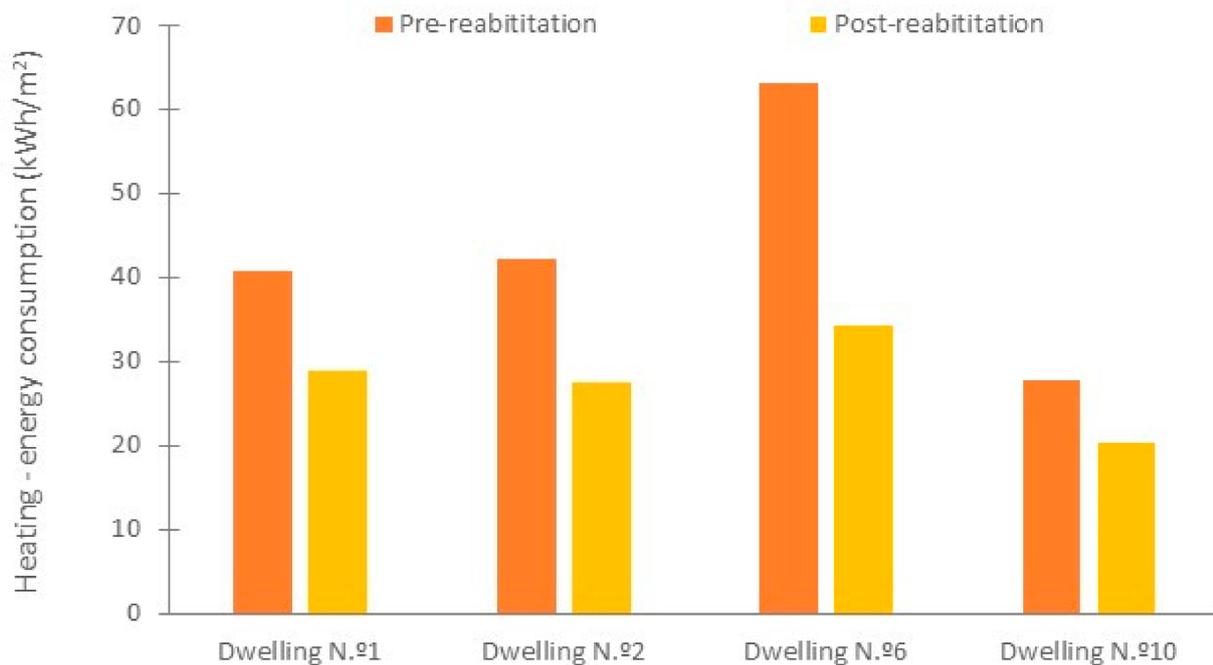
Figure 20. Energy consumption of the heating system in the dwellings number 1, 2, 6, and 10 in kWh/floor area.

Figure 20 shows the energy consumptions with heating of the dwellings N°1, N°2, N°6, and N°10, considering the pre- and post-renovation scenarios. In line with the observation in the previous section, it is possible to see the vertical location in the building influence on the energy consumption of the dwellings. Since one of the renovation actions was the thermal insulation of the attic, the dwelling N°6 was the one with the most evident decrease in heating energy consumption after the renovation. Dwelling N°10, as it is the dwelling located in the most favorable location of the building in the heating season, had the lowest change, in percentage, with the renovation.

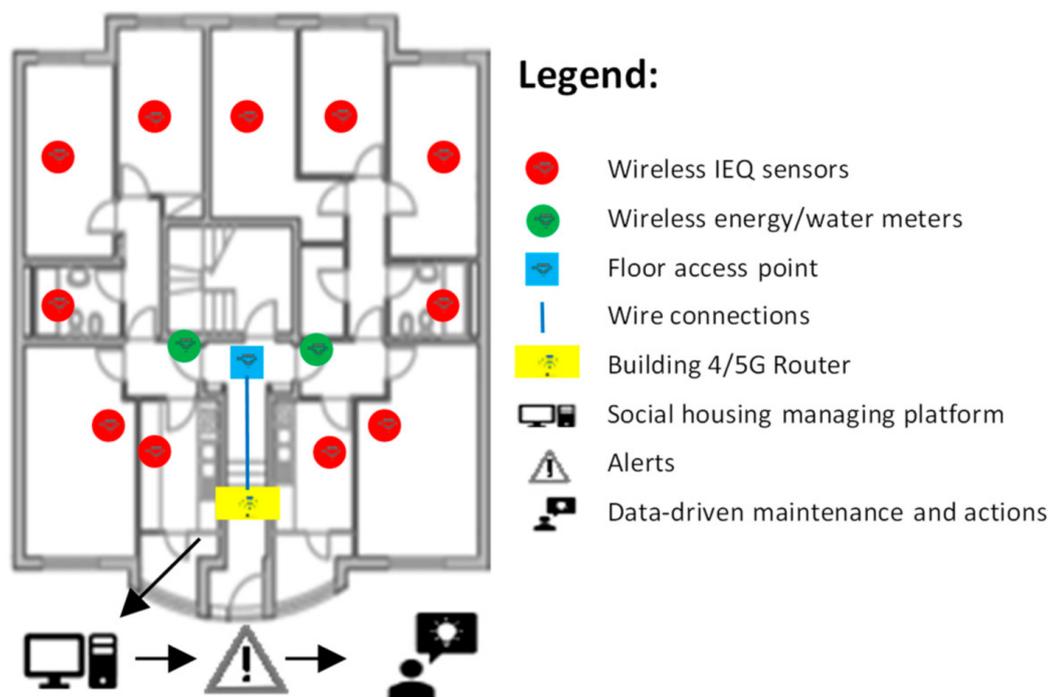
Figure 21. Proposed monitoring system architecture.

The proposed monitoring system architecture is based on individual devices with sensors of temperature and relative humidity in every room. The knowledge discovered from each sensor differs from the room type. It could be used to determine thermal comfort in the main room and the risk of condensation and health-related risks in all the compartments. The system architecture proposal is represented in Figure 21. The individual sensors should be wirelessly linked with an intermediate access point that should be connected to a router that sends the data to a cloud data warehouse. To reduce the internet services costs, it is possible to use only one router per building and intermediate access points wired to it. A platform should be created to access the data stored and constantly analyze the data in real-time. The advantage of this methodology is to have multidisciplinary alerts, given the thresholds as reference values, notifying the operator if outlier values are being registered. The advantages of this solution would be the possibility of accessing information whenever necessary, controlling errors almost immediately, and less disruption to occupants due to less frequent visits. The future renovation design will also be more data-driven, and the maintenance operations could be more predictive. A

disadvantage would be the energy consumption of the sensors that should be connected to the electrical network. However, the energy consumption of temperature and relative humidity sensors mounted on an Arduino platform is very low ($\ll 1$ Wh). On the other hand, this architecture allows continuous monitoring without visiting the interior of the dwellings and makes possible the inclusion of another type of sensors, with higher energy consumptions. The inclusion of these sensors is not possible with an energy supply guaranteed by batteries, and these sensors could be used to increase the knowledge on IEQ like CO₂, PM_{2.5}, and TVOC sensors [24,35]. It is also important that the energy and water consumptions of each dwelling are measured by energy/water meters, and the information should be supplied to the intermediate access points of each floor.
