# Transition and Transformation of a Rural Landscape: Abandonment and Rewilding

**Citation:** Ellis Burnet, J.; Ribeiro, D.; Liu, W. Transition and Transformation of a Rural Landscape: Abandonment and Rewilding. *Sustainability* **2021**, *13*, 5130. <https://doi.org/10.3390/su13095130>

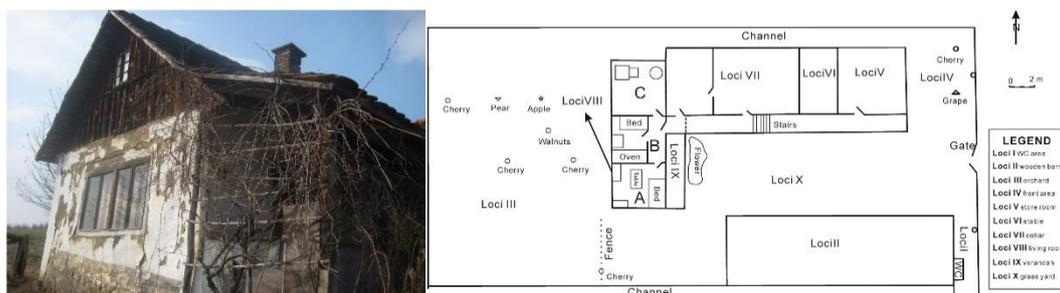
**Figure 2.** (Left) The condition of the abandoned Site 1 (Photograph: Wei Liu). (Right) The plan of the farmstead at Site 1.

The farmstead and barn belonging to Site 1 (Figure 2) are clustered and oriented north–south, with an eastern aspect. The kitchen is the central room, with a brick and tiled fireplace occupying almost the entire length of the southern wall. A single window is located in the center of the west wall, providing a view of the orchard. The southern room is a day room/dining room with simple, rustic furniture and utensils. A large window faces south and a smaller window opens onto the eastern veranda. The northern room is partially below ground level, and has an earthen floor and a small east-facing window. The room was apparently a wine-making and storage cellar. A ladder leads to the attic area above.

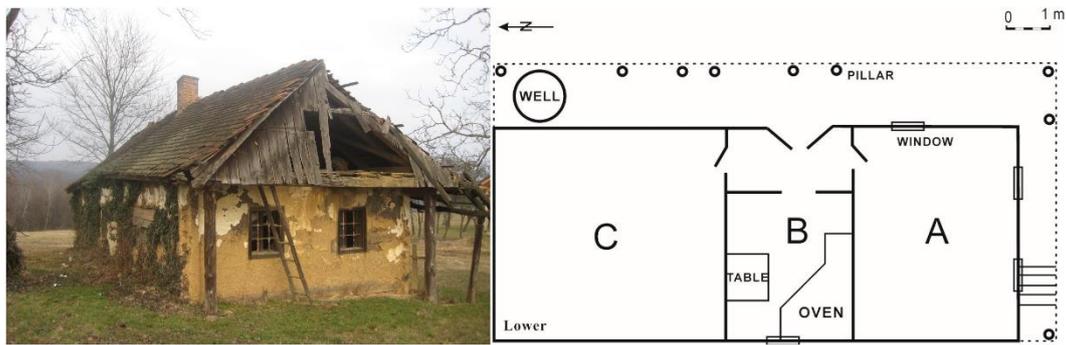
**Figure 3.** (Left) The condition of the abandoned Site 2 (Photograph: Wei Liu). (Right) The plan of the farmstead at Site 2.

The farmstead of Site 2 (Figure 3) consists of three rooms: a centrally located kitchen with a very low doorway, to the south a square room with two windows to the south and one to the east, and a northern cellar/storage or workroom with a very small, light opening without glazing in the eastern wall. All of the floors are of beaten earth with an irregular surface. It has a low gable roof with an attic, which previously had two small north and south windows, the remains of which are in the attic. A veranda runs along the eastern side of the building with roughly carved veranda posts and finer carved roof beams. A lintel light is positioned above the twin-paneled wooden front door. The horizontal wall planks had been filled with abode, a clay-water-straw mixture, and covered thickly with the same material and painted with lime paint. An outside ladder leading to the attic is attached to the south wall. A covered well is located under the veranda roof at the northern end.

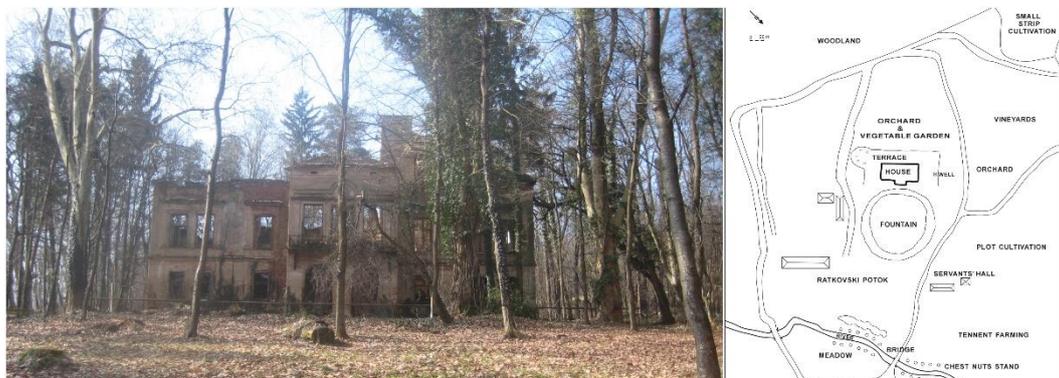
**Figure 4.** (Left) The condition of the abandoned Site 3 (Photograph: Wei Liu). (Right) The plan of the Manor at Site 3.

Double-panelled wooden doors lead into an entrance hall at Site 3. Six ground floor rooms face the front of the building. At the eastern end of the ground floor is a doorway directly facing the well. A wide central hallway with marble terrazzo flooring runs through the middle of the building, separating the reception rooms from the living quarters [33].
