Recovery Assessment of Permanent Housing after the 2004 Tsunami in Thailand toward Sustainable Planning

Abstract: In this study, a recovery assessment of the permanent housing and living conditions in the aftermath of the 2004 Tsunami in Phang-nga Province, Thailand, was conducted using geoinformatics technologies, field observations, and living-related parameters from basic minimum need (BMN) data retrieved from the Ministry of Interior. In the results, 29 permanent housing projects were mapped, classified into five sizes (very small, small, medium, large, and very large), and overlaid with the tsunami-inundated zone visually interpreted from satellite images. Thirteen out of twenty-nine projects were reconstructed in the inundation zone (in situ), while the rest were relocated to higher ground. Permanent houses were rebuilt in 18 communities in three patterns: single-story or one-story houses (511 houses), single-story and raised-basement houses (58 houses), and two-story houses (712 houses). The selected BMN's living-related parameters, such as sufficient water for household consumption (dimension: dwelling), employment of people between 15 and 60 years old (dimension: economy)

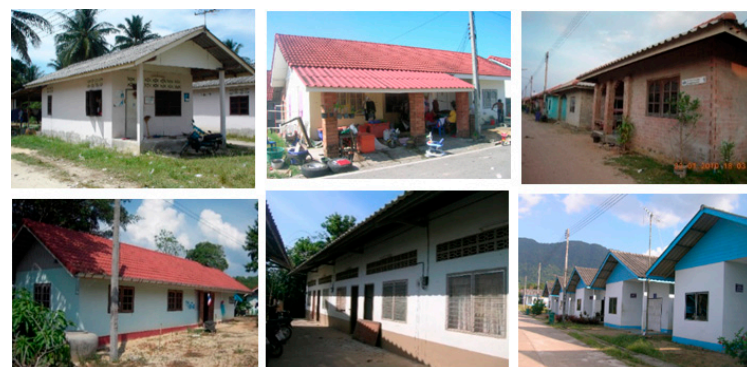
**Figure 2.** One-story houses in the study area.

There were 511 one-story houses reconstructed in 12 projects: 125 units under five projects (Tub Tawan 1, Ruamsuk Tawee Sup Munkong, Lam Prakarang, Muang Mai, and Town House Ban Thung Ong) were reconstructed in the exact same locations, while 386 units under seven projects (Pui Pornthip, Krung Sri Bang–Pun In-see, Kachad–Pru Teow, Por Tek Tueng, Ruam Mue Ruam Jai, Ruam Jai–Surat Thani, and Thepparat) were built in new locations. Some patterns of the one-story house are presented in Figure 2.

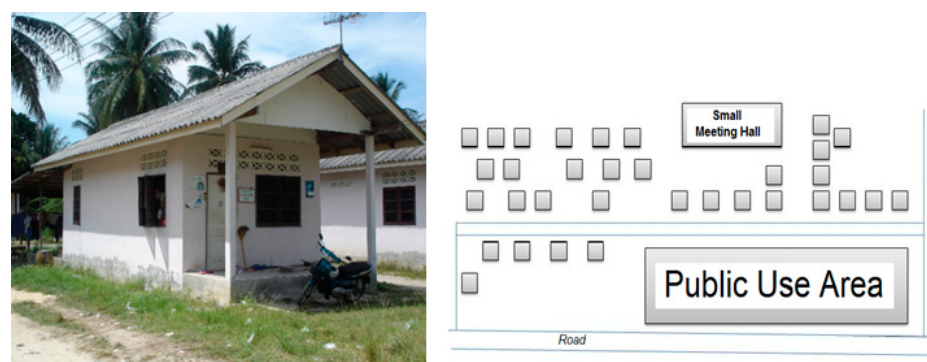
**Figure 3.** One-story house and layout of the permanent houses in Tub Tawan 1.

Figure 3 presents the patterns of one-story houses and the layout reconstructed for the project, namely, Tub Tawan 1.

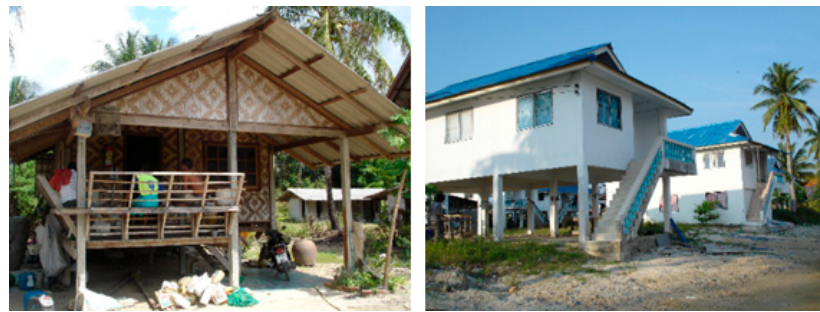
Figure 4. Single-story and raised-basement houses in the study area.

We found four projects (Tub Tawan 2, Koh Kor Khao Pier 1, Koh Kor Khao Pier 2, and Thung Tuek) that reconstructed 58 raised-basement houses in the same locations for most of the Moklen or local tribes along the Phang-nga coast. Figure 4 presents the patterns of the raised-basement houses built for tsunami victims.

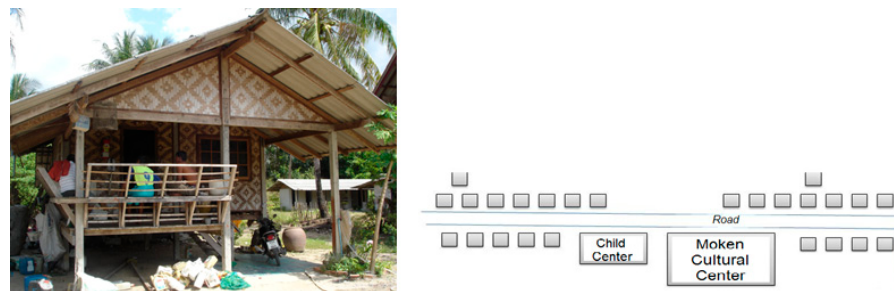
Figure 5. Single-story and raised-basement houses and layout of the permanent houses in Tub Tawan 2.

In Figure 5, new houses in Tub Tawan 2 were reconstructed in a parallel-lines layout. The pattern of houses was adopted from the destroyed houses, after consulting with the Moken in this area. Single-story and raised-basement houses were also reconstructed in Thung Tuek, Koh Kor Khao Pier 1, and Koh Kor Khao Pier 2. No single-story or raised-basement houses were reconstructed in any other reallocated areas.

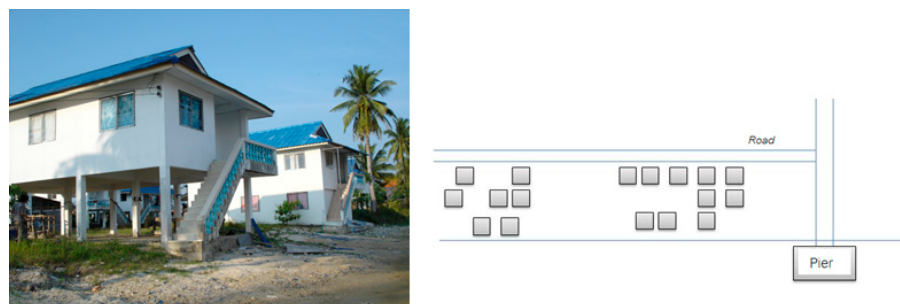
Figure 6. Raised-basement houses and layout of the permanent houses in Koh Kor Khao Pier 1 and Koh Kor Khao Pier 2.

Based on our observations, the single-story and raised-basement houses reconstructed projects in Tub Tawan 2 and Thung Tuek have a narrow gap between the ground and the first floor, so adjustments or modifications to the basement in these locations was limited. Unlike the single-story and raised-basement houses reconstructed near Koh Kor Khao Pier, which have a higher space between the ground and the first floor, some houses had their basements modified to create a larger living space, as shown in Figure 6.

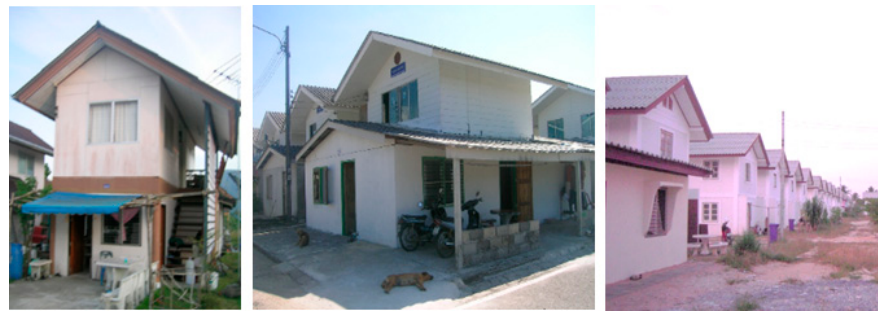
Figure 7. Two-story houses in the study area.

Sai) were reconstructed in new locations. Figure 7 presents some patterns of the two-story houses built in the study area.

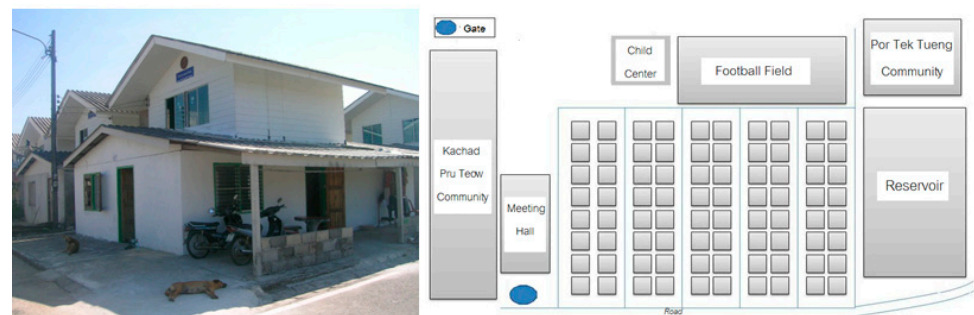
Figure 8. Two-story houses and layout of the permanent houses in Rotary Pru Teow.

Figure 8 presents the patterns of two-story houses and the layout reconstructed for the project, namely, Rotary Pru Teow.

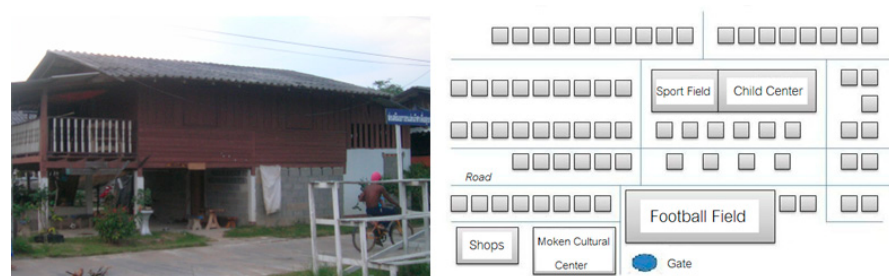
Figure 9. Two-story houses and layout of the permanent houses in Moklen Ban Thung Wah.

A similar pattern for houses in Bang Kaya was found in other projects, such as Rotary Pak Wip, Sutthachon, Rotary Lam Pee, Rotary Tub Pla, and Nam Sai (with a larger front porch and more space than the others). The pattern of the houses in Moolanithi Chaipaana–Kachad–Suppanimitre and Moolanithi Chaipattana–Kachad looked similar. The houses reconstructed in these projects had a larger living space than the others. However, the new pattern of two-story houses built in parallel lines (see Figure 9) was not familiar to nor did it fit with the lifestyle of Moklen Ban Thung Wah. The layout of the houses was not conducive for people to manage their usual cooking space and lifestyle and did not consider the natural environment for comfortable living. In addition, the arrangement of dwellings had blocked the wind flow in summer [30].
