# Internet-of-Things-Based Geotechnical Monitoring Boosted by Satellite InSAR Data

IoT-Based Geotechnical Monitoring Boosted by Satellite InSAR Data.

## 3. Case Study: Gediminas Castle

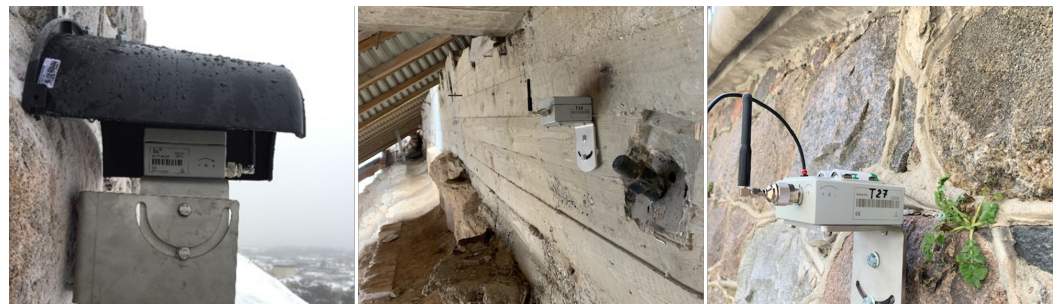
**Figure 6.** Gediminas Castle tiltmeters installation examples. Courtesy of GPS Partneris.

The tiltmeters are installed on the walls of the castle, at the top and at the bottom of the hill, and some installation examples are displayed in Figure 6.

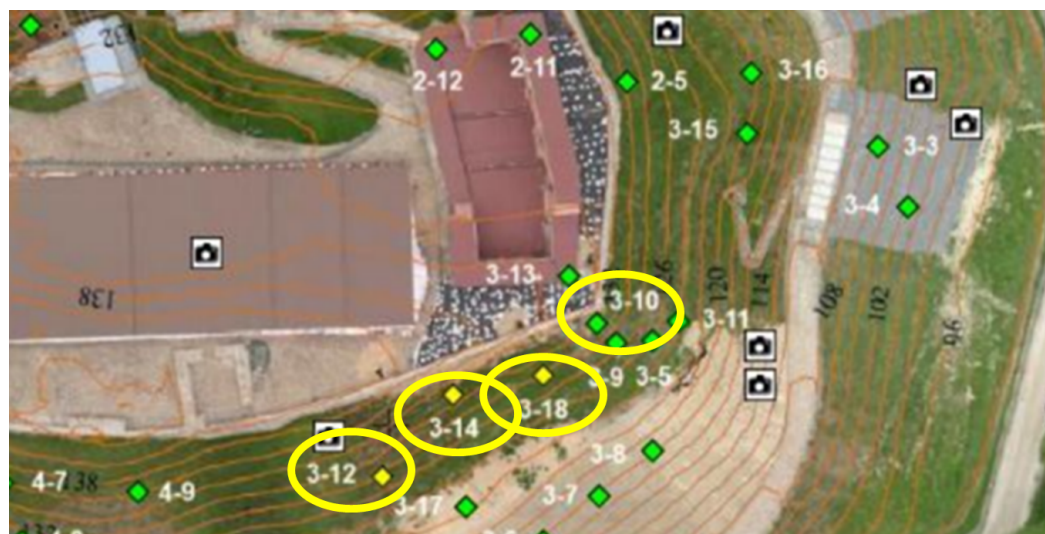
**Figure 7.** Location of the total stations that detected the incident highlighted in yellow.

The movement was detected by the prisms highlighted in Figure 7.

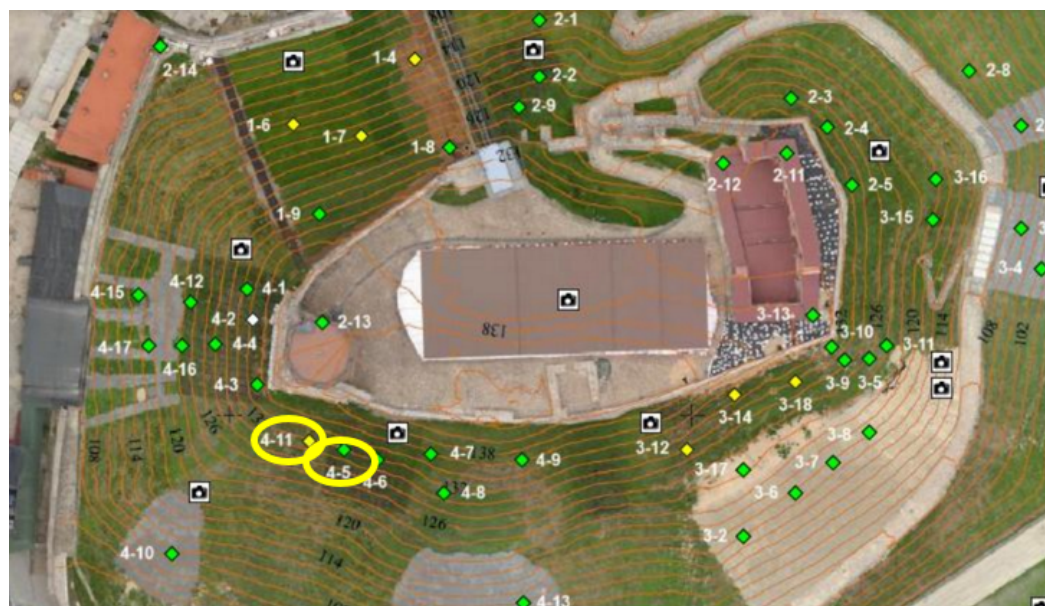
**Figure 13.** Total station prisms' locations that detected the July 2020 event.

The movement was detected by the prisms highlighted in Figure 13, whose measurements are displayed in Figure 14.

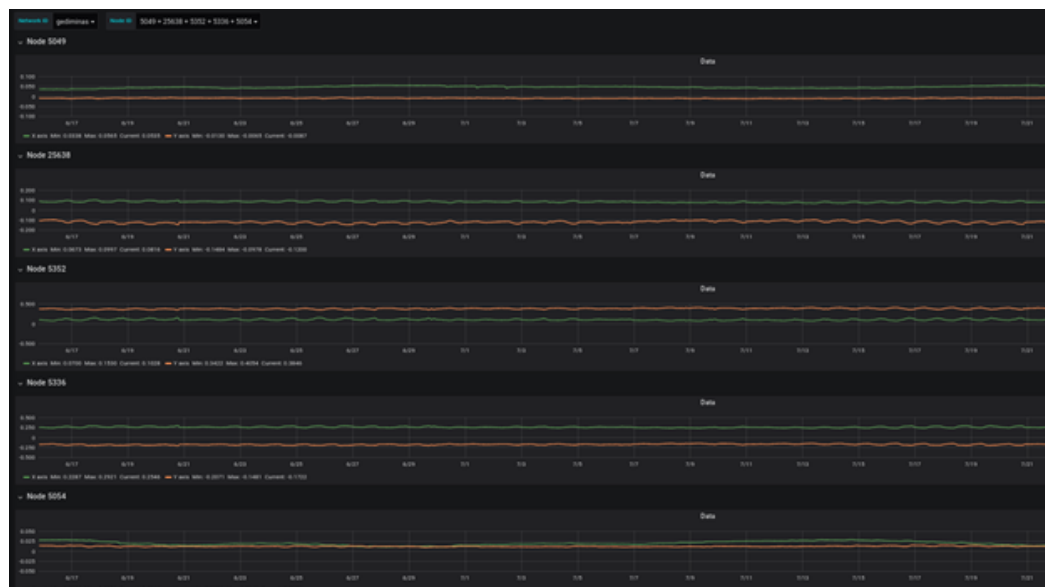
**Figure 15.** Tiltmeters data in the region of interest during the July 2020 event.

Figure 15 presents the results of the Loadsensing tiltmeters located in the region of interest of the event. No significant displacements were observed during July 2020 by any of the tiltmeters.
