# Laser Scanning Investigation and Geophysical Monitoring to Characterise Cultural Heritage Current State and Threat by Traffic-Induce Vibrations: The Villa Farnesina in Rome

**Keywords:** terrestrial laser scanning; geophysical monitoring; cultural heritage; traffic-induced vibrations; Raphael's frescoes; Villa Farnesina; Lodge of Galatea

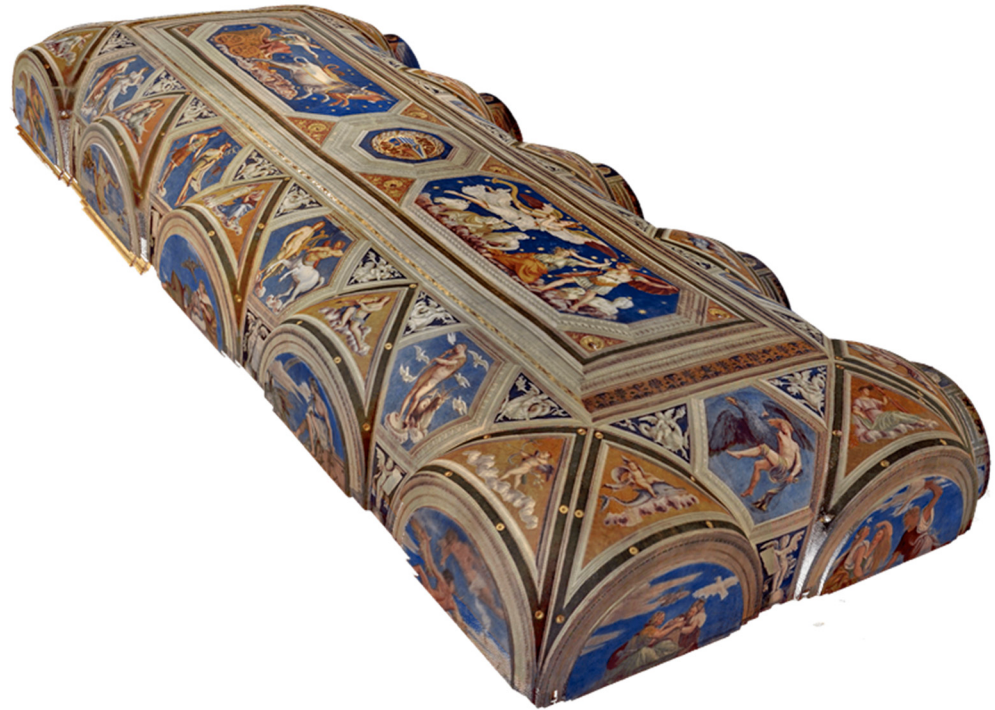
Figure 3 shows the vault through the arrangement of all point clouds. However, the point clouds were analysed singularly, as seen the results reported in the figures shown in the next section, in order to both avoid introducing errors due to their alignment and effects on the images due to the variability of the natural light conditions.

**Figure 3.** 3D reconstruction of the Lodge of Galatea through the alignment of six point clouds.

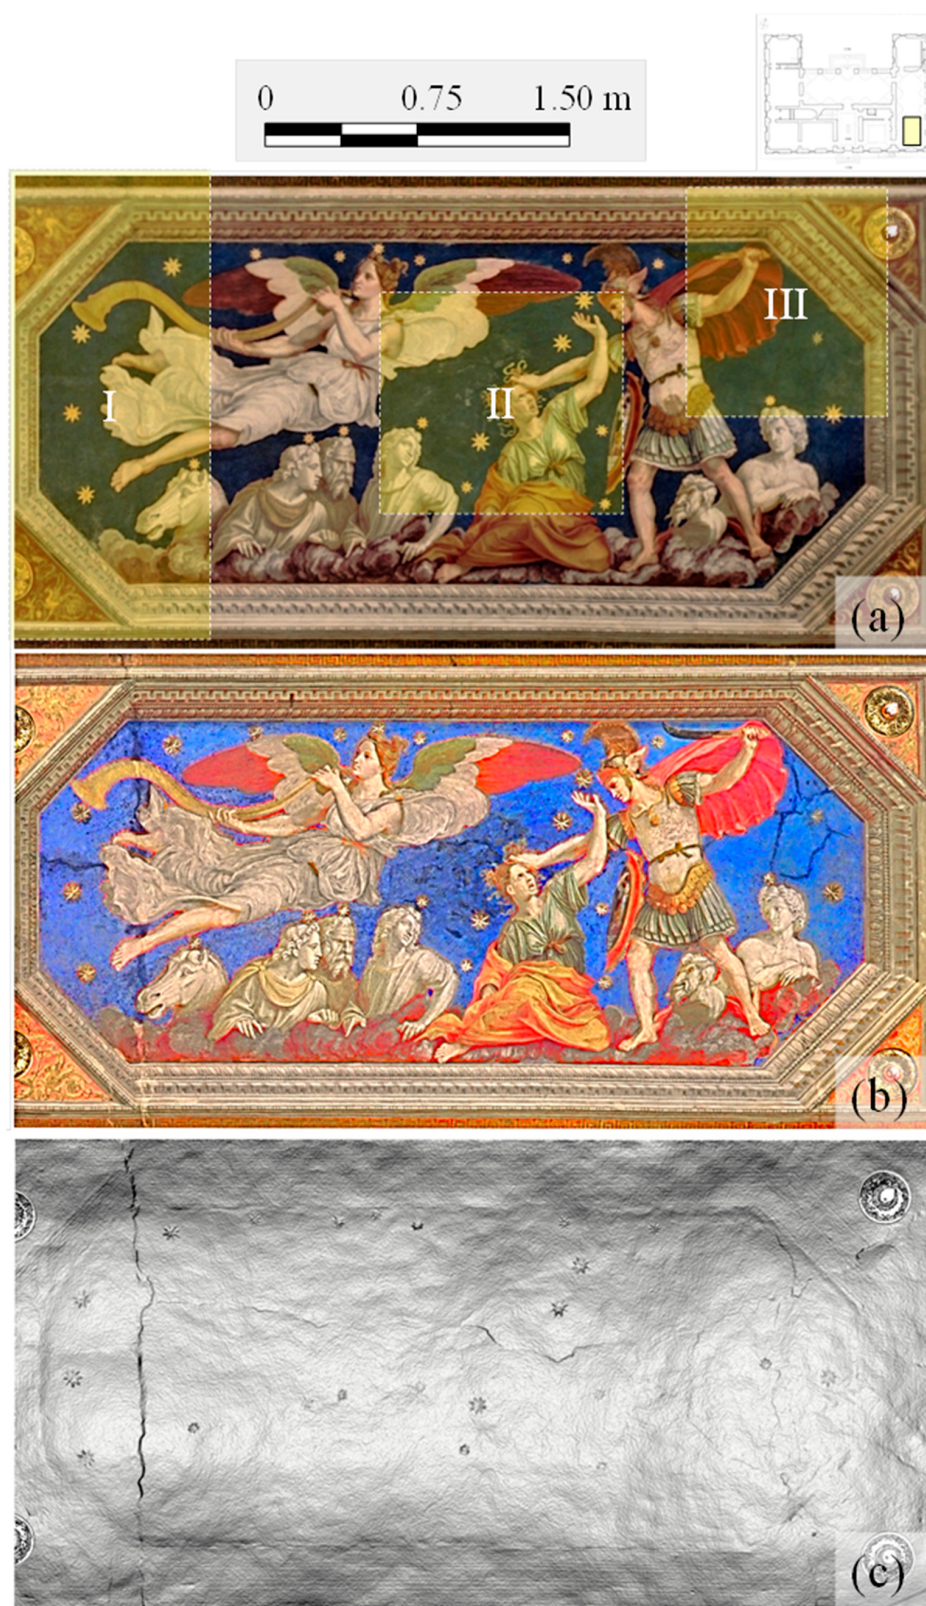
The 3D model of the Lodge of Galatea allows for the detection of crack signs and alteration in the plaster on the entire vault. By analysing the two frescoes, which feature Elice (Figure 8) and Perseus and Medusa (Figure 9) and cover a large part of the upper area of the vault, these signs are difficultly detectable with the naked eye or through non-professional pictures, as well as by the 3D-coloured model (cf. Figures 8a and 9a). Instead, cracks and alterations become more evident when the same model is enhanced by means of composition of the information both on the colours and intensity (cf. Figures 8b and 9b). Moreover, these findings were also found for the model representing local morphology (cf. Figures 8c and 9c).

**Figure 9.** Fresco of Perseus and Medusa on the vault of the Lodge of Galatea investigated through laser scanning: image extracted from the point cloud with colour information (a); image with enhanced combining colours and intensity (b); morphology obtained by the inclination of the normal direction with respect to a local plane by interpolating the neighbourhood points by 2 cm (c).

Moreover, some other local cracks can be identified on the frescoes, e.g., those shown in the box III of Figure 8a, with detail in Figure 10(III), and in the box III of Figure 9a, with detail in Figure 11(III).
