# Analysis of the Low-Frequency Debris Flow Disaster Induced by a Local Rainstorm on 12 July 2022, in Pingwu County, China

**Abstract:** Low-frequency debris flows often lead to severe disasters due to large energy releases and strong concealment. However, the understanding of formation conditions, movement processes, and disaster-causing mechanisms of low-frequency debris flow is still limited, especially regarding occurrences within the large catchment (>50 km<sup>2</sup>). This study presents a typical case of large-scale, low-frequency debris flow occurring in the Heishui catchment (102.65 km<sup>2</sup>), Pingwu County, China. The movement process, disaster characteristics, and causes of the Heishui debris flow were analyzed in detail through field investigations and remote sensing interpretation. The results indicated that the Heishui debris flow is a large-scale, low-frequency, dilute debris flow with a recurrence period of over 100 years. The debris flow was primarily initiated from the right branch gully, Longchi gully, triggered by a local rainstorm with a maximum hourly rainfall return period of over 20 years. The main cause of casualties and building damage is attribut

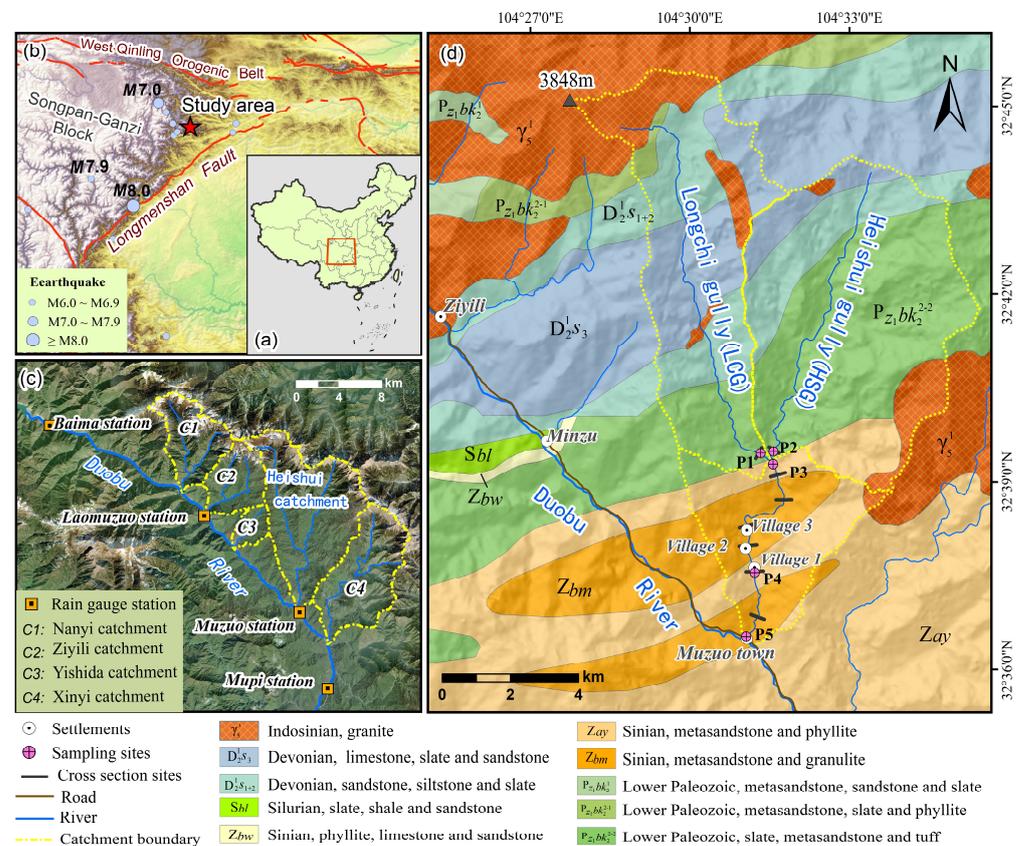
**Figure 1.** Location and geological background of the study area. (a) the location of the study area; (b) a map showing the simplified geological background and earthquakes around the study area; (c) the location of the rain gauge station and four catchments adjacent to the Heishui catchment; (d) a map of lithology and villages and field work sites.

The study area is located in a geologically complex region at the intersection of the Songpan–Ganzi Block, Yangtze Block, and West Qinling Orogenic Belt (Figure 1b).

The regional geological structure is complex and is strongly affected by seismic activity. According to the United States Geological Survey (USGS) earthquake data records (<https://earthquake.usgs.gov/earthquakes/>, accessed on 12 September 2022), seven earthquakes ( $M \geq 6.0$ ) occurred within 100 km of the study area from 1900–2022. Based on the seismic intensity maps released by the China Earthquake Administration, the study area is located in the region that had a seismic intensity of VI during the Jiuzhaigou earthquake ( $M7.0$ ) on 8 August 2017, and in the region that had a seismic intensity of VIII during the Wenchuan earthquake ( $M8.0$ ) on 12 May 2008. According to the 1:200,000 geological map surveyed by the Sichuan Provincial Geological Bureau, the lithology of the study area mainly includes Indosinian granite, Devonian sandstone, siltstone, and slate; Silurian slate, shale, and sandstone; Sinian metasandstone, limestone, phyllite, sandstone, and granulite; and lower Paleozoic Bikou Group metasandstone, sandstone, slate, and tuff (Figure 1d).

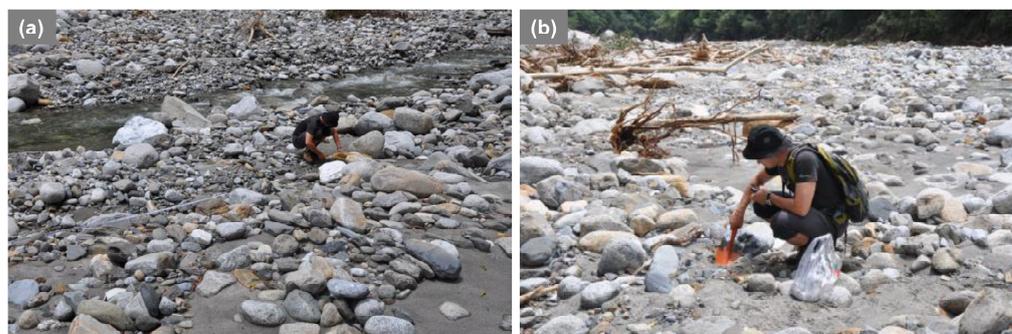
**Figure 2.** Field measurement of particle size ( $>60$  mm) (a) and sampling of debris flow deposition (b).

To obtain more detail on the initiation, mobilization, erosion, and deposition processes of Heishui debris flow, two field investigations were conducted on 16 July 2022 and 1 August 2022. Information on the debris flow timeline, movement process, and damages to the debris flow was obtained through interviews with eyewitnesses to the event. Seven cross-sections were selected and measured in the straight and smooth segments without embossments, trunks, or other blockages that could interrupt the debris flow, and one boulder blockage cross-section was measured at the narrow site near village 1 (Figure 1c). The geomorphic settings of these cross-sections were carefully measured and analyzed, including channel width, flow height (judged from the level of mud imprinted on the bank or based on the extent of moss and vegetation damage to gully sidewalls), roughness of the slope bed (refer to the bed particle composition, the ratio of stones, sand, and gravel), and boulder blockage dam size and geometry. In addition, we also conducted solid particle size measurement and statistical analysis with a size  $>60$  mm along the channel. Specifically, two 50-m-long strips were measured near cross-section 3 and cross-section 8, respectively. The particle size of boulders larger than 60 mm was measured in the 3-axis direction at intervals of 1 m, and its lithology was also recorded (Figure 2a). Moreover, five samples for grain size distribution were collected from the debris flow deposits (Figures 1c and 2b). The grain size samples were measured using sieve analysis, and particles with diameters less than 0.25 mm were measured using Mastersizer 2000 produced by Malvern Panalytical (Chipping Norton, Australia).

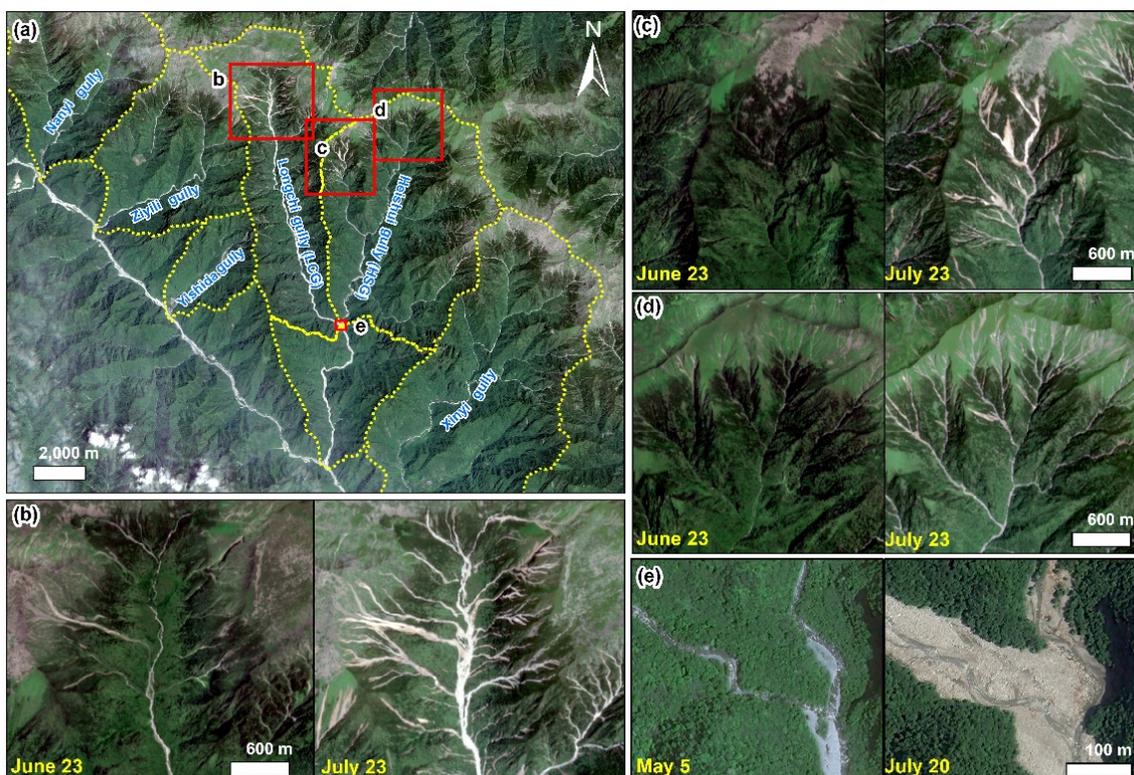
**Figure 3.** Comparison of remote sensing images before and after the debris flow event. (a) Sentinel-2A image of the Heishui catchment; (b–d) Sentinel-2A images of the debris flow-forming zone; (e) JL1 images of the intersection area of the LCG and HSG.

Remote sensing interpretation and field investigation indicate that the debris flow was initiated from the branch gully, LCG. Clear signs of debris flow initiation were left on the post-disaster remote sensing images, including damage to vegetation, exposure of fresh rock and soil masses, and notably wider ditches in the upstream of LCG and HSG (Figure 3). Based on field investigation and comparison of erosion and accumulation of the LCG and HSG, it was inferred that the debris flow mainly originated from the LCG.

left over from the Quaternary glaciers overlies the bedrock. The average slope of the zone where the debris flow formed in the LCG is  $29.3^\circ$ , meeting the slope conditions for debris flow initiation [15]. Remote sensing images showed that more than 25 branch ditches and gullies were activated, and the total erosion area was  $1.58 \text{ km}^2$ , accounting for 4.4% of the total area of the LCG (Figure 3b,c). Although several branches and ditches in the HSG also showed obvious initiation characteristics, the erosion area only accounts for 1.7% of the HSG area, and its scale and intensity area were far less than those of the LCG (Figure 3c,d). The main channel of the LCG is long and narrow, with an average gradient of 12.1%, while the length of each branch is short, which is conducive to rapid confluence. The branch ditches and gullies quickly converged to form channel runoff, which drove the boulders and sediments in the main channel of the LCG to continuously carry the sediments forward. A large number of stones and sediments rushed out of the LCG, the channel widened significantly, and they accumulated at the confluence, strongly squeezing the HSG (Figure 3e).

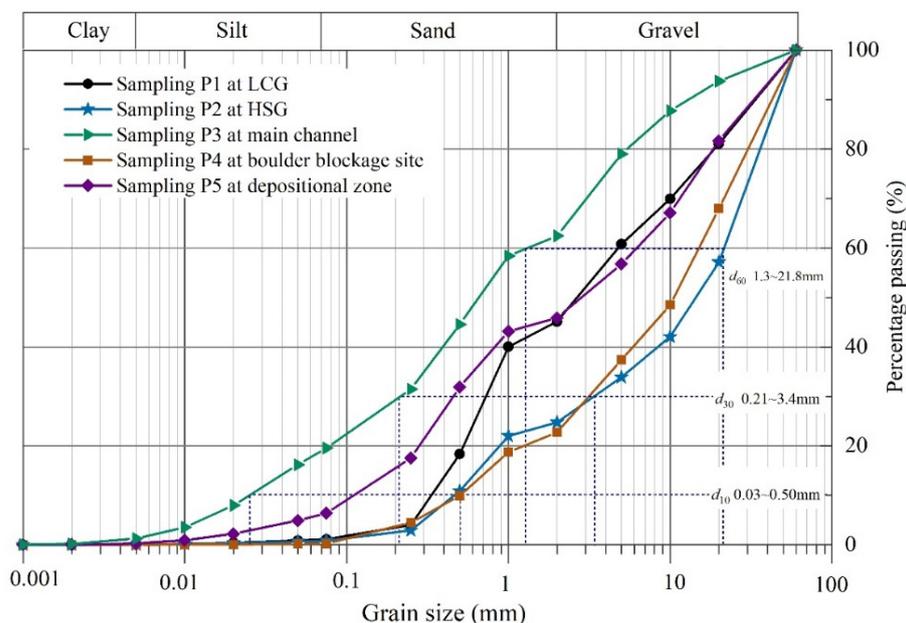
**Figure 4.** Particle size ( $\leq 60 \text{ mm}$ ) distribution of the debris flow samples in the study area.

The particle curves of the five debris flow deposit samples (the maximum particle size is 60 mm) in the Heishui catchment reveal that they contain a lower proportion of fractions of fine-grained material (Figure 4). The particle curves of P2 and P4 are similar and exhibit a high proportion of gravel (2–60 mm), approximately 73.2% on average, while the proportions in P1 and P5 are close to 54.5%. The sand (0.75–2 mm) contents are 22.5%~44.0%, and P1 has the highest proportion. P3 has higher proportions of clay (<0.005 mm) and silt (0.005~0.075 mm), 1.27% and 18.3%, respectively, while the other samples' clay contents are less than 1%. According to the grain size distributions of five samples, the debris flow density was calculated using an empirical method proposed by Chen et al. [40]. The results showed that the debris flow density in this event ranged from  $1.55\text{--}1.58 \text{ g/cm}^3$ , indicating that it was a diluted debris flow with a volumetric solid concentration of less than 50% [41].

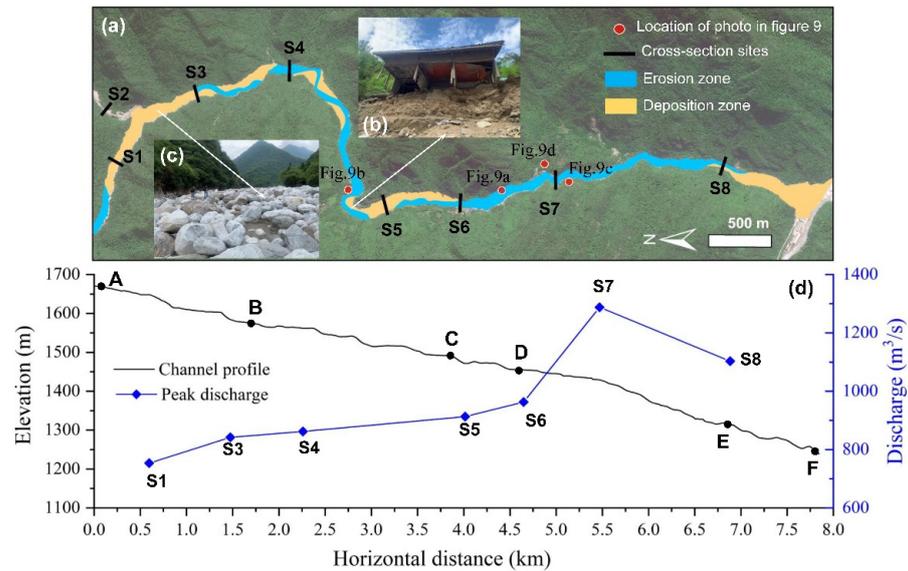
**Figure 5.** Characteristics of channel erosion, accumulation, and discharge changes during debris flow movement. (a) channel erosion and accumulation changes and the location of cross-sections and photo in Figure 9; (b,c) photos of channel erosion and deposition; (d) debris flow peak discharge and the longitudinal channel profile of the LCG to the outlet of the main channel corresponding to (a).

The peak discharge of the Heishui debris flow varied with movement and deposition in different segments (Figure 5). The peak discharge near the outlet of the LCG (cross-section S1) was  $753.6 \text{ m}^3/\text{s}$ , which was 3.6 times that of the outlet of the HSG (cross-section S2). It also indicated that the debris flow mainly originated from the LCG. The peak discharge gradually increased to  $963.2 \text{ m}^3/\text{s}$  at cross-section S6. At cross-section S7, the

discharge increased sharply to  $1287.9 \text{ m}^3/\text{s}$  and subsequently decreased to  $1102.9 \text{ m}^3/\text{s}$  near the outlet of the main channel (cross-section S8). The large amount of energy released by the debris flow strongly eroded the channel bed and banks and caused collapses and landslides on the bank slope. Strong erosion occurred at the bend of the channel, leading to the phenomenon of an ultrahigh curve. The maximum mud height reached 14 m, which washed away the bases of houses, and accumulations formed on the convex bank (Figure 5b).

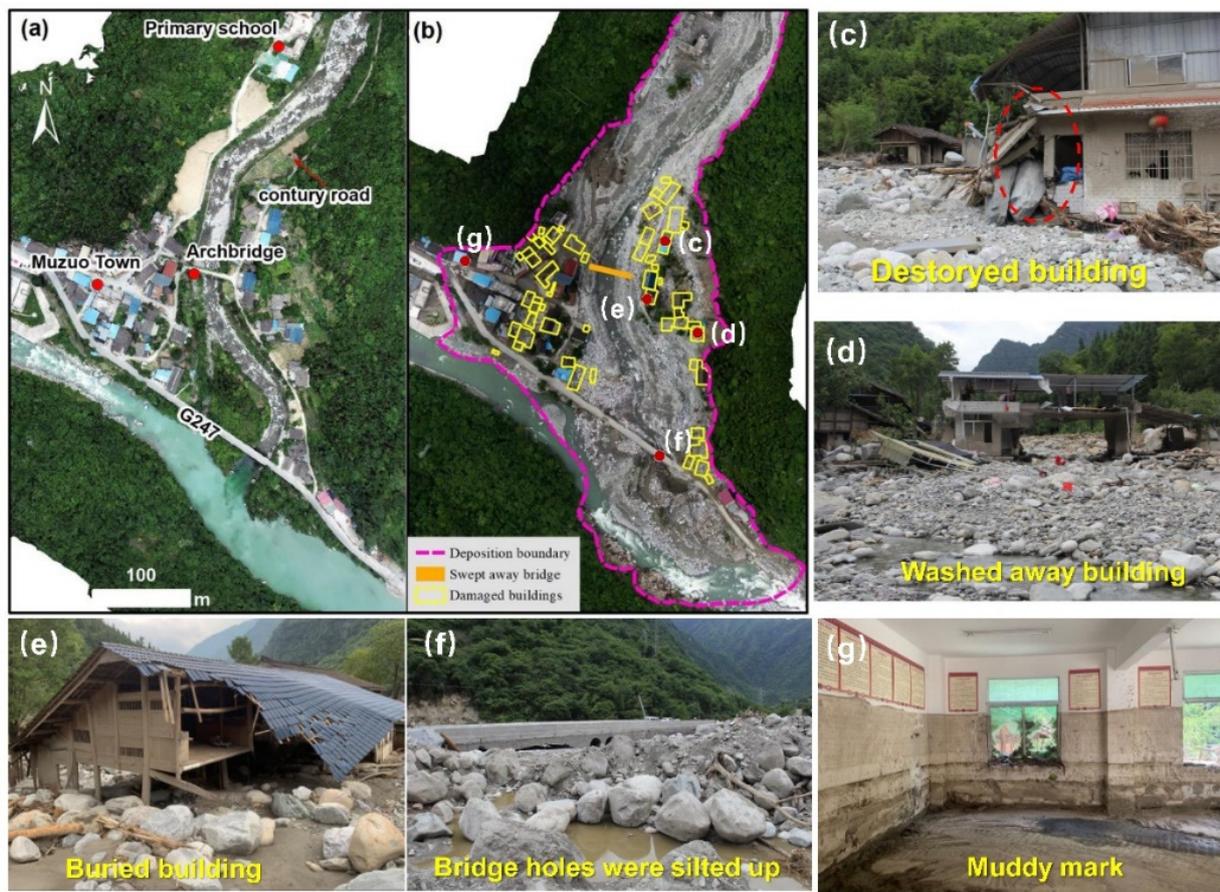
**Figure 6.** Deposition and damage in the downstream section of the main channel. (a) UAV image taken in June 2022; (b) buildings and bridges swept away in damaged areas. (c–g) photograph of damaged buildings and a buried bridge taken on 2 August.

The Heishui debris flow had a strong carrying capacity, and much of the solid material carried by the debris flow was eventually deposited in segments AB and EF, causing the most severe damage (Figure 6). Large boulders with a diameter of more than 1 m are common in the deposition zone, and the maximum measured boulder size was  $5.8 \text{ m} \times 2.7 \text{ m} \times 1.8 \text{ m}$ . Stones and driftwood blocked the main hole and part of the adjacent hole of the national road G247 arch bridge at the outlet of the channel (Figure 6f), resulting in a significant increase in the channel bed and flood water level. The debris flow swept through the Muzuo town, damaging 31 houses to varying degrees (Figure 6b). Houses situated close to the gully were either completely washed away or buried and damaged, leading to the deaths and disappearance of local residents (Figure 6d,e,g). Additionally, the country road connecting Muzuo town to Heishui village and the arch bridge were both completely damaged. The comparison of elevation points before and after the disaster revealed that the maximum thickness of accumulation was 11.7 m, with an average thickness of approximately 3.7 m. The deposition area was approximately  $9.4 \times 10^4 \text{ m}^2$ , and the volume of accumulated solid material was approximately  $3.5 \times 10^5 \text{ m}^3$ , indicating that this event was a large-scale debris flow. This catastrophic disaster resulted in a direct economic loss of 480 million RMB.

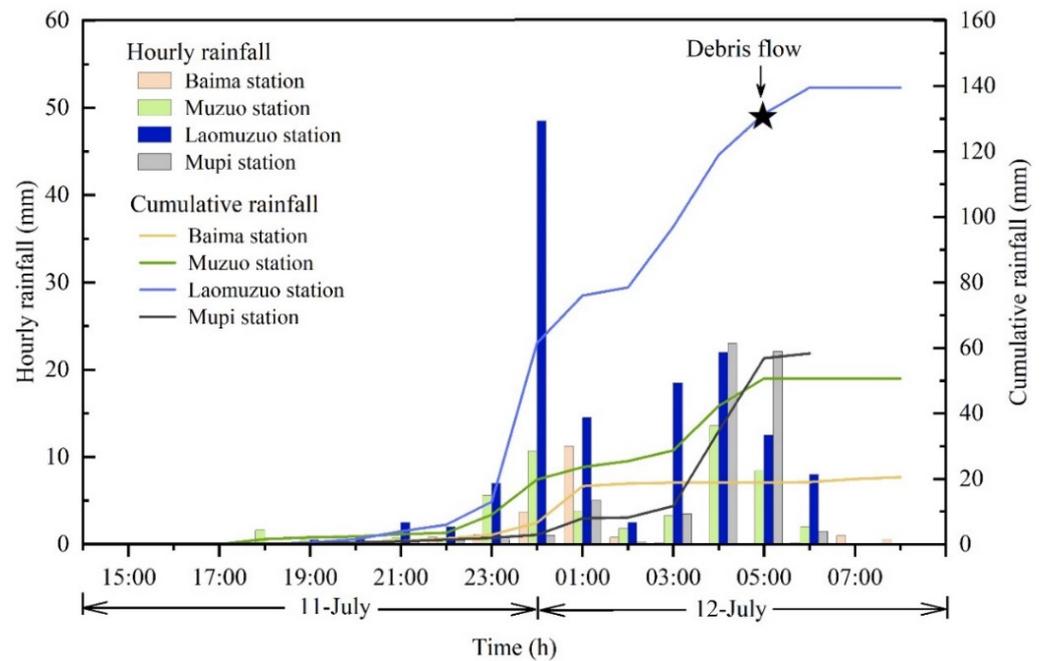
**Figure 7.** Antecedent hourly rainfall and cumulative rainfall prior to 11 to 12 July 2022, for the rain gauge stations around the Heishui catchment.

Short-duration, high-intensity rainfall was the key initiator of the Heishui debris flow. Heavy rainfall occurred in the Duobu River basin starting at 18:00 on 11 July. However, the rainfall intensity and accumulation amount from 18:00 on 11 July to 6:00 on 12 July at the four stations varied greatly. The accumulation rainfall at Baima station, Laomuzuo station, Muzuo station, and Mupi station was 18.8 mm, 131.5 mm, 50.7 mm, and 58.0 mm, respectively (Figure 7). Field investigation showed that among the multiple catchments between the four rain gauge stations, only the Ziyili catchment, Yishida catchment, and Heishui catchment experienced debris flows on 12 July, which led to the destruction of residential houses and roads (Figure 8). Both the Ziyili catchment and Yishida catchment are located on the left side of the Heishui catchment, adjacent to the LCG branch, and originate from the same mountain ridge (Figure 1b,c). The rainfall records and the distribution of the debris flow catchment indicated that the rainstorm center was concentrated in the regions of the LCG, Ziyili catchment, and Yishida catchment. Although Muzuo Station is located at the outlet of the Heishui catchment, its straight-line distance from the top of LCG is about 17 km, while the distance between Laomuzuo Station and the top of Longchigou is about 8 km. Moreover, the altitude of Muzuo Station is 1244 m, while the altitude of Laomuzuo Station is 1550 m. Therefore, in terms of both distance and altitude, the rainfall at Laomuzuo station is the most suitable for representing the rainfall level that triggered the debris flow.

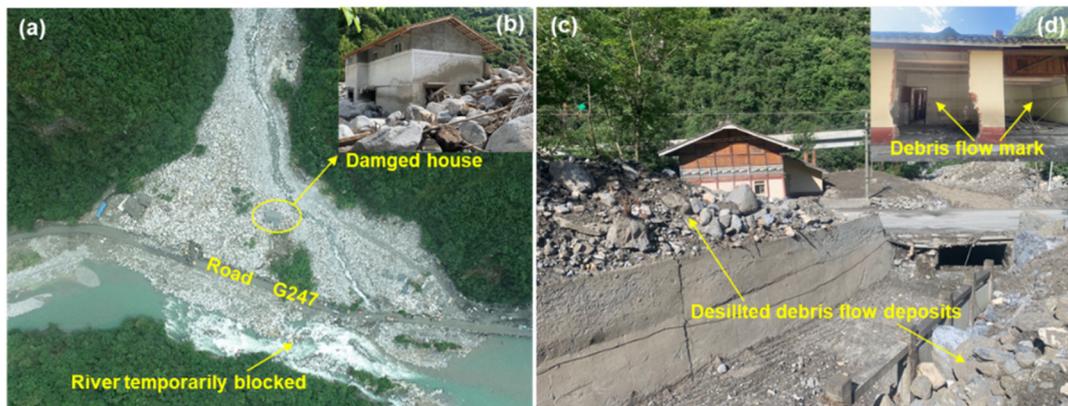
**Figure 8.** Photos of debris flow disasters at the outlet of the Ziyili and Yishi catchments. (a,b) photograph showing damaged houses and the temporary blockage of the Duobu River caused by the Ziyili debris flow. (c,d) photograph of a silted channel and house damaged by the Yishida debris flow.

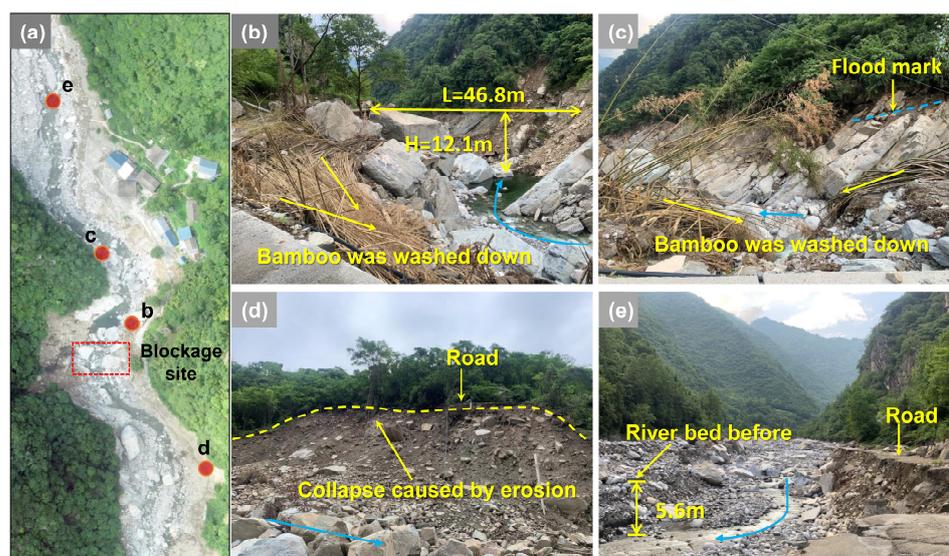
**Figure 9.** Aerial image and photographs of the channel environment around boulder blockage sites. (a) aerial image of the channel and location of each photo; (b,c) size and shape of the boulder dam, and bamboo was washed down toward the flow vortex; (d) bank collapse caused by erosion downstream of the boulder blockage and outburst site; (e) erosion upstream of the boulder blockage site.

The debris flow discharge increased  $324.7 \text{ m}^3/\text{s}$  from cross-section S6 to S7 with an average of  $395.9 \text{ m}^3/\text{s}$  per kilometer, which is 6.8 times that of S1 to S6. According to the field investigation, no significant gully confluences or large landslides occurred between cross-sections S6 and S7. The debris flow discharge increase within a short distance is often related to channel blockages and outbursts in narrow gullies and sharply curved sections due to landslide deposits, collapse deposits, natural boulders, and artificial dams [44,45]. Boulder blockage and outburst phenomena were observed near cross-section S7 (Figure 9). The blockage site was located in a narrow and curved part of the channel, with several large boulders remaining on the left bank. The largest boulder had a size of approximately  $13.9 \text{ m} \times 6.1 \text{ m} \times 5.1 \text{ m}$ , occupying most of the river, and only a  $3.2 \text{ m}$  wide area was available for the passage of flow. Consequently, the stones, sand, and driftwood carried by the debris flow from upstream had difficulty passing through this narrow section, leading to channel blockage. The maximum flow depth, as determined from muddy marks, was  $12.1 \text{ m}$ , and the top width of the blockage dam was  $46.8 \text{ m}$  (Figure 9b). The temporary dam ultimately failed because of the continuous accumulation of debris flow material, which increased the pressure on the temporary dam. The sudden breach of the temporary dam led to bamboo falling toward the center of the breach (Figure 9b,c). The high energy of the debris flow caused strong erosion downstream, resulting in the collapse of the channel bank and the road subgrade washing away (Figure 9d). At the same time, retrogressive erosion occurred upstream of the dam, with erosion depths ranging from  $2 \text{ m}$  to  $6 \text{ m}$  (Figure 9e).

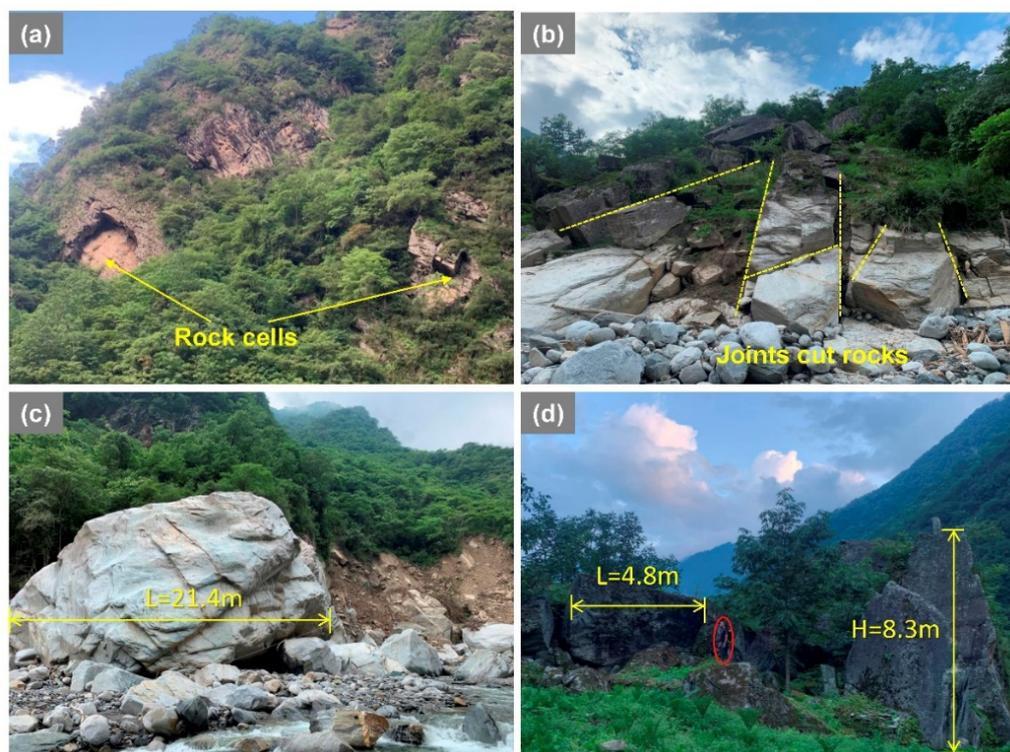
**Figure 10.** Boulders and their development environment. (a) rock cells are developed on the right bank of the channel (camera direction: northeast); (b) rock blocks cut by joint fissures on the left bank (camera direction: northwest); (c) a large boulder downstream of the blockage site; and (d) large boulders scattered on the left bank slope of the blockage site (red circle represents a man as a reference).

Hard rock regions are more prone to collapses and rockfalls, thereby providing a favorable environment for boulder blockage [19]. The Heishui catchment is located on the southern slope of the West Qinling Orogenic Belt, where the exposed rocks are mainly weather-resistant igneous rocks and metamorphic rocks. Field investigations found that cracks and joints are well developed in the rocks, and a large amount of the bedrock on the hillsides had been cut into blocks, forming rock cells and hazardous rocks that are prone to rockfall and collapse (Figure 10a,b). The rocks and boulders from collapses and rockfalls are generally large in volume and quantity, accumulating in or crowding some parts of the channel, and they are difficult for floods to transport [46]. In the Heishui catchment, numerous large boulders were scattered on the slopes and in the channel, with the largest boulder in the channel measuring  $21.4\text{ m} \times 11.8\text{ m} \times 6.7\text{ m}$  and located approximately 50 m downstream from the blockage site (Figure 10c,d). In addition to rocks and boulders, large wood chunks and fragments also contribute to blockage and have been observed in debris flow events [47–49]. Remote sensing interpretation showed that the Heishui catchment has a high vegetation coverage of nearly 87%, and some trees on the slope and channel banks were involved in the debris flow. Driftwood was also found in the channel and deposition zone (Figure 6e,f), indicating a potential contribution to boulder blockage.
