Detecting Large-Scale Landslides Using Lidar Data and Aerial Photos in the Namasha-Liuoguey Area, Taiwan

Keywords: large-scale landslide; Lidar technique; shading map; scarps; stability analysis

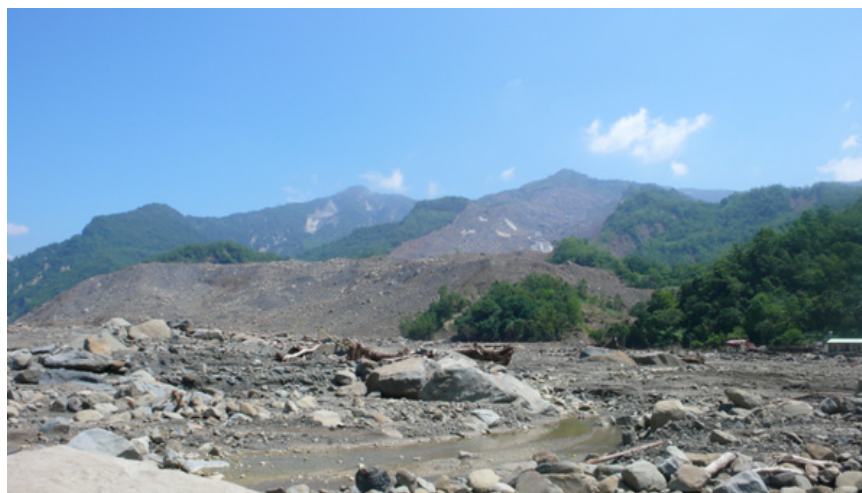
Figure 1. The Shiaolin landslide in Chishan River watershed, Kaohsiung City, triggered by Typhoon Morakot.

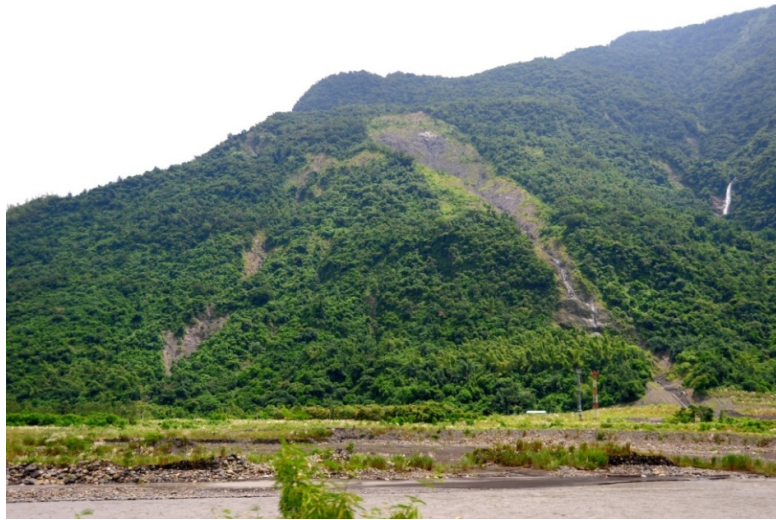
Figure 2. The large-scale landslide beside the Laonong River, Kaohsiung City, triggered by Typhoon Morakot.

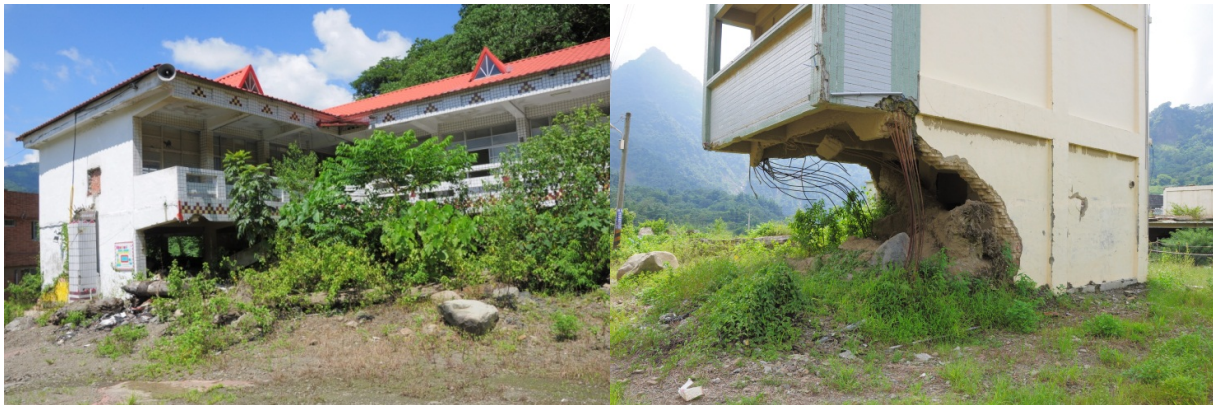
Figure 3. Damage of an elementary school (left) and a resident's home (right) caused by debris flow affecting torrent KSDF007 in Nansalu Village, Kaohsiung City.

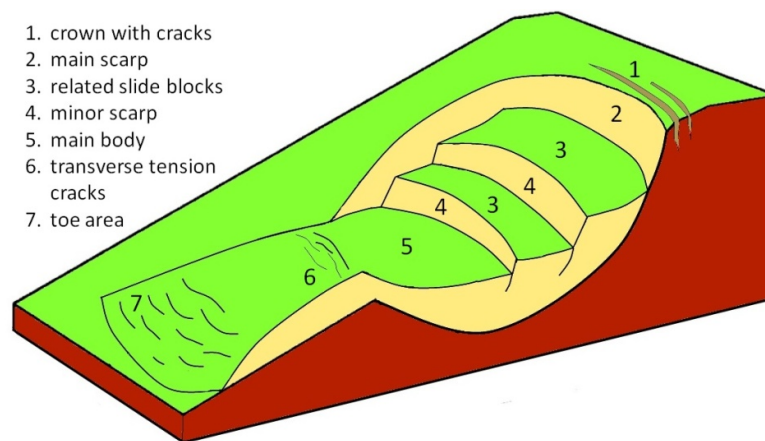
Figure 7. The geomorphologic characteristics of large-scale landslide (modified from Varnes [10]).

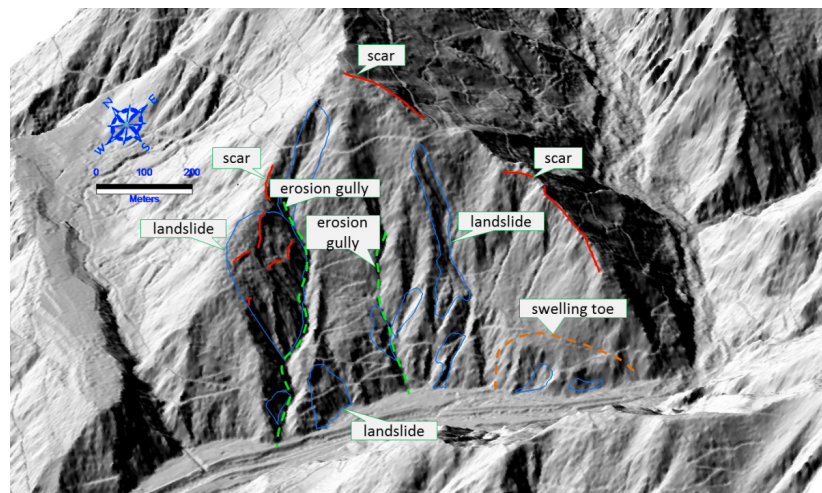
Figure 12. Example of identified large-scale landslides and their features in the Maya area of the Namasha study area.

an example of an identified large-scale landslide and its features in the Maya area, Namasha study area. From the figure, we can identify some small landslides in the whole large-scale landslide area. For some of them, the erosion gullies and side cracks are well developed and can be easily recognized. There are many scars parallel to each other in the crown area. Figure 13 is the slope map of the same landslide area which enhances the topographic variations, and provides supporting evidence of landslide geomorphologic features. Comparisons of Figures 12 and 13 allow us to recognize features such as slag areas near the top of the swelling toe between two erosion gullies, and next to the scars on the crown. Combining the results illustrated in Figure 12 and 13, the large-scale landslide area is identified by markings made in red lines in Figure 13.

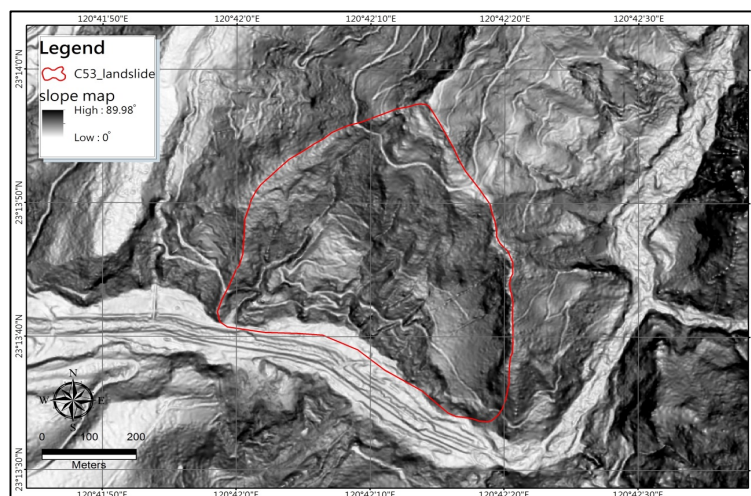
Figure 13. Example of the slope map of the large-scale landslide in the Maya area of the Namasha study area.

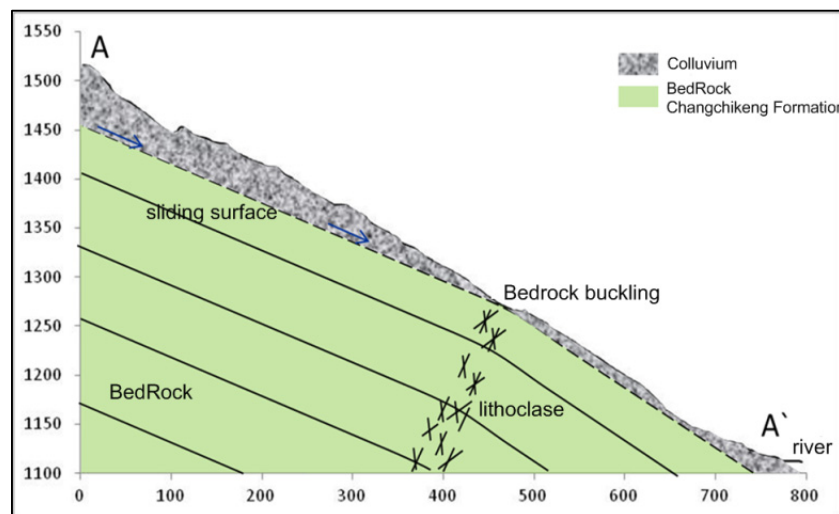
Figure 21. Schematic geological cross-section along profile A-A' of A6 landslide based on field investigation

buckled layers. A schematic cross-section along profile A-A' is illustrated in Figure 21. The upper layer is colluvium and the lower one is bedrock in the Changchikeng Formation [8].

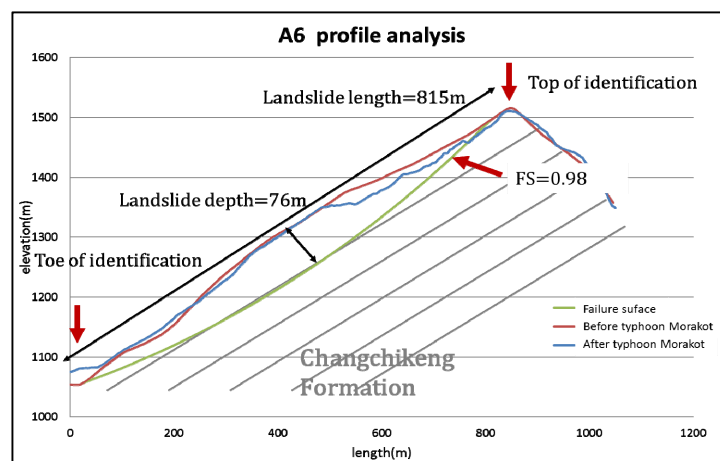
Figure 23. The critical sliding surface *versus* profiles showing before and after Typhoon Morakot of the A6 large-scale landslide.

Stability analysis of the A6 landslide was conducted to verify the failure condition, and the location of the critical failure surface was compared to the slope profile variation after the Typhoon Morakot. The geotechnical parameters were referred to data of similar geological formations (Lin *et al.* [13]), and after back analysis, the parameters used were: unit weight of 23.5 kN/m³, ground water table reached the top of available gullies and near the ground surface, cohesion of 50 kPa, and a friction angle of 26 degrees. The corresponding safety factor with these parameters was 0.98. The resulting critical sliding surface is plotted against the slope profiles before and after Typhoon Morakot in Figure 23. The differences between the original slope profile and profile after Typhoon Morakot provide information on the locations of head scarp, scars of possible sliding surface, and bulging or deposition near down-slope. The critical sliding surface determined from the back analysis fits the location of linear structure/scars and the topographic variations well at the crest and toe as shown in Figure 23. The head scarp of the critical sliding surface is located in close proximity to the edge of the

slope and matches the scarp of the profile after Typhoon Morakot. The stability analysis provides cross validation of the mapped large-scale landslide, and the critical sliding surface can be used to check the possibility of failure occurrence and estimation of the landslide volume and amount of remaining unstable materials.

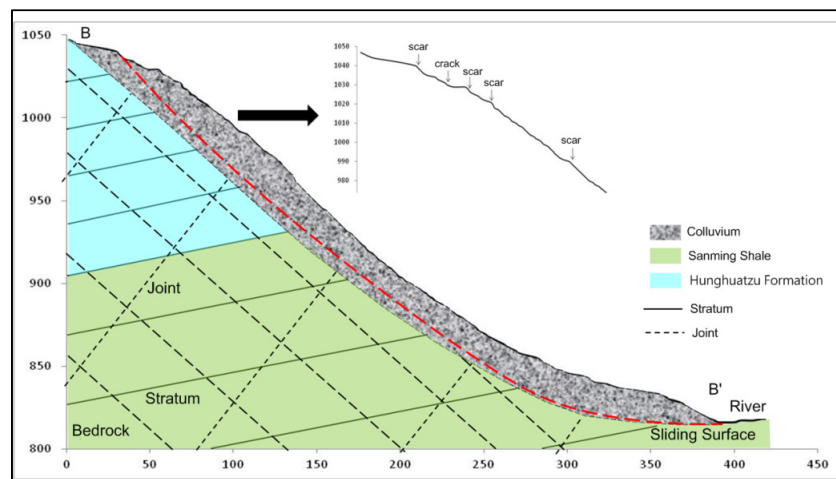
Figure 24. Schematic geological cross-section along the profile B-B' of A112 landslide based on field investigation.

and a small reverse fault across the river to the north of the A112 landslide could be detected. The landslide involved a thick colluvium layer, and a shear zone containing black clay was also observed near the estimated sliding surface. A 5 m wide fracture and 1.5 m high head scarp was observed near the crest of the estimated sliding surface. The cross-section along the profile B-B' is illustrated in Figure 24. The upper layer is represented by colluvium and the lower layer is bedrock in Hunghuatzu Formation and Sanming Shale [8].

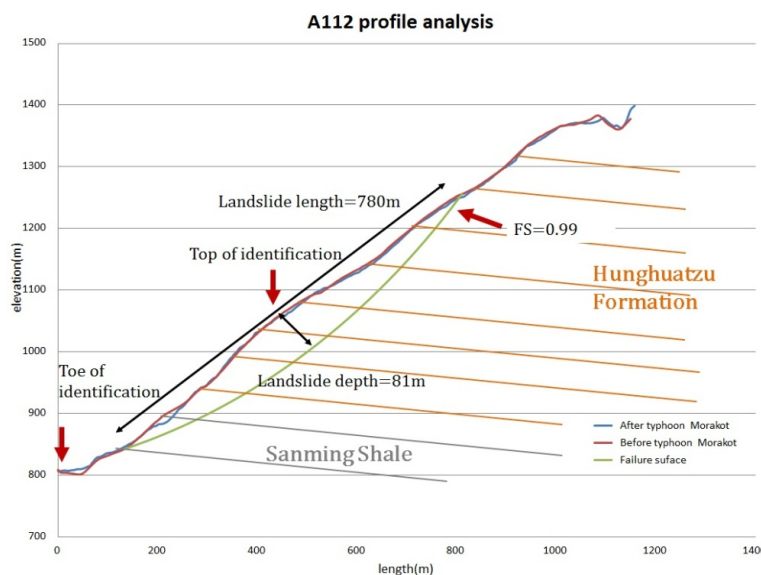
Figure 26. The critical sliding surface *versus* profiles before and after Typhoon Morakot of the A112 large-scale landslide.

Back analysis of the stability of the A112 landslide was conducted to verify its failure condition in a similar fashion to the back analysis conducted for the A6 landslide. The parameters used in the back analysis were: unit weight of 23.5 kN/m^3 , ground water table reached the top of available gullies and near the ground surface, cohesion of 40 kPa, and friction angle of 28 degrees. The corresponding safety factor based on the parameters set above was 0.99. The resulting critical sliding surface can be observed as fitting quite well with the topographic variations of slope profiles when plotted against the slope profiles before and after Typhoon Morakot in Figure 26. However, the critical sliding surface appears to extend beyond the landslide identified by Lidar, which can be seen clearly by mapping the critical sliding surface with the yellow profile on the aerial photo and shading map in Figure 27. The aerial photo and Lidar shading map were re-examined leading to the discovery of another crack/linear
