# Fatigue Loading Test on Screw-Retained Lithium Disilicate Crowns Adhesively Cemented on Titanium Abutment

**Abstract:** The aim of this study was to assess the mechanical behavior and the microleakage of crown abutments made of lithium disilicate (LDS), adhesively bonded to preconditioned titanium bonding base under dynamic loading considering the type of teeth incisors, premolars, and molars. Thirty-three monolithic LDS implant supra-structures, representing a copy of natural tooth morphology (central incisor, second premolar, or first molar) were fabricated and bonded to titanium bases, screw-retained on the implant, and subjected to dynamic loading of 250,000 loading cycles at 2 Hz. After mechanical cycling, specimens were immersed in 5% methylene blue solution for 24 h at 37 °C. Microleakage was evaluated under magnification. The presence or absence of the following parameters were also evaluated: abutment screw deformation, abutment deformation, crack or craze line on the ceramic structure, adhesive failure between titanium base and ceramic superstructure, failures in ceramic superstructure or titanium base, and remaining cement around titanium base and ceramic superstructu

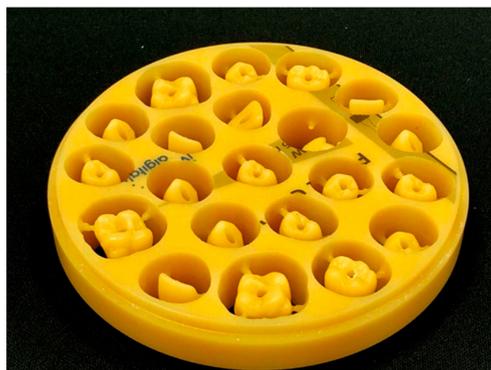
**Figure 1.** The hybrid crown abutments milled from IPS e.max multi-wax pattern (Ivoclar Vivadent, Schaan, Liechtenstein).

A Viteo<sup>®</sup> titanium bonding base for single-tooth restoration abutments with 6 mm height was scanned with a high-precision laboratory laser scanner (Zirkonzahn S600 ARTI, Norcross, GA, USA). Crown restorations were CAD-designed using customized transmucosal profiles based on the natural teeth shapes (Figure 1).

The crown abutments were milled from IPS e.max multi-wax pattern (Ivoclar Vivadent, Schaan, Liechtenstein) using a Zirkonzahn m4 wet heavy metal-milling unit. The final restorations were pressed by IPS e.max ingots (Ivoclar Vivadent, Schaan, Liechtenstein), with minor hand work and crystallization process performed in IPS Programat press furnace, according to the manufacturer's guidelines (e.max press ingots IPS (multi investment system)).

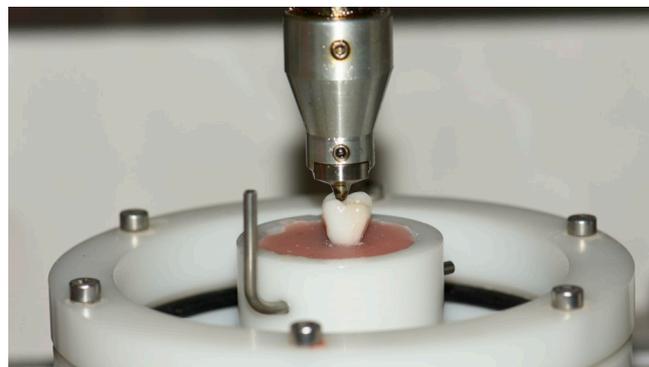
**Figure 2.** Dynamic loading of upper molar with masticatory simulator (CS-4, SD Mechatronik, Westerham, Germany) for fatigue testing. Embedded implant with crown in standard sample pot. Steel cone antagonist adjusted to touch the crown at the fissure.

The ceramic structure was cleaned the same way as the base. Afterwards, the bonding surface was etched with 5% hydrofluoric acid (IPS Ceramic Etching Gel) for 20 s. The surface was rinsed under running water and dried with air. Monobond Plus was applied and left to react for 60 s. Then the residue was distributed with dry air. A new mixing syringe was attached to the Multilink Hybrid Abutment (Ivoclar Vivadent, Schaan, Liechtenstein) for cementation of each sample. A thin layer of the cement was applied to the bonding surface of the base and to the ceramic suprastructure. Afterwards, both components were assembled in alignment, according to the position of the marking waterproof pen. The parts were slightly pressed to each other, their position was checked, and they were then tightly pressed for 5 s. All probes were manually cleaned from the excess immediately after cementation with scalpel blade #15. Glycerine gel was applied on the crown margin to prevent formation of an inhibition layer. After the polymerization of the cement was completed (Bluephase Power Cure, Ivoclar Vivadent, Schaan, Liechtenstein), the glycerine gel was rinsed off with water. All crown abutments were screw-retained, attached to the implants with titanium screws and tightened up to 35 Ncm. The screws were retightened after 10 min to avoid the possibility of screw loosening. The samples were then stored in distilled water at 37 °C for 24 h before testing. All samples were subjected to dynamic loading in a computer-controlled dual-axis chewing simulator (Chewing Simulator CS-4; SD-Mechatronik, Westerham, Germany) for 250,000 loading cycles (1 clinical year of operation) at a frequency of 2 Hz. A loading force of 50 N for the group of incisors and 150 N for premolars and molars was applied by a standard sample pot steel cone 30° antagonist. Samples were embedded in the sample pots with PMMA and steel cone antagonist touching the crown. Vertical strokes were performed according to the manufacturer's recommendations (Figures 2 and 3).

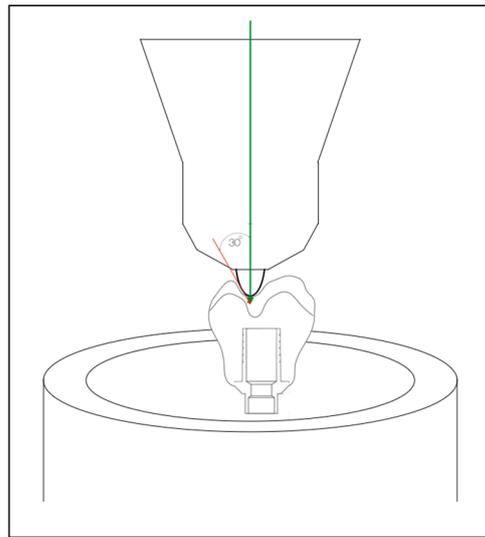
**Figure 3.** Dynamic loading with masticatory simulator scheme. Vertical stroke up: 2 mm, vertical stroke down: 2.5 mm, speed up: 60 mm/s, speed down: 20 mm/s, horizontal stroke: 0 mm, speed: 20 mm/s.

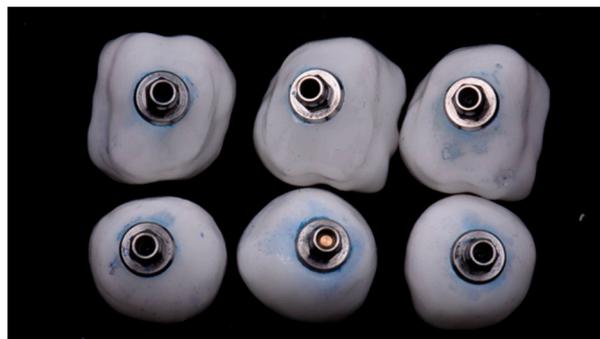
**Figure 4.** Hybrid abutment specimens after the dye exposure, thoroughly washed under running tap water for 5 min.

After the loading cycles were completed, specimens were immersed in freshly mixed 5% methylene blue dye solution for 24 h at 37 °C. After the dye exposure, the specimens were thoroughly washed under running tap water for 5 min (Figure 4).

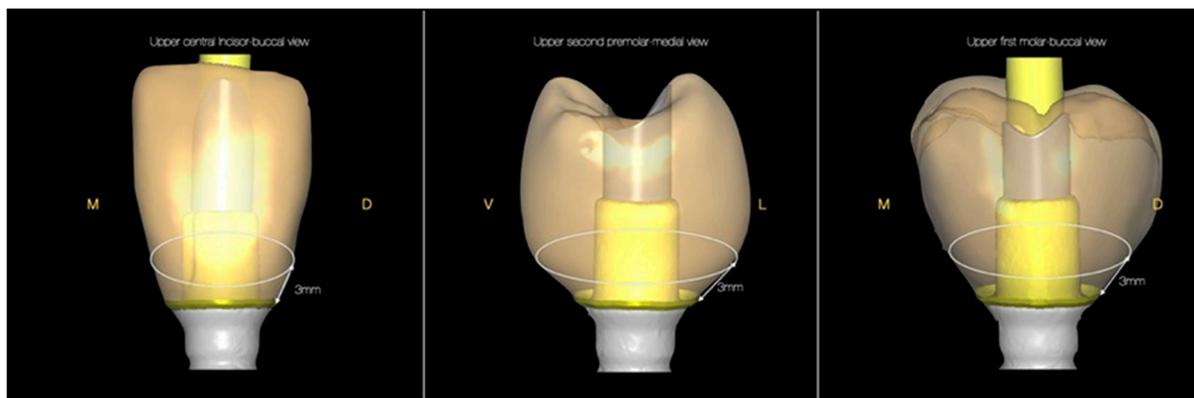
**Figure 5.** Three-dimensional model of standardized abutments virtually sectioned horizontally at 3 mm above the implant platform. Front view.

All samples were virtually sectioned horizontally at 3 mm above the implant platform to analyze the volume and thickness of the ceramic material around the compared standard titanium base abutment (Figures 5 and 6).

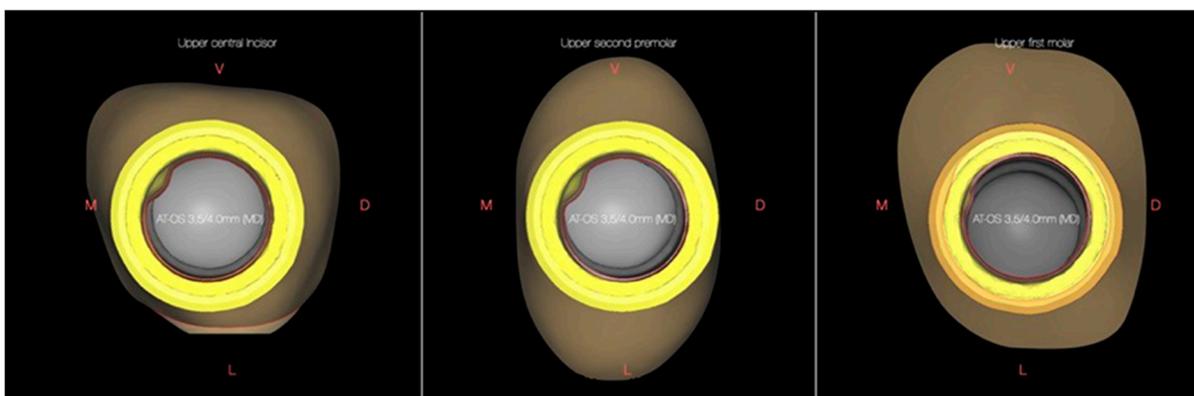
**Figure 6.** Three-dimensional model of standardized abutments virtually sectioned horizontally at 3 mm above the implant platform. Occlusal view of critical areas at risk of fracture.

The remaining thickness of the material was measured in the medial, distal, buccal, and palatal areas (Table 2).

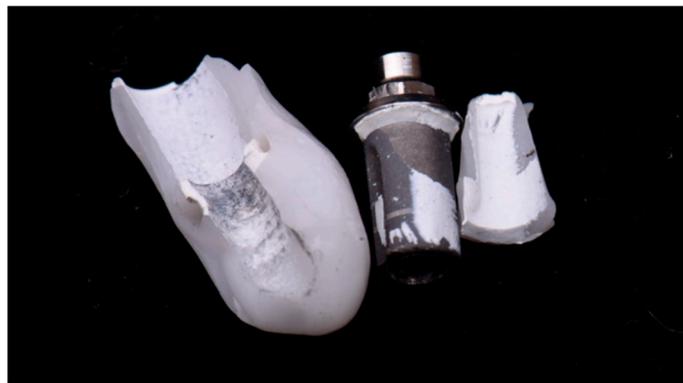
**Figure 7.** Fracture lines over the medial and distal walls. The cement layer of the fractured sample remains on the ceramic surface and the titanium base.

Table 1 shows the frequency of registered incidents of the parameters analyzed after the mechanical loading. One fracture was observed in the group of the premolars after loading of 5500 cycles. Fracture lines were drawn over the medial and distal walls. The cement layer of the fractured sample remains on the ceramic surface and the titanium base was clean.

Single restorations of LDS have been well studied in natural teeth, with material fatigue tested on crowns of varying occlusal material thickness. Therefore, specially designed LDS crowns were used in this study in order to recreate the natural tooth morphology and natural emergence profile as much as possible. There are many factors which play an important role in the resistance of the restorations, such as the intra-individual variety of the cervical shape of each tooth group, as well as between the groups in general. Usually, the position of the titanium base was not centered and the peripheral thickness of ceramic material could be critically reduced. The diameter of the deep sub-gingival part and the marginal part of the emergence profile of the restoration differed in the tooth groups, depending on the volume and quality of the surrounding soft tissues. After the evaluation of the initial hypothesis, with a scheme of standardized teeth slices at 3 mm below the CJ line and compared to the standard titanium base abutment, a critical thickness of the ceramic wall of 0.5 mm was chosen. The established critical areas were the medial and distal proximal walls of the molar, the disto-lingual walls of the central incisor, and the proximal walls of the premolar, where the thickness of the ceramic material around the abutment was critically low. These measurements coincided with the results established in the virtually sectioned 3D samples. A fracture of one of the premolar samples was observed over both the medial and distal walls of the restoration, which are the critical areas at risk of fracture. A smooth relationship between the titanium bonding Viteo<sup>®</sup> base and the restorative material is the basis for a strong bond that will withstand external influences, which coincided with the working hypothesis; therefore, it was accepted (Figure 7).

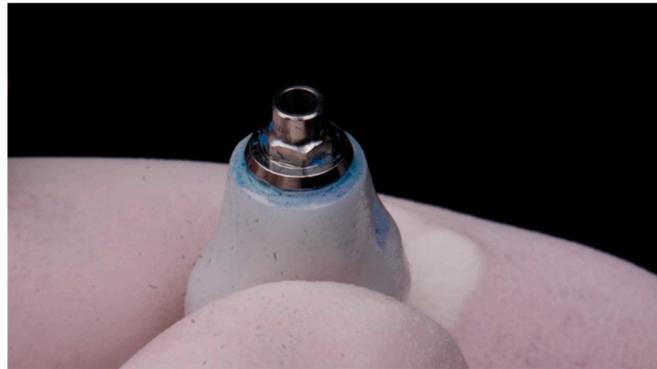
**Figure 8.** Over-contour profile of the restoration and the excess of the cement are visible from the significant accumulation of blue dye in that area.

To ensure sufficient fracture resistance of the samples, the LDS part of the abutment was slightly thickened in the connection area with the subsequently placed titanium base platform. This production defect led to over-contour profile of the restoration, which became a plaque-retentive area, and the excess of the cement could not be properly cleaned. This was visible from the significant accumulation of methylene blue dye in that area (Figure 8).

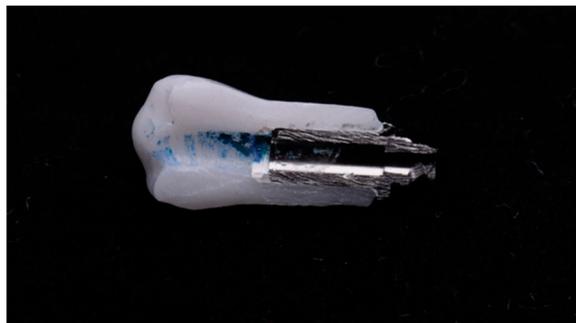
**Figure 9.** Subsequently, the dye penetration was evaluated under magnification. No microleakage was observed in any of the samples. The cement layer was equally distributed without any signs of penetration of the dye.

All samples were vertically sectioned through the center of the restorations, from the mesial to the distal surface, with a water-cooled diamond saw with 1 mm thickness. However, no dye penetration was registered (Figure 9).
