Article

Experimental Studies on the Stability Assessment of a Levee Using Reinforced Soil Based on a Biopolymer

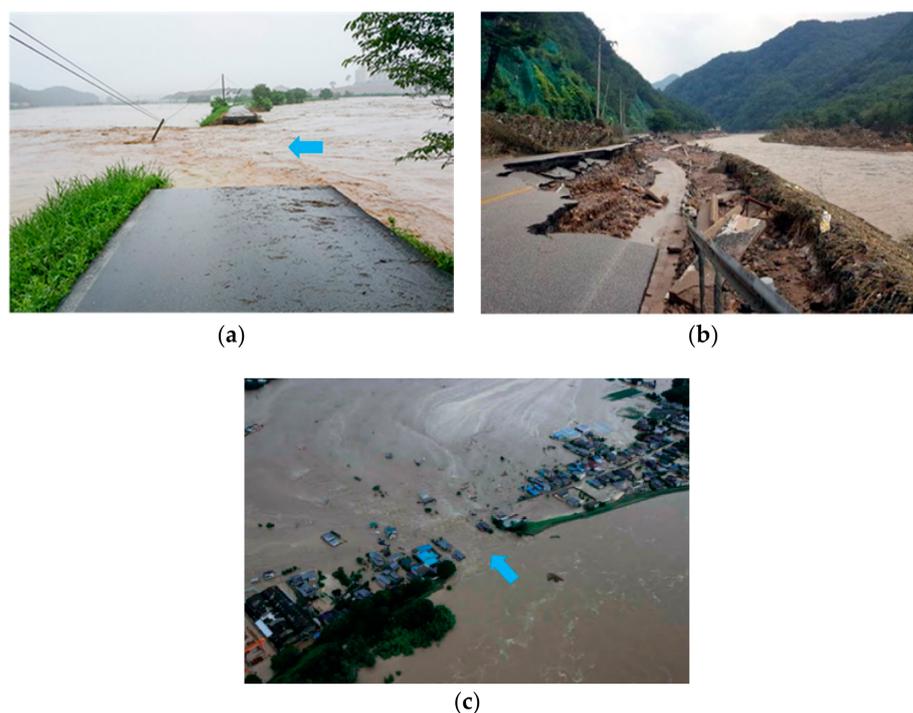
Figure 1. (a) Levee breach on Cheonan River in Korea; (b) road breach and levee scouring in Chungbuk, Korea and (c) levee breach on Kinu River in Japan.

Among the recent cases of levee breaches in South Korea and other countries, the localized heavy rain in 2017 in Chungcheong of South Korea caused huge losses in property by scouring an interface between a river structure and levee, or by breaching the levee and revetment. In Ibaraki in Japan, the record-high rainfall in September 2015 broke the east levee of Kinu River, which was around 200 m in length, and caused enormous flood damage (Figure 1). Unfortunately, such cases of levee breach are continuously increasing.

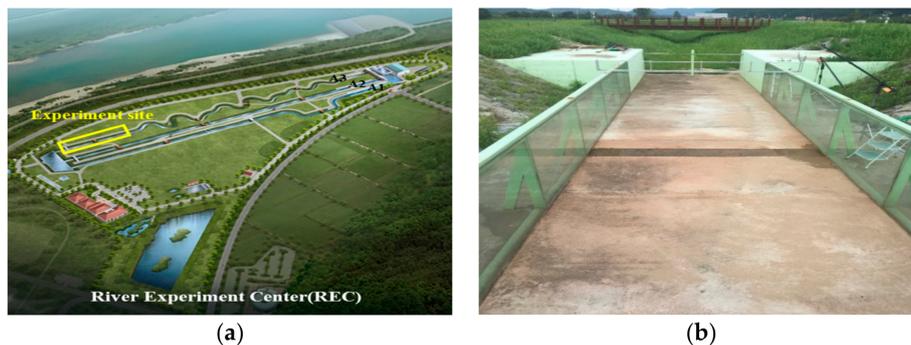
Figure 2. (a) View of REC and experimental site and (b) experimental channel (A3).

A mid-sized levee of 1 m in height, 1 m in length, and 3 m in breath, with a 1:2 slope and 5 m length, was constructed at the Andong River Experiment Center (REC) of the Korea Institute of Civil Engineering and Building Technology (Figure 2). The aim of the hydraulic experiment was to comparatively analyze the behaviors of levees during an overtopping breach between an earthen levee and the proposed levee using the newly developed substance, and to verify the retardation effects on the levee breach according to the thickness applied.

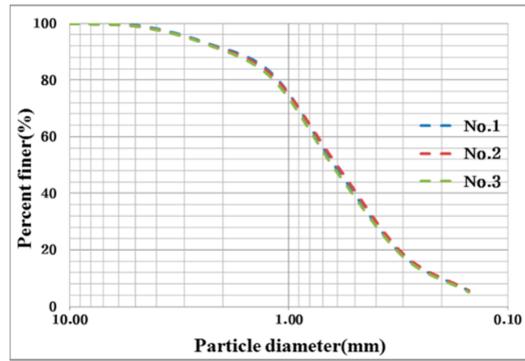
Figure 3. Grain size distribution.

The sand used in the experiment, based on the soil classification system, is a uniform well-graded sand (SW), in which 50% is retained on or above a No. 200 sieve (Figure 3). By using this type of soil, which is vulnerable to crack, the performance of the bio-polymer mixed with the most vulnerable of materials becomes more apparent, and the formation of overflow breach cross-sections is induced. Since the sand used in the experiment changes each time, three particle size distribution tests were conducted to verify the consistency of each test.

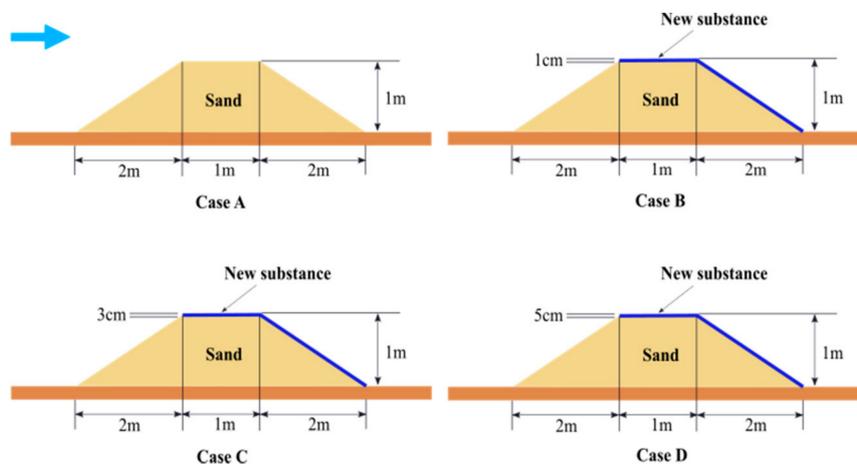
Figure 4. Experimental conditions.

The new substance was fabricated based on a formula (1 g of biopolymer, 10 g of water, and 50 g of sand) provided by the KAIST. In addition, the performance of the proposed levee was verified by applying different thicknesses (e.g., 1, 3, 5 cm) of the new substance (Figure 4). By varying the thickness of the new substance, the retardation effects on a breach over time can be quantified.

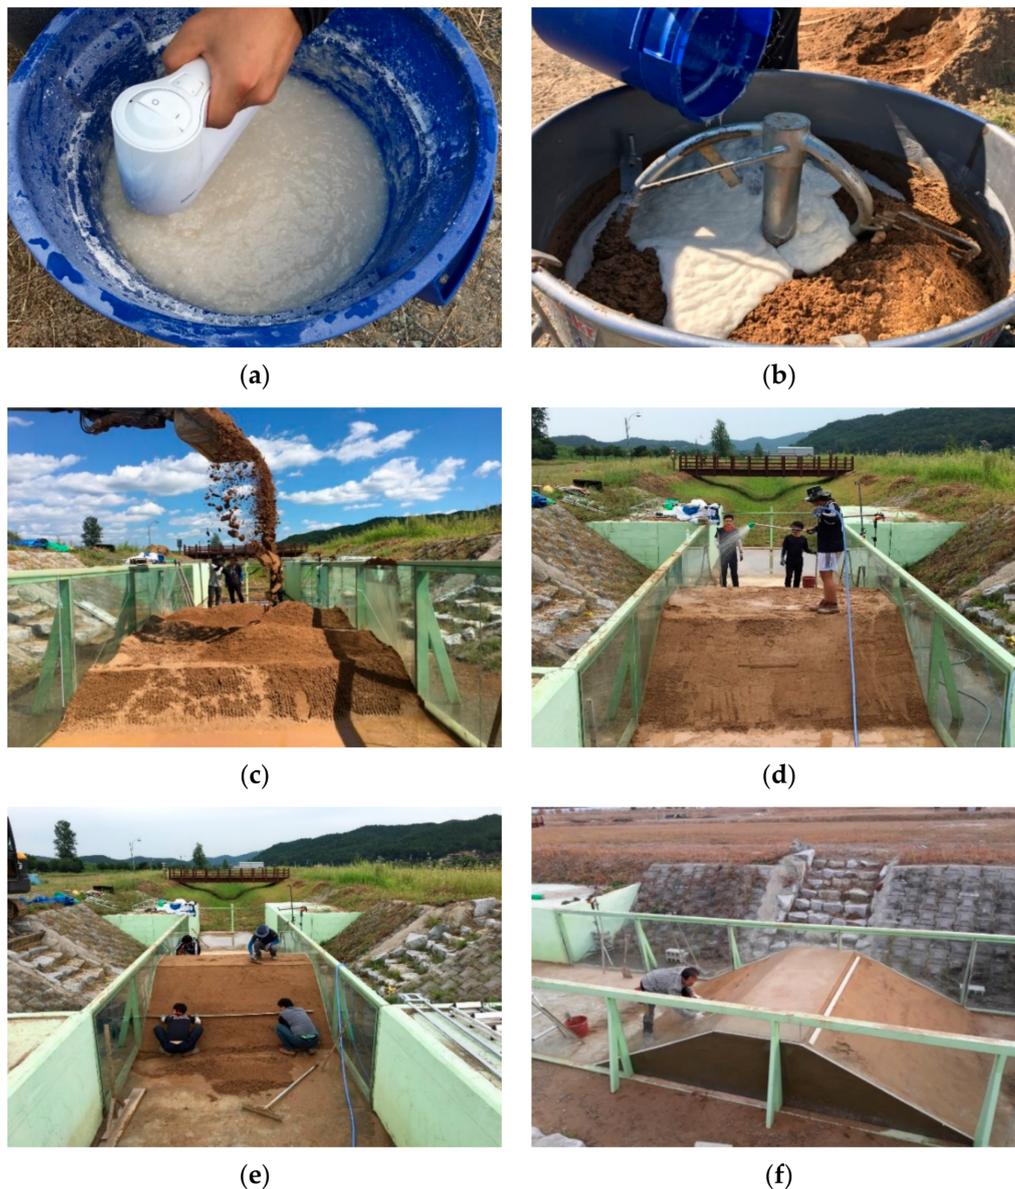
Figure 5. (a) Mixing with biopolymer and water, (b) mixing with biopolymer solution and sand, (c–e) creating a levee model, and (f) covering with the new substance.

The body of the levee was constructed as follows. Using an excavator (0.2 m³), the sand was dropped from a height of 3 m and was used to build the base of the levee. Next, the levee was built by repeatedly placing water-packed 20 cm layers on top of each other. After building the earthen levee, the biopolymer solution was made by diluting a powder biopolymer with water, and the solution was then mixed with soil. The new substance was then plastered over the levee crest and slope (Figure 5). As a result, the breach mechanisms between the earthen levee and the proposed levee using the new substance were compared.

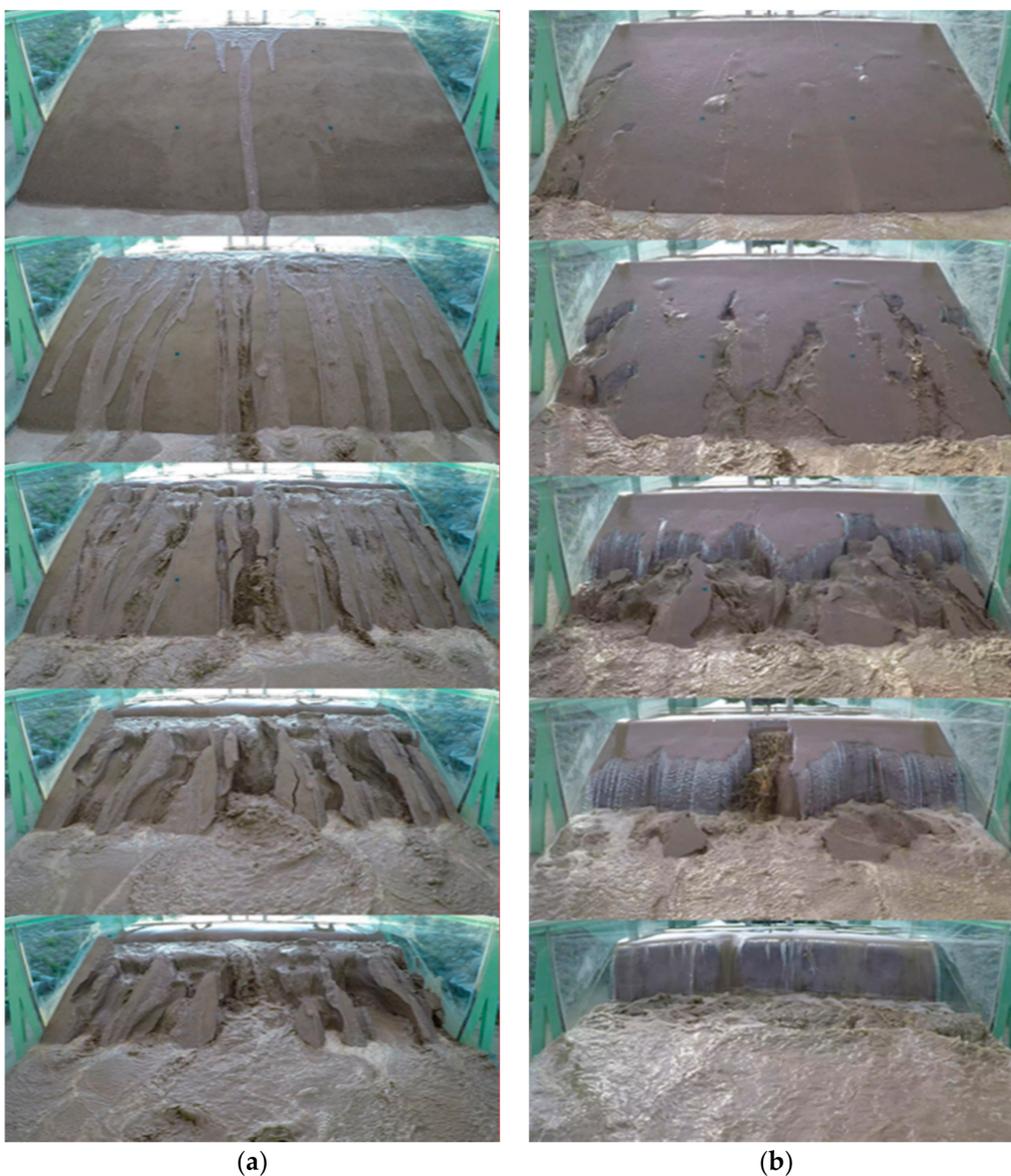
Figure 6. Breaching pattern (a) in the earthen levee, and (b) in the levee covered with the new substance.

This experiment using an earthen levee also showed that the initial overflow caused the levee crest and slope to be eroded. In other words, the initial flow on the levee slope developed a main flow channel that led to erosion. The continuous flow and the increase in the flow velocity aggravated

the streamwise erosion, which resulted in gully erosion with many small gullies. Ultimately, as the amount of overflow increased, the levee crest completely collapsed, and a deep breach surface was generated, which resulted in the maximum breach width owing to a strong shear stress. In the case of the proposed levee using the new substance, the initial overflow caused cracks on some parts of the cover; water penetrated the cracks, resulting in the cover peeling off or inflating. This seemed to be because the new substance was not completely consolidated, or the bio-soil dissolved in the overflow. Accordingly, the new substance needs to be improved by conducting further experiments. A strong vertical flow, which was generated as the resistance to the overflow on the levee crest, caused local scouring at the slope bottom, which resulted in vertical erosion (Figure 6). If the breaching mechanisms of the two types of levees can be compared over the same time, the differences between all breaching processes can be better identified. However, because the earthen levee had a much shorter breaching time than the proposed levee, the breaching process was divided into phases, irrespective of time.

The proposed levee with the new substance showed a totally different breaching pattern than the earthen levee. Although the runoff increased after a certain period of time and every part of the

levee was destroyed, unlike the earthen levee where the levee crest started collapsing owing to the initial overflow, the proposed levee did not show any erosion of the levee crest during the initial phase of overflow, but rather gradual erosion starting from the levee toe. The area of erosion tended to significantly decrease over time. The overtopping breach was observed by applying different thicknesses of the new substance. There was only a difference in the amount of collapse, and the overall pattern of the breach was similar. Consequently, because the new substance reduced the peak runoff by retarding the levee breach, it will be effective in reducing flood damage in low-lying areas or preventing secondary damage from a sudden collapse.

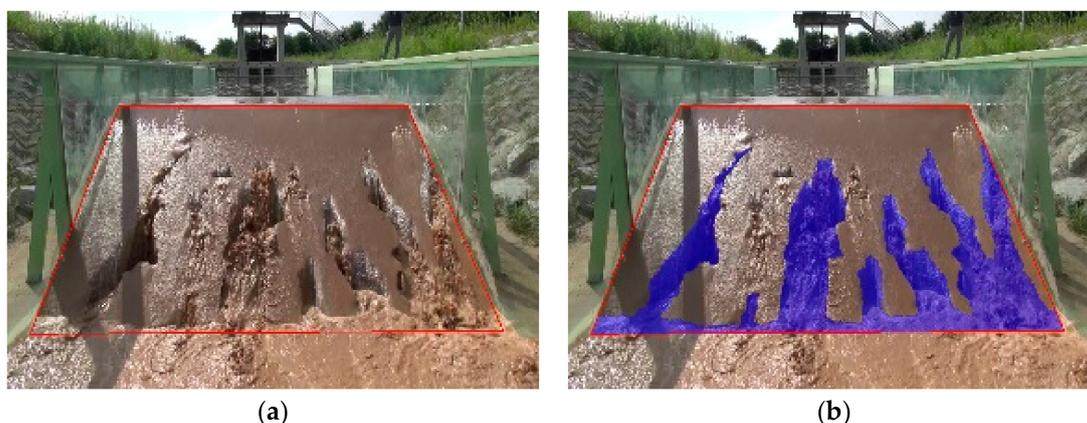
Figure 7. (a) Image calibration and (b) digitizing of breach range.

The experimental images taken by the image measuring system were edited and analyzed to verify the scale of the breach over time. Because an image-based analysis is very likely to produce an uncertain or erroneous calculation of the soil runoff caused by an overflowing levee breach, cross-sectional images of a breach on a levee slope were selected and quantitatively analyzed. For the quantitative analysis, the images of the levee slope were captured over time, calibrated, and then digitized to determine the range of the breach (Figure 7).

Graphic software was used for a pixel-based analysis of the target area. In this way, the scales and rates of the levee surface breaches were calculated. Under some experimental conditions, the compaction was not uniform, and an excessive breach was reproduced. To obtain stable results, the experiment was performed twice under each condition. The total number of pixels, which corresponds to the levee slope, was 105,000. Ultimately, the pixel was converted into eroded area as a physical unit. When a breach started, the area lost was calculated every 30 s. The breaching rate was assumed to be 0% at the moment when an overflow occurs. When the surface-breaching rate exceeded 90%, even when the experiment was repeated under the same conditions, the results tended to be inconsistent or the data were unstable. For this reason, any breaching rates over 90% were considered as complete breaches and excluded from the analysis range.

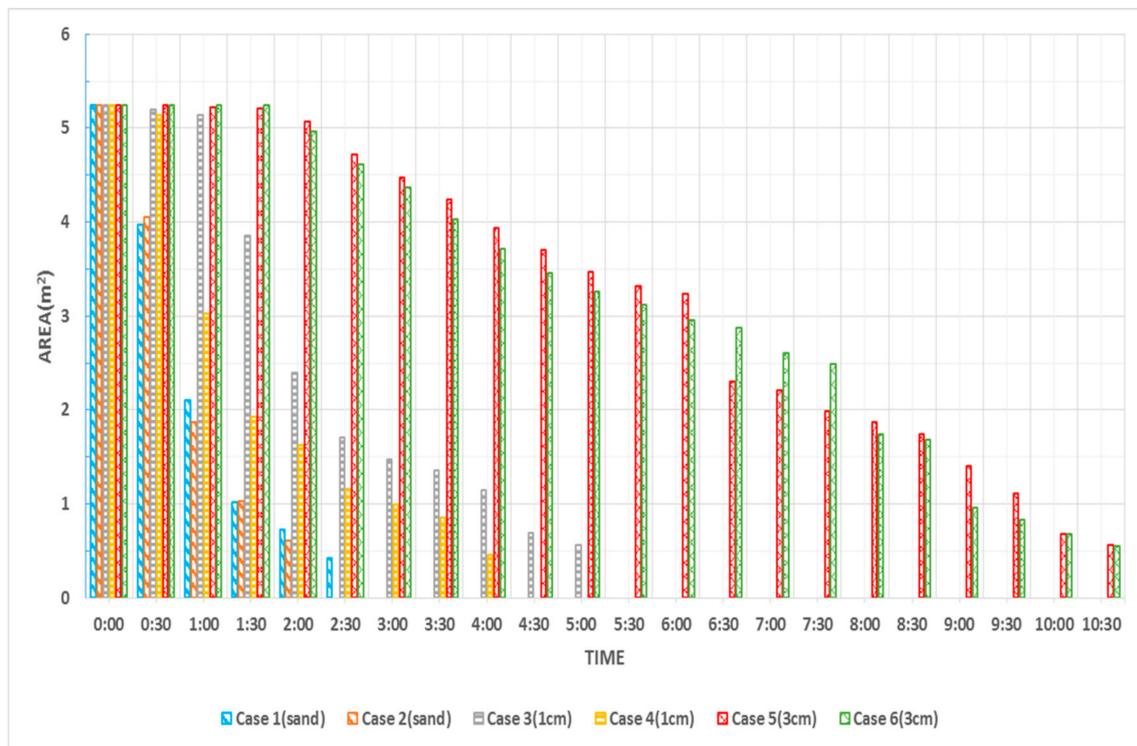
Figure 8. Reduction in the area along experimental cases over time.

As for the trend in the area reduction over time, which is illustrated in Figure 8, the earthen levee (Cases 1 and 2) showed a drastic decrease in the area simultaneously with the occurrence of an overflow. After 150 s, the area was reduced by over 90%, indicating a complete breach. In Case 3, where a 1 cm thickness of the new substance was applied, the area was maintained for 60 s after an overflow occurred. After 90 s, the area gradually decreased and then showed a drastic decrease until 150 s. Another case of a 1 cm thickness of the new substance (Case 4) showed a reduction in the area at the initial phase of overflow, which differs from the trend in Case 3. This indicates that the percentage of cracks created during the fabrication of the new substance greatly affected the initial breaching rate. The error tended to decrease over time. Compared to Cases 1–4, the 3 cm thickness (Cases 5 and 6)

maintained the same area for a while after the occurrence of the overflow. On the whole, the area tended to gradually decrease over time.

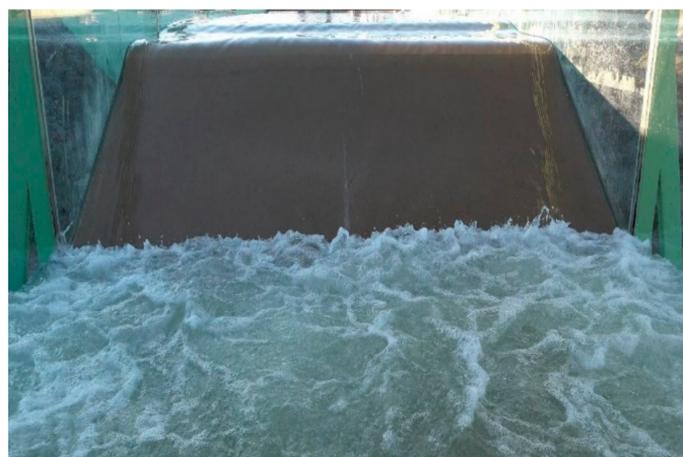
Figure 9. Backwater problem in the case of a 5 cm thickness.

However, when a 5 cm thickness of the new substance was applied, the breach was so excessively retarded that the levee toe began to be inundated with an overflow of water. In other words, the backwater effect affected the experiment with a thickness of 5 cm. For this reason, the performance of the levee could not be analyzed, and this case was excluded (Figure 9). As mentioned above, the experimental setup of this study conversely induced a water flow from the downstream end toward the upstream end. Accordingly, the overflow of water came back to the downstream end before the levee was breached. To evaluate the performance of a levee with the new substance applied at over 5 cm in thickness, the experimental channel needs to be modified accordingly.

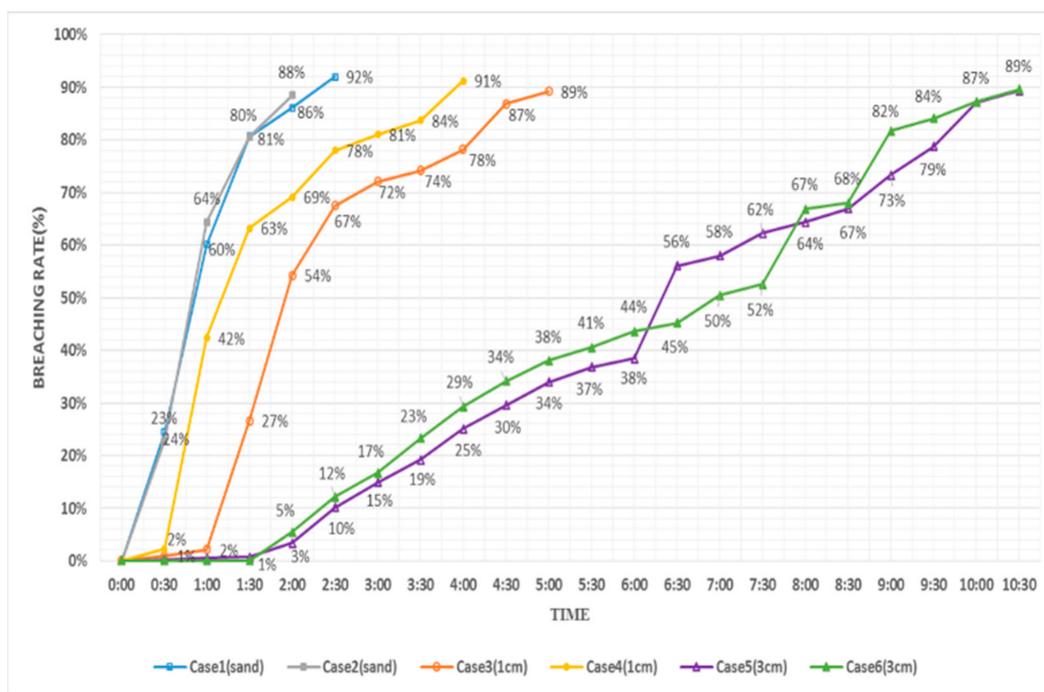
Figure 10. Breaching rates along experimental cases over time.

Figure 10 shows the breaching rates of the levee surface over time. Because an overflow occurred, the breaching rates of the earthen levee (Cases 1 and 2) were 23–24% at 30 s, 60–64% at 60 s, 80–81% at 90 s, and 86–92% at 120 s and after. The breaching rates of the levee with 1 cm of the new substance (Cases 3 and 4), with the exception of the initial overflow phase, were 54–69% at 120 s, 67–78% at 150 s, 72–81% at 180 s, 74–84% at 210 s, and 78–91% at 240 s and after. Another levee with 3 cm of the new substance (Case 5 and 6) showed a breaching rate of 5% or less until 120 s, and reached a 50% breaching rate at as late as 390 s. This levee was gradually breached until 630 s, after which the breaching rate exceeded 90%, indicating a complete breach. When the 1 and 3 cm thickness of the new substance were applied, the total breaching times were calculated to be 300 and 630 s, respectively, and based on the above breaching rates. These results indicate that the breach could be retarded by 2 to 4.2 times that of the earthen levee.
