Case Report

# Contribution of Excessive Supply of Solid Material to a Runoff-Generated Debris Flow during Its Routing Along a Gully and Its Impact on the Downstream Village with Blockage Effects

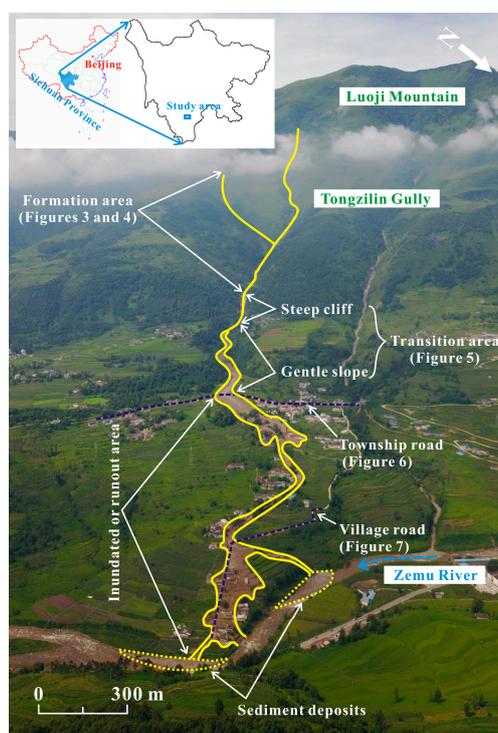
**Figure 1.** An overview of the study area by aerial photography on 8 August 2017 with the site location of the study area on a map of China.

In this work, a debris flow that occurred in the Puge County will be used as a case study (Figure 1). Aimed at understanding the mechanism of sediment supply conditions that influence the evolution of debris flows and artificial structures that influence movement process, the event will be analyzed in detail in the paper. Emergency field investigations identified three regions in the study area: the formation area, the transition area and the inundated or runout area, which reflect, respectively, the corresponding different activity characteristics of debris flows. After comprehensive analyses of the results of the field investigation and three essential factors (generation of surface runoff; supply condition and channel steepness), the contributions from the excessive supply of solid materials and local blockage with outburst along the gully channel will be discussed systematically in this paper.

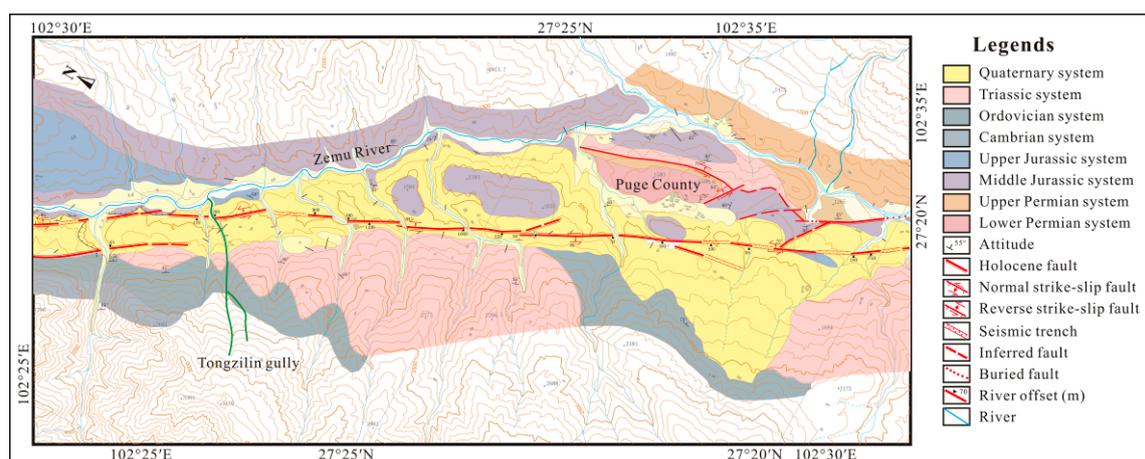
**Figure 2.** Geologic and geomorphic map of the Zemuhe fault zone around the study area.

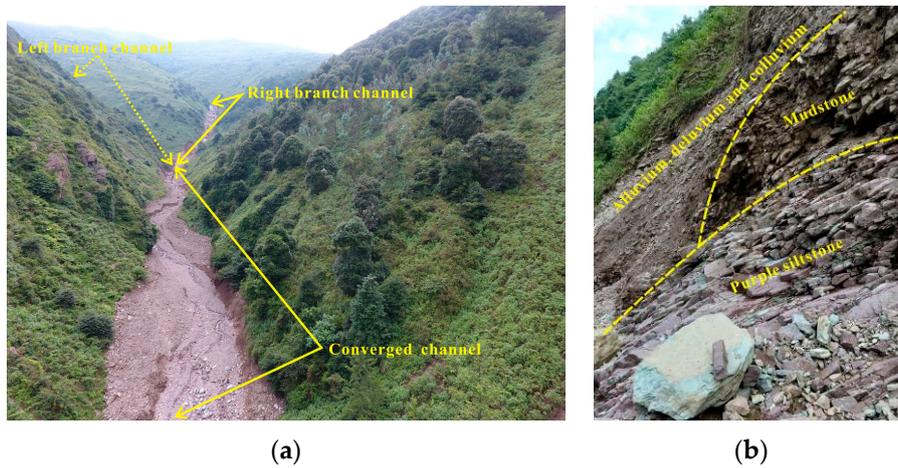
**Figure 3.** (a) An overview of the formation area in the study area by aerial photography. (b) Lithological composition exposed behind the bank slope.

over 400 m from the convergence in the catchment channel with a flow direction of N73°E due to the difficulties raised by the steepness. The right channel in the formation area is characterized by an irregular topography transforming from a V-shape to a U-shape with a bed width ranging between 5 and 12 m. As shown in Figure 3, the slope gradient of channel banks of the Tongzilin gully is approximately 25°–35°. The slope is mainly covered by Quaternary alluvium, deluvium and colluvium, with several bedrocks exposed locally in steep slopes and cliffs. The bedrock is characterized by purple siltstone and mudstone with a dip angle of approximately 40°. Because of the influence of fault activities, the rock mass is broken with abundant joints and fractures. As shown in Figure 4, the slope surfaces of both the channel banks have a sharply scoured topography, with the loss of vegetation cover. The toes of the banks have been incised and eroded with an undercutting depth of 1–6 m. A number of outcrops are characterized by rocks wrapped in sediment and a few plant roots on the undercutting surface. A significant amount of residual materials were retained in the gully channel, most of which are washed rocks characterized by siltstone (purple, grayish green and grayish yellow). These rocks were transported by the debris flow from places with higher elevations.

The local side edges are covered by several rocks in the gully bed that are wrapped in sediments and originated from the collapse of the bank slope. The residual crushed rocks in the gully channel vary in size, mainly from 0.05 m to 0.15 m, and a few large stones vary from 1.0–2.5 m.

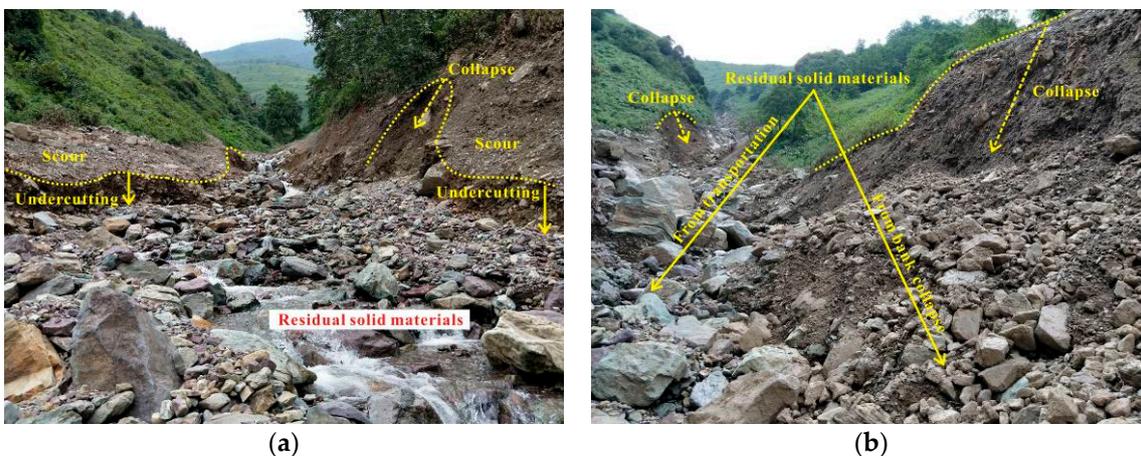
**Figure 4.** (a) An overview of the gully channel in the formation area. (b) Morphological observation of the residual material in the side edge of the gully channel of the formation area.

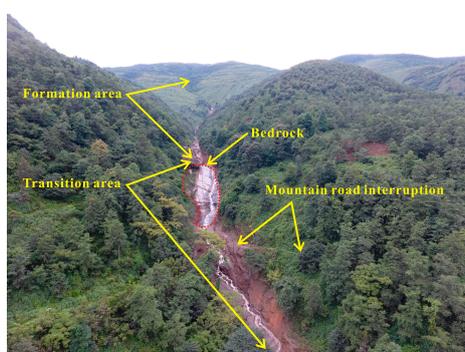
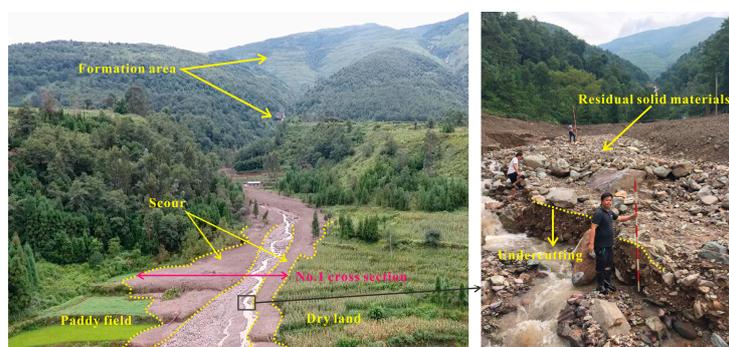
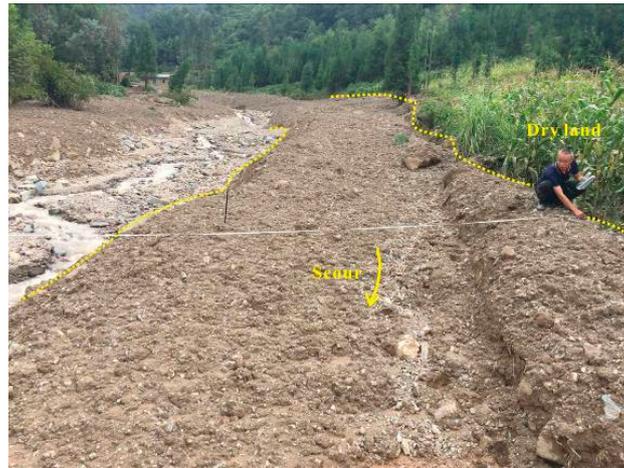
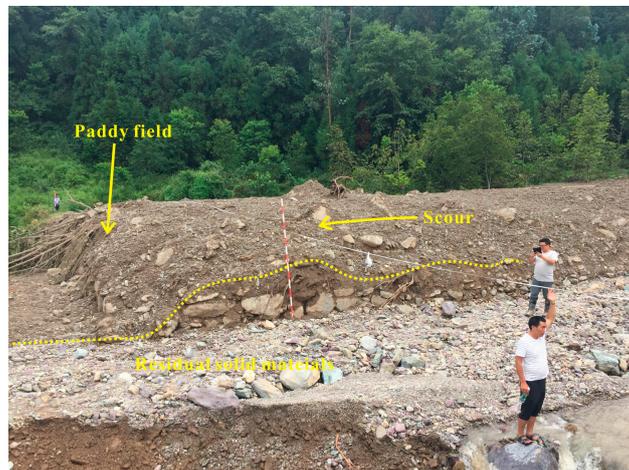
**Figure 5.** (a) A photo of the gully channel between the formation and transition areas. (b) A photo of the gully channel in the transition area. (c) Scour of the right bank of the gully channel in the transition area. (d) Scoring of the left bank of the gully channel in the transition area (all photos were shot on 9 August 2017).

The transition area flows on a steep cliff and a gentler slope. As shown in Figure 5a, a large bulk of bedrock was exposed at the top region of the steep cliff. The altitude difference of the steep cliff is approximately 200 m. In the steep cliff, the scale amplification of the debris flow occurred due to the erosion of the accumulated deposits in the gully channel and its movement also accelerated substantially because of the large altitude difference which led to a change of morphological characteristics similar to that in the formation area. During the flows, the debris interrupted the mountain road below the exposed bedrock and destructed the roadbed at the junction of the steep cliff and gentle slope. Because of the hydraulic erosion on the sediment bed, the surface runoff took away loose solid material and the shallow surface of accumulated deposits and gradually turned into a debris flow [9,48,49]. Field surveys on the surface geomorphology after the debris flow event show that a layer of mud sediment was left and accumulated on the scoured surface on both sides. Three cross-sections are selected from downstream to upstream for the measurement of morphological characteristics (Table 2). Because of the great erosive energy caused by a large slope gradient, both channel banks were eroded and incised with an undercutting depth of approximately 1 m. This is particularly evident at the location near the corner where the sediment deposits have a larger covering width. In the channel and its neighboring area, broken stones of different sizes are left on the earthen surface by transportation from higher places.

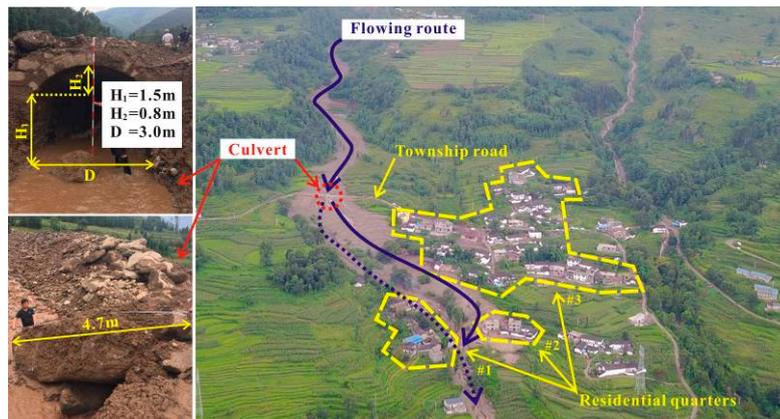
**Figure 6.** Route diversion of the debris flow after the arc culvert of the township road in the inundated or runout area with morphological observation of the cleared arc culvert of the township road and the great stone block in the arc culvert after cleaning (all photos were shot on 9 August 2017).

Two roads cross the channel in the inundated or runout area at elevations of 1505 m and 1420 m, respectively. The township road was constructed in 2015 at an elevation of 1505 m. In addition, a flat section of channel with a width of 8–10 m was formed because of excavation and an arch culvert was built up to discharge the surface runoff around the subgrade. The arch culvert has a width of 3.0 m, a sidewall height of 1.5 m and an arch height of 0.8 m (Figure 6). As shown in Figure 6, a large stone, with an approximate length of 4.7 m, a width of 2.0 m and a height of 1.7 m, was found when cleaning the culvert after the events. The giant stone that was transported by debris flow blocked the culvert with the expansion of the inundated or runout area by accumulating solid material at the entrance of the arch culvert, further causing discharge diversion because of the burst after blockage.

In the content of geomorphology, the outburst refers to the sudden release of surface runoff or debris flow when the barrier collapses or is eroded. The local blockage and outburst along the gully channel caused by culverts of the road project is another reason for the painful outcome. That is because the blockage and outburst changes the route of the debris flow which may aggravate the property damage and casualties. However, the original plan of facilitating the siltation and discharge control eventually enhanced the geologic hazard due to the fact that the culvert designs underestimated the discharge of the debris flow. The blockage of the culvert is a significant phenomenon in debris flow [27]. When the debris flow moved to the arch culvert (as shown in Figure 6), the flow movement was obstructed because of improper design. At that moment, the arch culvert and the solid materials inside played the role of a temporary dam and the part of surface runoff flow along the original channel by overflow. With the continuous supplement from the debris flow, the solid materials were collected behind the temporary dam as well as on the road surface nearby. During the accumulation process of solid materials, the accumulation of solid materials above the road surface had a shocking impact until they were destroyed. When the part of the blockage above the road surface was destroyed, the accumulated solid materials generated an outburst. After the destruction, the debris flow changed its direction with a tendency of running to the lower elevation since the road surface is characterized by a dip angle from the horizontal level. Eventually, the debris flow changed flow direction and inundated at the #2 and #3 residential quarters with tremendous velocity. If no blockage effect occurred within the arch culvert, only the #1 residential quarter may have been inundated and the damage may have been substantially reduced. However, in this event, 18 deaths were caused in the #2 and #3 residential quarters.

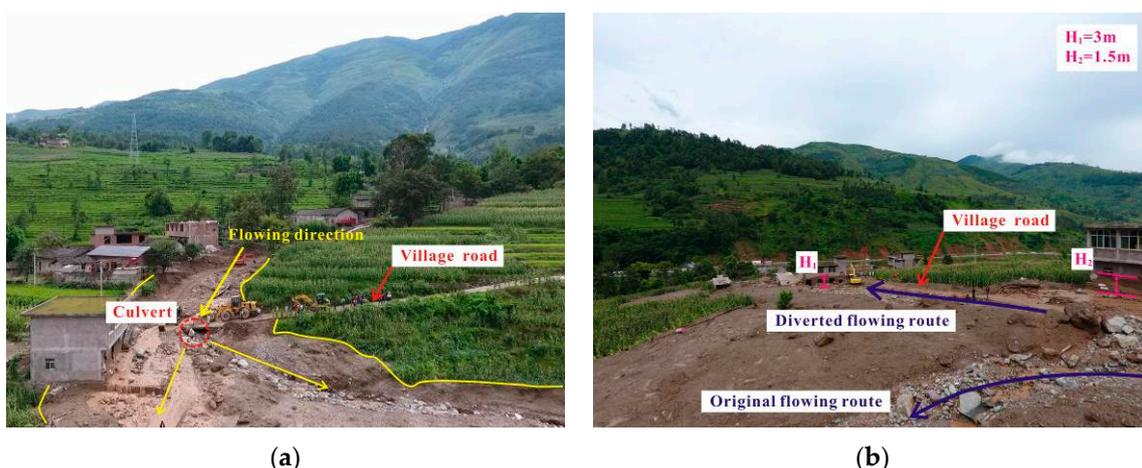
**Figure 7.** (a) Flow direction diversion of the debris flow after the rectangle culvert of the village road in the inundated or runout area. (b) Hazard trace situation after the diversion of the debris flow in the inundated or runout area (all photos were shot on 9 August 2017).

After rapidly changing the flow direction, the debris flow spread and inundated the #2 and #3 residential quarters, causing 18 deaths and the destruction of houses. The sediment deposits silted up in front of the buildings had a covering height of approximately 3–4 m. A small portion of the debris flow ran through the culvert or over the road surface and continued to run along the original channel. The village road was constructed in 2014 at an elevation of 1420 m. A rectangular culvert had a height of 1.5 m and a width of 2.6 m where the original channel has a bend with a turning angle of approximately  $60^\circ$ . As shown in Figure 7, when running through this area, the debris flow carried large block stones, occluding the rectangular culvert and further causing the second discharge diversion. A flow ran along the original channel into the Zemu River and the other flow rushed straight down to the residential quarters along the village road killing seven people and covering the buildings with sediments. Eventually, the two flows entered the Zemu River and turned into two piles of sediments and blocked the river channel with a shape of a circular sector in a view of a vertical angle.

The blockage secondly occurred in the rectangle culvert, however with several differences from the first one because of topographic differences: (i) the original channel has a turn of 60° in the rectangle culvert; (ii) the road surface is parallel to the horizontal level. Known from the post-disaster situation, the debris flow was divided into two parts when passing through the second culvert. The original channel has a change of direction after the culvert. One part ran along the original channel by overflow and the other part continued the preceding flow direction by outburst.

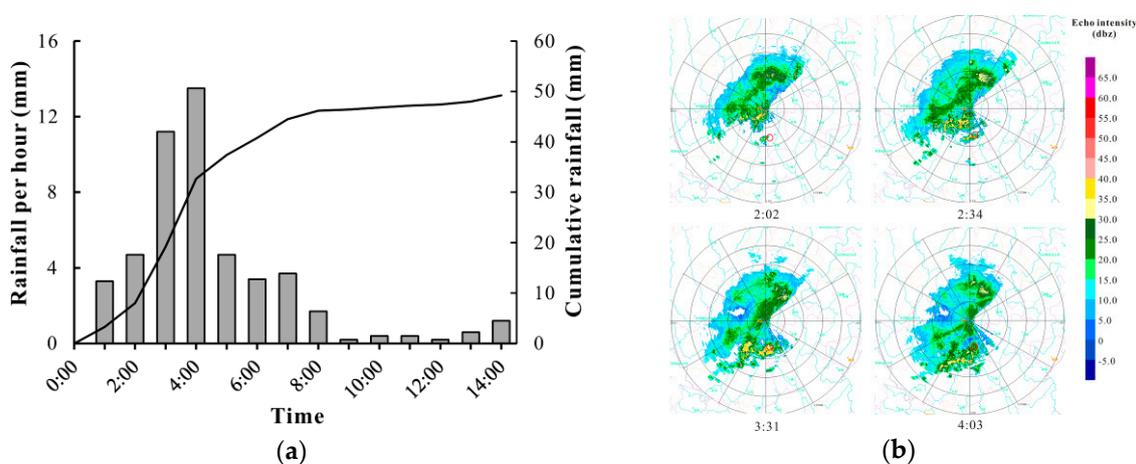
**Figure 8.** Rainfall characteristics on 8 August 2017. (a) Hourly and cumulative rainfall measured by the Qiaowo meteorological station. (b) Evolution of the reflectivity factor at an elevation of 2.4 degrees on the Doppler radar of Xichang city.

The closest meteorological station is located at the northwest of the study area and the distance is about 1.2 km from the study area. Rainfall data are shown at hourly intervals in Figure 8a, together

with the cumulative rainfall. Rainfall intensity progressively increased and reached a maximum value of 13.5 mm/h between 3:00 and 4:00 a.m. and decreased thereafter.

The study area was completely covered by a Doppler weather radar which is located at Xichang city and can cover an area with a radius of 150 km. The radar location is approximately 47 km away from the study area and the scan elevation of the reflectivity factor is  $2.4^\circ$ . As shown in Figure 8b, at approximately 2:02 a.m., a small part of local convection with a peak echo intensity of 30 dBz (unit of radar reflection factor) was observed in the northwest of the study area. Then, at approximately 2:34 a.m., the peak of the echo intensity was observed in correspondence with regions located southwards and the peak echo intensity was increased. At approximately 3:31 a.m., the main echo was observed in the immediate vicinity of the study area; combined with local convection, it caused the initiation of sustained precipitation. In this moment, the peak echo intensity (reaching 40 dBz) was located in the study area. After 4:03 a.m., the echo intensity in the study area decreased, however the peak intensity of the main echo was still 30 dBz. After that, the peak echo intensity in the study area weakened.

According to the dynamic analysis of the Doppler weather radar, the occurrence time of the debris flow was estimated to fall between 3:30 a.m. and 4:00 a.m. In the previous hazards, such as the Zhouqu, Wenjiagou and Yingxiu events, the cumulative precipitation before the hazard occurrences was not smaller than 100 mm [37–39]. As shown in Figure 8, the recorded cumulative precipitation in this event was only 49.2 mm, which is a relatively small value. The elevation difference of the basin in the Tongzilin gully is approximately 2038 m and the basin areas above 2000 m are the regional high intensity rainfall zone without a meteorological station. The current meteorological station is located at an elevation of approximately 1400 m. Therefore, the measured value of precipitation is likely less than the real value in the middle and upper reaches of the basin area.

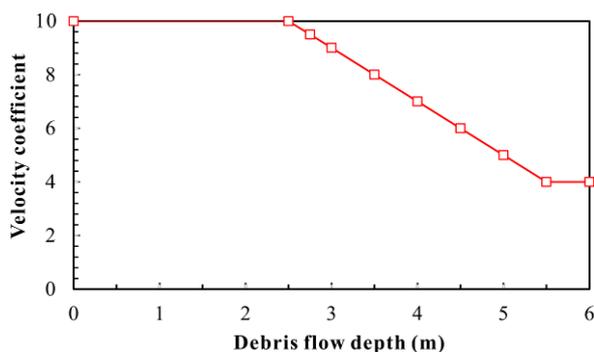
**Figure 9.** Recommended values of the velocity coefficient ( $K_c$ ) by debris flow depth ( $H_c$ ).

$K_c$  is a factor that is related to debris flow depth of which the value can be obtained by Figure 9;

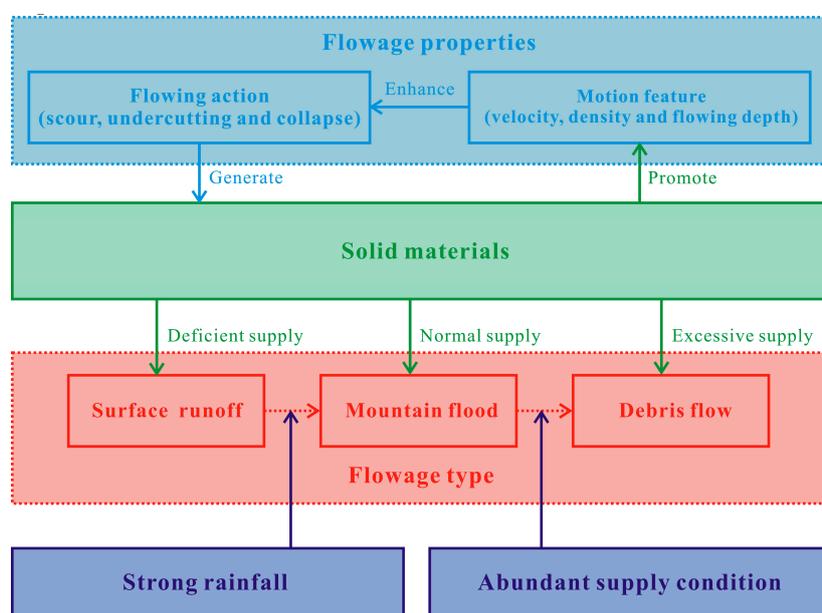
**Figure 10.** Evolution of mountain water hazards and the cascading process of the supply for hazard formation and development.

According to local residents, a large-scale mountain flood has not occurred in the past 100 years. When a rainfall with intermediate intensity occurs, a small-scale surface runoff is formed with low scraped depth. In terms of the impact of the small-scale surface runoff on the supply conditions, abundant accumulated deposits exist in the gully channel that originated from mass movement processes (shallow landslides, collapses, rockfall and others) and tectonic activities. Due to the rare occurrence of severe mountain floods in the past, plenty of solid material has remained in the gully channel in the past 100 years. Different discharges generate different scale of debris flow as matter of the availability of loose sediment at the channel bed [27–29]. In this event, the abundant surface runoff carried out more supplies of solid materials from the actions of scour, undercutting and collapse. The abundant surface runoff is able to mobilize large quantities of sediments with the flow velocity depending on runoff discharge, while flow depth and sediment concentration is dependent on the grain size [52,53]. The constant supplies persistently improve the motion features (velocity, density and depth) of flow and further persistently enhance the erosion action. As shown in Figure 10, this interaction generates the scale amplification and energy escalation to develop flows in a cascading way. Eventually, the excessive supply of solid material allows the development of a large scale and catastrophic debris flow.

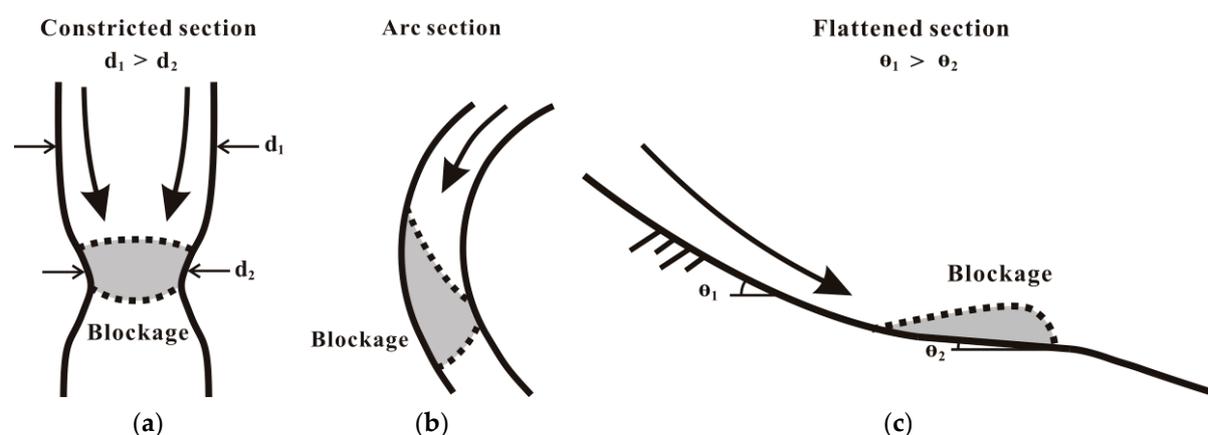
**Figure 11.** Blockage types of debris flows occurring on natural topography: (a) constricted section of gully channel, (b) arc gully channel and (c) intersection between the gully channel of the larger longitudinal gradient and the gully channel of the smaller longitudinal gradient.

The dynamics of the propagating surge is a function of different parameters, including the sediment content, channel slope angle and run off [54]. As shown in Figure 11, the common types of natural topography that are favorable for the blockage of debris flows included (i) the constricted section of gully channel, (ii) arc gully channels and (iii) the intersections between the

gully channels of different longitudinal gradients. The causes of the blockage were the reduction of flow area, the change of flow type and the decrease of flow velocity. The occurrence of the debris outburst, however, requires some necessary conditions, i.e., certain slope gradients on both sides and sufficient supply of solid materials. The slope in this area is sufficiently steep for the generation of large scale surface runoff, implying a significant amount of gravitational energy. As such, the gravitational energy of abundant solid materials in the debris flow has been converted to kinematic energy, which can eventually destroy the blockage. The potential energy is not enough without water, and solid material would stop. There is also the contribution of the inertia of the arriving solid-liquid mixtures at the obstructed site. In some circumstances, the responses of surface and underground water were also involved in the outburst phenomenon, including the seepage forces within the blockage, the osmotic force of underground water and the erosion by surface water. However, in general, the blockage and outburst that are caused by natural topography have little influence on human activities.

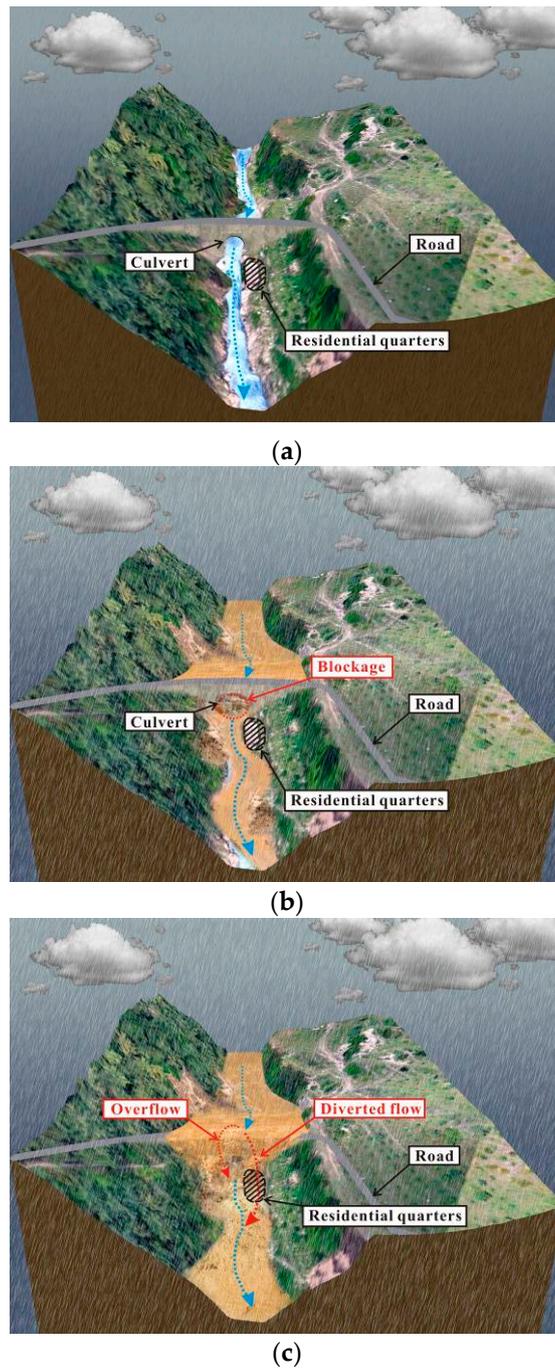
**Figure 12.** Diagrammatic sketches of different sorts of flow: (a) normal surface runoff, mountain flood or small-scale debris flow passing through the culvert; (b) a large-scale debris flow passing through the culvert and (c) a special circumstance of a large-scale debris flow passing through the culvert with the participation of a great stone block.

When a debris flow spreads into human settlements, the blockage followed by outburst that is caused by civil works (such as the culvert or other types of buildings) turns out to be a serious threat to the safety of human life and property. It usually occurs as a result of the combination of multiple factors, especially when excessive solid materials are available [55–57]. If it is a normal surface runoff or a small-scale debris flow, as shown in Figure 12a, it would pass through the culvert without the blockage because of the lack of sufficient solid material. As shown in Figure 12b, debris flow of a large scale cannot be discharged through the culvert and a blockage that acts as a dam temporarily occurs. During the process, as shown in Figure 12c, some of the debris flow runs across the road surface by overflow. The blockage above the road surface will eventually be destroyed by the continuous coming of the debris flow behind. One example of the outburst is depicted in Figure 12c. Following the outburst, the release of aggregated potential energy instantaneously made the debris flow at a high velocity. In this event, the two discharge diversions that were caused by the blockage and outburst are similar, however they have several differences. The discharge diversion occurring at the rectangle culvert of the village road is because the original channel makes a turn right there. The discharge diversion occurring at the arch culvert of the township road, however, is a special case that is mainly controlled by the small transverse slope gradient of the road surface. Because some residential quarters are in the downstream direction, the debris flow has caused severe damage to the properties and several casualties, which could have been avoided with a stronger discharge capacity culvert.

- (4) The transformation of natural topography by human activities is likely to increase the risk of geologic hazards. In the case of the Puge event, the blockage effect of two culverts made great contributions to the movement of debris flow by changing the flow direction. The construction of prevention and mitigation measures for geologic hazards must consider the occurrence and movement. Therefore, coordinating the relationship between humans and nature is the key to dealing with geologic hazards, including the rational layout of human living space, the thoughtful design of hazard prevention, mitigation construction and the effective conservation of soil and water.
