# Highwater Mark Collection after Post Tropical Storm Dorian and Implications for Prince Edward Island, Canada

**Abstract:** Prince Edward Island (PEI), Canada has been experiencing the consequences of a rising sea level and intense storms on its coasts in recent years. The most recent severe event, Post Tropical Storm Dorian (Dorian), began impacting Prince Edward Island on 7 September 2019 and lasted for over 20 h until the morning of 8 September 2019. The measurement of highwater marks (HWM) from the storm was conducted between 25 September and 25 October 2019 using a high precision, survey grade methodology. The HWM measured included vegetation lines, wrack lines, beach, cliff, and dune morphological features, and tide gauge data at 53 locations in the Province along coastal areas that are exposed to high tides, storm surge, high winds, and wave runup. Photos were taken to provide evidence on the nature of the HWM data locations. The data reveal that Dorian caused extensive coastal floods in many areas along the North and South Coast of Prince, Queens and Western Kings Counties of Prince Edward Island. The floods reached elevations in excess of 3.4 m at some locations, posing

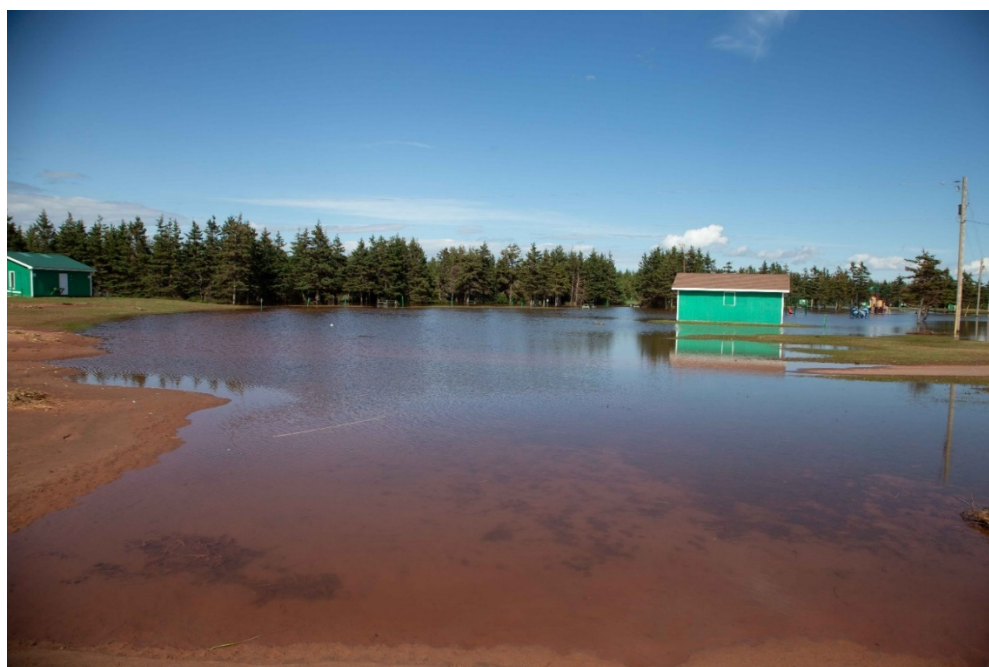
**Figure 8.** Storm Surge Flooding West Point, PEI.

Figure 8 is a photo of storm surge flooding at West Point near the lighthouse at Cedar Dunes Provincial Campground on 9 September 2019, over 24 h after the peak water level occurred. The saline surge water overtopped a low-lying dune and was trapped when the storm waves subsided.

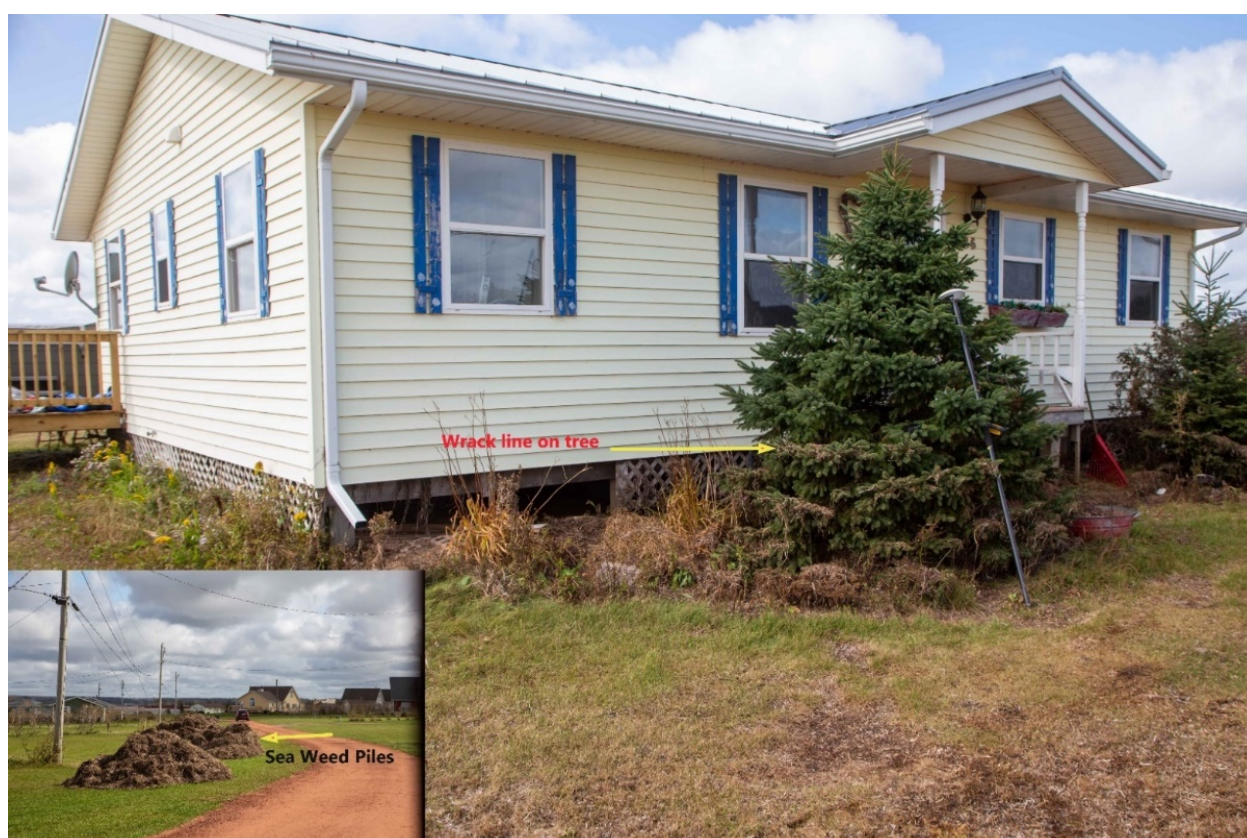
**Figure 11.** Seaweed wrack line on trees on MacEwen's Island after Dorian with Inset Map Showing Sea Plant Piles.

The storm surge hit the Hebrides subdivision at McEwen's Island, PEI on the night of 7 September and the early morning of 8 September 2019 and did some damage to cottages. The tide rose to a height of 20 cm above the floor of one cottage located on the isthmus to McEwen's Island (see Figure 11) ripping away the front entryway stairs from the frame, carrying it across the small tidal inlet of New London Bay to the opposite southwest shore by the water and waves. Water rose on the trees outside the cottage to a depth of 91 cm with sea moss debris deposited on the trees, as shown in Figure 11.

There were piles of sea moss and sea plants all along the lower sections of Hebrides Lane and Skye Lane as shown on Figure 11. The geographic location of cottage on the low-lying isthmus to MacEwen's Island is provided in Figure 12. This area is very vulnerable to storm surges during events such as Dorian.

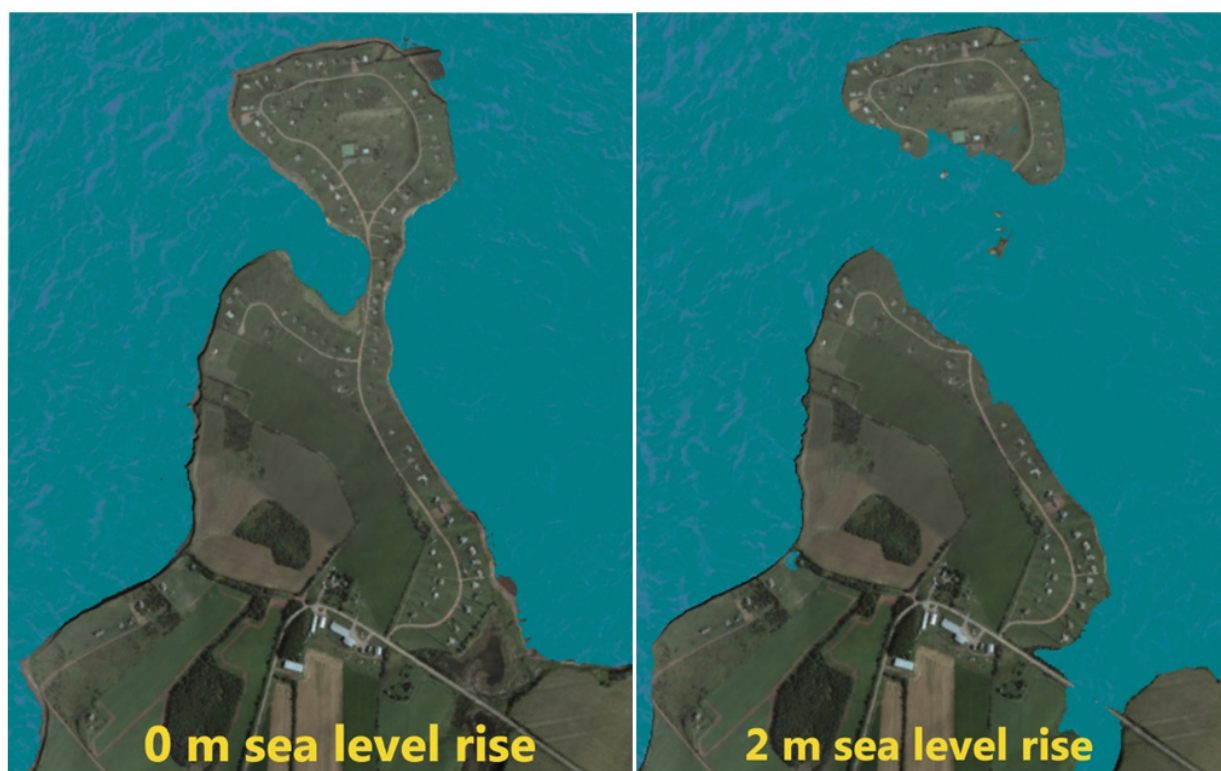
**Figure 13.** Visualization of areas impacted by 2 m storm surge on MacEwen's Island.

The causeway road to the other part of MacEwen's Island was also flooded during the storm. Figure 13 shows the visual impact of the area inundated by the storm surge which reached 2.17 m geodetic (CGVD28). These visualizations are created using the CLIVE tool developed by Fenech et al. [4].

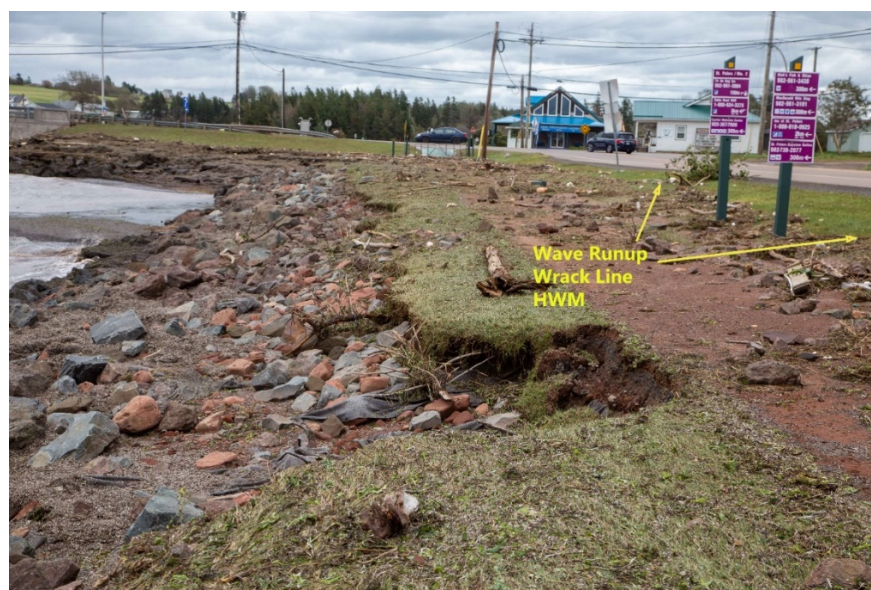
Figure A1. HWM from Wave Runup Wrack Line at St Peters Bay.

| Location | Longitude | Latitude | Geodetic High-Water Level (CGVD28) (m) | Vertical * Precision (m) | Category (as Defined by URS Group, 2006) |
|---|---|---|---|---|---|
| St. Peters Bay Park N end 2 (Figure A1) | −62.5834 | 46.4184 | 2.97 | 0.04 | Wave runup, Wrack line |

Figure A1 shows the extent of flooding from the storm surge and wave runup at St. Peter's Bay as evidenced by the HWM wrack line in the photo.
