Article

## Estimation of Soil Erosion Rates and Eroded Sediment in a Degraded Catchment of the Siwalik Hills, Nepal

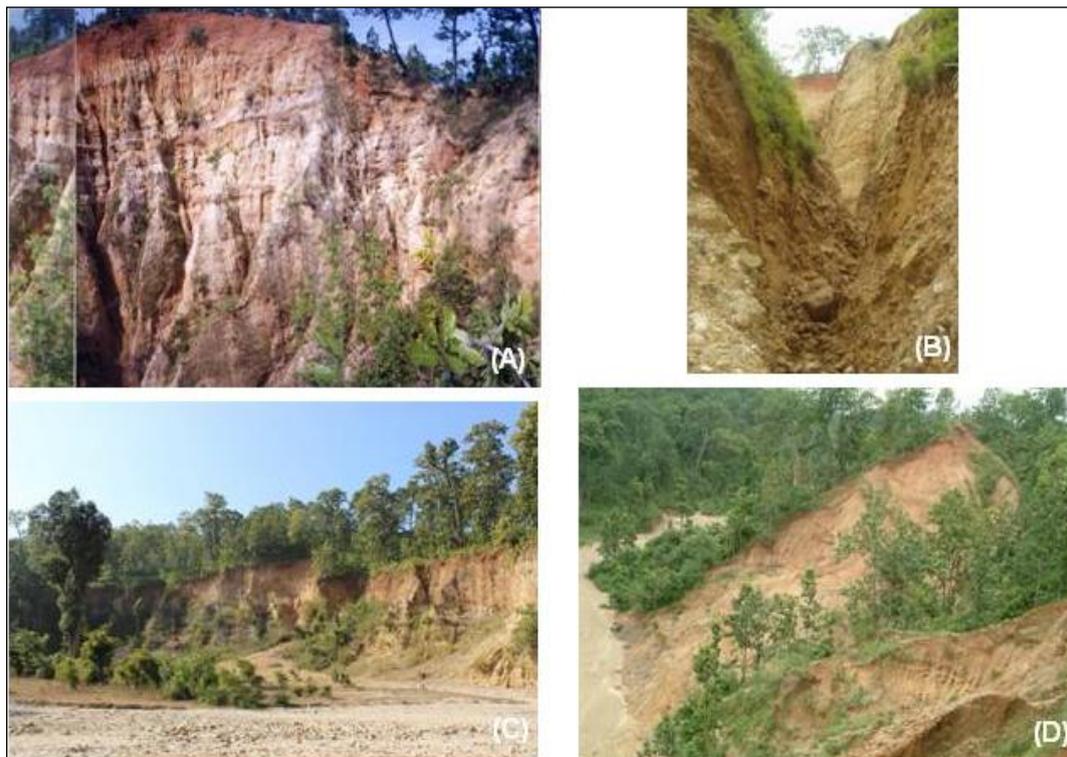
**Figure 2.** Different types of sediment sources: (A) gully head; (B) gully channel side slopes; (C) eroded bank slope; (D) landslide.

Tropical deciduous forest cover (mainly *Shorea Robusta*) dominates the upper reach of the catchment [31] whereas the middle reach comprises a combination of forest, shrubs and terrace cultivation (Figure 1B). The lower reach mostly consists of a combination of human settlement and cultivation. This region is characterised by humid tropical climatic conditions where mean winter daytime temperatures are between  $22^{\circ}\text{C}$  and  $27^{\circ}\text{C}$  and summer temperatures exceed  $37^{\circ}\text{C}$  [27]. The average annual rainfall is  $1,875 \text{ mm}$  as measured at Lahan and Gaighat [32]. The catchment has many tributary watercourses and numerous drainage flow paths that mostly originate from the upper and middle reach of the catchment. Various types of soil erosion were evident within the catchment, predominantly sheet erosion, gully erosion, river bank erosion and landslides (Figure 2).

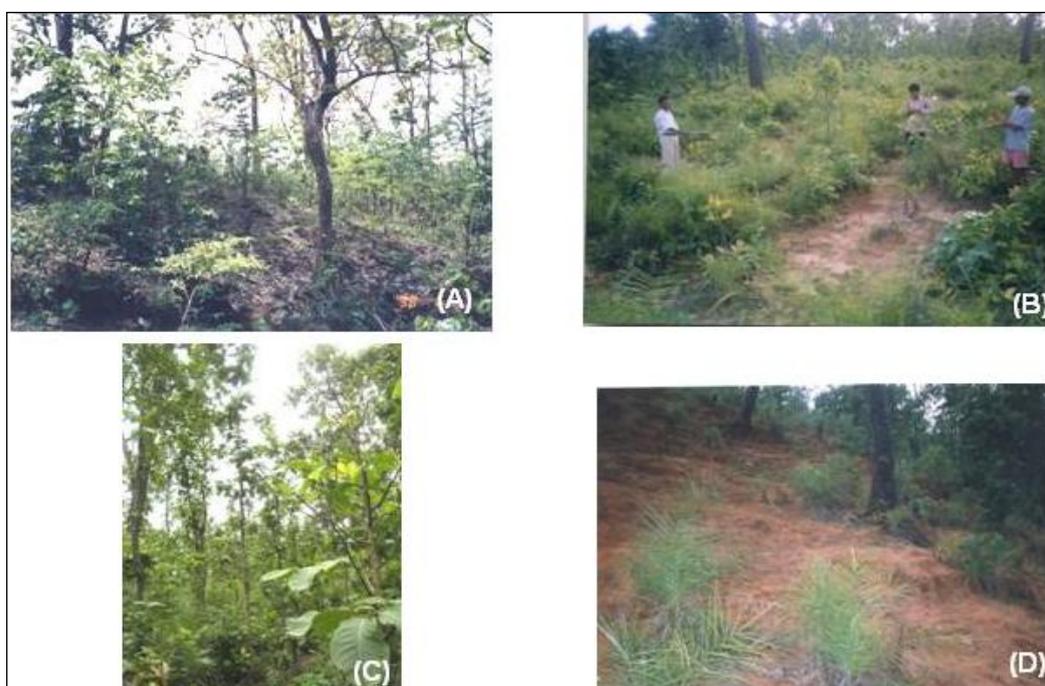
**Figure 3.** Sheet erosion monitoring sites: (A) dense forest; (B) shrub and bush; (C) dense forest with shrub; (D) bare ground.

A total of four monitoring sites were established considering different land covers (Figure 3, Table 1). The local slope gradient of these sites varied from 10 to 35 degrees and slope length from 9 to 38 m which were representative of the typical land topography of the Siwalik Hills. The sites located on the forest and shrubs generally consisted of black soil containing mostly silt and fine sand. The site on the bare land however comprised of red soil with silt and fine sand. Erosion pins were inserted into the soil along five slope transects with 3–5 m intervals across the slope. For each transect, five pins were spaced at 5 m intervals downslope. The lengths of the pins that were left exposed above the soil surface were measured two times a year (during summer and winter) using a measuring tape with a precision of 1 mm. The bulk density of the surface soil at each site was also measured. Thus, the mass of soil eroded or deposited per unit area ( $\text{kg m}^{-2}$ ) can be calculated by multiplying the change of length of the pins left above the soil surface, by the bulk density of the soil layer [39].

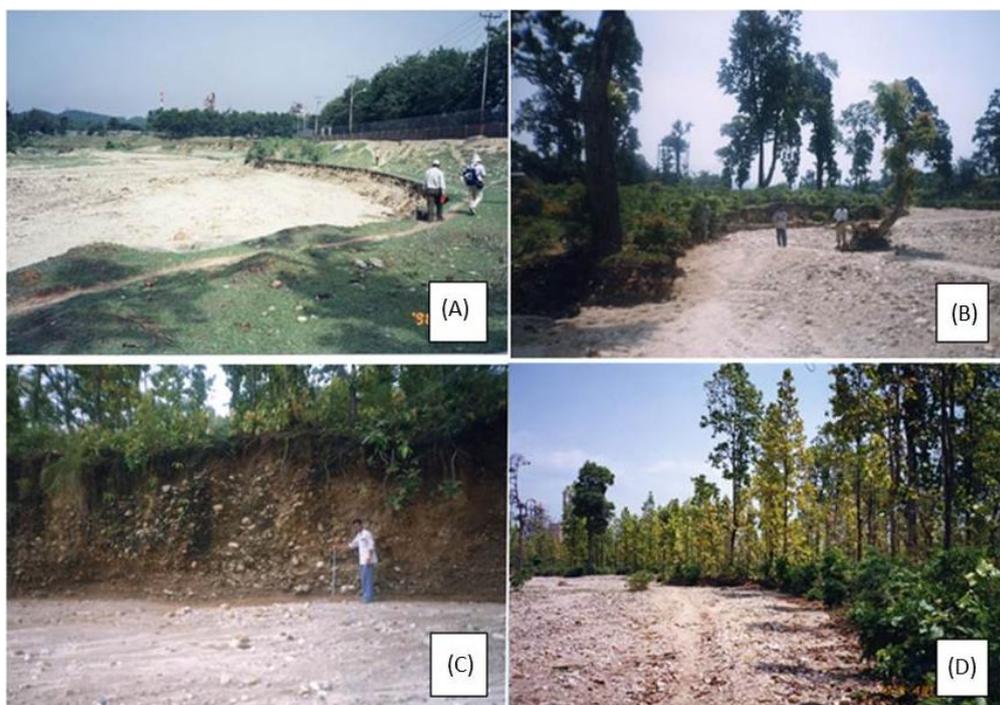
**Figure 6.** Examples of different types of stream banks and vegetation ((A) bare land; (B) shrubs; (C) shrubs and grass; (D) dense forest).

Three types of near-bank vegetation can be found: dense forest, shrubs and grass, and bare land. In the upper and middle reaches, the majority of the banks consisted of forest cover, especially young Sal (*Shorea Robusta*) forest. Partially dense forest, shrubs and grass dominated the lower terraces. No vegetation cover could be witnessed further downstream leading to the exposure of the banks to either agricultural land or bare land. Examples of bank vegetation are presented in Figure 6.
