# Airborne Asbestos Fiber Concentration in Buildings: Surveys Carried Out in Latium (Central Italy)

**Citation:** Bruno, M.R.; Campopiano, A.; Olori, A.; Angelosanto, F.; Sinopoli, F.; Cannizzaro, A. Airborne Asbestos Fiber Concentration in Buildings: Surveys Carried Out in Latium (Central Italy). *Minerals* **2023**, *13*, 233. <https://doi.org/10.3390/min13020233>

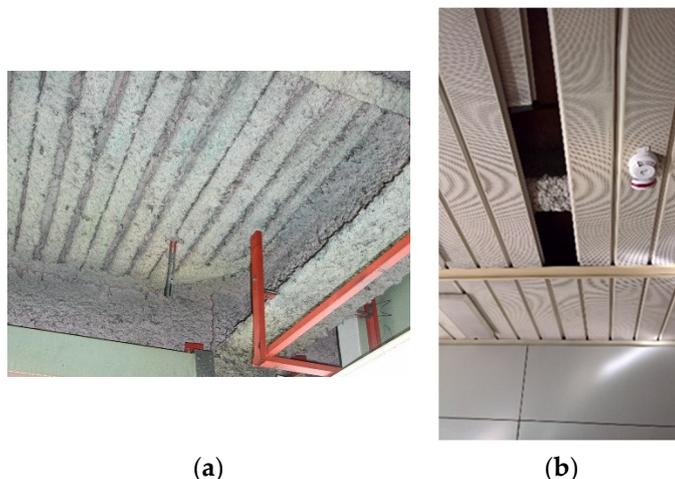
Building A was a large machine shop in which there was an overhead crane running along two walls to transport materials. Its load-bearing structures showed a mixture of sprayed amosite and gypsum (Figure 1a) as insulation. The friable ACM was covered

by a perforated metal ceiling. Between the ACM and the metal ceiling were sheets interposed. This solution could be considered an enclosure remediation, although it was not a completely airtight sealing barrier (Figure 1b).

**Figure 1.** (a) Asbestos sprayed on load-bearing structures of a building. (b) Under normal use conditions, the friable ACM was covered by metal suspended ceiling.

Notably, despite the ACM enclosure, the highest maximum fiber concentration (1.8 f/L) was measured in building A, where the presence of an overhead crane (Figure 3) likely stressed the ACM with continuous vibrations that caused fiber dispersion.

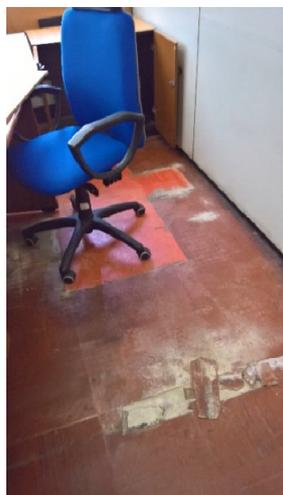
Although many ACMs were found in good condition, some were damaged. Figure 2 shows a damaged vinyl-asbestos floor, from which asbestos fibers could be released into

the air. In some areas of the floor, the tiles were removed, leaving exposed a layer of black bitumastic adhesive that might itself contain asbestos.

**Figure 2.** Example of damaged vinyl–asbestos floor tiles in office building.

Regarding vinyl–asbestos flooring, the release of fibers during normal use is unlikely, but they can be released if the floor is cut, abraded or perforated [12]. It was noted that

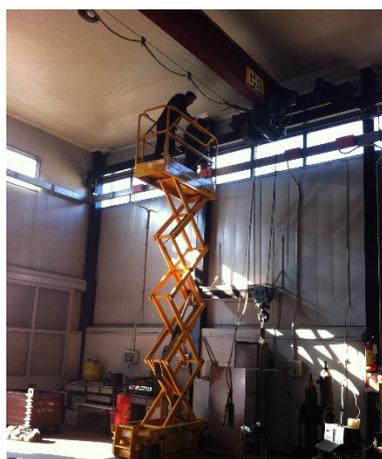
**Figure 3.** Overhead crane present in building A. The figure shows two operators on lifting platform collecting samples of dust settled on the overhead crane.

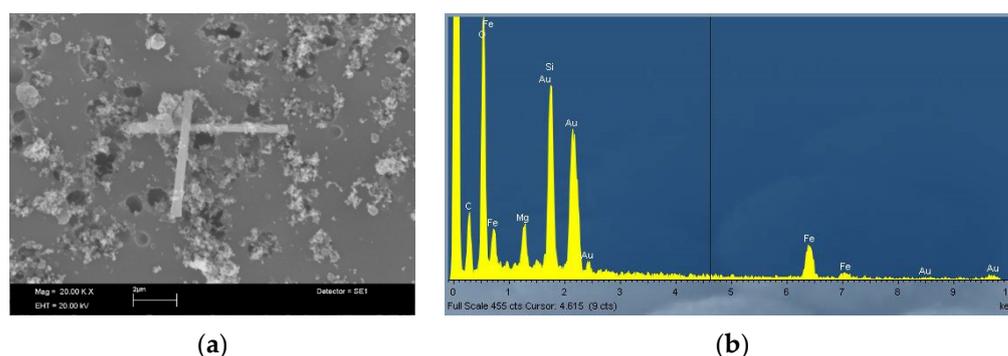
SEM-EDS analysis performed on the air samples confirmed the presence of airborne fibers of the same type as the asbestos present in the ACMs (Figure 4).

**Figure 4.** SEM image of airborne amosite fibers collected in building A on polycarbonate filter (a) and related EDS spectrum (b).

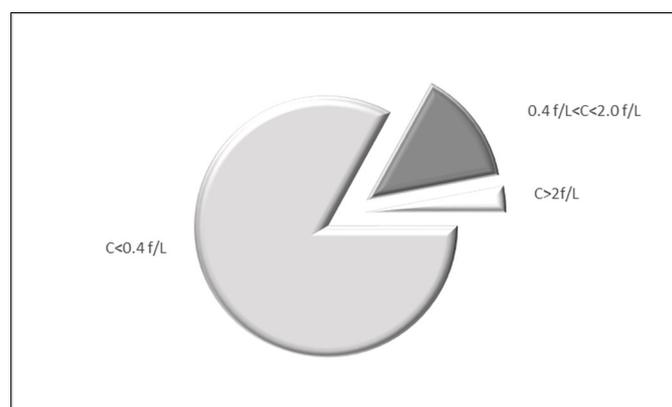
In public office buildings with non-friable ACMs, 198 air samples were collected and 87% of the measured airborne asbestos fiber concentrations were below the detection limit. In 11% of the measurements, airborne asbestos concentrations were above 0.4 f/L and below 2 f/L. Finally, 2% of the measurements showed concentrations above 2 f/L. The air samples having the highest concentrations came from one building in which ACMs were highly deteriorated.

The results for public office buildings with non-friable ACMs are shown in Figure 5.

**Figure 5.** Maximum concentration of airborne asbestos fibers measured in public buildings with non-friable ACMs.

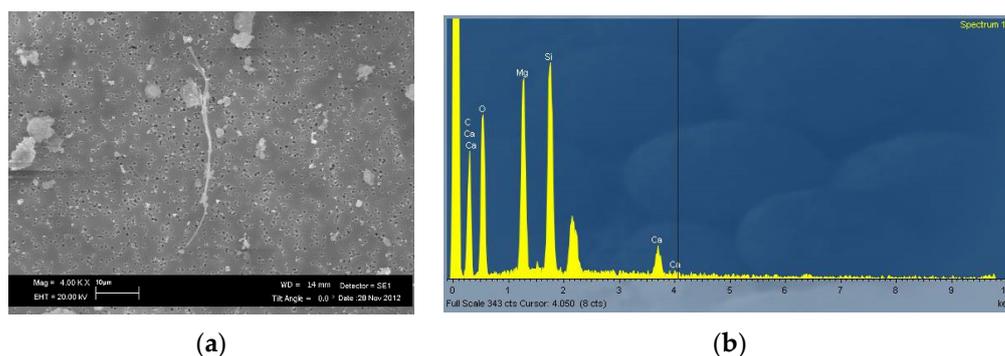
SEM-EDS analysis showed that chrysotile fibers were present in a few air samples (Figure 6).

**Figure 6.** SEM image of airborne chrysotile fibers collected in a building with non-friable ACMs on polycarbonate filter (a) and related EDS spectrum (b).

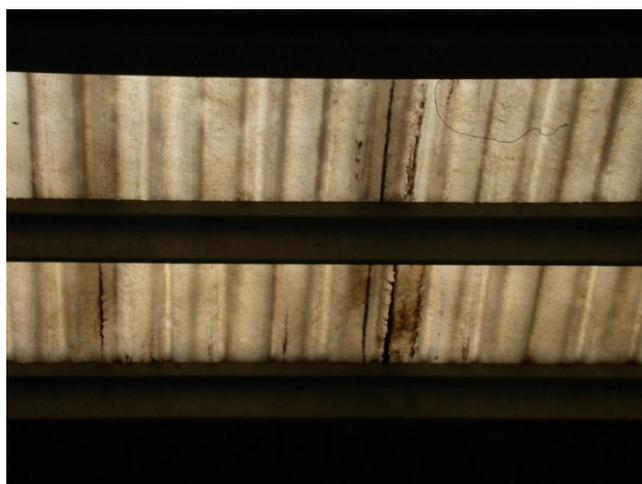
The highest indoor concentration values were measured in rooms with damaged exposed asbestos cement roofing (Figure 7).

**Figure 7.** Example of a damaged exposed asbestos cement roofing in indoor environments.

Years after installation, asbestos–cement materials are subject to complex degradation that leads to a decrease in product consistency and the surfacing of asbestos fibers. This can occur in varying amounts depending on a number of parameters, such as exposure to atmospheric agents [21–24], pollutants [25–27] and fractures due to indirect (vibrations, etc.) or direct (maintenance interventions, demolition, or acts of vandalism) mechanical action.

The degradation suffered by the roofing may affect the condition of the ACM when it is exposed inside the building (Figure 7). This was the case for the clothing warehouse shown in Table 4, in which the maximum airborne asbestos concentration was 2.7 f/L.

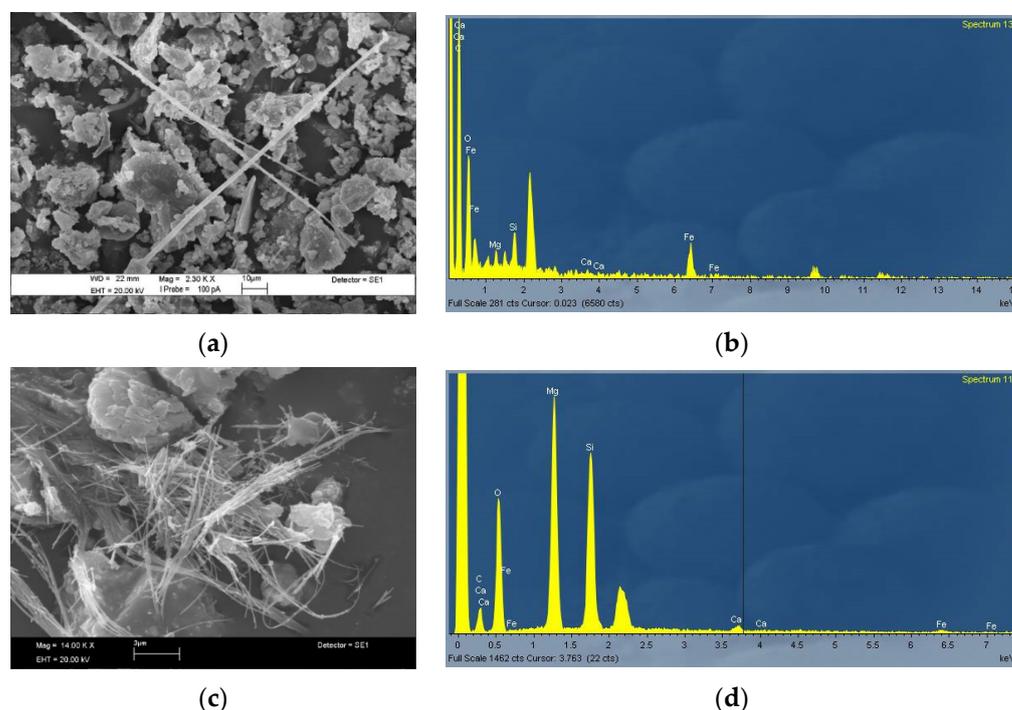
Interestingly, although the concentration of airborne fibers measured in these buildings (Table 1) was always below the set indoor limit value of 2 f/L, a non-negligible amount of asbestos fibers was found in the collected dust. Figure 8a shows some amosite fibers detected in a settled dust sample collected from a building with friable ACMs. Under these circumstances, the main concern was resuspension of the settled fibers in the air. Asbestos fibers were often found even in rooms where ACMs were absent and far from the areas where asbestos dispersion could be expected.

**Figure 8.** An example of SEM image of amosite (a) and chrysotile (c) fibers in settled dust samples collected in building A, with friable ACMs, and in a storage warehouse with non-friable ACMs, respectively. Related EDS spectra, ((b,d), respectively) are also shown.

Analysis of settled dust rarely showed asbestos fibers in samples taken in buildings where non-friable ACMs were present. Specifically, chrysotile fibers were detected inside warehouses with highly damaged and exposed asbestos–cement roofing (Figure 8b).
