Case Report

Multi-Analytical Investigation of Stains on Dimension Stones in Master Valentim's Fountain, Brazil

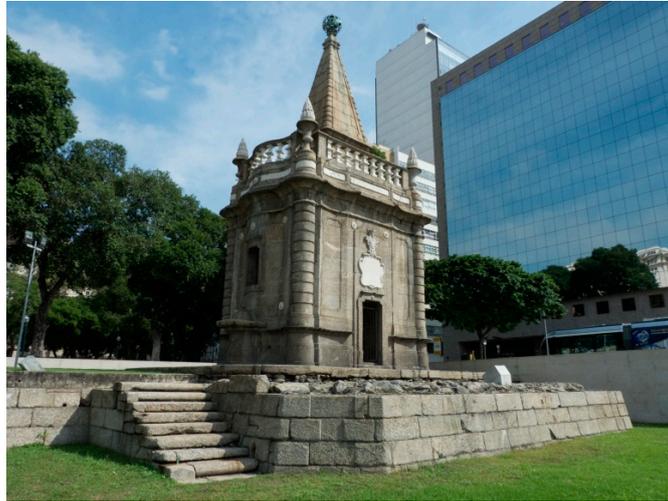
Figure 1. Master Valentim’s fountain, located in Rio de Janeiro, Brazil.

The architecture of “Master Valentim’s fountain” (Figure 1), as it is commonly called, was inspired by Rococo, the last phase of the Baroque period, that emerged in France in the mid-1700s [4]. The fountain was built in Gneiss and Lioz limestone [5]. To connect the Gneiss blocks and other blocks of the monument, Master Valentim applied his expertise in the manipulation of molten metals [6].

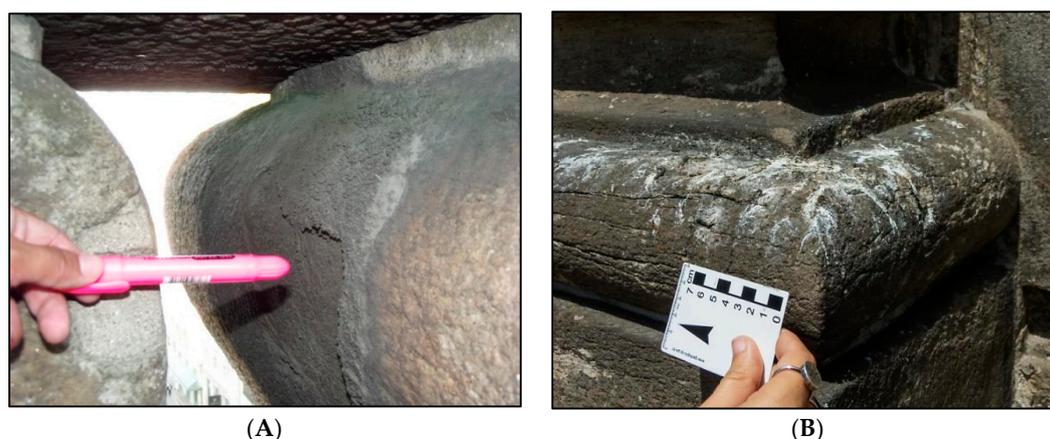
In Rio de Janeiro, due to atmospheric pollution and proximity to the sea, monuments are constantly degraded, with black crust formation (Figure 5A) and efflorescence (Figure 5B) being observed.

Figure 5. (A): Black crust in gneiss; (B): Efflorescence in gneiss.

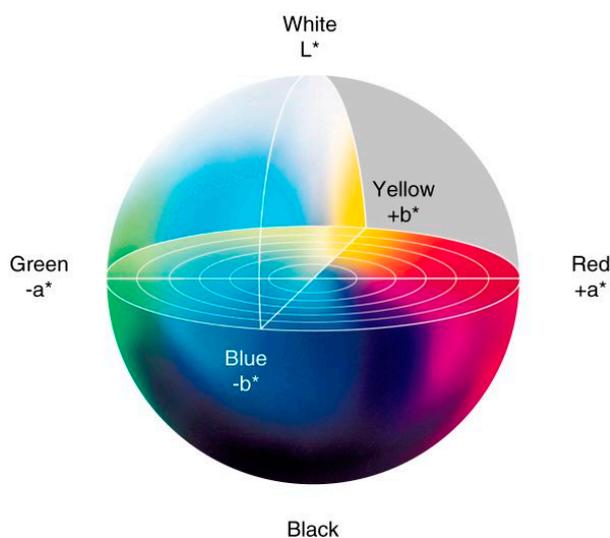
The results were expressed on CIELAB three-dimensional color space reference (Figure 6), where the L^* axis represents the lightness of a color from the darkest black ($L^* = 0$) to the brightest white ($L^* = 100$); the a^* axis indicates the greenness or redness of a color, with $a^* < 0$ representing green, whereas $a^* > 0$ represents red; and the b^* axis expresses blue and yellow opponent colors, with negative values of b^* for blue, and positive values of b^* for yellow. Consequently, when the values of a^* and b^* are equal to zero, true neutral gray is expressed [30].

Figure 6. Representation of the CIELAB coordinates [30].

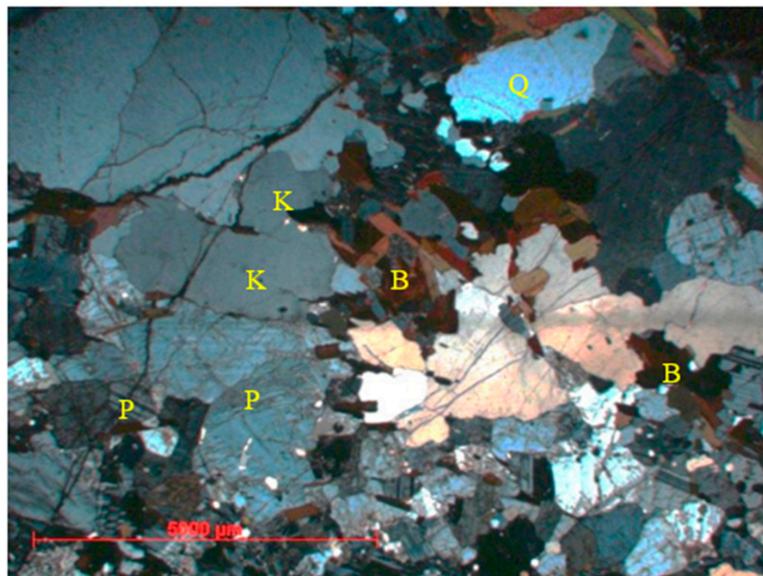
Microscopically, the sample is characterized by granoblastic and porphyroblastic textures, and medium-to-coarse inequant grains, highlighting well-developed microcline and plagioclase crystals. The stone sample exhibited significant alterations and microcracks, which are often occupied by recrystallized quartz grains (Figure 7). The mineralogical composition is mainly quartz, K-feldspar, plagioclase, and biotite. The accessory minerals are muscovite, garnet, and opaque minerals ($\approx 1\%$). Sericite appears as an alteration mineral.

Figure 7. Photomicrograph of the stone sample taken by cross polarized light showing porphyroclastic texture and microcracks. Mineral abbreviations: Q, quartz; K, K-feldspar; P, plagioclase; and B, biotite.

The quartz crystals are anhedral, with varied sizes and incipient microcracks, as well as plate and sutured boundaries with other minerals. Stretched and recrystallized crystals were observed surrounding the plagioclase and microcline minerals.

The petrographic analysis allowed classification of the stone sample as Augen Gneiss. The sample showed microcracks and significant alterations that are possibly related to weathering effects.

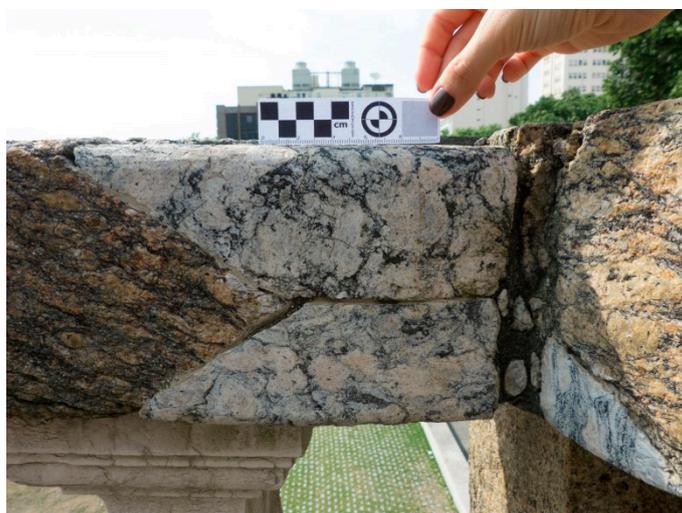
Colorimetric tests were performed to evaluate the replacement parts in previous restorations. It was easy to discern the original Gneiss stones from the replacement parts with the naked eye, since the latter were in a better polished state and were different colors (Figure 8). In the case of the restoration carried out on the Lioz limestone balustrade and torches (Figure 9), although the difference was more subtle, it was still perceptible. Regarding the gloss, the new pieces exhibited an increase in the values, but without relevance.

Figure 8. Substitute piece on a Gneiss block.

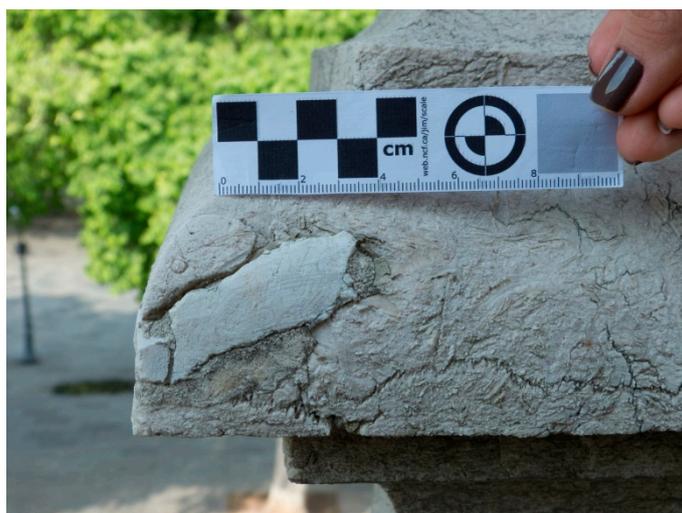
Figure 9. Lioz limestone area with restored part.

The analyses showed that the Lioz limestone is a light faded brown, and slightly orange, possibly due to the weathering effects. Nevertheless, there is chromatic compatibility between the new parts and a sound Lioz limestone. On the other hand, Gneiss showed a tendency to brown, with a more intense orange. The substitute stones for the Gneiss showed a grey color that was slightly orange.

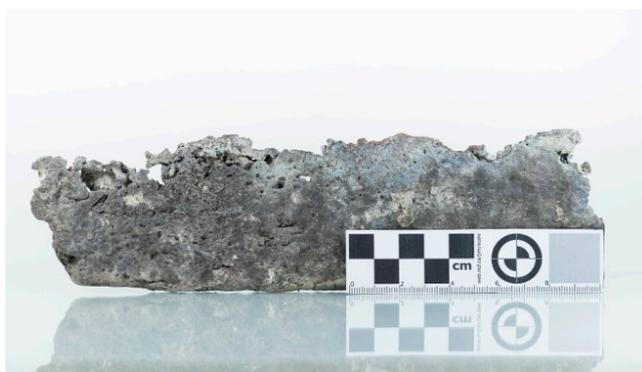
XRF analyses were performed at three different points on the connection plate (Figure 10), and the results indicated lead (Pb) as the major element. Such a result was expected, since Pb was widely used by Master Valentim in his works. Furthermore, smaller levels of aluminum (Al) and silicon (Si) were verified, as well as traces of other elements. The values derived from the analyses ranged from 77.8% to 88.9% for lead oxide (PbO), 4.4% to 10.0% for silicon oxide (SiO₂), and 1.9% to 3.7% for aluminum oxide (Al₂O₃).

Figure 10. Lead plate used to connect the stone blocks of the monument.

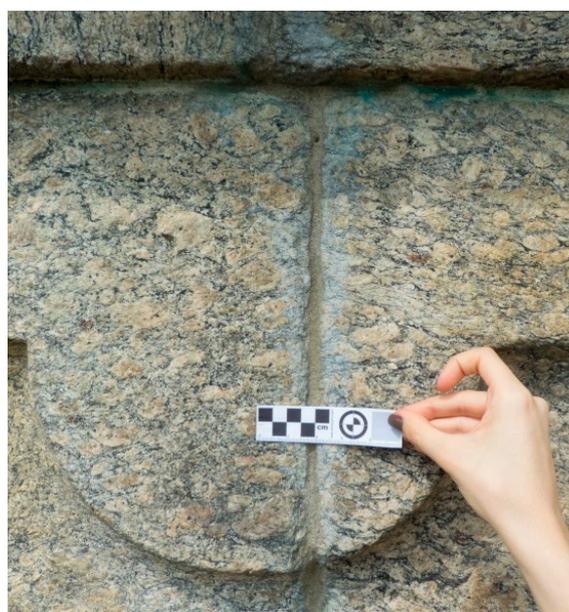
The XRF analysis performed on the light stains (Figure 11) indicated a high content of lead (Pb) and silicon (Si).

Figure 11. Light staining area on a Gneiss block.

The levels observed were approximately 50% Pb, 38% Si, and 8% Al, besides other elements. These results suggest that these stains may have originated from the association of the lead of the plates used to connect the blocks with other elements such as sulfur (from the pollution present in the environment of high urban movement), forming an insoluble salt of white coloration.

In the future we intend to study methods of cleaning the fountain to remove stains without affecting the surface of the stones, since PbSO₄ is only removed with acid attack.

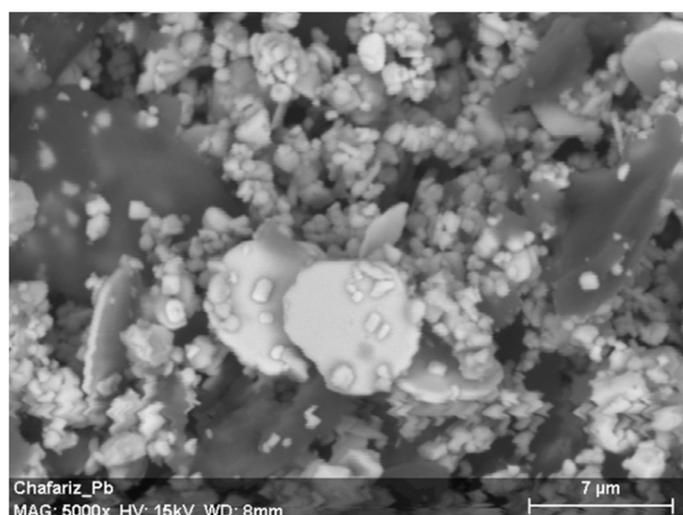
Figure 12 shows the SEM image zoom of the staining area of the analyzed samples. The SEM-EDX results identified peaks of chlorine (Cl), potassium (K), carbon (C), sulfur (S), calcium (Ca), oxygen (O), iron (Fe), sodium (Na), magnesium (Mg), silicon (Si), and lead (Pb). Quantitative analysis indicated about 65% Pb. In order to verify the possible elements related to Pb in the light staining area analyzed, elemental mapping of Pb, S, C, and Si was performed in Figure 13.

Figure 12. SEM image zoom of the staining area.

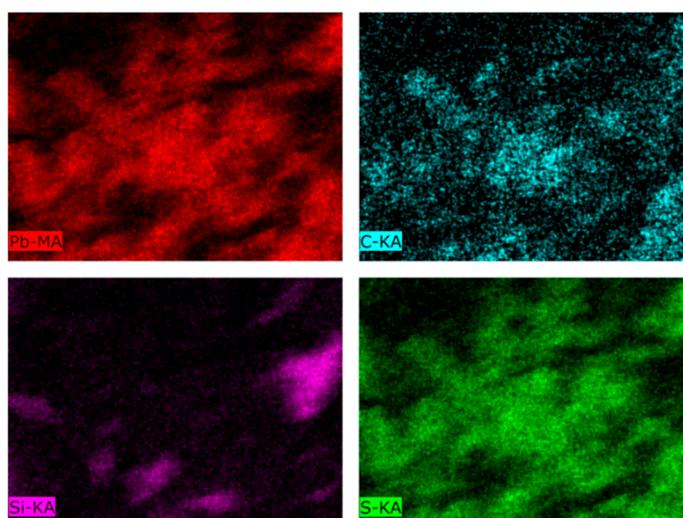
Figure 13. Elemental mapping of Pb, C, Si, and S, individually.

SEM-EDX investigation confirmed the presence of lead, sulfur, and carbon on the light staining area. Elemental mapping suggested that sulfur is the main element associated to lead. Therefore, it is possible that the light stains are PbSO_4 . The sulfur pollution emanating from vehicles was deposited on the surface of the fountain, and this element was associated with the lead used as a grout, forming the stable salt of lead sulphate.

Such results suggest that sulfur is the main element associated to lead. It is also possible to observe association between Pb and C, but occurring to a lesser extent when compared to S.

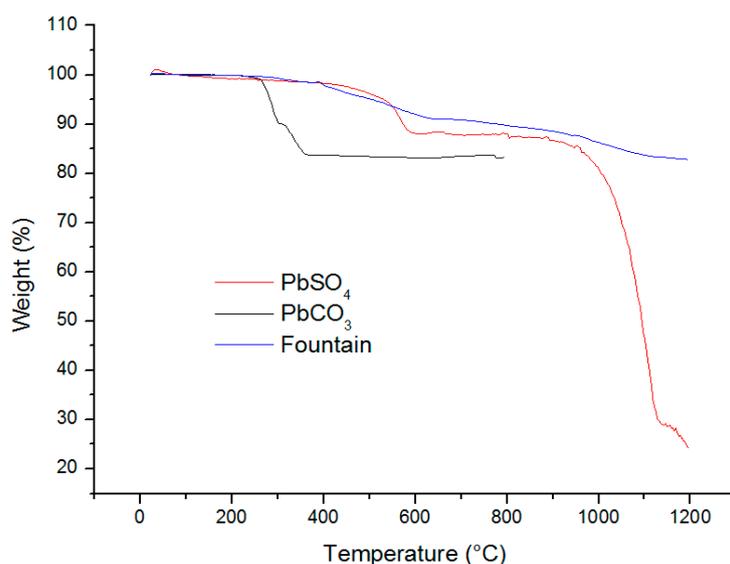
The results of ATG (Figure 14) indicated that the sample concerning change in the fountain is related to PbSO_4 formation, since the thermal degradation curve is similar to this pure salt. Thus, it was believed that the sulfur pollution emanating from vehicles was deposited on the surface of the fountain, and that this element was associated with the lead used as a grout, forming the stable salt of lead sulphate.

Figure 14. Thermal degradation curve showing the losses in each step with a rate of 10 °C/min.
