# Effect of Hot Mill Scale on Hydrogen Embrittlement of High Strength Steels for Pre-Stressed Concrete Structures

**Abstract:** The presence of a conductive layers of hot-formed oxide on the surface of bars for pre or post-compressing structures can promote localized attacks as a function of pH. The aggressive local environment in the occluded cells inside localized attacks has as consequence the possibility of initiation of stress corrosion cracking. In this paper, the stress corrosion cracking behavior of high strength steels proposed for tendons was studied by means of Constant Load (CL) tests and Slow Strain Rate (SSR) tests. Critical ranges of pH for cracking were verified. The promoting role of localized attack was confirmed. Further, electrochemical tests were performed on bars in as received surface conditions, in order to evaluate pitting initiation. The adverse effect of mill scale was recognized.

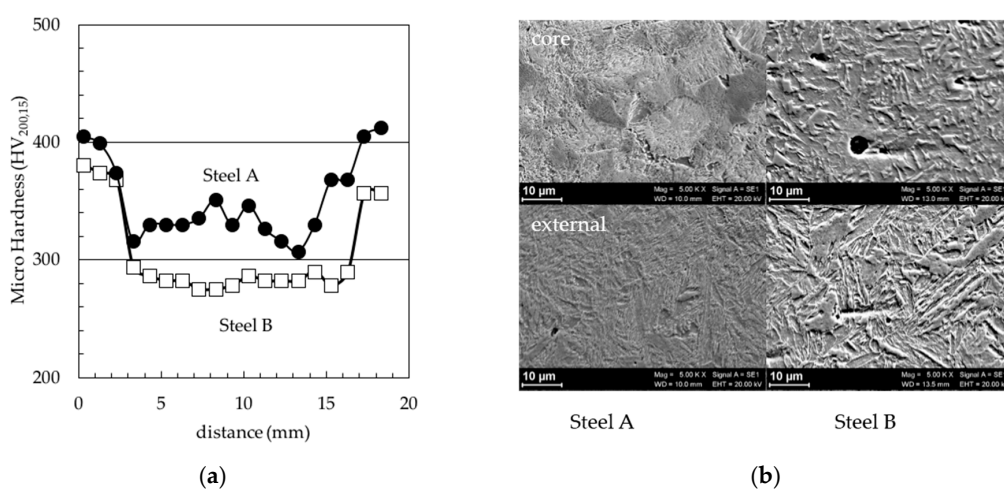
**Figure 1.** (a) Vickers 200g micro-hardness profile ( $\text{HV}_{200,15}$ ) and (b) microstructure (5000 $\times$ ) of the considered steels.

The chemical composition and mechanical properties of the steels are reported in Table 1. The bars were produced through an in-line heat treatment by water quenching with self-tempering. Thus, a different microstructure between core and surface layers is observed. The external layer is characterized by tempered martensite, with hardness in the ranges 390–410  $\text{HV}_{200,15}$  and 360–380  $\text{HV}_{200,15}$  for the two steels respectively (Figure 1). The bars are covered by a mill scale.

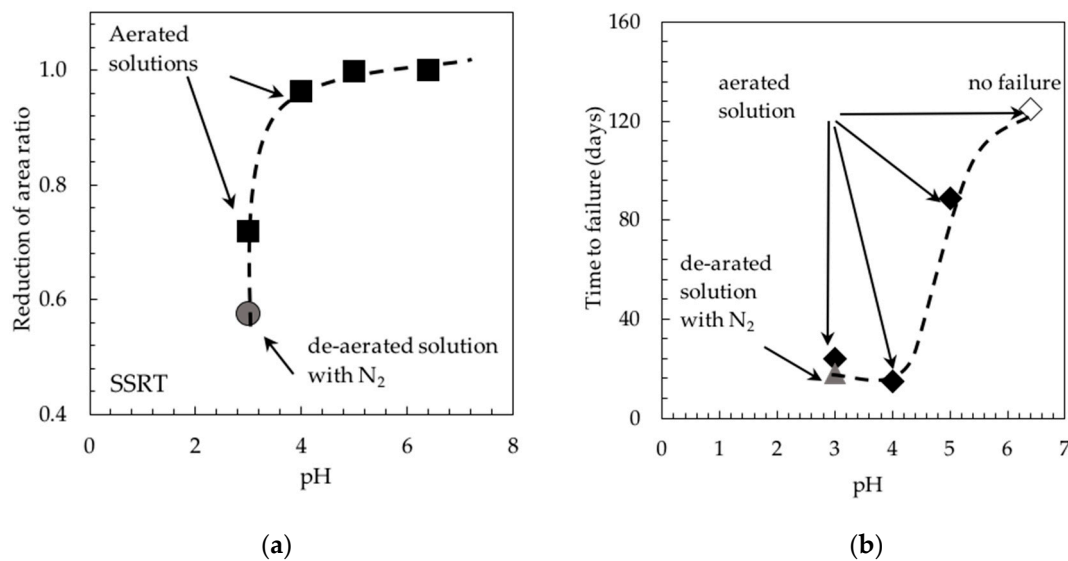
**Figure 5.** Effect of pH on (a) the area ratio ( $R.A.\%_{\text{environment}}/R.A.\%_{\text{air}}$ ); (b) the time to failure of the Constant Load test specimens.

decreases (Figure 4). The loss in ductility due to environment is expressed in Figure 5a as reduction of area ratio (ratio between the value of the reduction of area in environment and the reduction of area in air —  $R.A.\%_{\text{environment}}/R.A.\%_{\text{air}}$ ). Low values of this parameter indicate the insurgence of SCC phenomena.

The results of Constant Load tests confirm the effect of pH on SCC. Figure 5b shows the time to failure of specimens loaded at 90% of yield strength. The time to failure increases with pH; specimens did not break in the solution with pH 6 after 4 months of testing.

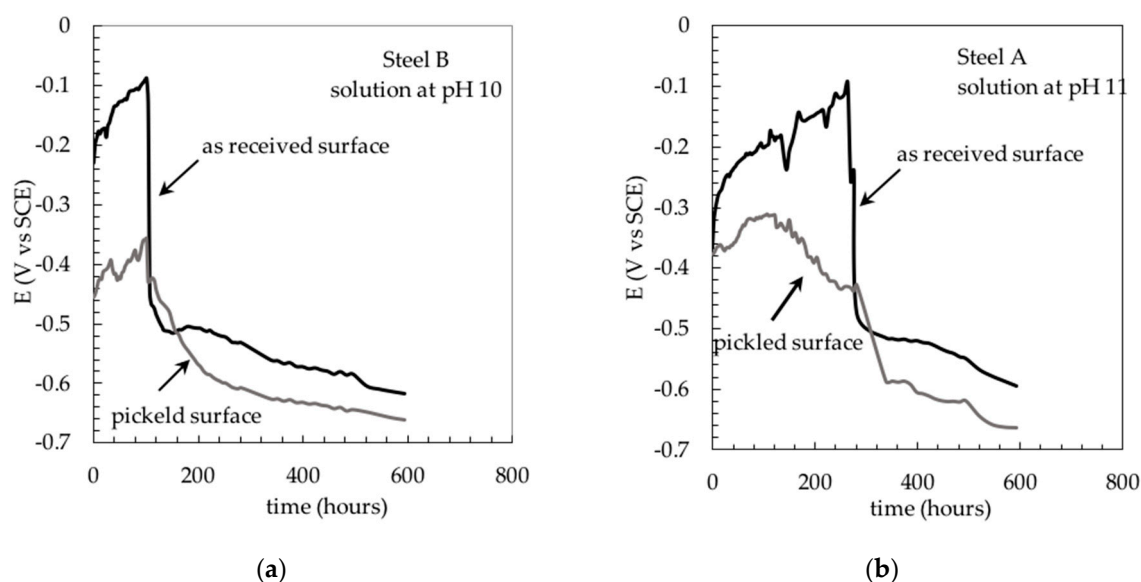
**Figure 7.** Corrosion potential vs time curves for the tested steels in solution at (a) pH 10 and (b) pH 11.

After the initial period, depending on the pH of the solution, the anodic polarization due to calamine becomes no more significant. The corrosion potential decreases to active potentials of pickled specimens due to the formation of deep localized attacks and the progressive change of the oxide scale, which is not stable at room temperature (Figure 7). Thus, the effect of calamine is especially evident in the first periods of exposure, which is a function of pH, increasing with it.

It is therefore conceivable that, in case of partial covering of the surface with this oxide, which occurs as the oxide tends to melt, there may be localized corrosion between the areas still covered with oxide and those with non-coated surfaces. This can be done for all pH investigated up to 12.5: beyond this value, the specimen can passivate. At  $\text{pH} < 12$  there is a competition between the location of the attack between shielded areas and free areas, and the dissolution of the oxide film. The lower the pH of the solution, the greater the speed of destruction of the film, so it is conceivable that the maximum localization of the attack is for pH between 11 and 12. These results are confirmed by the observation of the samples recovered after the monitoring of the corrosion potential at different pH (Figure 7).

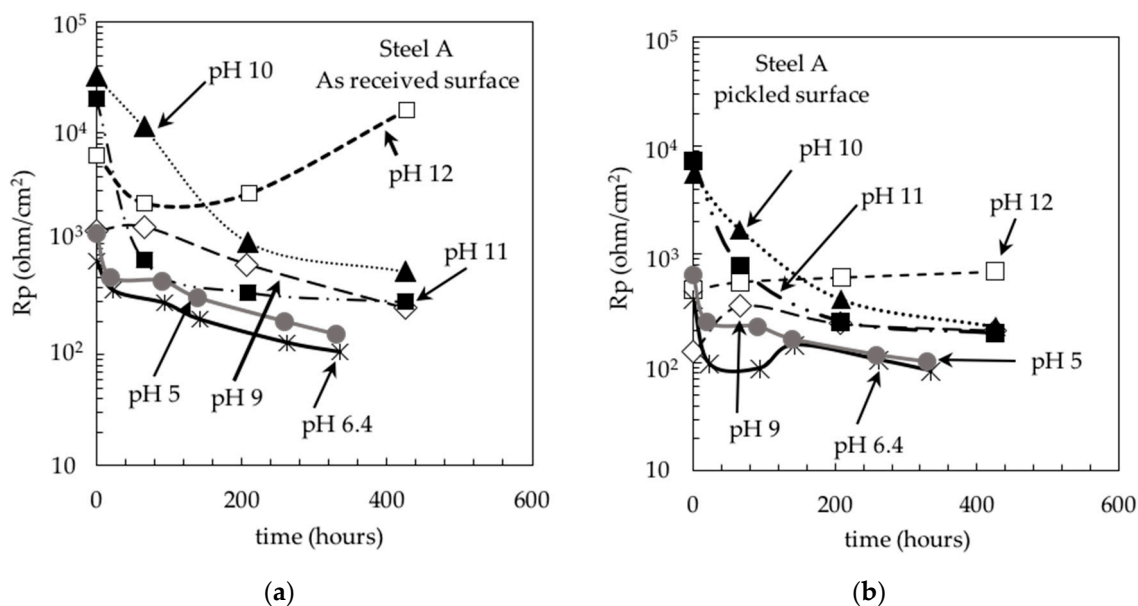
**Figure 8.** Polarization resistance vs time curves for steel A, as a function of different pH, with (a) as received surface and (b) pickled surface.

Figure 8 compares the polarization resistances measured on the specimens in as received surface conditions with mill scale and after pickling. The average corrosion rate evaluated on the specimens in as received conditions is initially low (high values of the polarization resistance in Figure 8) because of very small anodic areas uncovered by the scale. Afterwards, the corrosion rate of the specimens tends to similar values of pickled specimens.

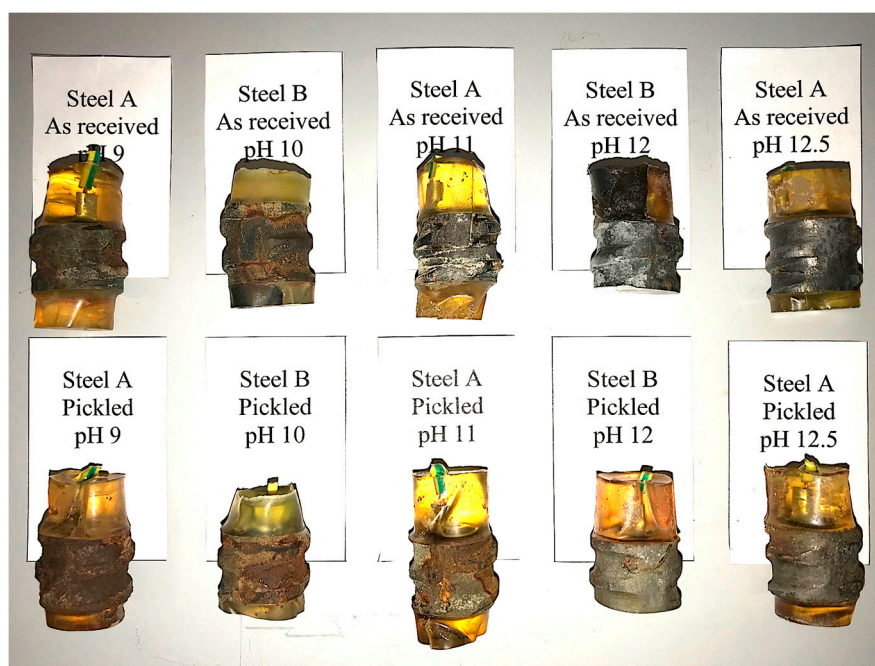
**Figure 9.** Specimens with as received or pickled surface after the immersion tests at different pH.

Figure 9 shows the specimens after the immersion tests at different pH. At pH lower than 10 and higher than 12, there are no differences between the specimens with as received or pickled surface. In the first case, a generalized corrosion was observed, whereas at pH higher than 12 all the specimens are in passive conditions, without evidence of corrosion products. In the range of pH from 10 and 11, the pickled specimens showed uniform corrosion; on the contrary, the specimens with as received surface showed un-attacked areas, with the presence of calamine and some corroded regions around the un-attacked areas. No differences between the two considered steels were founded in the electrochemical behavior.

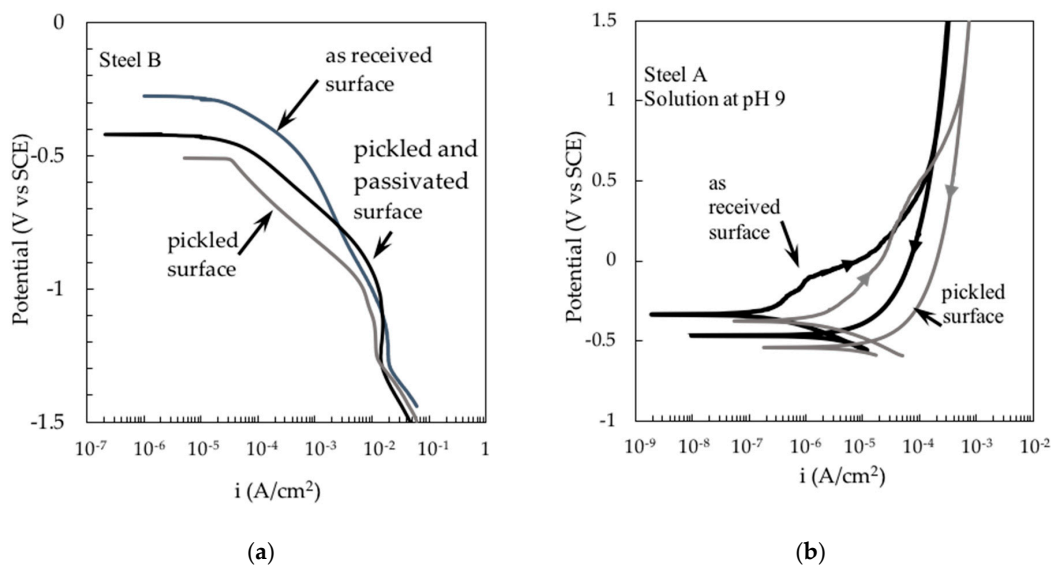
**Figure 10.** Effect of surface conditions on (a) cathodic potentiodynamic curves of the steel B in alkaline solution (pH 14) and (b) anodic cyclic potentiodynamic curves of the steel A in pH 9 solution.

Figure 10a shows the potentiodynamic cathodic curves obtained on as received surface and after pickling. The pickled surface was also tested after 48 h of passivation in the solution. It could be noted that the specimens with presence of calamine have low overvoltages at potentials above the oxygen limiting current density zone. The data confirm that calamine can act as a good cathode for the oxygen reduction.

Figure 10b and Figure 11 show the effect of mill scale on the cyclic potentiodynamic curves as a function of pH. The mill scale modifies the anodic polarization curves of the steels. In solution at pH less than 11, the steels show active dissolution, independently from the surface conditions (Figure 10b). At pH 13, a passive behavior was always observed (Figure 11a). In the pH range between 11 and 13 it is possible to observe noticeable differences between the anodic cyclic potentiodynamic curves.

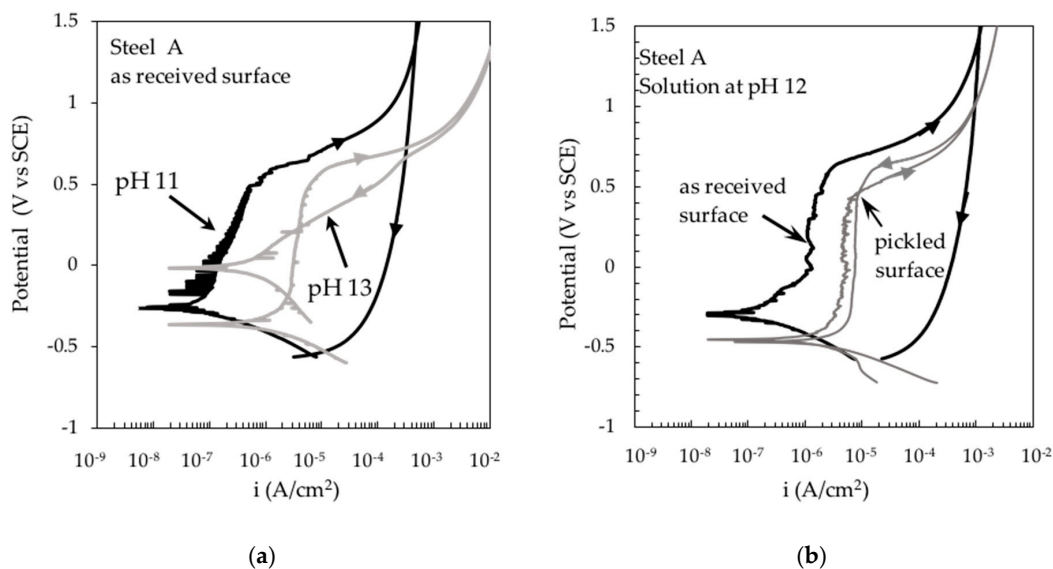
**Figure 11.** (a) Effect of pH on anodic cyclic potentiodynamic curves of the steel A in as received conditions, covered by a mill scale; (b) Effect of surface conditions on anodic cyclic potentiodynamic curves of the steel A in pH 12 solution.

The anodic current is low for the as received surface specimen at the beginning of the test, due to the presence of the oxide scale that protects the metal surface. Oxygen evolution at high potentials, both on steel and on scale, produces similar current densities on as received specimens and pickled specimens. After the potential scan is inverted, the specimens with as received surface show a great hysteresis, while the specimens with polished surface maintain a passive behavior (Figure 11b).

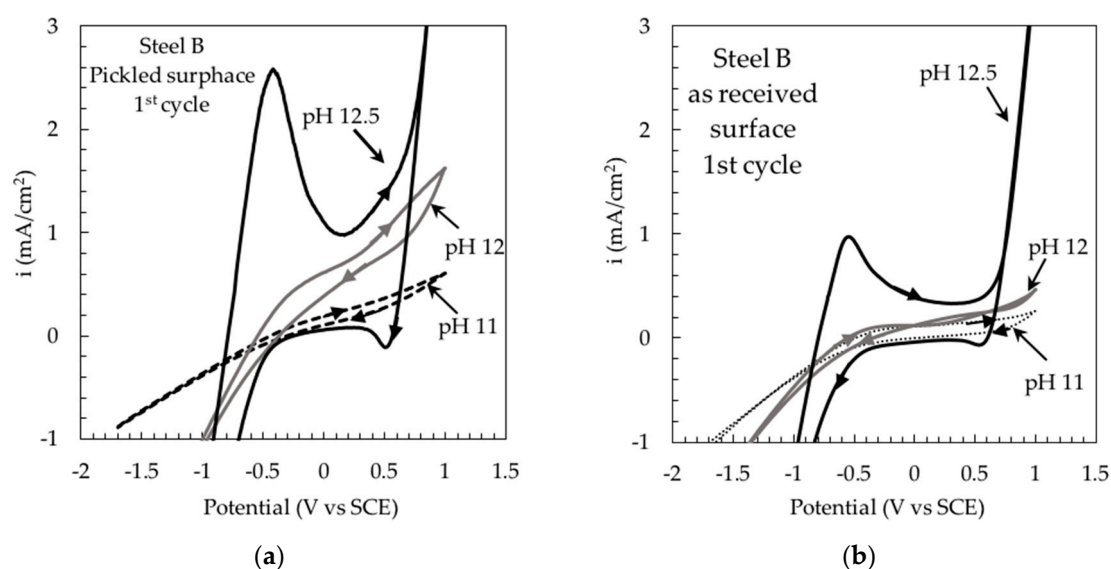
**Figure 12.** Cyclic voltammetry tests of steel B in solution at different pH; (a) specimens with pickled surface; (b) specimens with as received surface.

In the cyclic voltammetry tests (Figure 12) it is possible to observe the appearance of the passivation peaks of the iron only at pH 12.5. At pH 12, a hint of peaks appears, more pronounced for specimens with pickled surface than those with as received surface. The current values recorded for the pickled specimens are higher than those for specimens with the as received surface, shielded from the calamine scale. Once the passivation of the specimen intervenes, the cathodic reduction of oxygen on as received specimens occurs at a potential lower than the values observed on pickled specimens, confirming the electrocatalytic effect of the calamine. With respect to literature data [28–30], the peak of the Fe/Fe(II) reaction is not present on the cyclic voltammetric curve, for all the surface conditions of the specimens. This could be due to the presence of the hot-formed oxide on the specimens, but it also shows how pickling cannot restore an iron surface completely absent from oxides. On the other hand, the presence for all the specimens of the large oxidation peak from Fe(II) to Fe(III) clearly indicates that the hot-formed oxide film does not isolate the underlying metal from the environment. On the contrary, it allows the irreversible growth of the film by anodic oxidation, as shown by the increase in the amplitude of the peak in the second potential cycle and by the absence of the conjugate reduction peak.

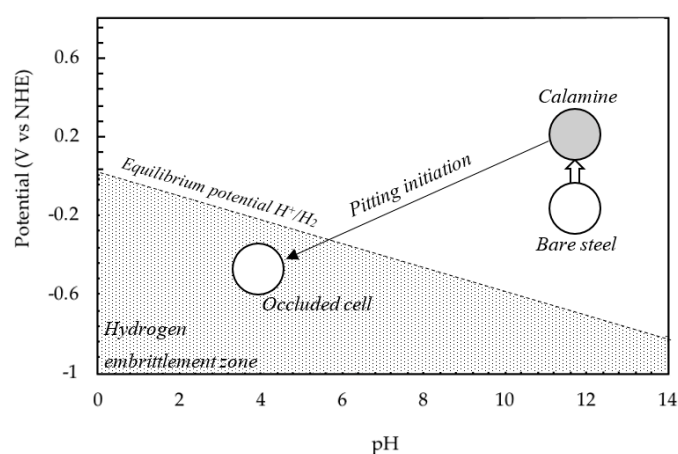
**Figure 13.** Role of calamine on insurgence of favorable conditions for hydrogen embrittlement in neutral or slight alkaline environment.

Finally, the promoting role of calamine on stress corrosion cracking in neutral or slight alkaline solutions can be sketched as proposed in Figure 13.

When a bar is embedded in alkaline solutions at pH higher than 12.5, this becomes passive, independently from the surface conditions. If the pH of the environment decreases at values lower than 12, the presence of calamine increases the corrosion potential of the bar and, in the area where the oxide scale is not present, some localized attacks may be initiated. Inside the localized attack, the pH decreases and, contemporaneously, the open circuit potential decreases too, so the hydrogen evolution reaction becomes possible. In these conditions, in the presence of susceptible steel and mechanical stress, hydrogen embrittlement can take place. For very high strength steels, with a low critical intensity factor, very small defect generated by hydrogen embrittlement can promote brittle catastrophic fracture [1].
