Article

# Influence of the Alkaline Reserve of Chloride-Contaminated Mortars on the 6-Year Corrosion Behavior of Corrugated UNS S32304 and S32001 Stainless Steels

Department of Materials Science and Engineering—IAAB, Universidad Carlos III de Madrid, Avda. Universidad 30, 28911 Leganés, Madrid, Spain; fvelasco@ing.uc3m.es (F.V.); matorres@ing.uc3m.es (M.T.-C.)

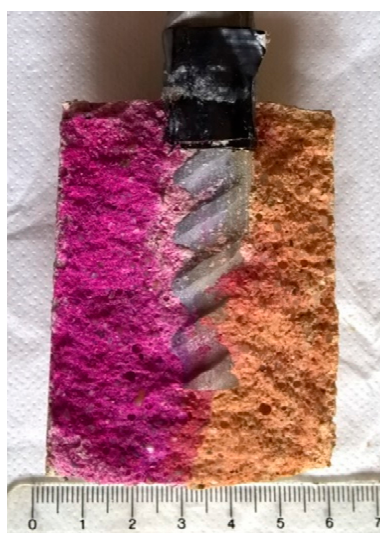
**Figure 2.** Image of a broken reinforced sample previously exposed to  $\text{CO}_2$ , after the use of phenolphthalein (left) and yellow alizarin (right) indicators to check pH.

Figure 2 shows an example of the results obtained after the use of phenolphthalein (on the left part of the broken mortar) and yellow alizarin (on the right part). The use of both indicators indicates that the mortar samples which were previously exposed inside the carbonation chamber had a pore solution pH similar to that given by the carbonate/bicarbonate buffer (around 10.2) or higher, as the surface wetted with phenolphthalein became violet (i.e., pH > 10) and the surface wetted with yellow alizarin was yellow and slightly reddish (i.e., pH < 12). So, the samples had a reduced alkaline reserve and their pHs can be initially considered as between 10 and 12.
