Article

# Critical Analysis about Emerging Technologies for Building's Façade Inspection

**Citation:** Dias, I.S.; Flores-Colen, I.; Silva, A. Critical Analysis about Emerging Technologies for Building's Façade Inspection. *Buildings* **2021**, *11*, 53. <https://doi.org/10.3390/buildings11020053>

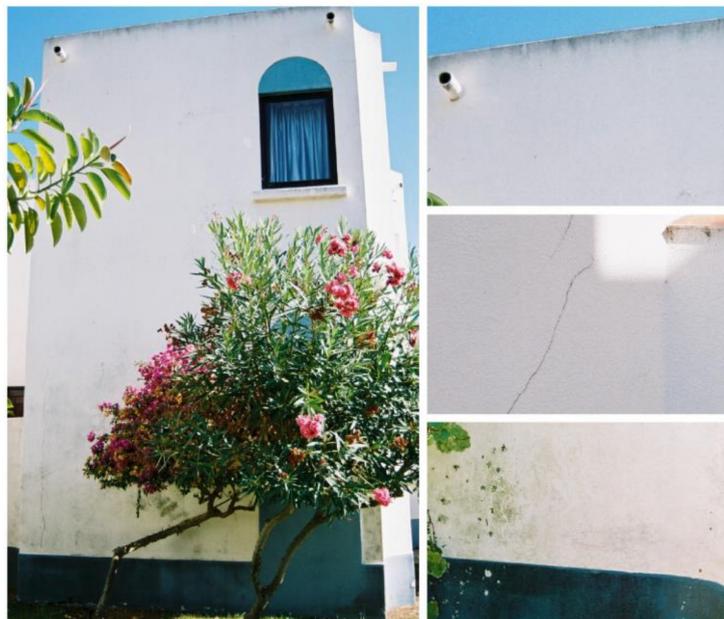
To discuss the reliability of this severity of the degradation ( $S_w$ ) index, two case studies are presented in this paper: (i) a continuous element (a rendered wall) and (ii) a discontinuous element (a natural stone cladding). These two claddings represent different challenges in the calculation of severity of the degradation index, which will be presented later. Figure 1 describes a rendered wall inspected according to the global inspection system. The case study is a building located in Tavira, Algarve (South of Portugal). The façade is oriented toward the west and present an average level of protection against the wind and rain. In terms of environmental factors, the inspected building is located at less than 3 km from the sea in a rural environment and exposed to normal conditions of air temperature and relative humidity. The total area of the facade analysed is 105.52 m<sup>2</sup> and the render is 10 years old.

**Figure 1.** First case study: rendered façade (data sourced from Reference [46]).

Table 1 presents the defects in the rendered façade (Figure 1) observed during the visual inspection carried out during the fieldwork survey. The surveyor recorded the area of rendering affected by each group of defects ( $A_n$ ). The degradation condition level of each defect found ( $k_n$ ), according to its condition (taking into account the classification of defects proposed in Table 2), and the factor corresponding to the relative weight of each defect in the overall degradation of the façade ( $k_{a,n}$ ), according to Table 3. In summary, Table 1 presents the weighted degraded area ( $A_n \times k_n \times k_{a,n}$ ), taking into account the defects observed. In order to calculate the severity of the degradation ( $S_w$ ) index of this cladding, Equations (2) and (3) are used.

In Equation (3), the calculation of the severity of degradation ( $S_w$ ) for this case study is presented. The result is a  $S_w$  index of 13.39%, which means a slight degradation of rendered façade, according to Table 4.

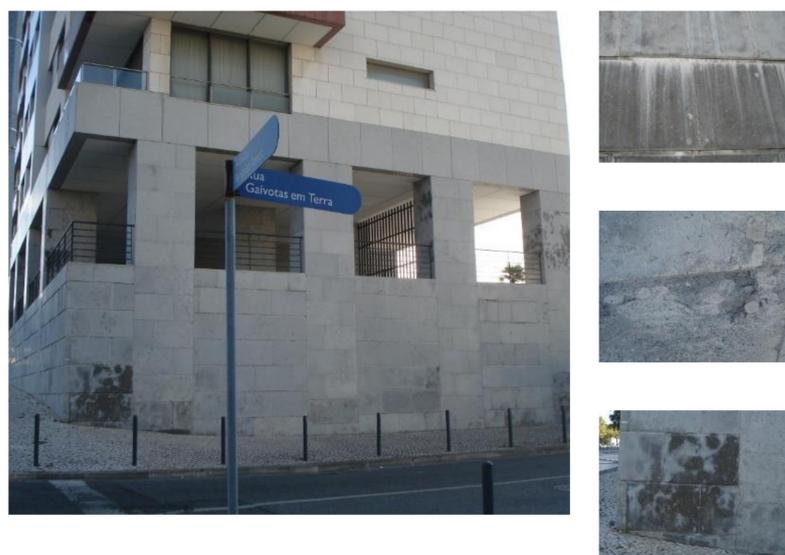
Figure 2 describes another case study, a natural stone cladding, directly adhered to the substrate, which was inspected using the global inspection system. This case study refers to a building located in Parque das Nações, Lisbon (Centre of Portugal). The façade is oriented toward the east and presents an average level of protection against the combined action of wind and rain. In terms of environmental factors, the inspected building is located at less than 3 km from the sea, in an urban environment, and exposed to unfavourable conditions of air temperature and relative humidity. The total area of the façade analysed is 75 m<sup>2</sup> and the natural stone cladding is 12 years old.

Figure 2. Second case study: natural stone cladding.

The defects observed in the natural stone cladding inspected (Figure 2) are synthesized in Table 5. The surveyor recorded the area of natural stone affected by each group of the defect ( $A_n$ ):  $A_v$ —visual anomalies,  $A_j$ —joint anomalies,  $A_f$ —bond-to-substrate anomalies, and  $A_i$ —loss-of-integrity anomalies. The degradation condition level of each defect found ( $k_n$ ) and the factor corresponding to the relative weight of each defect on the overall degradation of façade ( $k_{a,n}$ ) are assigned according to the condition classification in Table 6. In summary, Table 5 presents the weighted degraded area ( $A_n \times k_n \times k_{a,n}$ ) in order to calculate the severity of the degradation ( $S_w$ ) index (Equations (4) and (5)).

In Equation (5), the calculation of the severity of degradation ( $S_w$ ) of the second case study is presented. The result is a  $S_w$  index of 10.43%, which means a slight degradation (Condition C) of the natural stone cladding analysed, according to Table 7.
