# Mechanical Steel Stitches: An Innovative Approach for Strengthening Shear Deficiency in Undamaged Reinforced Concrete Beams

**Abstract:** In this study, reinforced concrete beams with insufficient shear capacity were strengthened on both sides of the beam along the shear openings by a novel approach: Mechanical Steel Stitches (MSS). This innovative method facilitates the application of strengthening the beams with a low-cost solution. In this concept, six specimens were experimentally investigated under vertical load. While one of the specimens was tested as a reference, the others were strengthened with MSS application at different ratios ( $\rho_{MS}$ ), ranging from 0.2% to 1% at both the beams' shear span. MSS were applied with the angle of 90° considering stirrup logic. The diameter, anchorage depth and mechanical properties of the MSSs were kept constant, and their effects on the strengthening of the beams in terms of ductility, strength, stiffness, and energy dissipation capacities were investigated by changing the spacing of the MSSs. The results revealed that increasing MSS ratio caused a dramatic positive change in the behavior in terms of both strength and energy diss

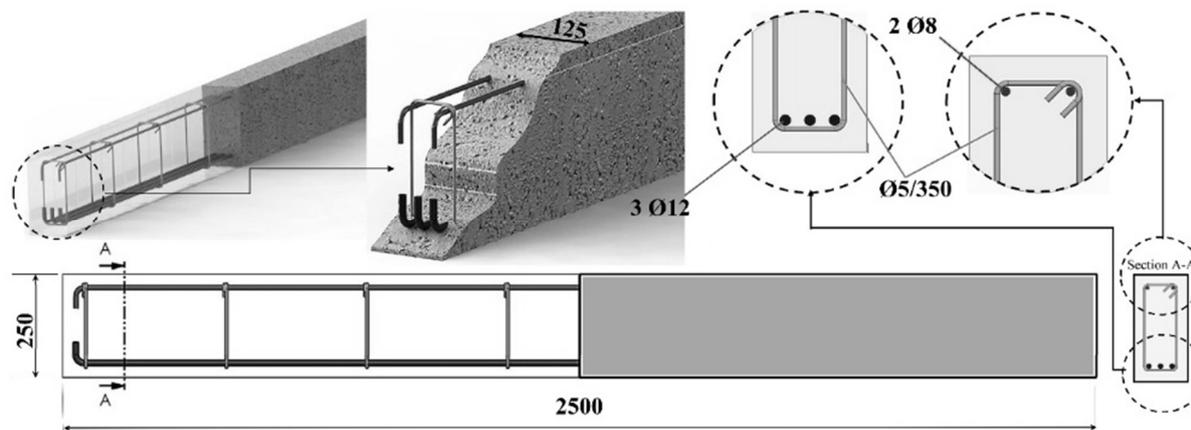
**Figure 1.** The reinforcement details of the specimens, dimensions in mm.

Shear deficient reinforced concrete beams were tested in Konya Technical University Construction and Earthquake Laboratory. The beams produced have a geometric scale of 1/2 and a cross-sectional area of 125 × 250 mm, and their length was 2500 mm. Details of the beam are shown in Figure 1. Although concrete compressive strength targets 20–25 MPa, the 28-day cylinder concrete compressive strength of the beams was calculated as 29 MPa (between C25 and C30 grade). The splitting tensile strength was determined as 1.3 MPa. B420c type ribbed 3φ12 ( $\rho = 0.0117$ ) longitudinal reinforcement was placed in the bending zone of the beam and 2φ8 ( $\rho' = 0.00347$ ) longitudinal reinforcement was placed in the compression zone. The reinforcement ratio considered in the design of the beams is higher

than the minimum reinforcement ratio ( $\rho_{\min} = 0.00306$ ), according to the Turkish Reinforced Concrete Building Code [79]. In addition, the longitudinal reinforcements were selected in accordance with the under-balance ductile design. The transverse reinforcements were applied as  $\phi 5/350$  mm. On the other hand, stirrup hooks were bent at  $90^\circ$ , which is common and contrary to the regulation. Additionally, 25 mm placers are used in the beams.

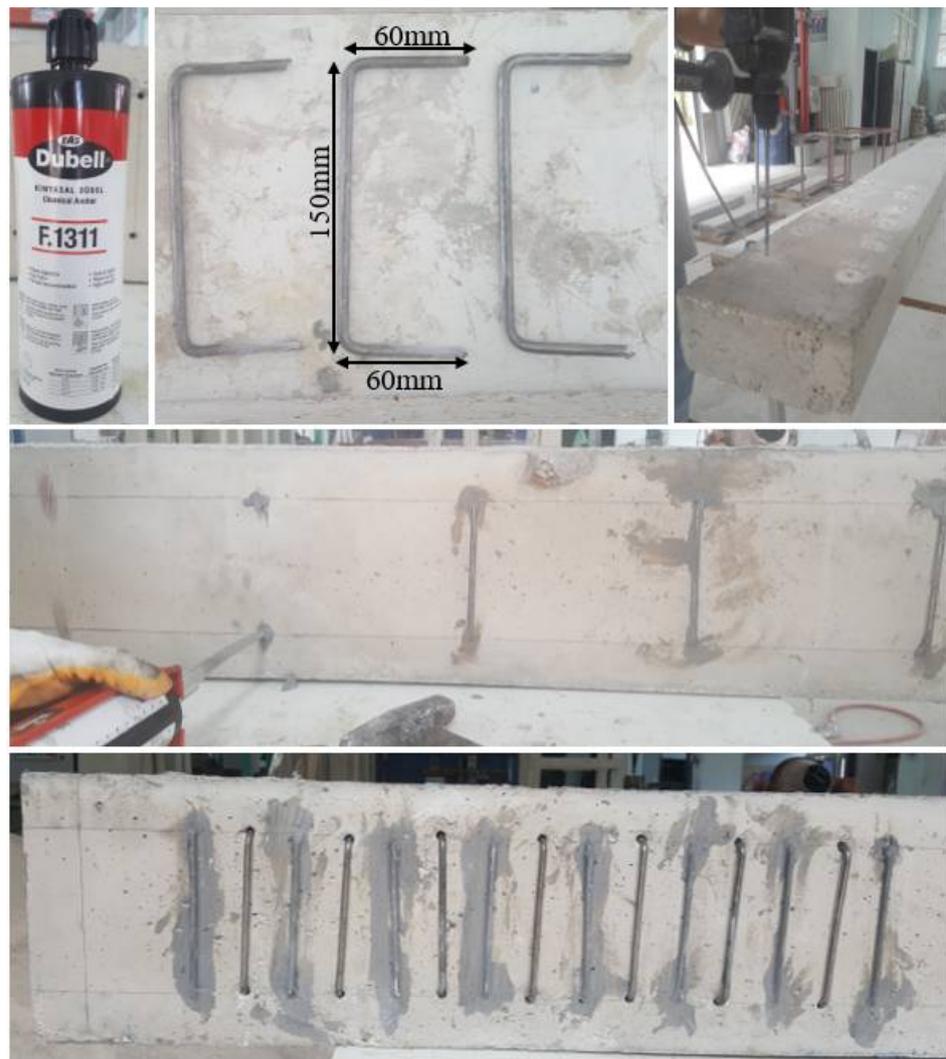
Figure 2. Strengthening beams with MSS.

In reinforcement applications, U-type mechanical steel stitches (MSS) were prepared by using a  $\phi 6$  mm diameter cold-formed transmission steel. Each stitch length is 150 mm, and the squares are designed as 60 mm ( $10\phi$ ). The points determined on the beam surface to be applied were drilled to a depth of 60 mm with an 8 mm diameter drill ( $\phi 8$ ), and the holes were filled with Dubell-F.1311 brand epoxy after cleaning with compressed air. Prepared U-type MSSs were placed in the holes drilled on both sides of the beam. According to the manufacturer's recommendations, after the MSSs were fixed to the beams with epoxy, they were left to cure for one day at room temperature ( $25^\circ\text{C}$ ). The MSSs applied to the shear opening of the beams were applied at  $90^\circ$  in stirrup logic (Figure 2). MS with five different placements was applied to the shear span of the beams (700 mm part). One is the reference (S0), and the other five represent the specimens strengthened by the placement of MSSs with different spacings (Figure 3).

The placed MSSs were applied considering the increasing volumetric ratio ( $\rho_{MS} = \frac{n \times A_{0,MS}}{b_w \times s}$ ). Here  $n$ ; number of stirrup arms,  $A_0$ ; stirrup cross-sectional area,  $b_w$ ; beam width and  $s$ ; MSS represents the application range. Details depending on the MSS diameter ( $\phi$ ), spacing ( $s$ ) and volumetric ratio ( $\rho_{MS}$ ) for beams reinforced with MSSs applied with different spacing are given in Table 2. All the MSSs made were placed perpendicular to the expected crack, taking into account the crack mechanism of the S0 beam at the end of the experiment. MSSs transmit force with the friction force they create between the surfaces to which they are attached. For this, the number and size of MSS are significant for effective strengthening. Therefore, MSSs were prepared considering the remaining height after deducting the rust, longitudinal reinforcement and transverse reinforcement allowances of the MSS beam. MSS application has very important advantages compared to other strengthening methods. First of all, since it is very easy to apply, fewer workers are needed compared to other reinforcement alternatives, and this process can even be carried out with a single worker. It is also the most cost-effective compared to other strengthening methods.

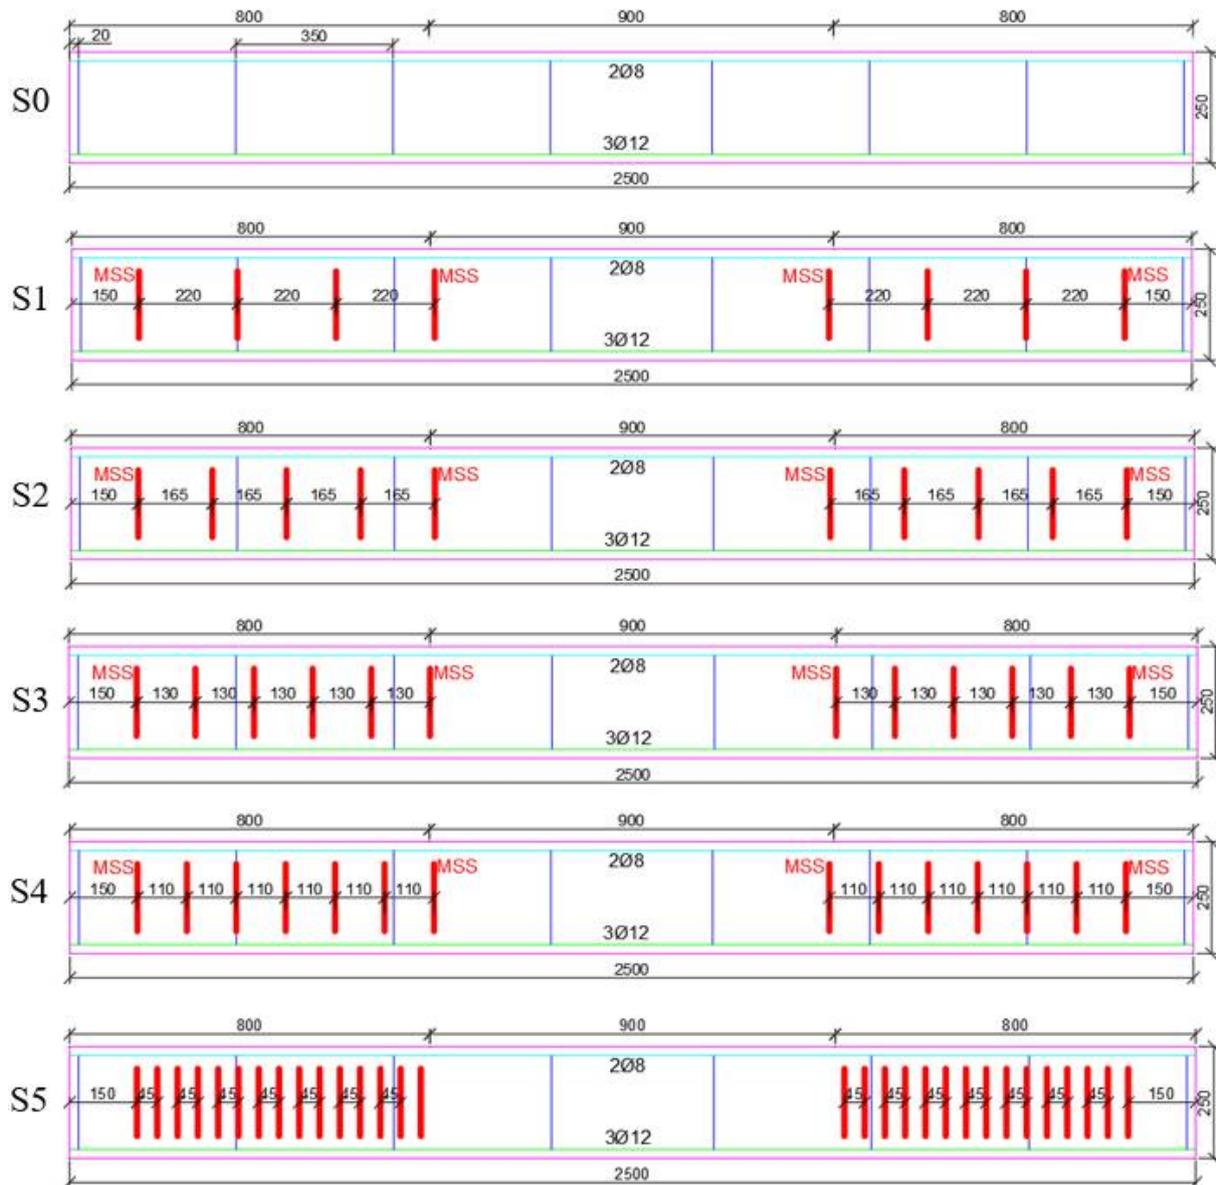
Figure 3. Appearance of test specimens after strengthening in mm.

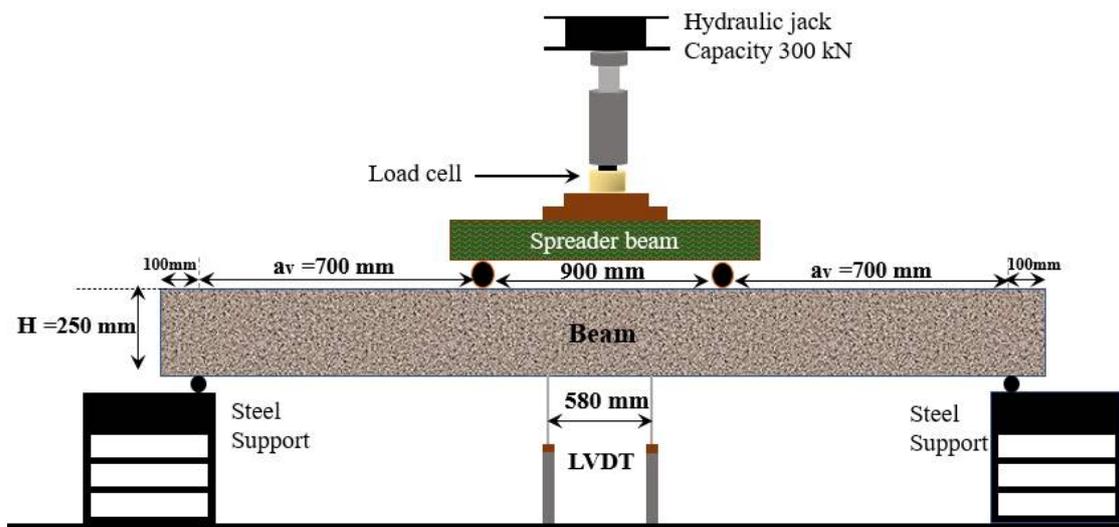
Figure 4. Four-point bending test setup in accordance with the standards used in the experiments.

The reference and strengthened specimens were tested under vertical loads in a four-point bending setup in the rigid steel loading frame shown in Figure 4. In Figure 5, the pre-experimental views of each specimen are shown. The beams are simply supported so that 100 mm of them fits on the supports. Since shear damage in the reference beam was desired, the  $a_v/d$  ratio (shear span to depth ratio (70/22.5) (mm/mm)) was chosen as 3.11 [80,81]. In this way, the formation of shear damage was observed in reference S0. The load cell used for loading the beam has a capacity of 300 kN. A load-displacement curve was obtained for each specimen by considering two displacement meters (LVDT)

located in the middle of the beam, and the load and the distance between them are 160 mm. All records were recorded with the data collection system. As a result of splitting the load from the vertical piston into two over the spreader beam, a single load transfer is achieved. With vertical monotonic loading, 10 kN increments were continued until the end of the experiments. The experiments continued with displacement control depending on the behavior of the beams at the time of yielding. In the experiments, each monotonic loading was waited for a short time to mark the cracks on the test.

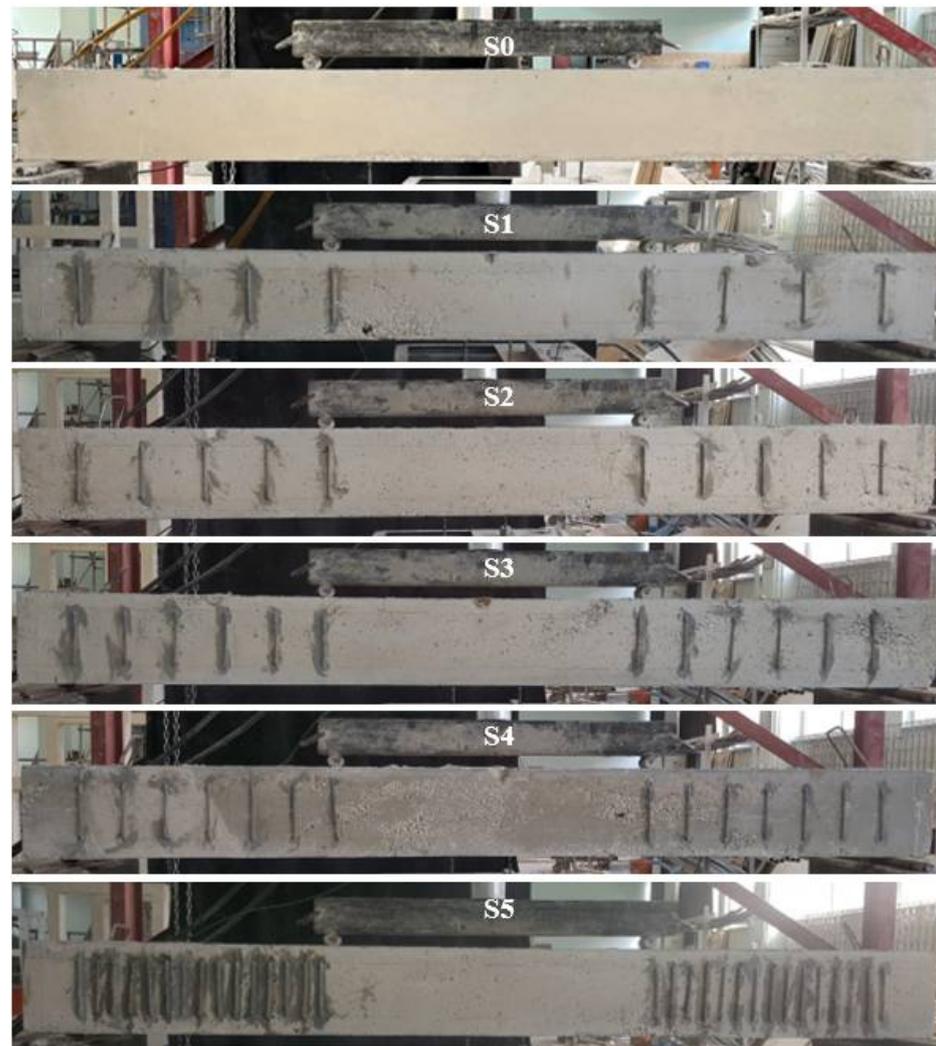
Figure 5. Pre-experiment view of reference and reinforced beams.

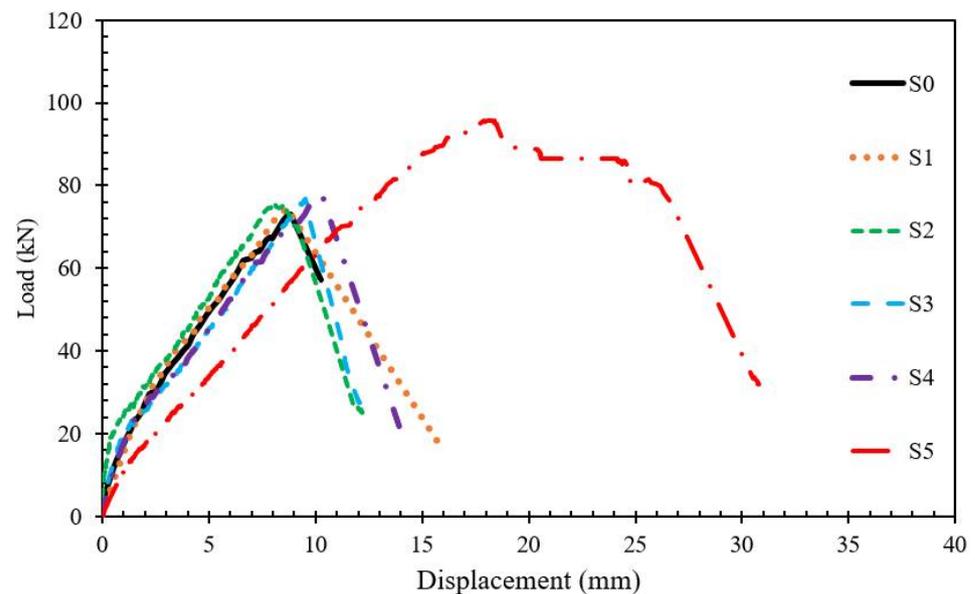
Figure 6. Comparison for load-displacement, S0–S5.

In the experimental study, vertical load-mid-point displacement graphs of each specimen were drawn. By comparing the reference specimen (S0) with the strengthened specimens (S1, S2, S3, S4 and S5), deep discussions on MSS were reached. Comparisons were made step by step with the systematic application of MSSs to the beam. Graphical comparisons were made by considering the increasing volumetric ratio of MSS ( $\rho_{MS}$ ) in strengthening applications. This way, behavior changes and suggestions could be put forward clearly. In the experiments, the number of MSS (4, 5, 6, 7 and 15) applied to the beams was increased step by step. Each experiment was compared with previous experiments, and a cumulative evaluation was made at the end. In other words, the number and range of MSSs were determined by making evaluations before each reinforcement design. All MS applications were performed along the shear span on both sides of the beam. Experimental studies, respectively, are explained in detail and interpreted by comparison. Comparisons are limited by the load carrying capacity, stiffness, ductility and energy dissipation capacity. The test results of all specimens are summarized in Table 3. In addition, the comparison of all specimens is shown in Figure 6. During the whole experiment, no peeling and rupture damage was observed in the MSSs, and shear, bending and adherence damage were observed in the concrete. This also showed that the anchor length ( $10\phi = 60$  mm) of the applied MSSs was sufficient. At the end of the experiment, comprehensive damage analyzes were performed for each specimen.

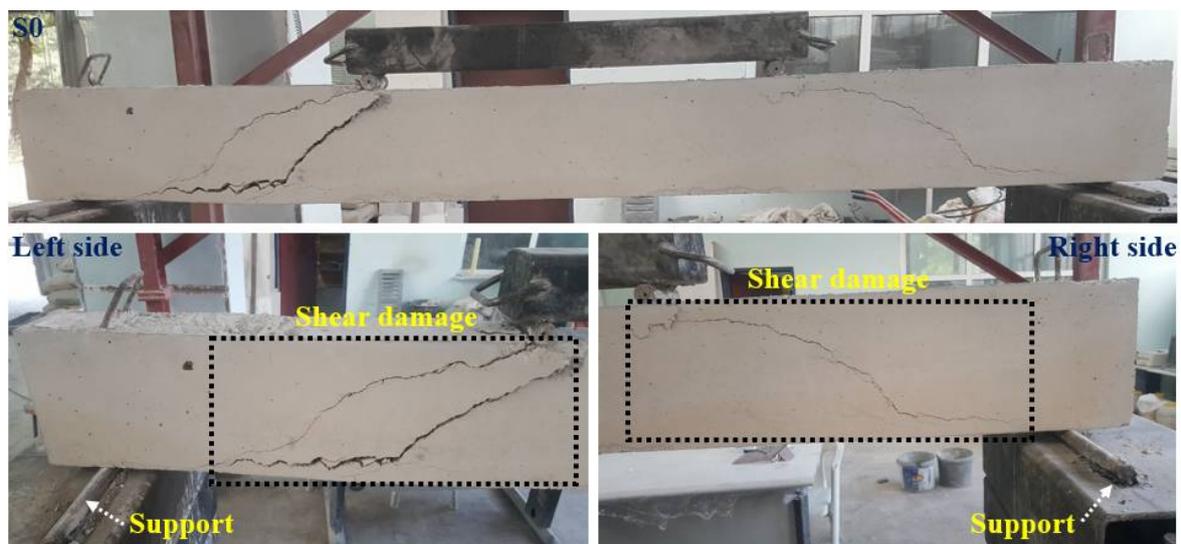
Figure 7. S0 specimen.

The S0 specimen was tested as a reference beam with insufficient shear reinforcement. The vertical load was applied in increments of 10 kN. The first cracks in the experiment were observed in the middle span of the beam (in the bending region) and at the load level of 30 kN. These first cracks represent linear elastic cracks at the minor level. With the load reaching 60 kN, shear cracks observed in beam shear openings occurred below the neutral axis (midpoint of the beam section). With the vertical load of 70 kN and the current displacement of 8.3 mm, the shear cracks extended to the support point under the spreader beam. Finally, when the S0 specimen reached the maximum load level of 73 kN at 8.83 mm displacement, sudden and brittle shear damage occurred in the left shear opening. This showed that the beam design with insufficient shear and the selected  $a_v/d$  ratio were sufficient. A damage analysis view of the beam is given in Figure 7. When the damage analysis is examined, it is seen that typical shear damage occurs. Choosing the stirrup spacing as 350 mm caused the cracks formed in the shear opening of the beam to

extend along the beam height with increasing load. The absence of stirrups to limit the propagation of cracks made the occurrence of shear damage inevitable.

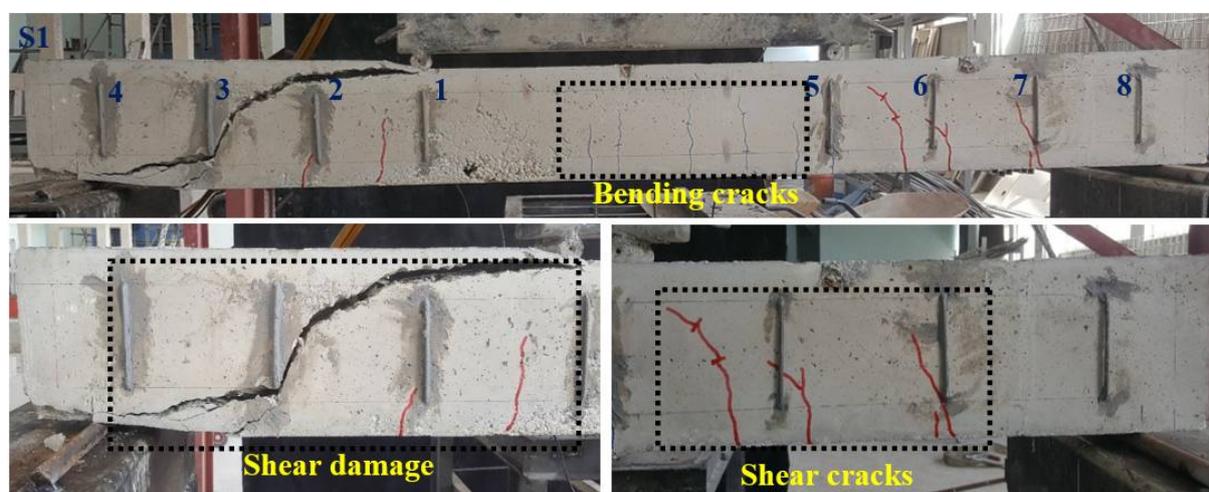
**Figure 8.** Damages at S1.

Specimen S1 was strengthened by epoxy application of 4 MSSs with a diameter of 6 mm, a length of 150 mm and an anchor length of 60 mm on one side of the shear opening of the reference beam (S0). In other words, the S1 beam was strengthened by applying a total of sixteen MSS to the beam shear openings. In the experiment, the first minor bending cracks started to appear in the middle span of the beam at a load level of 10 kN. When the load reached 30 kN, a displacement of 2.68 mm occurred in the middle region of the beam. At this load, the minor cracks extended towards the neutral axis. Additionally, as shown in Figure 8, the first capillary shear cracks occurred in the lower left part of MSS 2, just below MSS 5, and finally in the middle of MSS 5 and 6. With the load reaching 40 kN, a new crack occurred in the bending region. In addition, elongation was observed in the shear crack between 5 and 6 MSS at this load value. After this load value, a new shear crack

was observed between MSS 1-2 and MSS 6-7 in the shear zone at 50 kN load level. With the load reaching 60 kN, no further elongation or new cracks were observed in the cracks in the bending region. With the load reaching 74.59 kN and the displacement reaching 8.67 mm, shear damage occurred in the left shear opening of the beam, passing through the middle of the MSS 2-3, and the experiment was terminated. Up to a certain value of the load, the crack propagation, which reaches 6 MSS, is prevented by the mechanical stitches. When the damage observed between MSS 2 and 3 in the left shear opening is examined, it is understood that the cracks try to reach the beam pressure zone by the shortest route. As a matter of fact, the angle of the shear damage in the reference sample with the horizontal is less. Here, the presence of MSSs 1 and 2 caused a partial change in the location of the shear damage. In addition, when compared to the S0 specimen, there was an increase of approximately 2.17% in the load-carrying capacity. This shows that the MSSs that are located makes a very small contribution to the load-carrying capacity. Finally, as in the S0 specimen, sufficient ductility could not be achieved in the S1 specimen.

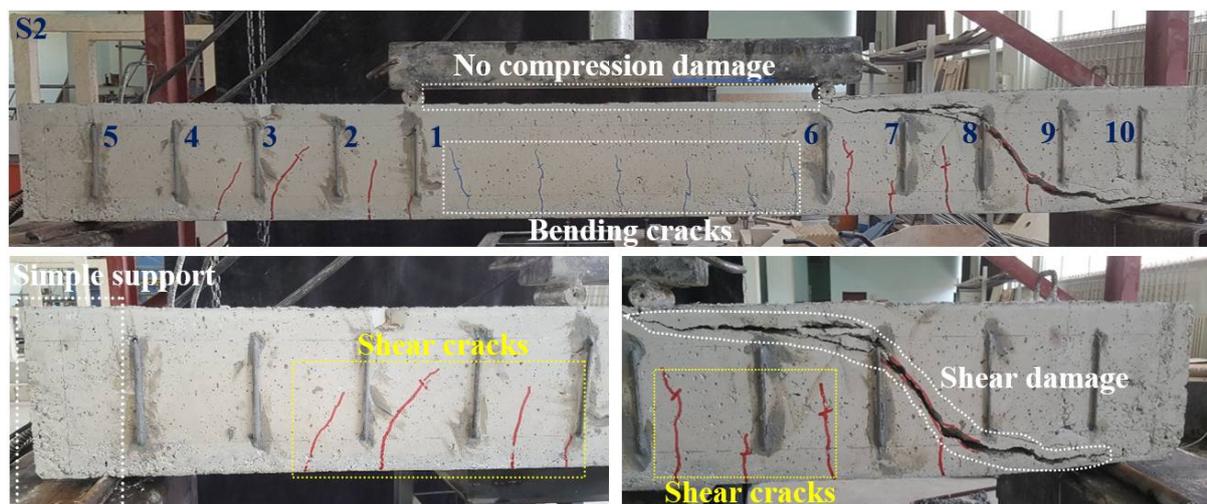
Figure 9. Damages at S2.

In the S2 specimen, the number of MSS was increased to 5. In this way, the distance between the MSSs has been reduced to 165 mm. The total number of MSSs placed on the beam shear zone is twenty. In the S2 specimen, the first microcracks were observed at the 20 kN load level, that is, at the vertical displacement level of 1.65 mm. These cracks represent elastic cracks. With the vertical load of 30 kN and the displacement value of 2.92 mm, the first shear cracks occurred between the MSSs 6-7 and 7-8. At this load value, it was observed that the cracks in the middle region of the beam were elongated towards the neutral axis, and new cracks were formed. Since the vertical load on the beam reached 50 kN and the displacement value reached 5.26 mm, shear cracks occurred between MSSs 1-2 and 2-3. In addition, bending cracks observed in the middle of the beam at this load value were limited to the neutral axis level. With the load reaching 60 kN and the displacement 6.23 mm, new shear cracks were observed between the MSSs 3-4 and 8-9. Finally, with the load reaching 75.79 kN and the vertical displacement 8.07 mm, shear damage occurred in the right shear opening and the experiment was terminated. It cannot be said that sufficient MSS number and spacing are provided in terms of ductility in the S2 specimen, where shear behavior was observed. However, the load-carrying capacity of the S2 specimen increased by 3.8% and 1.6%, respectively, compared to the S0 and S1 specimens. MSSs applied to the S2 specimen did not significantly contribute to the bending stiffness of the beams. This indicates that due to the fact that the shear capacity does not increase significantly, it can respond to less rotational demand and that the longitudinal reinforcements in the tension zone do not yield. The damage of the S2 specimen at the end of the test is shown in Figure 9. When Figure 9 is examined, the failure has migrated between MSSs 8 and 9. The

shear damage in S2 is quite similar to the damage in S1. Reducing the MS gap in the S2 specimen partially changed the path of the crack. However, if it is taken into account, the occurrence of shear damage passing through the upper part of the MSS 8 and the lower point of the MSS 9 showed that the cracks were directed to the damaged points by drilling holes beforehand. This shows that there should be MSSs that prevent the propagation of cracks. Since this situation is thought to be possible only by reducing the MSS interval, the following test specimen was prepared.

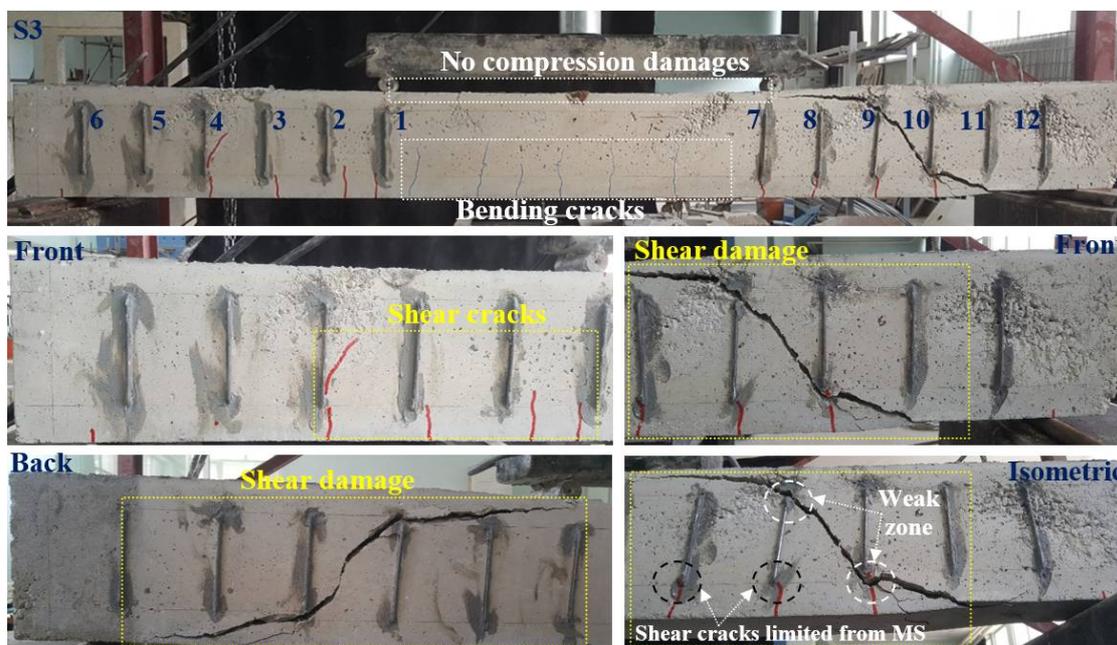
Figure 10. Damages at S3.

Although the MSSs placed in the S2 increased the load carrying capacity slightly, the S3 was created because they could not prevent shear damage. The total number of MSS placed in the S3 sample is twenty-four. The distance between each MSS was set to 130 mm. The aim here is to prevent the shear cracks to be formed by more MSS. For this, the first three bending cracks were observed in the middle of the beam with monotonic increasing loads and a load of 20 kN and a displacement of 1.95 mm (Figure 10). Cracks continued to increase in the bending zone as the load reached 30 kN and the displacement reached 3.98 mm. In addition, the first shear crack occurred at this load value between the 1-2 and 2-3 numbered MSSs in the left shear span. With a load of 50 kN and a displacement of 5.74 mm, minor shear cracks were observed at the lower points of MSSs 4, 7, 8 and 9. No propagation was observed in bending cracks at the neutral axis level at this load level. This indicates that the shear capacity is more difficult. With a load of 70 kN and a displacement of 7.34 mm, a minor shear crack started from the lower part of the MSS 4 and along the height of the MSS. This crack did not propagate in subsequent loadings. At this load level, the increase in minor shear cracks, especially in the right and left shear span, indicates that the shearing capacity is approached. Finally, with the load of 76.90 kN and the displacement of 9.53 mm, shear damage occurred with the propagation of the crack between the MSS 9-10 in the left shear span. Particularly, the weak areas at the upper point of MSS 9 and the lower point of MSS 10 accelerated the progression of the crack. In terms of load carrying capacity, the S3 increased by 5.34%, 3.08% and 1.45%, respectively, compared to S0, S1 and S2. The fact that sufficient ductility value could not be obtained with the increase in load carrying capacity showed that the number of MSS should be increased.

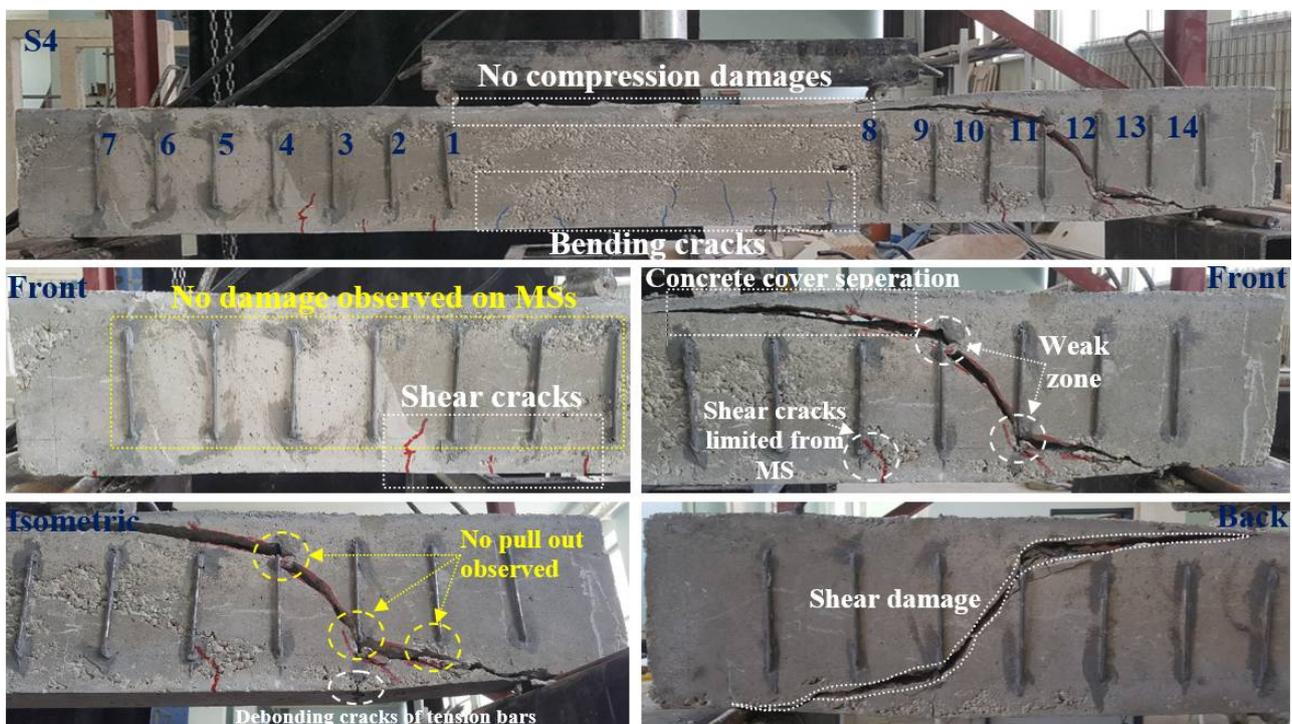
Figure 11. Damages at S4.

Since the desired ductile behavior could not be obtained in the S3, the MSS spacing was reduced to 110 mm. In this way, more MSS was applied to prevent possible shear damage that may occur in the shear zone. In other words, shear damage was tried to be prevented with seven MSSs placed on one side of the shear opening of the designed S4 specimen. In this way, the behavior change was investigated with a total of twenty-eight MSSs applied to the beam. In this loading, the first crack similarly occurred in the bending region at a load of 30 kN and a displacement of 3.63 mm. When the load is 40 kN and the

displacement is 5.23 mm, the first shear crack was observed between MSS 3 and 4. When the load is 60 kN and the displacement is 7.16 mm, a shear crack occurred between MSS 1-2, 2-3 and the lower right of the MSS 10. The crack, which started under the MSS 13 with a vertical load of 70 kN and a displacement of 8 mm, progressed between MSS 11 and 12 and reached the upper cap (Figure 11). Finally, shear damage occurred when the vertical displacement reached 10.17 mm and the vertical load reached 78.10 kN. The load carrying capacity of the S4 increased by 6.98%, 4.69%, 3.03% and 1.56%, respectively, compared to the S0, S1, S2 and S3. However, since the ductility ratio was calculated as 1.36, it can also be said for S4 that sufficient ductility could not be obtained according to the literature. Although the load carrying capacity of the S1, S2, S3 and S4 obtained by strengthening the S0 up to this stage was relatively increased, the inability to obtain ductile behavior indicates that the MSSs do not work in the stirrup logic existing in the beam. The number of stitches was applied as 4 (range 220 mm), 5 (range 165 mm), 6 (range 130 mm) and 7 (range 110 mm) on one side in the shear area until this stage, but it was thought that more frequent MSS should be applied since shear damage could not be prevented. Since the crack formed in the shear zone at each step reached the beam's upper head between the two MSS in the shortest way and caused the formation of shear damage.

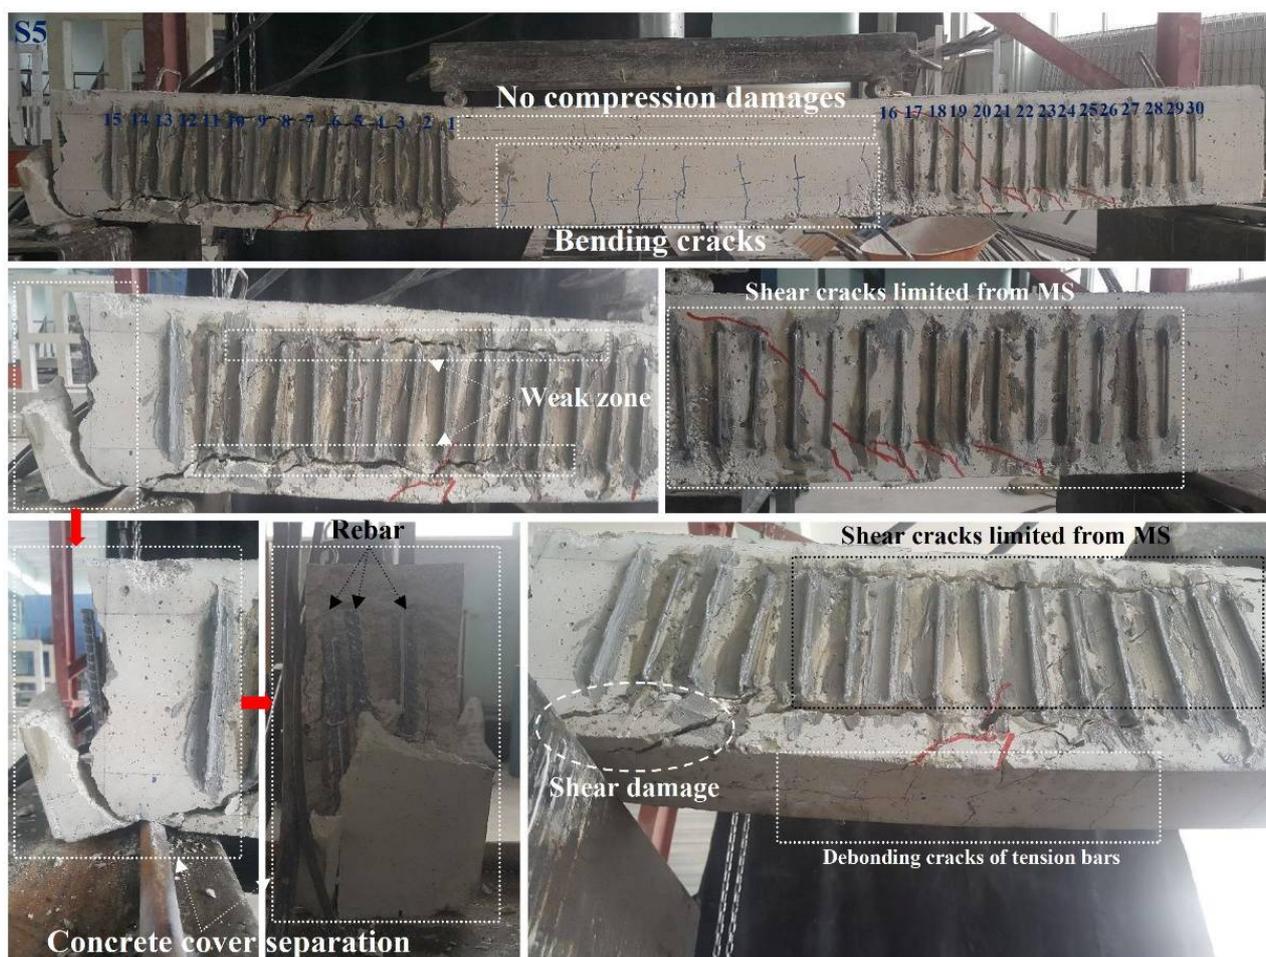
Figure 12. Damages at S5.

Finally, the S5 was prepared in order to strengthen the S0 beam. The difference between S-5 from other reinforcement types was that the most frequent (range 45 mm) MSS application was made along the shear opening. In this way, the behavior of MSSs placed in the stirrup logic in the most common situation was clearly seen. For this, fifteen MSS were applied to one side of the shear opening. In this way, the beam was strengthened using a total of 60 MSS. Initial bending cracks were observed for the S5 specimen at a load of 20 kN and a displacement of 2.56 mm. With the load of 30 kN and the displacement of 4.43 mm, the elongation of the cracks in the bending region was observed. In addition, at this load value, the first shear crack occurred in the right shear span of the beam, just below the 26 numbered MSS. With the increase in the load, new cracks were formed in the beam bending region with a load of 40 kN and a displacement of 6.16 mm and the elongation in the existing cracks continued. This was evaluated as a sign that the applied MSSs increased the shear capacity and forced the bending region of the beam. In addition, a shear crack was observed under the MSS 7 in the left shear opening at this load value. With the load reaching 50 kN and the displacement 7.94 mm, new cracks were formed in

the bending region and elongation was observed in the existing cracks. When the load reached 60 kN and 9.47 mm, the cracks in the bending zone reached the neutral axis level. In addition, a shear crack was observed just below MSSs 1 and 22. With the increase in the vertical load, the 19-20-21 MSSs with 70 kN load and 11.27 mm displacement tried to prevent the propagation of shear cracks. At this load, new bending cracks also formed and moved towards the neutral axis. This showed that bending reinforcements started to yield at this load value. When the load reached 80 kN and the displacement reached 13.69 mm, the crack reaching MSS 19 advanced towards MSS 18. The propagation of cracks in the right shear span indicates that the shear capacity was forced. In addition, the fact that it continues to elongate in the cracks in the bending region at this load value shows that the longitudinal reinforcements are also forced. As the load reached 90 kN and the displacement reached 16.45 mm, the propagation of the cracks in the bending zone stopped. The crack reaching the number 18 MSS progressed and advanced to the bottom of the spreader beam right support. In addition, shear cracks were observed under MSSs 7 and 8 in the left shear opening at this load value. Finally, with the load reaching 95.74 kN and the displacement 17.89 mm, the load carrying capacity suddenly decreased and the experiment was terminated. It was observed in Figure 12 that cracks progressed on a horizontal line in the upper and lower parts of the MSSs in the left shear span. Due to the application of the applied MSSs between the lower and upper reinforcement, cracks developed from the weakest link. The MSSs present in the left shear span prevented the cracks from expanding and causing shear damage. Therefore, the support area, which was not reinforced, was broken by remaining weaker. When the specimen was examined, the test was terminated by the fracture of the weaker shell concrete than the point where the longitudinal reinforcements in the support area just ended. As a result, it can be said that the applied MSSs prevent the beam from direct shear damage. Considering the load carrying capacity, the S5 showed an increase of 31.15%, 28.33%, 26.30%, 24.49% and 22.58%, respectively, compared to the S0, S1, S2, S3 and S4 specimens.

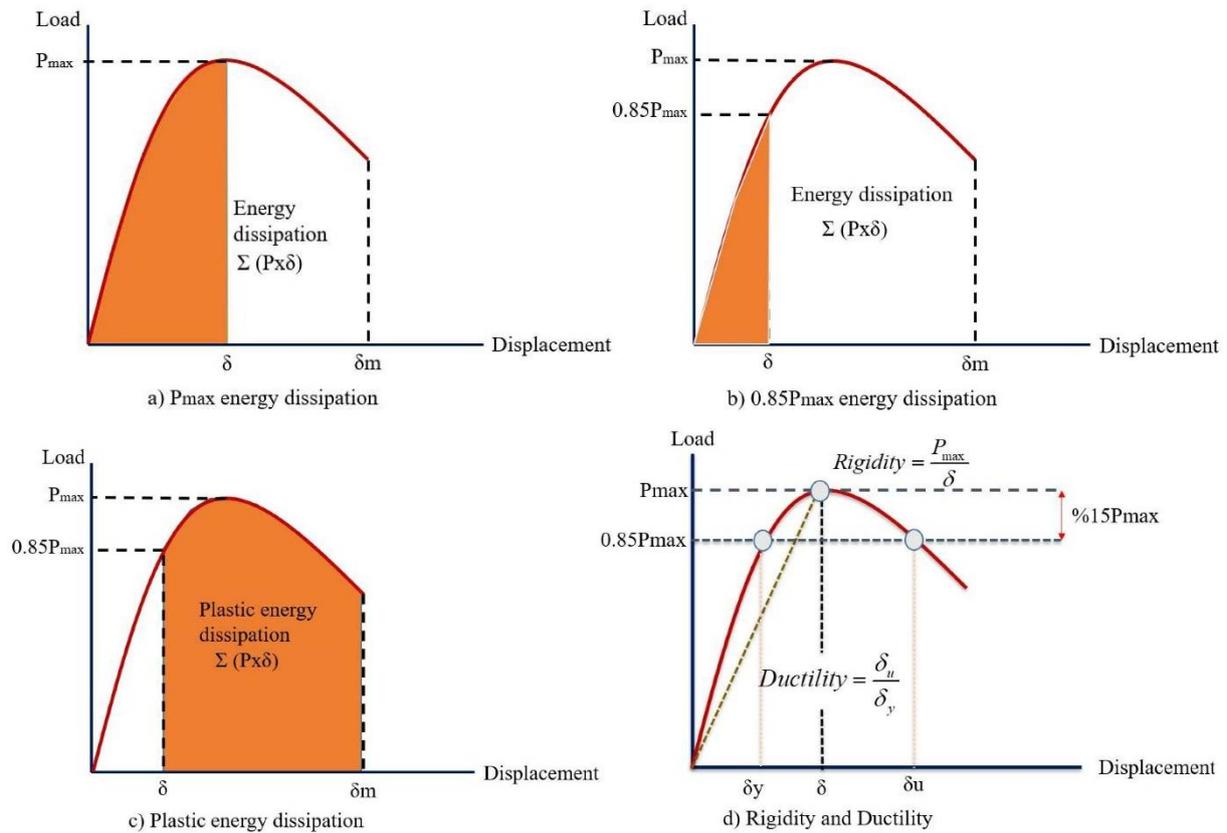
Figure 13. Energy dissipation capacity, ductility, and rigidity calculation of specimens.

The energy dissipation capacities of each specimen are given in Figures 13 and 14 and Tables 4 and 5. When compared in terms of elastic energy dissipation, the S5 specimen showed an increase of 142.30%, 133.33%, 142.30%, 110% and 103.22%, respectively, compared to the S0, S1, S2, S3 and S4 specimens. This shows that the energy dissipation temporarily stored in the linear elastic behavior of the S5 specimen is the highest compared to other strengthening methods. In other words, it shows that the elastic energy dissipation capacity of the S5 specimen is better under sudden vertical load effects. The energy dissipated after damage to the building elements, especially under forced effects such as earthquakes, is known as plastic energy. In this respect, the S5 specimen has a higher plastic energy dissipation capacity. In other words, the S5 specimen has 8.62 times, 3.17 times, 3.85 times, 4.52 times and 3.85 times more plastic energy dissipation capacity than S0, S1, S2, S3 and S4 specimens, respectively. Although the S5 specimen has the highest plastic energy dissipation capacity among the reinforcement alternatives, it can be said that this is not at a sufficient level when evaluated with ductility, especially the high plastic energy dissipation capacity in S5 is due to the frequency of applied MSS. If this situation is considered to be applied to the beams in the stirrup logic, it should be applied at maximum 45 mm intervals. It should be noted that otherwise, direct shear damage to the beam will occur.

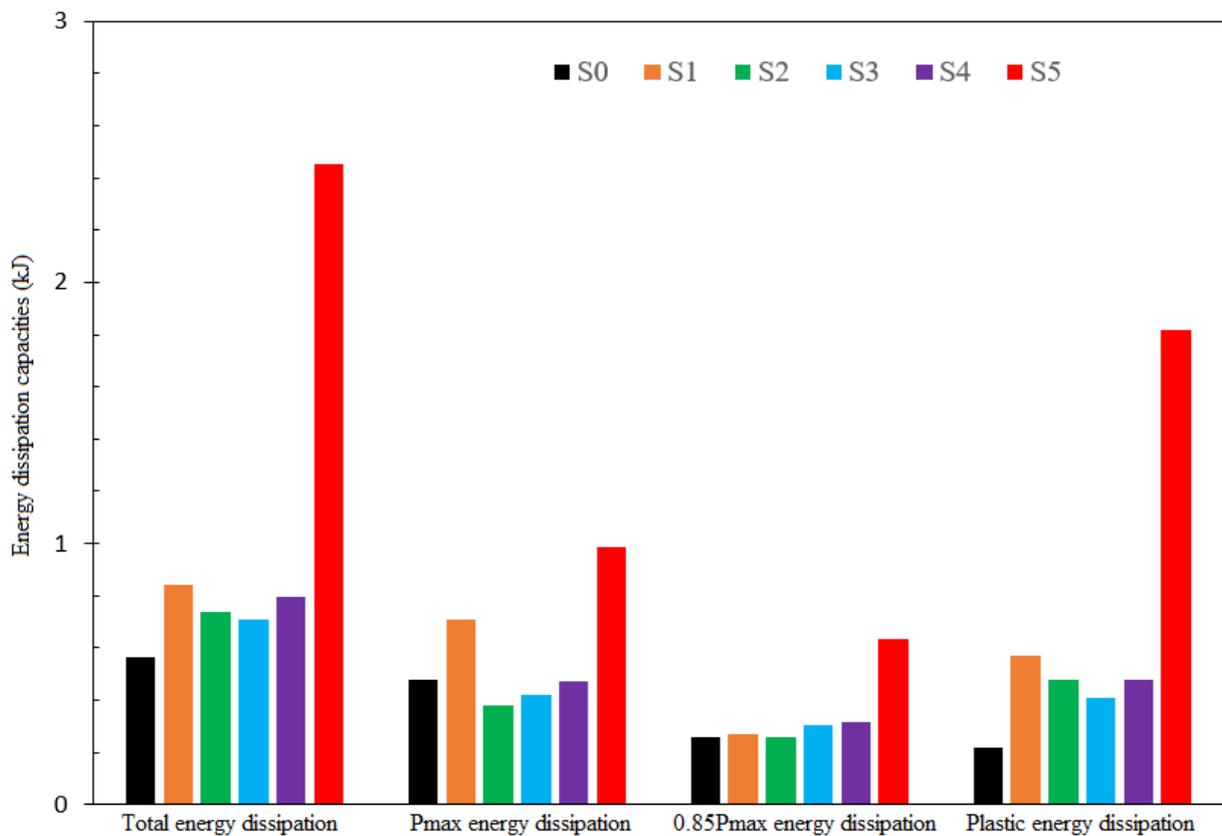
Figure 14. Energy dissipation values for specimens.
