# Renovation of Modernist Architecture Study Based on Selected Cases

**Abstract:** Modernist architecture is one of the most significant movements which serve as grounds for contemporary creations. At the beginning of the 20th century, the impact of new structural and building technologies allowed designers to find new ways of architectural expression. It is rooted in thought-out composition and simplicity which serve as a background for the exposition of structure. The geometrical interplay of a building's elements highlights the impressively thin structures and raw surfaces of novel building materials. Nowadays, in selected regions, the architecture of the Modernist Period is neglected or loosely refurbished. As an effect of this phenomenon, buildings are demolished or deprived of aesthetical values. Thus, this article aims at showing an overview of sectional research on good practice. We base the study of on-site design implementations of several modernist architecture refurbishments and focus on technology and design assumptions with optimised thermal modernisation. The paper reveals a set of examples for the refurbishment of modernist architecture, with calculations of heat e

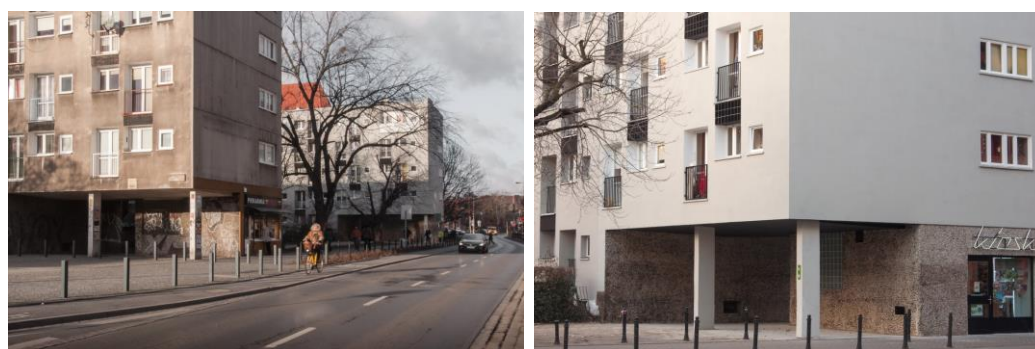
**Figure 1.** The blocks by Nankiera square—original and refurbished with recreated details (photography by the courtesy of Patryk Kusz/VROA Architekci).

New development founded the municipal company called ‘Revitalizations of Wrocław’ (in the Polish language ‘Wrocławskie Rewitalizacje’; no longer existing). The renovation included one section of the building and serves as an example for other parts governed by local housing associations. The main goals were thermal modernization and reconstruction of the original block’s appearance. However, adding layers, i.e., insulation to the façade, would cause a change in the initial depth of the windows’ mounting and would affect in disadvantageous ‘puffing’ of the architecture. Therefore, the original depth of openings was a priority, and the small windows occupy space on the external wall surface (Figure 2). Other glazed elements mount 15 cm deep into the façade (also according to the original solution). Flashings, balustrades and glass tiles in the strips between the windows are as close to the original ones as possible. The cladding from pebbles covers the ground floor area as in the original. The ironwork has a graphite colour, and the gable elevation composition crowns a newly designed neon above the entrance to the service point (Figure 1).

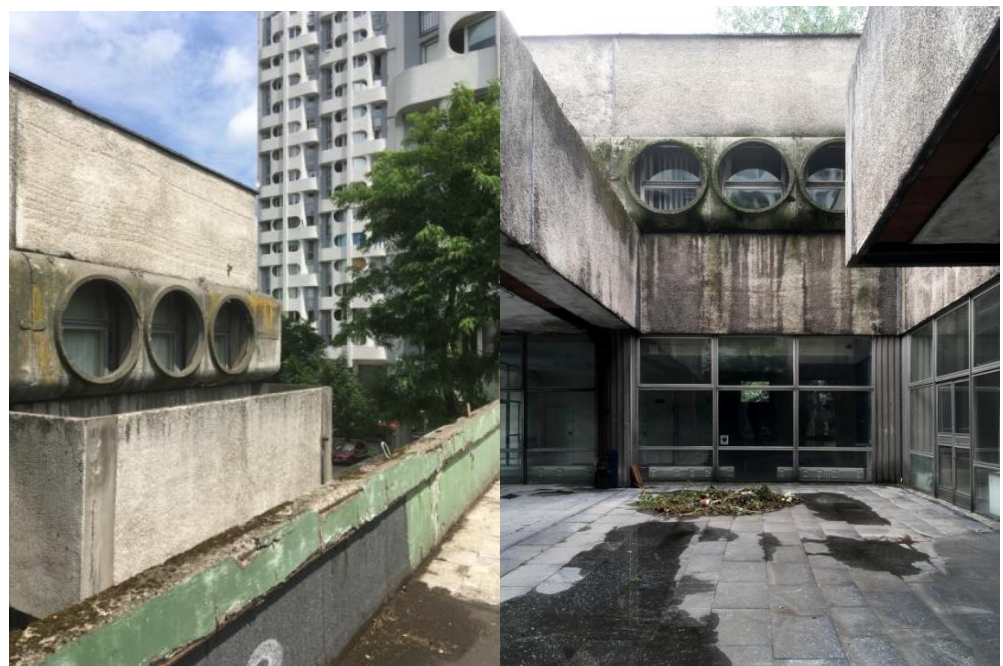
**Figure 5.** The commercial pavillon by Grunwaldzki Square—the existing condition (photograph by the Authors).

The building is a part of the mentioned residential complex. Jadwiga Grabowska-Hawrylak, Krzysztof Sasiadek (1968–1978) performed the original design, while Marta Mnich, Łukasz Wojciechowski, Hubert Różycki (2020) drew renovation plans [20]. The pavilion occupies a plot near Grunwaldzki bridge among several commercial spots elevated on a pedestrian platform. The two-story building with a basement has a reinforced concrete structure. Its characteristic spaceship-like façades constitute precast decorative elements with external spiral stairs. The steps wrap around the cylindrical shaft of mechanical ventilation. Glass covers the ground floor façades, divided into three sections with aluminum frames. Above there is the characteristic ornament of an extended curved precast panel with openwork. Circular openings form a repetitive rhythm. Other external walls are opaque and made from aerated concrete, fixed with ceramic tiles and trapezoidal metal sheets (Figure 5), [20].

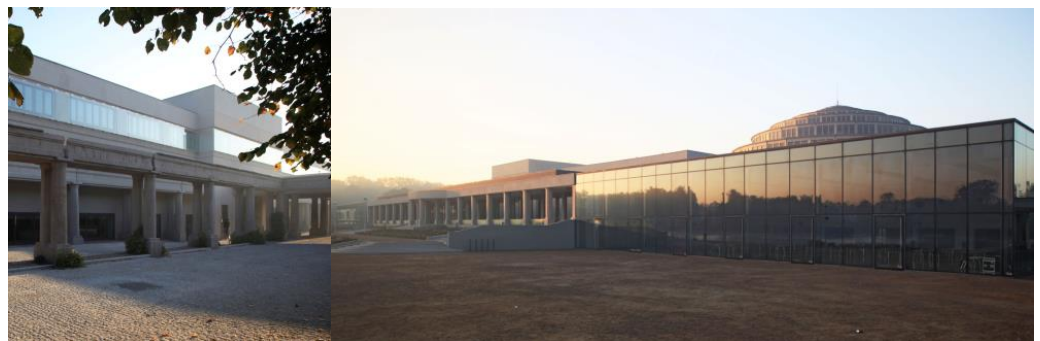
**Figure 7.** Renovation and refurbishment of the restaurant pavilion of the Centennial Hall complex in Wrocław—windows and glazed curtain wall (photographs by the Authors).

Two new and fully glazed wings extend the preserved structure. Cubatures accommodate an auditorium and multifunctional room, while the central part contains a foyer and restaurants, and above—on the mezzanine—office rooms. All technical equipment, storage rooms, service areas, and sanitary areas occupy the underground floor. While the original structure is part load-bearing brick masonry and partly reinforced concrete. It required strengthening of both walls and foundations and a partial change of existing slabs. The new structure was also added, made from steel and founded separately, in the two-story part of the building. The first floor has a light steel structure suspended from the beams of the slab over the floor. The skylight occupying the building's central part is a lightweight structure, as are the new extensions. Plate girders of variable height crown these parts. They have cast foundations of monolith reinforced concrete due to the high levels of groundwater. Opaque walls of existing and new extensions received original materials and colouring. A light-grey structural plaster covers them, polished into an even surface. Preservation of the original composition of façades was a key factor—the columns lean against the external wall. Thus, the remodeling assumed internal insulation. The method also allowed the original depth of the windows to be kept [21].
