# Strategy for Improving the Indoor Environment of Office Spaces in Subtropical Cities

**Citation:** Sung, W.-P.; Chen, T.-Y.; Liu, C.-H. Strategy for Improving the Indoor Environment of Office Spaces in Subtropical Cities. *Buildings* **2022**, *12*, 412. <https://doi.org/10.3390/buildings12040412>

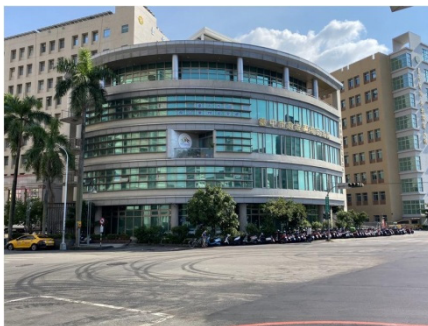
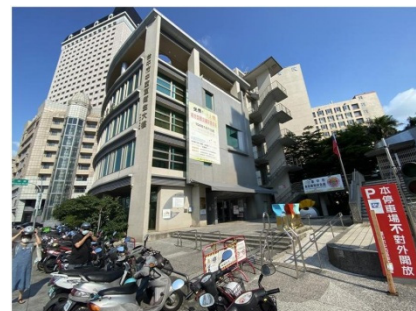
**(a)** Front photo of this test site.

**(b)** Office entrance of this test site.

**Figure 2.** The test site of office building in urban area.

This study mainly focused on the interior space of an office building (Figure 2) in the Taichung urban area, where experiments were performed and then improvement plans were implemented. Field tests were conducted before and after the implementation of the improvement plan to verify the changes. The office space of this field test was 1000 square meters, divided into three sections. The center held 38 office desks separated by partitions. Document storage areas occupied both sides of the office space, and the electrical equipment area was located in the front of the office. The space had two entrances and exits. Along the side of the office facing the road was a row of windows. Due to the exhaust from the passing vehicles, the air quality by the road was poor, so the windows on this side usually remained closed. Central air conditioning was applied for ventilation in summer, while in winter, the front and rear doors were opened and fans were used for ventilation. The electrical equipment area in the front of the office had two large photocopiers for printing, filing cabinets, and binders. Along both sides and the back of the office were filing cabinets for reference materials and other documents required by the office staff.

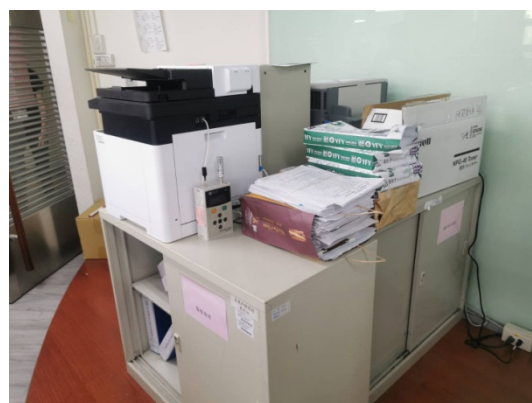
**Figure 4.** Detected device installed at photocopy area.

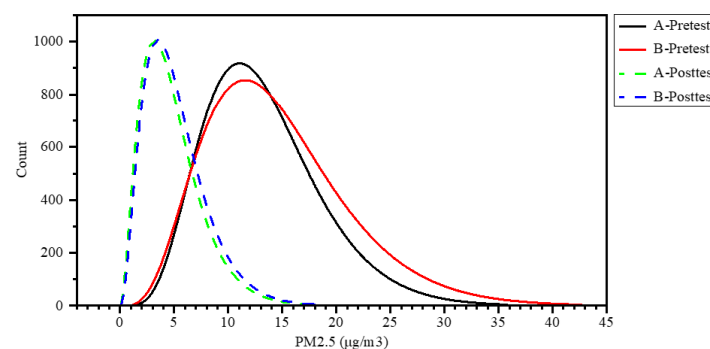
**Figure 9.** Distribution curve of PM<sub>2.5</sub> concentrations before and after the implementation of the improvement plan.

PM<sub>2.5</sub> and PM<sub>10</sub> concentration change interval after change in the photocopy area and the seating area has been narrowed, and the average maximum of PM<sub>2.5</sub> and PM<sub>10</sub> concentration has been reached below the standard value. The most commonly measured PM<sub>2.5</sub> concentration has been reduced to 3 µg/ m<sup>3</sup>. The most commonly measured concentration of PM<sub>10</sub> has been reduced to 5 µg/ m<sup>3</sup>. The photocopy area showed the same trend as the seating area. From Figures 9 and 10's waveform trend distribution, it was seen that the PM<sub>2.5</sub> and PM<sub>10</sub> variation ranges in the seating area were mainly photocopiers for toner laser printers, and the fine suspended particles produced by photocopying were susceptible to wind speed and direction. Susceptibility to airflow results in a wide distribution of these curves. However, after the implementation of this scheme, in addition to effectively reducing the distribution of suspended particles. Fine suspended particles were quickly removed by air exchange and forced ventilation.

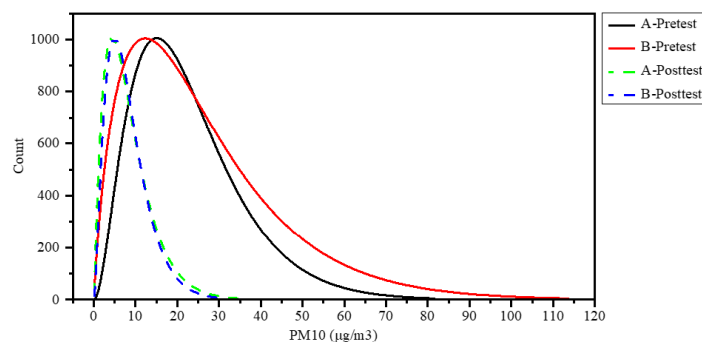
**Figure 10.** Distribution curve of PM<sub>10</sub> concentrations before and after the implementation of the improvement plan.
