Comparative Analysis of the 2023 Pazarcık and Elbistan Earthquakes in Diyarbakır

Abstract: Türkiye is prone to earthquakes due to its location on various tectonic plates, which can lead to a loss of lives and property. Recently, on 6 February 2023, two major earthquakes hit Pazarcık and Elbistan in Türkiye, causing widespread destruction on the East Anatolian Fault (EAF) zone. Even Diyarbakır, a distant province from the epicentre, was severely affected, highlighting the need to evaluate Turkish earthquake codes. As part of this evaluation, a structural analysis was conducted on earthquake-damaged and collapsed buildings in Diyarbakır. The study analysed three buildings with different levels of damage and six collapsed buildings as case studies. The seismic parameters of the earthquakes were compared to the values in the two recent earthquake hazard maps used in Türkiye's codes, as well as the Eurocode 8 damage limit values obtained from pushover analysis. The results revealed significant differences between the current seismic values of earthquakes and the current peak ground acceleration (PGA) values specified in the Turkish Earthquake Design Regulations. Additionally, the selec

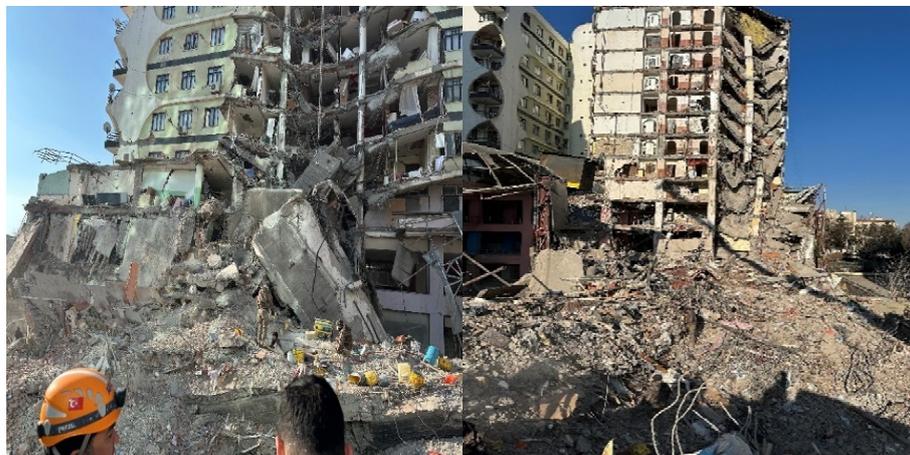
Earthquake amplitudes decrease in parallel with the distance–decay relationship as one moves away from the earthquake focal point, and accordingly, lower values were expected to be observed in Diyarbakır. However, the unexpected disproportionate destruction, damage and loss of lives in response to these low acceleration values raise some questions. In the observations made in the field after the earthquake, the presence of many structural defects, especially low-strength concrete and poor steel reinforcement, are noteworthy. In Diyarbakır province, the locations of a total of 18 buildings, including the building shown in Figures 6–8, 5 other collapsed buildings, 9 damaged (slightly, moderately and extensively damaged) buildings and 3 undamaged buildings, were marked with the help of the GPS on-site detection.

**Figure 6.** Collapsed buildings in Diyarbakır.

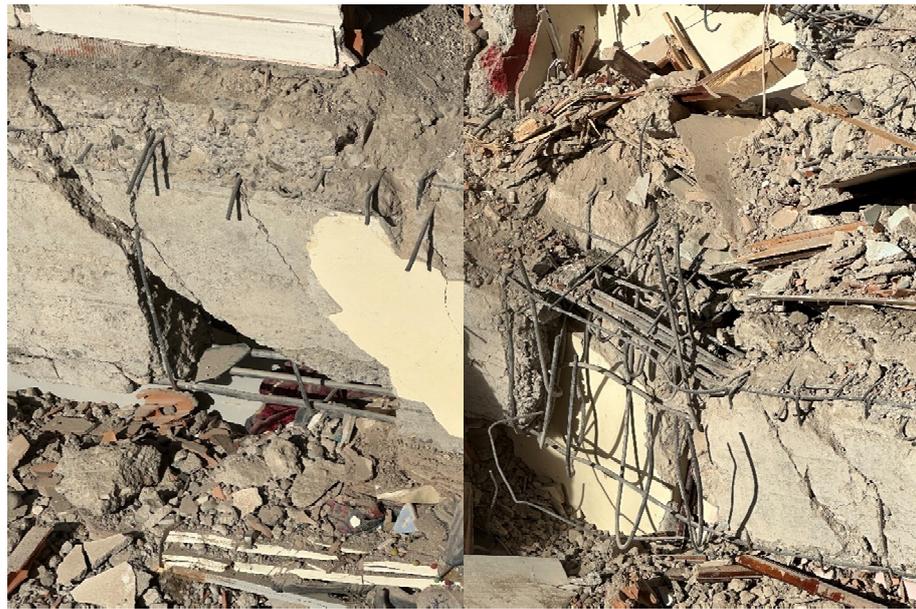
Figure 7. Shear damage of the beam and inappropriate stirrups.

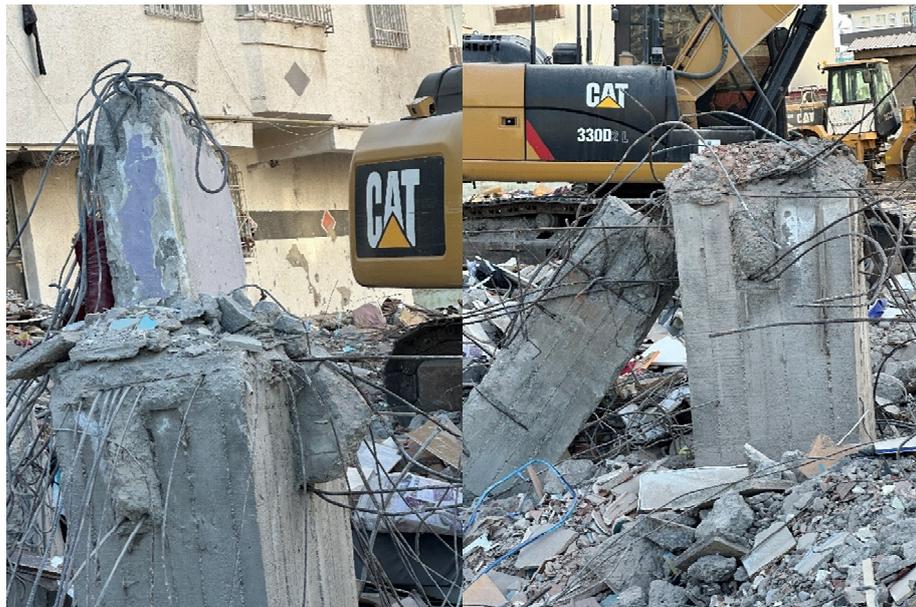
Figure 8. Retrofitting of the ground floor only and the failure of the old column.

Figure 8 shows the undamaged ground floor columns of the completely collapsed building. The slender column rising after the column with an exceptionally large cross-section might indicate that this building was subjected to an insufficient retrofitting process. Some damage examples of inappropriate shear walls and columns are illustrated in Figures 9 and 10.

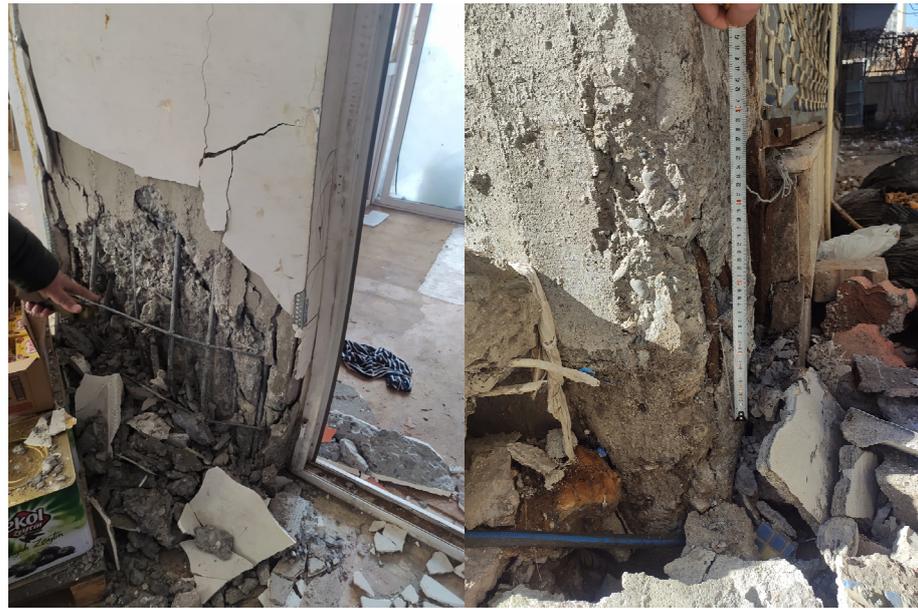
Figure 9. Extensively damaged columns.

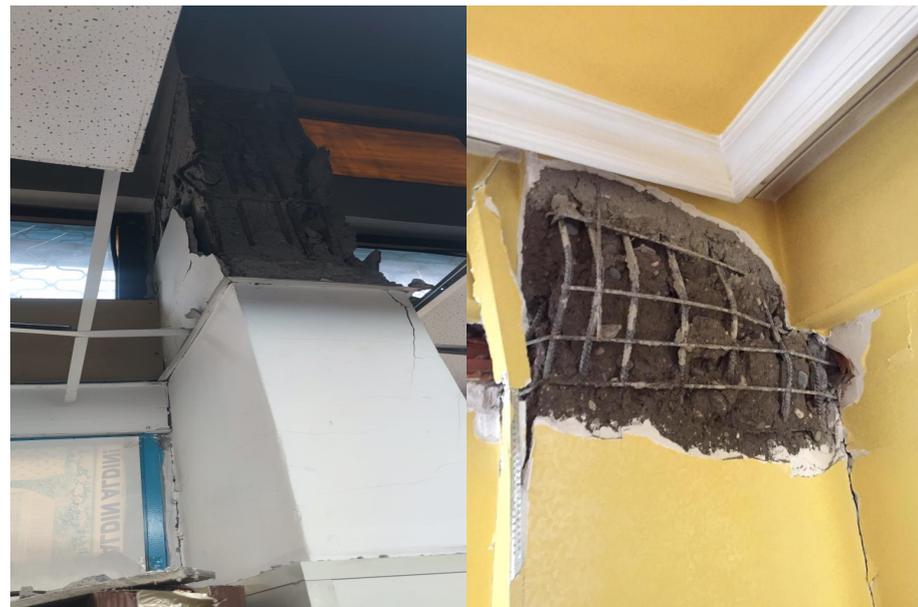
Figure 10. Damage to the short column and shear wall with poor concrete.
