# Article On the Factors That Determine the Bond Behaviour of GFRP Bars to Concrete: An Experimental Investigation

Keywords: GFRP bar; bond behaviour; pull-out test; concrete strength

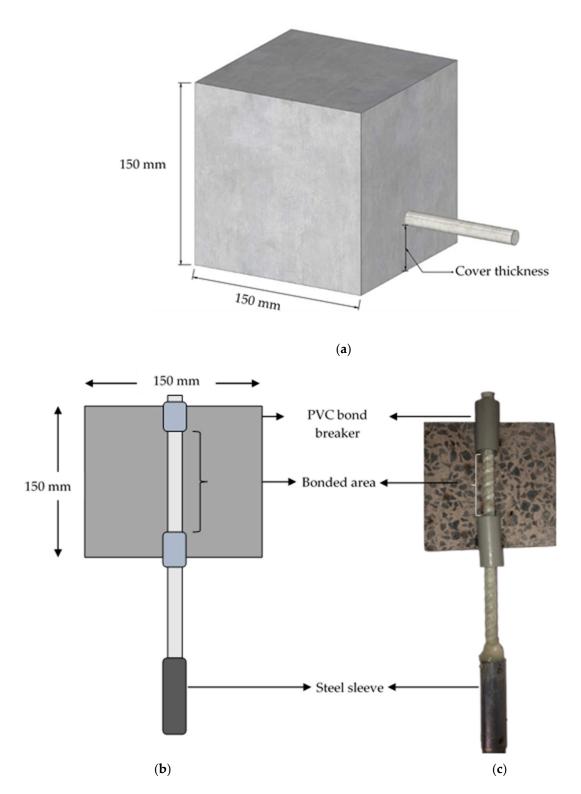
PVC pipes were used as a bond breaker to accurately set the embedment lengths and minimise stress concentrations at the edge of the bond lengths. As illustrated in Figure 2, a steel sleeve was also attached using high-strength epoxy resins to the pull end of the embedded GFRP bar to ensure a good grip at the jaws of the universal tensile machine (UTM). The details of the cross-sectional and dimensions of feature arrangements of the test specimen are expressed in Figure 2.

**Figure 2.** Details of pull-out test configuration: (**a**) overview of the bar and concrete block; (**b**) schematic section view of the pull-out test specimen; (**c**) section view of a pull-out test specimen.

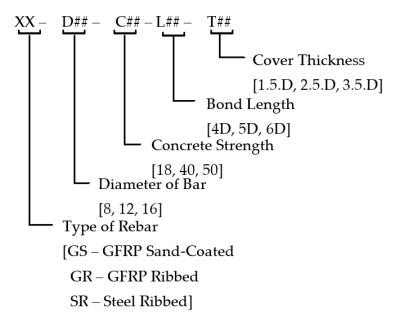
Figure 3 describes the designations of the specimens that represent the different factors under investigation. The details of the test configurations are given in Table 1.

Figure 3. Description of sample designation of test configuration.

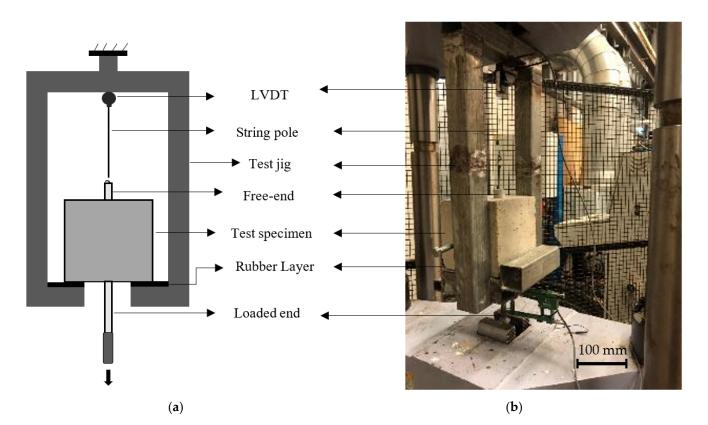
Figure 4 represents the schematic configuration of the pull-out test. The samples prepared (Figure 2) for the pull-out test were held in the jaws of a 600 kN universal testing machine (UTM) using a purpose-made jig, as shown in Figure 4. The test jig configuration consists of a welded square frame that is fitted on the UTM and onto which the sample is securely mounted.

The sample was pulled through the jaw of the UTM at a velocity of 2 mm/s. The force data were acquired via a 600 kN load cell. The relative slip of the rebar to the concrete block was recorded using a linear variable differential transformer (LVDT) with a self-retractable string mounted on the jig with the string attached to the free end of the GFRP bar, as indicated in Figure 4. The data for displacement and force were collected via computer software, and raw data were processed and averaged.

Figure 4. Configuration of the pull-out test: (a) schematic; (b) photograph.

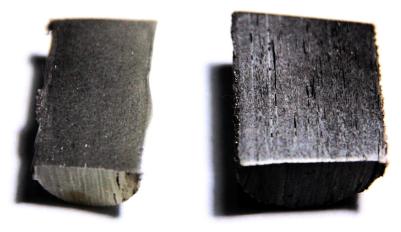
The thickness of the sand coating and the surface morphology of GFRP were examined via scanning electron microscope (SEM). The GFRP rebar sample for SEM was diametrically sectioned and gold-coated, as shown in Figure 5.

Figure 5. Longitudinally sectioned GFRP samples prepared for SEM analysis.

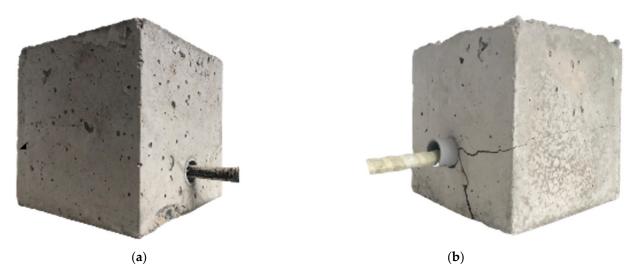
The examples of these types of failures observed are shown in Figure 6. It is observed that all sand-coated GFRP bars experience a rebar slippage failure irrespective of the

concrete strength. However, all ribbed GFRP and steel (normally ribbed) failed because of surrounding concrete splitting. This observation suggests that the ribbing of GFRP provided a better surface morphology to engage and optimise the mechanical contribution to the bond of GFRP bars to the concrete matrix.

Figure 6. Two types of failure patterns observed: (a) bar slipping; (b) concrete splitting.

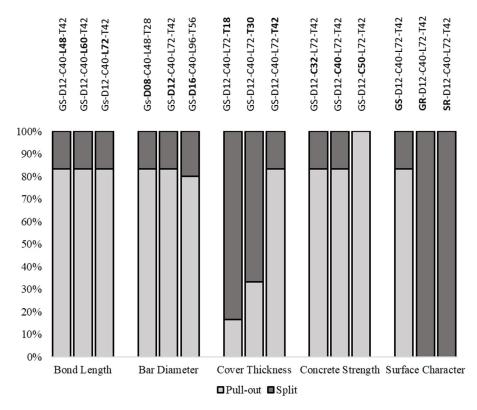
Figure 7 summarises the relative distribution of the types of failure of the pull-out tests. It is evident that surface morphology is a significant factor in determining the failure mode in the pull-out test of GFRP bars. It is seen that for sand-coated bars, 80% of the samples failed due to rebar slipping, and for the ribbed GFRP and steel rebars, 100% of the samples failed due to concrete matrix splitting.

Figure 7. Mode of failure occurred in each level of tested parameters.

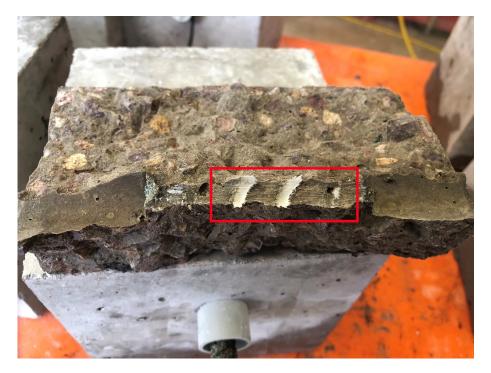
Concrete splitting was the predominant failure mode in the samples with GFRP and steel ribbed rebars. A typical surround concrete split is shown in Figure 8. This failure was characterised by a sharp release of energy in the form of a sudden blast of the concrete body in the vicinity of the rebar. This failure occurred very quickly, and this sudden loss of surface contact led to the stress concentration reaching the maximum bond strength. Any gradual slippage or slow crack propagation did not accompany the suddenness of the concrete fracture. The forensic observation of the interfacial bonding area of the failed specimens confirmed the role of ribs in resisting the slip, where the ribbed pattern was a clear artefact in the fractured concrete matrix, as evidenced in Figure 9.

Figure 9. Ribbed impression highlighted on split concrete in pull-out test for a GFRP ribbed bar.

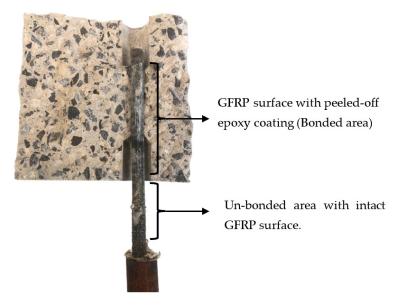
rebar specimens, the sand-coated rebar specimens displayed a softer failure where gradual slippage of the bar was observed until complete failure. Figure 10 shows the failed state of a test sample with sand-coated rebar, i.e., sand-coated bar in a cross-sectioned specimen. It is evident that the slipped area is characterised by the peeling of the originally epoxy-bonded sand coating around the rebar.

Figure 10. Cross-sectioned specimen showing pull-out failure effect on GFRP sand-coated bar.

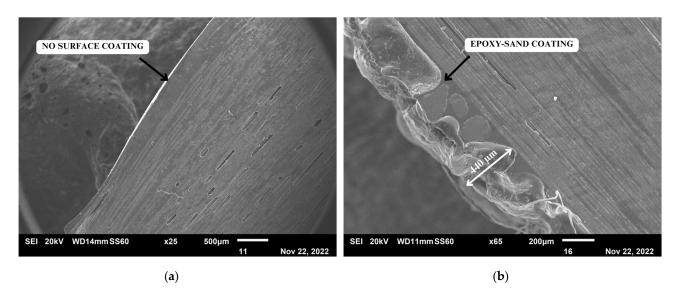
Figure 11 shows the surface morphology of the ribbed and sand-coated GFRP bar observed through a scanning electron microscopical (SEM) study. The sand coat has a thickness of about 400  $\mu$ m. The evidence from the failure modes suggests that sand-coated bars failed due to slipping through mostly because the sand coat is responsible for the loss

of mechanical gripping. The shear strength of the sand coats, therefore, is lower than the concrete strength since the surroundings effectively withstood the stress at failure.

Figure 11. Longitudinal cross-section of GFRP rebar: (a) ribbed rebar; (b) sand-coated rebar.

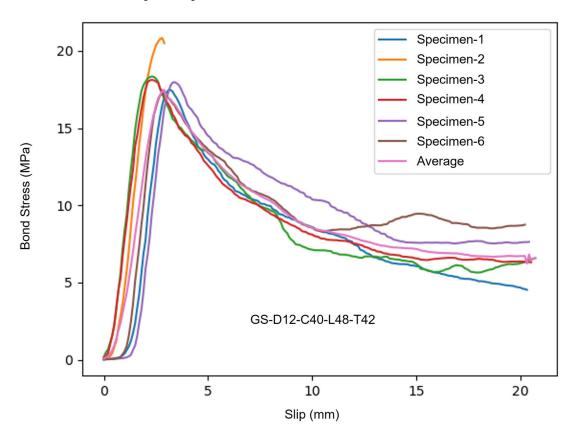
The analysis of the bond-slip mechanics is conducted to evaluate the energy absorbed for the failure of rebars. The curves were generated by averaging raw data from six test replications, as shown in Figure 12. The average bond stress to slip graphs of the five parameters investigated are shown in Figures 13–17, and the standard deviation of each data point is presented as a shaded trace behind each curve.

Figure 12. Bond stress observed on individual specimens.

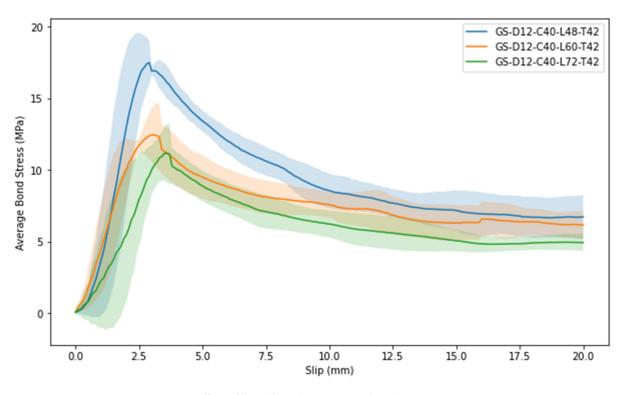
Figure 13. Effect of bond length on average bond stress.

In general, the strength pattern of sand-coated GFRP bars exhibited a linear-elastic behaviour until ultimate failure (Figure 13). After the peak load, a non-linear decrease was noted and then a plateau until the complete collapse of the samples. This is ascribed to the typical mechanical characteristic of pull-out behaviour.

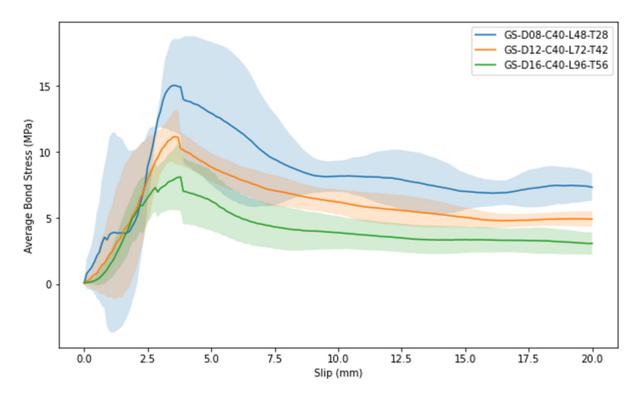
Figure 14. Effect of diameter on average bond stress.

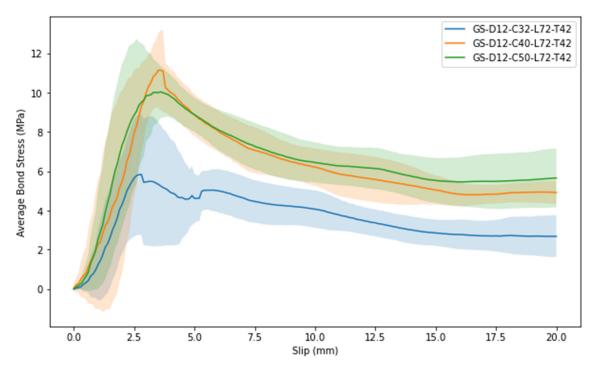
Figure 15. Effect of concrete strength on average bond stress.

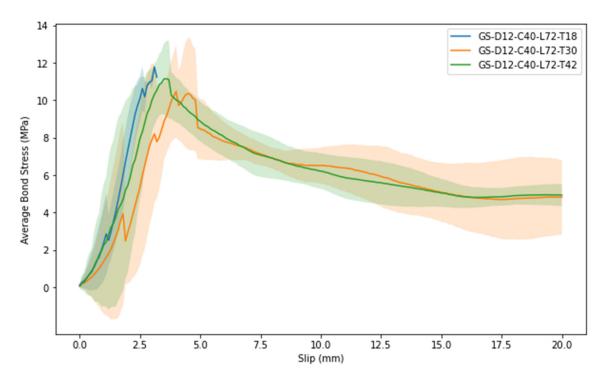
Figure 16. Effect of cover thickness on average bond stress.

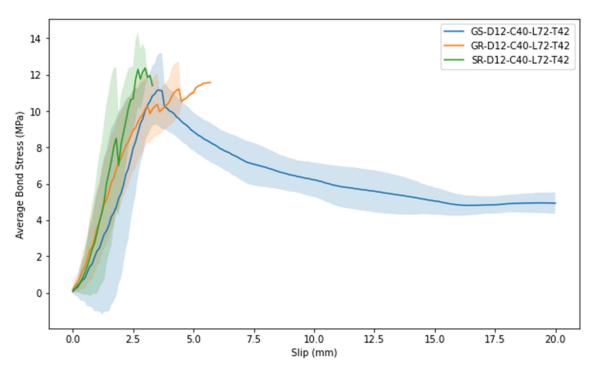
Figure 17. Effect of bar surface treatment on average bond stress.

A consistent bond behaviour pattern was noted among all the specimens with ribbed GFRP bars (Figure 17). Furthermore, the samples exhibited complete split failure after their ultimate mechanical bearing capacity. Hence, the stress curves ended at the beginning of the ascending path right after reaching their maximum.

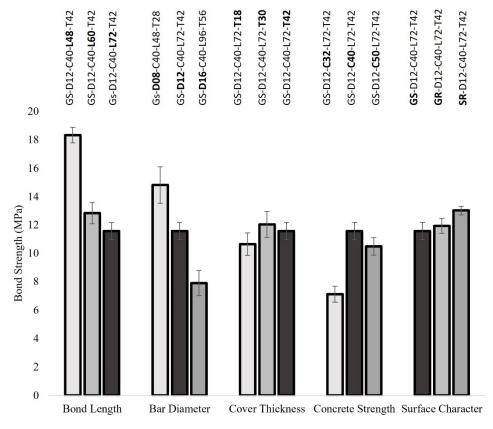
Figure 19 provides an overview of the bond strength of all pull-out test series, where the series are grouped by the parameters under investigation. Bar length and diameter have the biggest effects on imparting high bond strengths of 18.3 and 14.8 MPa, respectively. Furthermore, specimens with ribbed GFRP show the highest bond energy to their ultimate state, and the specimen with a bond length of 60 mm exhibited the second-highest bond energy.

Figure 19. Average bond strength of tested parameters.

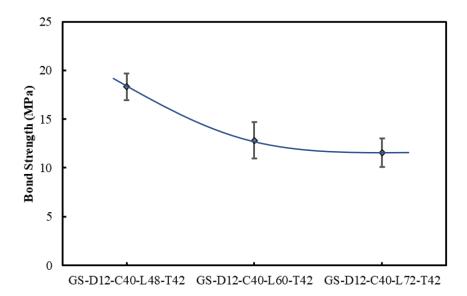
Figures 20 and 21 show the effect of the bond lengths and diameter of the GFRP bars on the bond strength. For 48 mm length (L48), the bond strength was the highest at 18 MPa, while it was significantly lower at about 13 MPa for L60 and L72. Similarly to the lengths, it was observed that bars with small diameters exhibit higher bond strength compared to large-diameter bars. There are a number of reasons supporting this observation: the confinement caused by voids, size effect and non-linear stress distribution. It is evidenced that smaller surface areas seem to give more effective and stronger bonds, in agreement with previous findings [37]. The effects of bar length and diameter on the bond strength are most likely probabilistic. When the sand-coated bar is subjected to stress, it may contain flaws or defects that can act as stress concentrators and initiate failure. Flaws can occur during the manufacturing process or arise due to other factors. The strength of the bond with a concrete matrix is influenced by the presence and size of these flaws. Assuming that the distribution of flaw sizes follows a statistical distribution, such as a Weibull distribution, the probability of failure for a fibre can be expressed as follows:

Figure 20. Effect of the bond length on the bond stress.

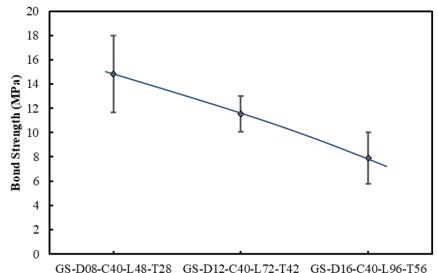
Figure 21. Effect of the rebar diameter on the bond strength.

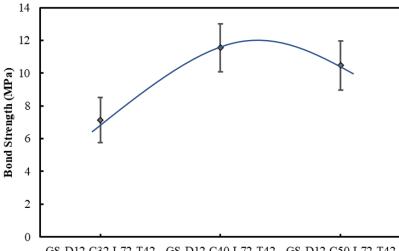
The effects of the compression strength of concrete were investigated with sand-coated bars embedded in 32, 40 and 50 MPa concretes. The bond strengths observed for the different concrete strengths are shown in Figure 22. The bond strength peaks with the 40 MPa concrete, indicating that this concrete strength allows for achieving the optimum bond strength. The data suggest that the bond strength was 7 MPa with 32 MPa concrete. It develops to about 11 MPa for 40 and 50 MPa concrete, an increase of some 70%. However, while high concrete strength seems to improve bond strength, increasing beyond 40 MPa does not provide additional benefits. Indeed, the coating peel-off found at the interface of the sectioned samples indicates that the trend of declining bond strength in high-strength concrete also depends on the strength of the epoxy outer layer of the sand-coated rebars.

Figure 22. Effect of the concrete strength on the bond strength for diameter at 12, and length at 72 for sand-coated GFRP bars.

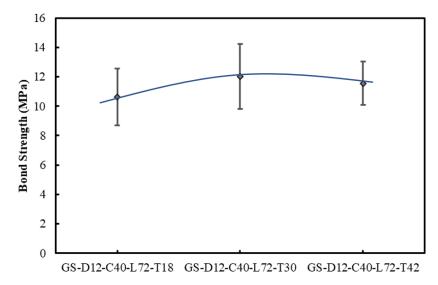
The effect of the cover thickness on the bond behaviour was investigated with three concrete covers: 18 mm, 30 mm and 42 mm. These covers correspond to the 1.5, 2.5 and 3.5 multiples of the bar diameters (12 mm). Figure 23 depicts the average bond strengths and provides the trend between these three variables. The specimens with a cover thickness of 30 mm give the highest average bond strength of 12.02 MPa, whilst the 18 mm and 42 mm cover thicknesses exhibited bond strengths of 10.64 and 11.55 MPa, respectively.

Figure 23. Effect of the cover thickness on the bond strength.

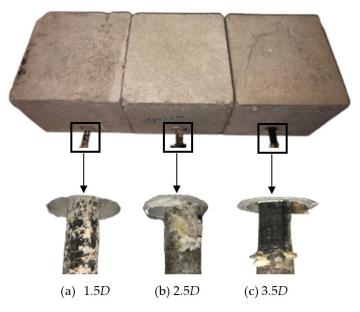
There is little variation in the bond strength with regard to the cover thickness, and this variation is not significant, i.e., within the confidence limits. It is shown that the cover thickness of 30 mm achieves the optimum bond strength. Figure 24 compares the failed specimens after the pull-out test. While observing the GFRP surfaces of specimens tested with a cover of 18 and 30 mm (Figure 24a,b), the presence of concrete particles is evident without much damage to the surface of the GFRP bar. On the other hand, the specimen with a cover thickness of 40 mm (Figure 24c) shows peel-off damage at the surface of the GFRP bar.

Figure 24. GFRP surface after pull-out test on cover thickness parameter.

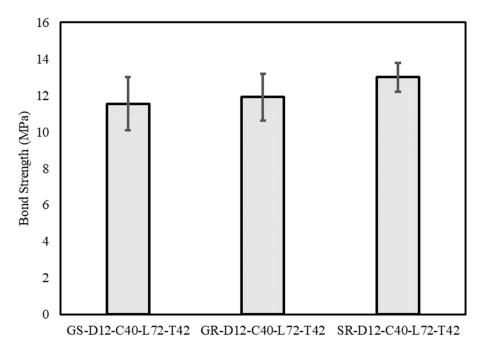
The effect of surface morphology was investigated with sand-coated and ribbed GFRP bars. As Figure 25 shows, the average bond strengths exhibited by sand-coated GFRP, ribbed GFRP, and steel ribbed rebars are 11.55 MPa, 11.91 MPa and 13.01 MPa, respectively. This shows that there is no significant difference between the sand-coated and ribbed GFRP bars. The differences in bond strength between both GFPRs and steel are also small and not statistically significant. It can therefore be concluded that the surface morphology and material of the reinforcement, whilst being engaged with the bond-slip of the reinforcement to the concrete, are not determinant fabrication parameters. However, it has been observed that ribbed bars failed with less slip than sand-coated ones. This outcome is mostly related to the failure of ribbed bars being strongly related to the compression strength of the concrete.

Figure 25. Effect of surface morphology on the bond strength.
