Article

An Investigative Study for the Seismic Performance of Composite-Reinforced Masonry Wall with Prestressing Technology

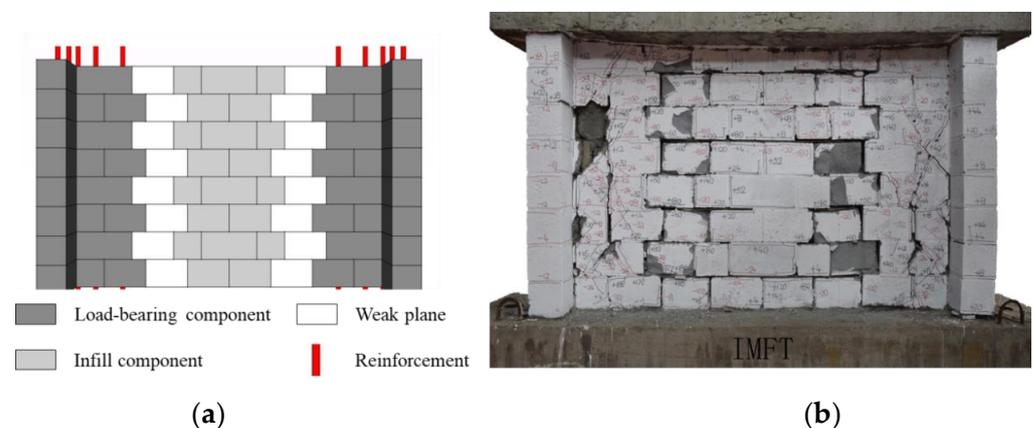
Figure 2. The description of ICMW system adopted from Chi et al. [18]: (a) schematic of ICMW system and (b) serious damage to ICMW system.

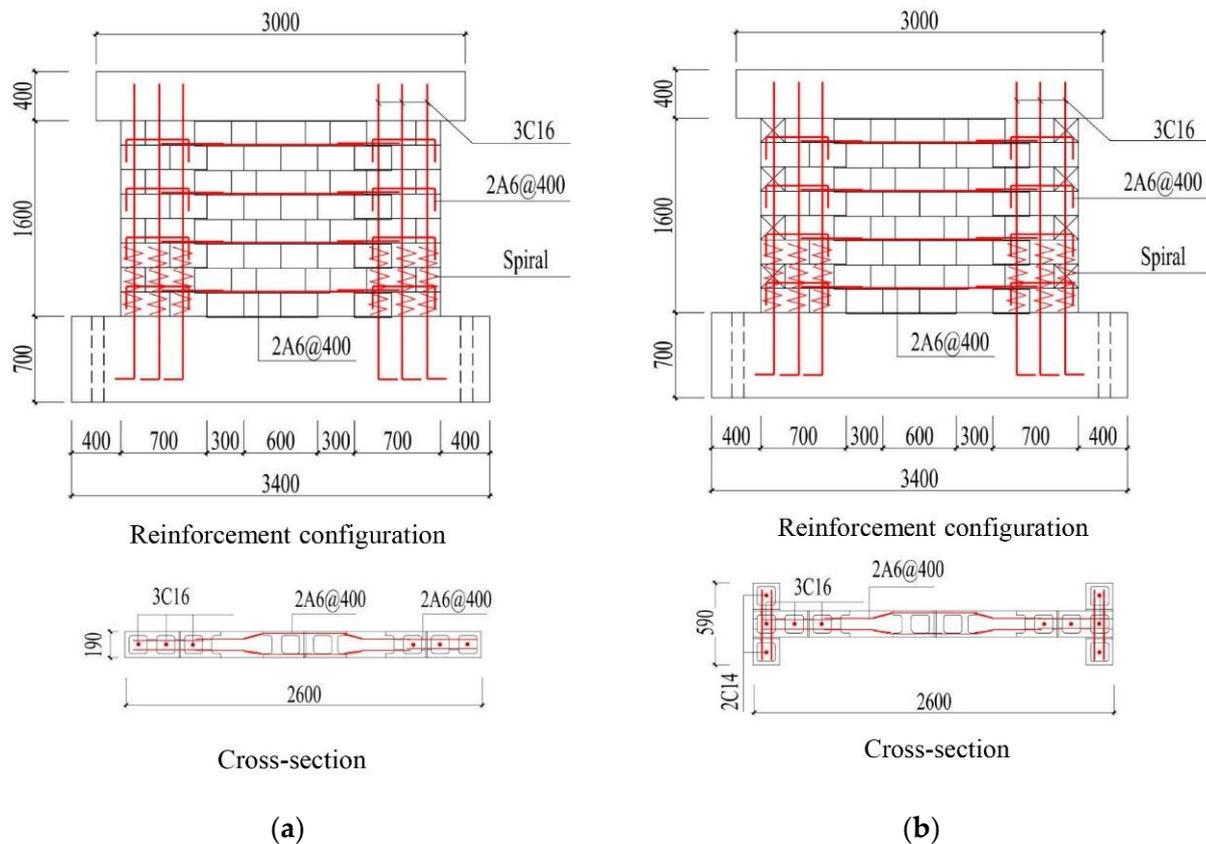
As shown in Figure 3, the overall height of the specimen was 2700 mm, while a top beam with a height of 400 mm and a bottom beam with a height of 700 mm were poured with the wall to provide end constraints. Two wall section types were constructed to investigate the influence of flanges on the seismic performance of the specimen. The specimens were divided into three functional zones, namely a load-bearing component composed of fully grouted CMWs, an in-fill component composed of ungrouted CMWs, and a weak plane composed of AAC blocks. To enhance the interaction between the load-bearing component and in-fill component, AAC blocks were placed in the shape of teeth; meanwhile, two plain bars were placed at the mortar layer of the ungrouted CMW and anchored in the fully grouted CMWs. To make comparisons with previous research, these specimens adopted a similar naming principal in Chi et al.'s study [18], where the symbol P was introduced to represent prestressing technology. Therefore, the specimen with a rectangular section was named IMFP, while that with a T-shaped section was named IMFTP. Detailed configuration information of the two specimens can be found in Figure 3 and Table 1.

Figure 3. Configuration of all specimens (dimensions in mm): (a) schematic of IMFP; (b) schematic of IMFTP.

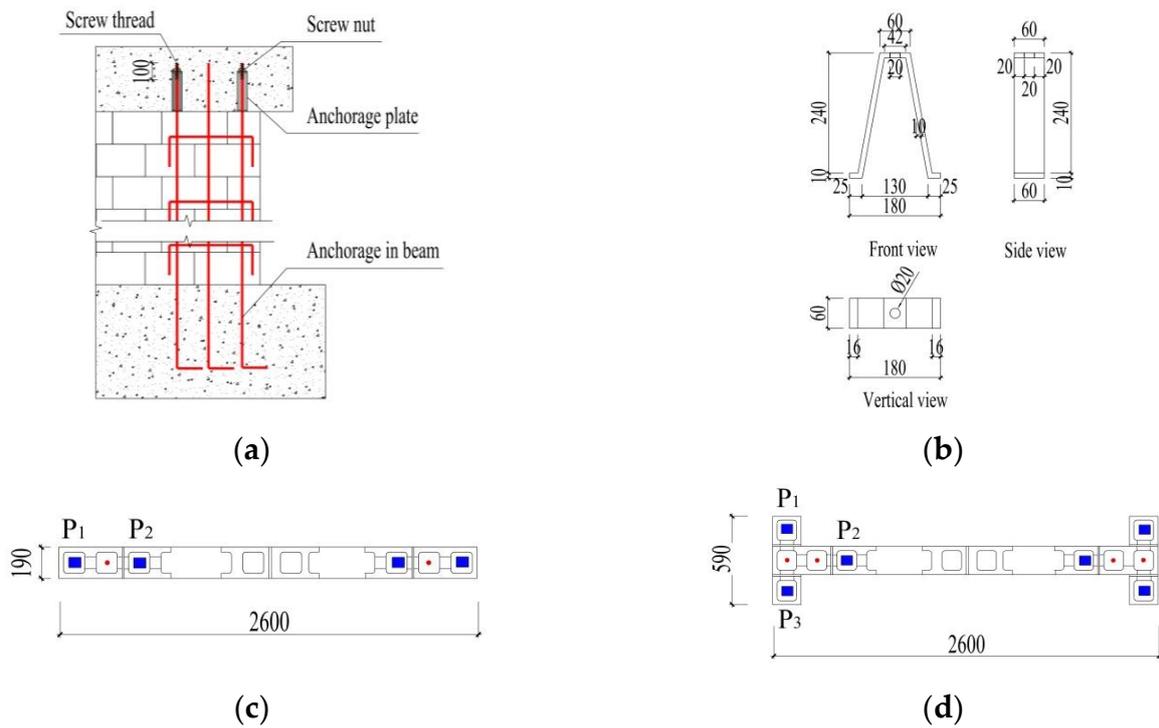
For prestressing technology, a bonded prestressing technology was proposed, and the construction details are outlined in Figure 4. It should be noted that the prestressing technology was used to improve the damage propagation of the load-bearing component of the ICMW; therefore, the amplitude of the prestress would not be larger, which was only applied on the section of the load-bearing component compared to that of the entire wall. As shown in Figure 4a, the vertical bars in the load-bearing component acted as prestressed bars simultaneously. One end of the bars was anchored to the bottom beam, while the other was premachined with threads. Figure 4c,d highlight the prestressing positions of the specimen with blue regions. The prestressed bars were symmetrically distributed at both ends of the load-bearing component, and the moment balance at the center of the section of fully grouted CMW was considered. To facilitate the construction and ensure the effectiveness of prestress, the magnitude of the prestress of each fully grouted CMW was set as 0.453 MPa, corresponding to the design axial compression ratio of 0.1, which was in accordance with GB 50003-2011 [37]. The detailed calculation process and results of the tensile stress of the vertical bars are shown in Table 2.

Figure 4. Details of prestressing technology: (a) schematic of prestressing technology, (b) anchorage plate (dimensions in mm), (c) prestressing zone in IMFP, and (d) prestressing zone in IMFTP.

Note: P₁, P₂, and P₃ represent the positions of prestress vertical bars, as shown in Figure 4.

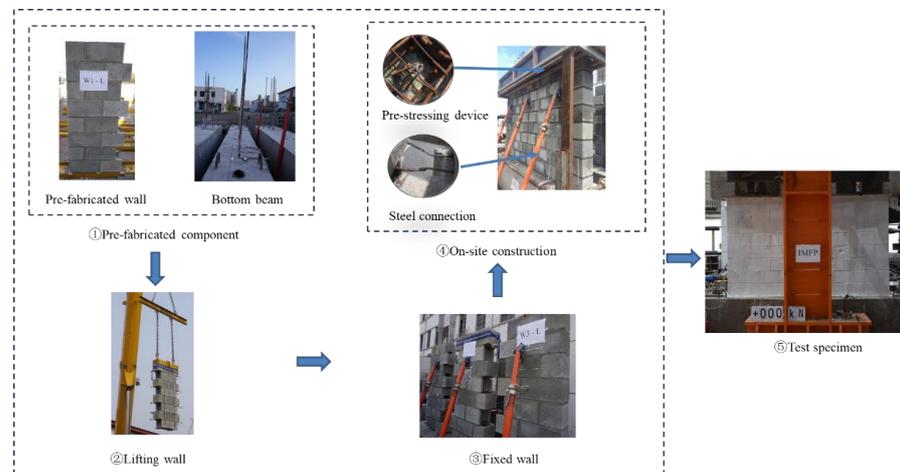
A construction plan of prestressing technology was tested in this experiment. As shown in Figure 5, hollow CMWs and bottom beams were separately prefabricated first; meanwhile, horizontal and vertical bars were arranged in the hollow CMWs and bottom beams, respectively. Then, the hollow CMWs were fastened and lifted for installation on the bottom beam. Steel struts were used to fix and vertically adjust the wall simultaneously, while AAC blocks were constructed in the tooth gaps between the hollow CMWs. Third, as vertical bars were inside the holes of hollow CMWs, anchorage plates were installed at the top face of the hollow CMWs. The ends of those bars were fixed by the anchorage plate and screw nuts using a torque wrench. It should be noted that the magnitude of the torque was set in advance to ensure that the magnitudes of stress and the strain variations in certain vertical bars were also monitored in real-time to ensure the effectiveness of the prestressing technology. After that, fine-aggregate concrete with an initial slump of 180 mm was used to grout the hollow CMWs of the load-bearing component, and top beams were constructed. All the specimens were cured in an appropriate environment before testing.

Figure 5. Process of specimen construction.

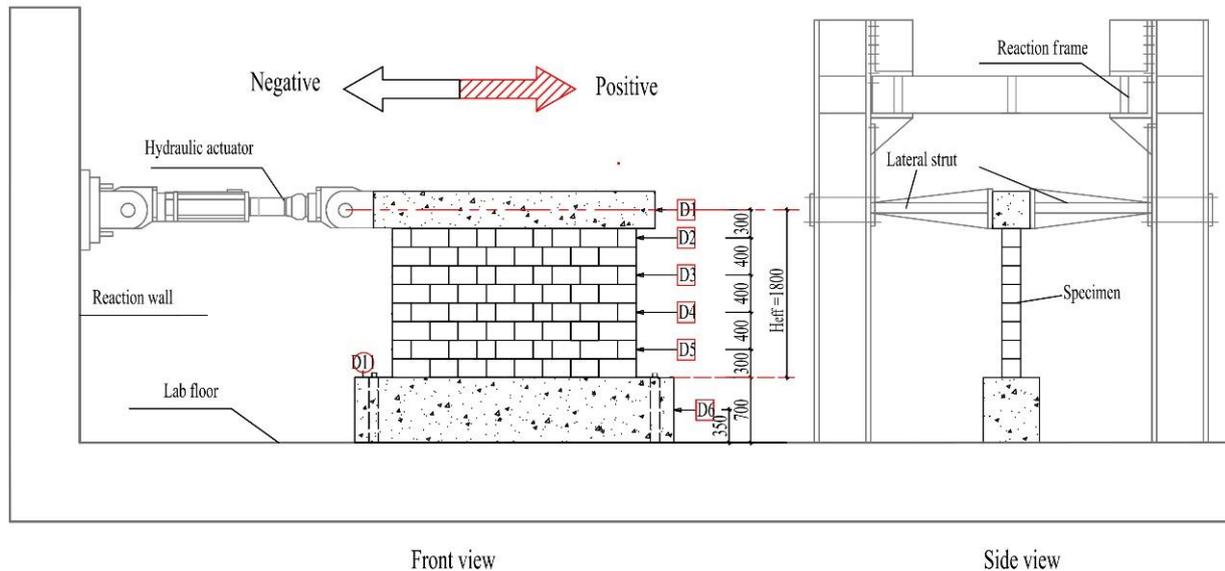
The test setup is presented in Figure 6. The specimens were fixed on the floor of the laboratory using two steel bolts, and the top beam of the specimen was connected to a lateral MTS hydraulic actuator using prefabricated steel plates. Meanwhile, two couples of later support were fixed on the reaction frame supported on both sides of the top beam of the specimen, thus preventing out-of-plane displacement. Furthermore, returning to practical engineering applications, the ICMW proposed in this study was designed to be used as a force-resisting system in low-rise buildings in villages and towns, so the

Figure 6. Test setup and schematic of instrumentation arrangements (dimensions in mm).

The measurements of the specimens are also plotted in Figure 6, marked by a red box. Linear variable differential transformers (LVDTs) can be divided into three categories according to their functionality. D1 and D6, which were placed at the center of the top and bottom beams, formed the first measurement category, and the difference between them was used as the loading control displacement. For the second category, D2–D5 were arranged on one side of the wall to obtain the deformation characteristics of the specimen. Moreover, D11 was a dial gauge used to monitor the vertical displacement of the bottom beam in real-time, which could indicate whether the bottom beam was fixed on the floor of the laboratory or not. On the other hand, strain gauges were also arranged in this experiment to monitor the stress of the steel bars. Unfortunately, it was found that many strain gauges failed during the experiment; therefore, the positions of the strain gauges are not marked in Figure 6, and a discussion on the stress of steel bars will not be carried out in this paper.

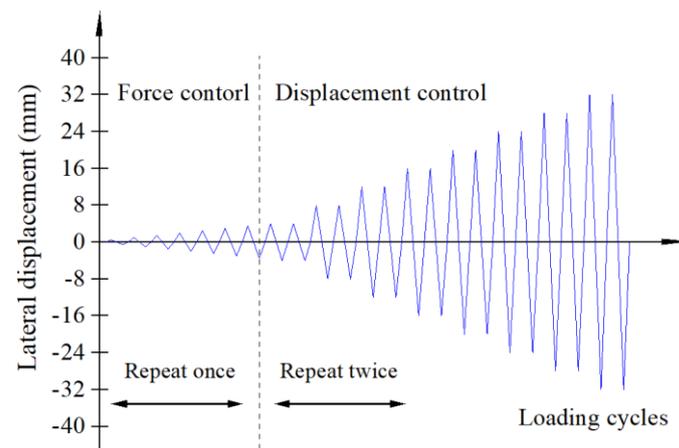
A force displacement loading mode was adopted in this experiment, and the loading protocol is plotted in Figure 7. A positive loading direction was defined as the direction when the lateral actuator applied thrust force on the specimen; accordingly, a negative positive loading direction was defined as the opposite direction, as shown in Figure 6. A force control loading protocol was adopted in the early loading stage to obtain information on the specimen in the elastic stage. Each load stage was repeated once, and the loading rates were 10 kN/min, indicating a quasi-static loading mode. When the inflection point occurred at the hysteretic curve, the force control loading protocol was replaced by the displacement control loading protocol, while the displacement cycle was repeated twice at each control displacement. In order to conduct a comparative discussion with previous research, the displacement control loading protocol used in this experiment was consistent with that used in Chi et al.'s study [18]. The damage propagation and deformation of the specimen were recorded in a timely manner during the experiment. Finally, the experiment was terminated when the lateral resistance of the specimen decreased to 60% of the maximum lateral resistance of the specimen measured in the test.

Figure 7. Loading protocol.

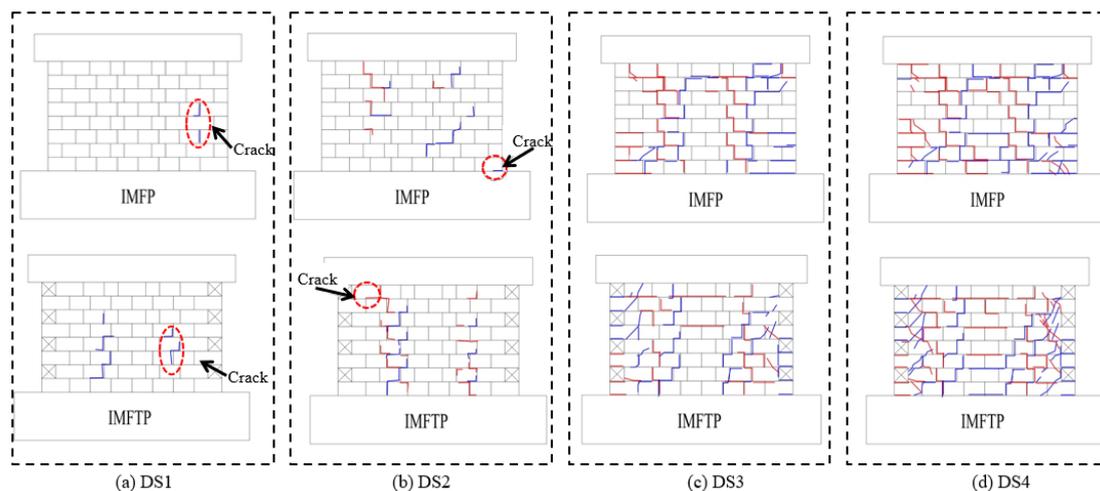
Figure 8. Crack propagation of specimens IMFP and IMFTP.

Figure 8 clearly indicates that stepped cracks first occurred in the mortar layers around the weak planes of the specimen. This phenomenon was consistent with the previous assumptions made about the functional zone of the specimen. As there was an increase in the loading force, cracks around the weak plane developed fully and occurred at the load-bearing component of the specimen, indicating that the specimen reached DS2. After that,

Summarizing the entire process of the specimen, the damage propagation can be divided into four stages based on the development zone of cracks and changes in the load-bearing capacity of the specimen. Therefore, four damage states (DSs) were defined in this study to describe the damage propagation of the specimen. The first state (DS1) corresponded to the stage when a crack first appeared in the whole specimen, thus reflecting the weakest zone of the specimen. The second state (DS2) corresponded to the stage when a crack first appeared in the load-bearing component of the specimen, which indicated that inelastic deformation occurred in the load-bearing component. In addition, the third state (DS3) and the fourth state (DS4) were related to the lateral resistance of the specimen. DS3 corresponded to the stage of the maximum lateral resistance of the specimen, while DS4 corresponded to the stage of 85% of the maximum lateral resistance at the decrease stage of the specimen, respectively. Therefore, the damage propagations of the specimen were plotted, as shown in Figure 8. The blue and red lines represent the propagation of cracks in the positive and negative directions, respectively.

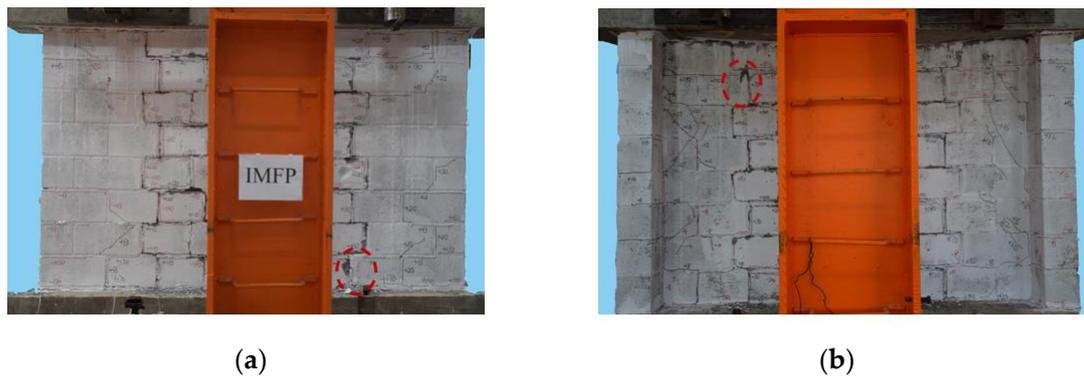
Figure 9. Damage state of specimens: (a) specimen IMFP; (b) specimen IMFTP.

with an increase in the loading displacement, weak planes were squeezed by functional components on both sides; hence, the mortar layers around the weak planes were split, and gaps appeared between the load-bearing component and in-fill component. Cracks were gradually observed at the top or bottom zone of the load-bearing component and in-fill component during the process of the specimen from DS2 to DS3, as shown in Figure 9. However, owing to the increase in the gaps, the cracks in the in-fill component were observed to no longer increase with the increase in the displacement, which demonstrated that the in-fill component did not participate in the later loading process of the whole specimen. Finally, damage to the load-bearing component gradually accumulated, and the in-fill component gradually withdrew from the specimen, leading to a decrease in the load-bearing capacity of the specimen.

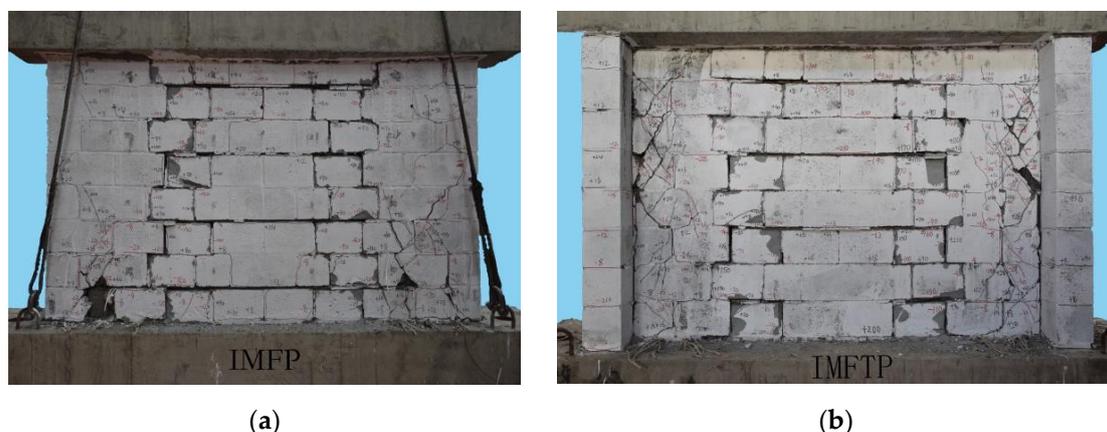
The final failure patterns of the specimens are shown in Figure 10. The similarity of the failure patterns of the two specimens was that the weak planes were seriously damaged, while the in-fill component still maintained in-plane integrity with few cracks. The load-bearing components were also seriously damaged; however, the failure pattern of each specimen was different according to the section type. For specimen IMFP with a rectangular section, the cracks were concentrated at the top and bottom zones, and bottom masonry face spalling occurred. However, for specimen IMFTP with a T-shaped section, the cracks were distributed uniformly, and cross-cracks occurred at the middle of the web plane of the load-bearing component, while only horizontal cracks were observed at the flange plane. Based on the typical failure characteristics of masonry walls in previously conducted studies in the literature [13–15], it could be concluded that bending failure and shear failure occurred in specimens IMFP and IMFTP, respectively.

Figure 10. End states of specimens: (a) specimen IMFP; (b) specimen IMFTP.

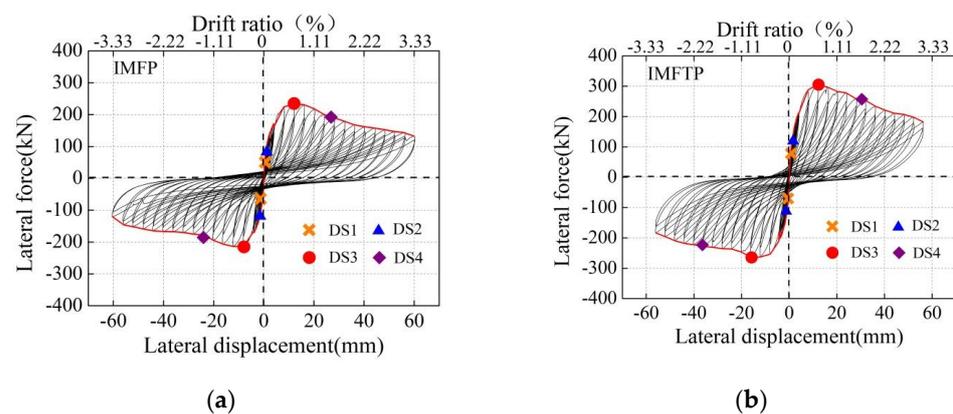
Based on the cyclic test results, the load–displacement hysteretic curves of the two specimens were plotted, as shown in Figure 11. The envelop curves and four damage state characteristic points are also depicted in Figure 11. The drift ratio (DR) was defined as the ratio of the top displacement and loading height of the specimen for subsequent analysis, while the loading height was calculated as 1800 mm, as shown in Figure 6. Therefore, a significant and nearly symmetrical pinching effect was observed in the load–displacement curves of the two specimens. The appearance of the overall load–displacement curves was S-shaped, and an obvious slip phenomenon was observed in the unloading stage of each loading loop. The lateral resistance of the specimen increased rapidly at the prepeak stage of the load–displacement curves and decreased gradually at the postpeak stage. Moreover, the characteristic point information corresponding to different damage states is listed in Table 4 and marked in Figure 11. The existence of flanges increased the maximum lateral resistance of specimen IMFTP by 32% compared to specimen IMFP, and the positive lateral resistance of the two specimens was higher than the negative lateral resistance owing to damage accumulation. Therefore, a detailed discussion of the seismic performance of the two specimens is carried out in the next section, and the relevant data of the comparison of specimens IMF and IMFT introduced by Chi et al. [18] were also adopted to assess the influence of the prestressing technology on the specimen.

Figure 11. Hysteretic curves of specimens: (a) specimen IMFP; (b) specimen IMFTP.

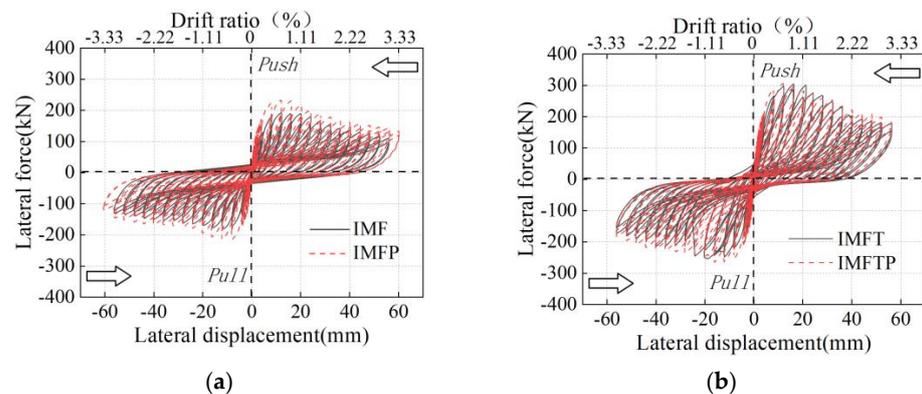
Hysteresis curves are the basis for analyzing the seismic performance of structures; therefore, a comparison of the hysteresis curves for the specimens with and without prestressing technology is plotted in Figure 12. As shown in Figure 12, an obvious pinching effect was observed at both comparisons of the specimens, and the overall appearance of the hysteresis curves of the specimens with and without prestressing technology was similar. Moreover, Figure 12 shows that the influence of the prestressing technology was marginal for IMFTP, while it became more important for IMFP. This phenomenon reflected

Figure 12. Comparison of hysteretic curves of specimens [18]: (a) specimen with rectangular section; (b) specimen with T-shaped section.

that there was a correlation between the improvement in the prestressing technology on the hysteresis curve of the specimens and the failure mode of the specimens. The shear failure of the specimens was mainly related to their shear strength, while the shear strength was commonly considered to be related to the horizontal steel bars, the compressive strength of the grouted masonry, and the compressive stress. In this study, the in-site vertical bars of the specimens were used to apply prestress, and this method can be regarded to improve the compressive strength of grouted masonry. However, the same configuration of the horizontal steel bars in specimens IMFTP and IMFT may be the main reason for their similar bearing capacity; that is, the shear failure of the specimens was caused by the insufficient configuration of shear reinforcement. A similar conclusion was also found in Hassanili et al. [26] and Laursen and Ingham [31]. Furthermore, the damage state characteristic points of the comparison specimens in the positive direction are listed in Table 5, and the normalized skeleton curve is plotted at Figure 13. The normalized lateral force and displacement were chosen as the vertical and horizontal axes. For normalization, the lateral force (V) and displacement (Δ) of each loading cycle of the specimens were divided by the max lateral force (V_{max}) and corresponding displacement (Δ_{max}), respectively. It should be noted that DS1 and DS2 of the specimens were related to the initial cracking of the specimens, directly determined by the tensile stress around the weak plane and fully grouted CMWs, respectively. In this study, the mortar strength remained consistent at the above locations of the comparison specimens, indicating that the tensile stress around the weak plane was greater than that in the fully grouted CMWs. The improvement in the mortar strength may have delayed the occurrence of DS1 in the specimens. Moreover, as shown in Figure 13, the upward trend of the normalized skeleton curve of the comparison specimens was observed to be similar before the specimens reached DS3. After that, the downward trend of the specimen with prestressing technology was lower than the specimen without, especially for the specimens with a T-shaped section. This indicates that the prestressing technology improved the seismic performance of the specimen after DS3, and this was also related to the ductility of the specimen, which will be discussed later. In this regard, a greater amount of experimental data is needed to validate this conclusion.

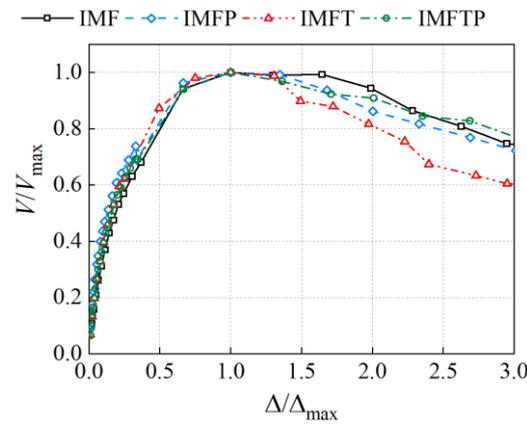
Figure 13. Comparison of normalized skeleton curve of specimens [18].

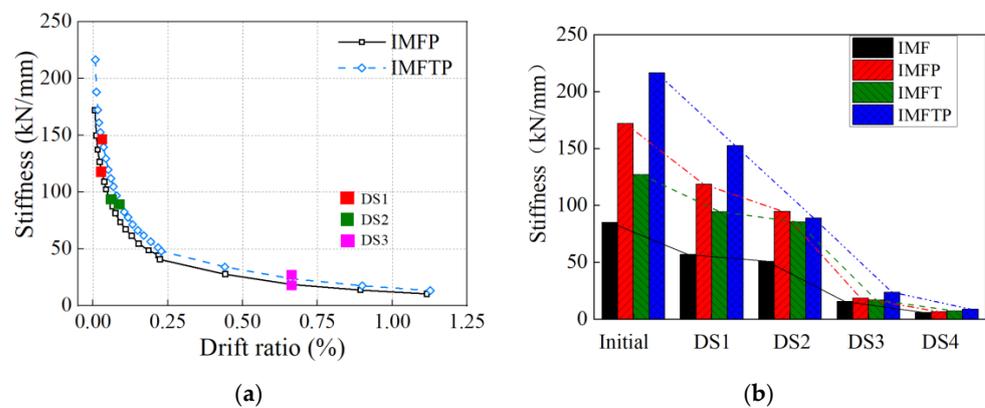
Figure 14. Comparison of stiffness degradation of the specimens [18]: (a) stiffness degradation of the specimens with respect to drift ratio; (b) stiffness of specimen at different DSs.

Table 5 and Figure 14 clearly indicate that the stiffness of the specimens decreased gradually with an increase in the drift ratio. The initial stiffness of specimen IMFTP increased by 26% compared to that of specimen IMFP. The values of K_{si}/K_{s0} at four damage states showed that the stiffness degradation trend of specimens IMFP and IMFTP was similar, while the stiffness degradation of specimen IMFP was faster than that of specimen IMFTP from DS2 to DS3. Moreover, owing to the prestressing technology, the initial stiffness of the specimens with a rectangular section and T-shaped section also increased by 101% and 70%, respectively. For further research, the normalized stiffness degradation of the comparison specimens with respect to the drift ratio is plotted in Figure 15. As shown in Figure 15, the rate of normalized stiffness degradation of the specimen with prestressing technology was higher than that of the specimen without prestressing technology. The stiffness of specimens IMFP and IMFTP was higher than that of specimens IMF and IMFT at DS2, while the stiffness of specimens IMFP and IMFTP was like that of specimens IMF and IMFT at DS3 and DS4, indicating that the influence of the prestressing technology on the stiffness of the specimen gradually weakened. In this study, in situ vertical reinforcement was used as a prestressed reinforcement, and the application of the prestressing technology was completed during the specimen construction process, resulting in an increase in the initial stiffness of the specimen. When the specimen was subjected to lateral force, those reinforcements participated in the mechanical mechanism of the specimen as a traditional reinforcement; therefore, the influence of the prestressing technology on the specimen was weakened with the increase in the drift ratio. However, further research is necessary for the purpose of verification.

Stiffness is an important index of the seismic performance of specimens that can be used to restore the model and nonlinear analysis of the specimens. In this study, the secant stiffness K_{si} was calculated from the slope of the line that joins the positive and negative peaks in each loading cycle [43,44], and the initial stiffness was determined as K_{s0} of the first loading cycle. Table 6 presents the values of that which responded to each damage state of the specimen, and K_{si}/K_{s0} at each damage state was also calculated and recorded for the normalization analysis. To clearly compare the stiffness degradation of the specimens, the stiffness of the specimens before they reached DS3 was analyzed, and the value of K_{si} of the specimens with respect to DR is plotted in Figure 14a, while the stiffness of the specimens at a different DSs is plotted in Figure 14b. Moreover, to analyze the influence of the prestressing technology, the data of specimens IMF and IMFT related to different damage states were also adopted and are listed in Table 6.

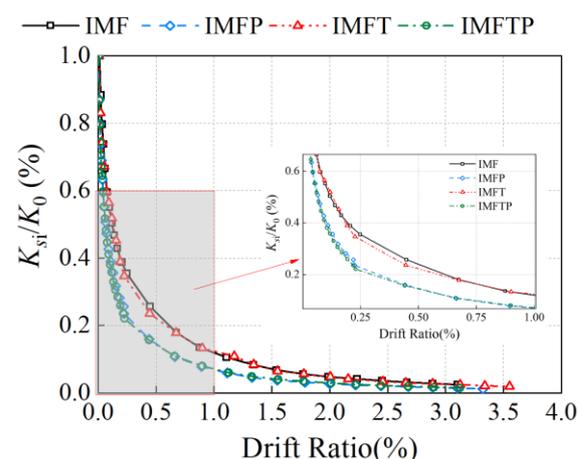
Figure 15. Comparison of the normalized stiffness degradation of specimens [18] with respect to DR.

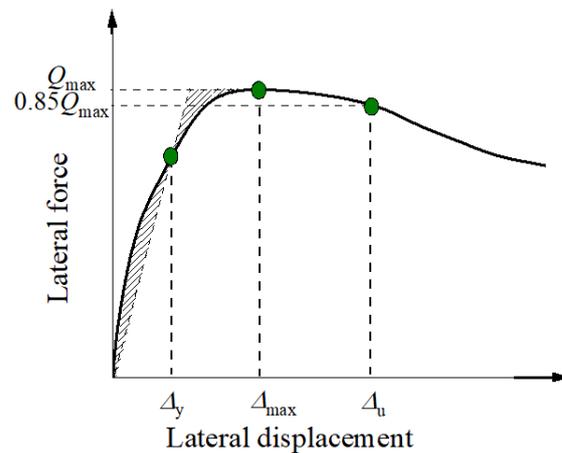
The displacement ductility can be used to evaluate the deformation capacity of specimens subjected to seismic load, thus avoiding brittle failure. In this study, the displacement ductility was defined as the ratio of the ultimate displacement (Δ_u) to the yield displacement (Δ_y). The ultimate displacement was chosen as the corresponding displacement of DS4, and the yield displacement was calculated using the energy equivalence method [45,46], as shown in Figure 16. Considering the influence of damage accumulation caused by the cyclic loading protocol, the analysis of the displacement ductility was calculated using data only from the positive direction. Hence, the calculation results of the two specimens used in this study and the comparison specimens in Chi et al.'s study [18] are listed in Table 7.

Figure 16. Method to calculate displacement ductility.

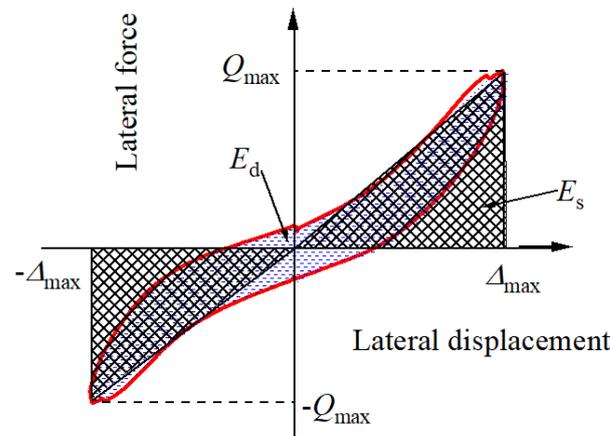
In general, the energy dissipation was calculated by the area enclosed by a single cycle of the load–displacement curve, as depicted by blue dashed lines in Figure 17, and the equivalent viscous damping can be calculated using formula $\zeta_{eq} = \frac{1}{2\pi} \frac{E_d}{E_s}$, where E_s is the strain energy at the maximum lateral force of the same cycle, which is depicted by black lines in Figure 17 [47]. Therefore, the energy dissipation and equivalent viscous damping of two specimens were plotted, as shown in Figure 18. Figure 18 clearly indicates that the energy dissipation of the two specimens increased rapidly after a DR of 2.0%, while that of specimen IMFTP tended to remain constant after a DR of 2.0%. Additionally, the equivalent viscous damping ζ_{eq} initially decreased, followed by a slight increase, and then a constant value was reached after a DR of 1.5% was achieved. Specimen IMFP finally converged at 8%, while specimen IMFTP finally converged at 14%, respectively.

Figure 17. Definition of energy dissipation and equivalent viscous damping.

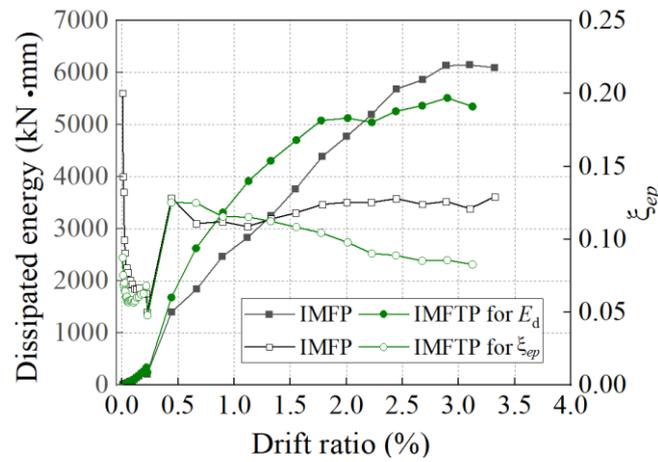
Figure 18. The energy dissipation and equivalent viscous damping of specimens with respect to DR.

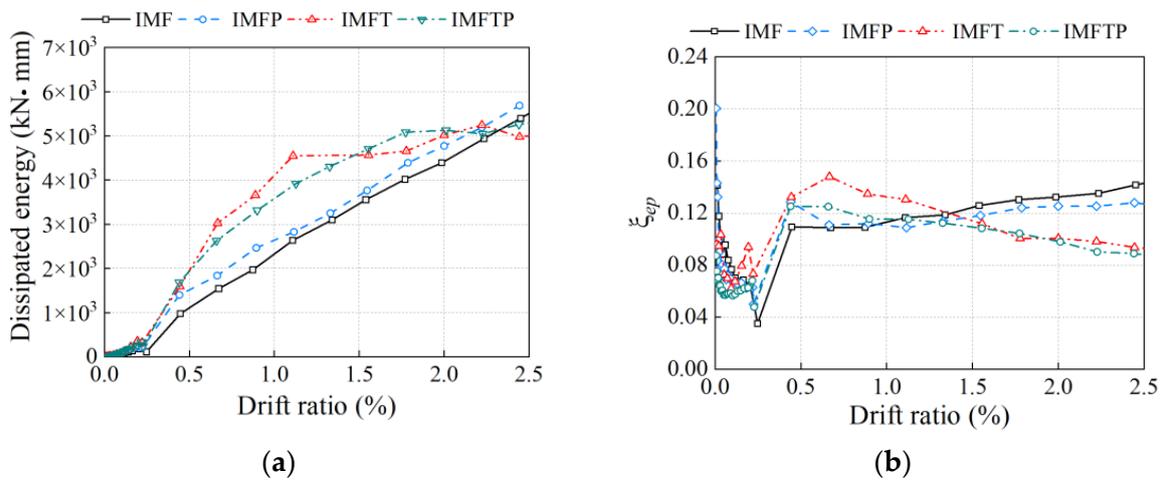
Moreover, analyses of the energy dissipation and equivalent viscous damping of the comparison specimens IMF and IMFT before the specimens reached DS4 were carried out in this study; the comparison results are drawn in Figure 19. The analyses showed that the influence of the prestressing technology on the energy dissipation and equivalent viscous damping of the specimens decreased with an increase in DR. The energy dissipation of specimens IMFP and IMFTP was higher than that of specimens IMF and IMFT, while the ζ_{eq} of specimens IMFP and IMFTP was lower than that of specimens IMF and IMFT before a DR of 0.25% was achieved. This indicated that the equivalent viscous damping of the

Figure 19. Comparison results of the specimens [18]: (a) energy dissipation; (b) equivalent viscous damping.

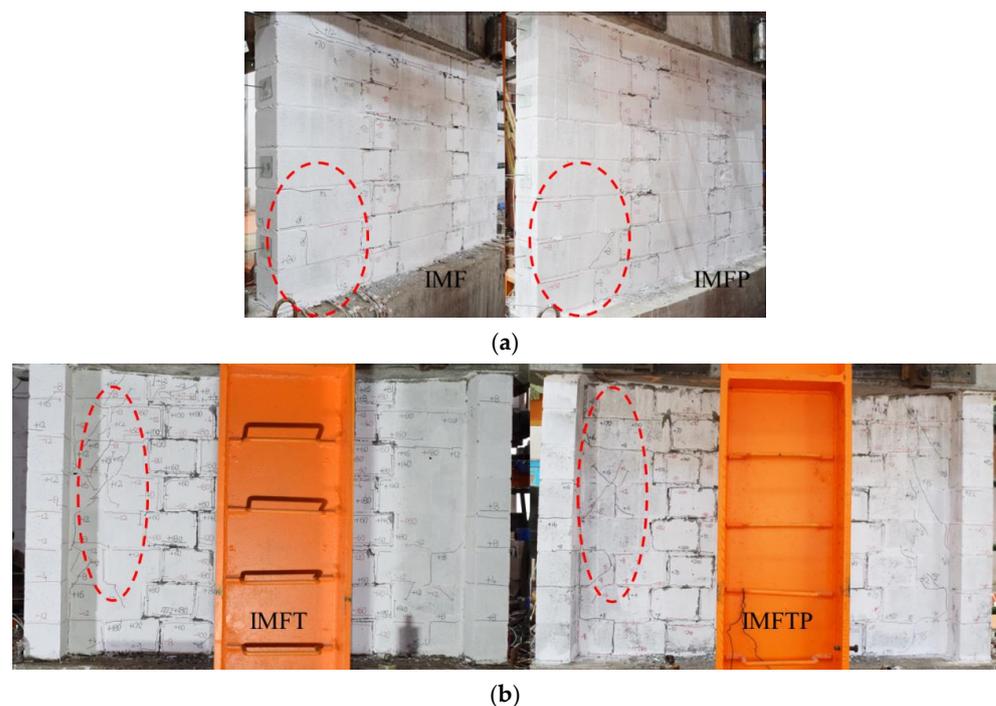
The crack propagation and deformation of specimens IMFP and IMFTP and the comparison specimens IMF and IMFT at the same DR are shown in Figures 20 and 21, respectively. As mentioned before, flexural failure was observed at the load-bearing component of IMFP, while shear failure was observed at the load-bearing component of IMFTP. Therefore, a similar failure pattern was observed in the specimens with a similar configuration of the load-bearing component, indicating that the prestressing technology did not change the failure pattern of the specimens. However, fewer and finer cracks were observed in the specimen with the prestressing technology, which showed that the prestressing technology improved the damage propagation of the specimen. With regard to the deformation of the specimens, IMFP-B represented that the load-bearing component of IMFP was away from the loading lateral actuator. The deformation of the specimens at different DRs was chosen corresponding to the specimens in different damage states. It could be observed that the deformation of the specimens could basically remain straight at a DR of 0.22%, while an inflection point occurred at a height of 1100 mm in specimens IMFP and IMFTP at a DR of 0.89%. As shown in Figure 21a,b, the deformation of specimen IMFP-B was slightly lower than that of the comparison specimen, while the deformation of specimen IMFTP-B was larger than that of specimen IMFT-B at a DR of +0.89%. This reflected a higher compressive stress and deformation in the bottom zone of IMFTP-B than in that of specimen IMFT. This phenomenon was related to the prestressing technology and failure pattern of the specimen. The prestressing technology could improve the specimen cracking situation caused by insufficient tensile strength; however, it could have had an impact on the compressive failure of the specimens due to having a smaller margin to develop new compressive strains. With regard to specimen IMFTP, the zone of the specimen at a height between 300 mm and 1100 mm was in the shear-compression zone, which may have resulted in larger deformation due to damage propagation. Therefore, it could be concluded that the prestressing technology had a positive influence on the damage propagation and deformation of the specimen before DS3; however, additional research on the deformation of the compression zone of specimens caused by a high compressive stress is essential, which will hopefully provide a reference for the value of prestressing in future structural design.

Figure 20. Comparison of crack propagation of specimens [18]: (a) DR = 0.67% and (b) DR = 0.89%.

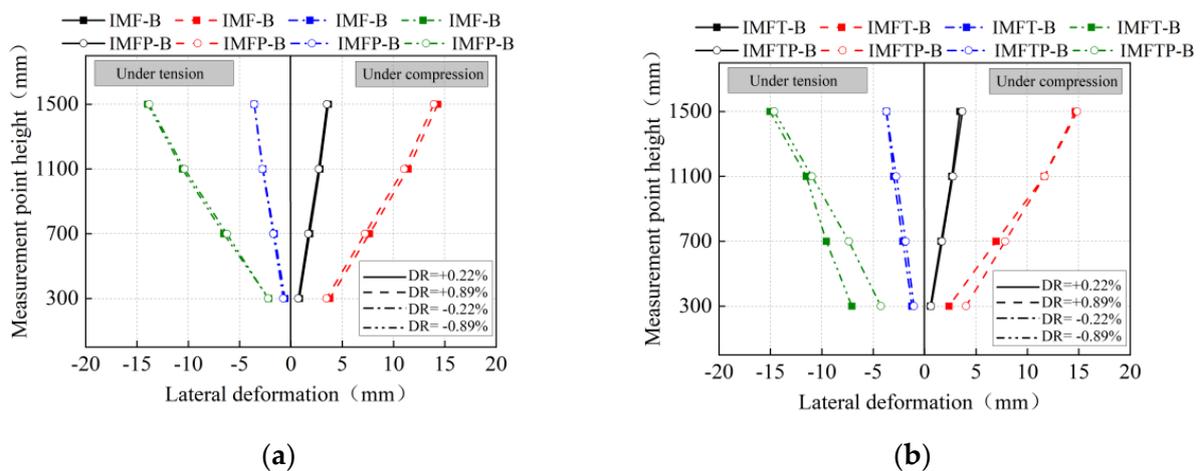
Figure 21. Comparison results of deformation of all specimens [18] along wall height: (a) specimen with rectangular section; (b) specimen with T-shaped section.
