Architectural Analysis of the First Major Rehabilitation in the 21st Century of Olbrich's Secession Building in Vienna

Abstract: The recent rehabilitation, reconstruction and adaptive reuse of Joseph Maria Olbrich's Vienna Secession Building, completed in 2018, has brought the building into a contemporary age. This research article analyzes the only extensive rehabilitation carried out on the Secession Building so far in the 21st century. It studies what was accomplished during this specific rehabilitation process, and in particular emphasizes the reasons why such a process is crucial for culture heritage buildings in the city of Vienna. The purpose of this research is to evaluate the rehabilitation procedures used for the Secession Building and to identify any weaknesses to be resolved in the next rehabilitation. It provides an example of rehabilitation for any future similar initiatives, demonstrating both its positive and negative aspects.

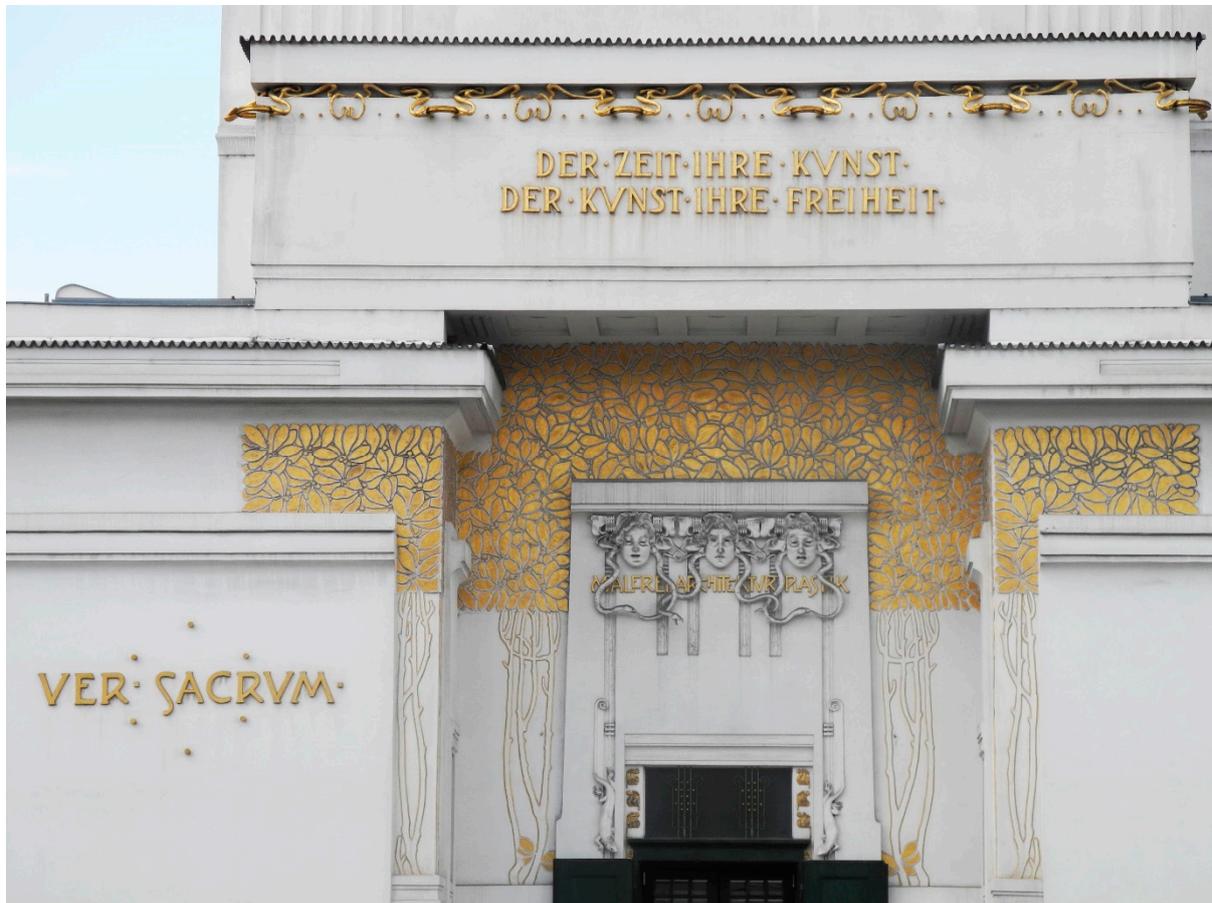
Figure 1. The photograph depicts the entrance facade of the Vienna Secession before it underwent renovation, in 2013. Photography: Biljana Arandelovic.

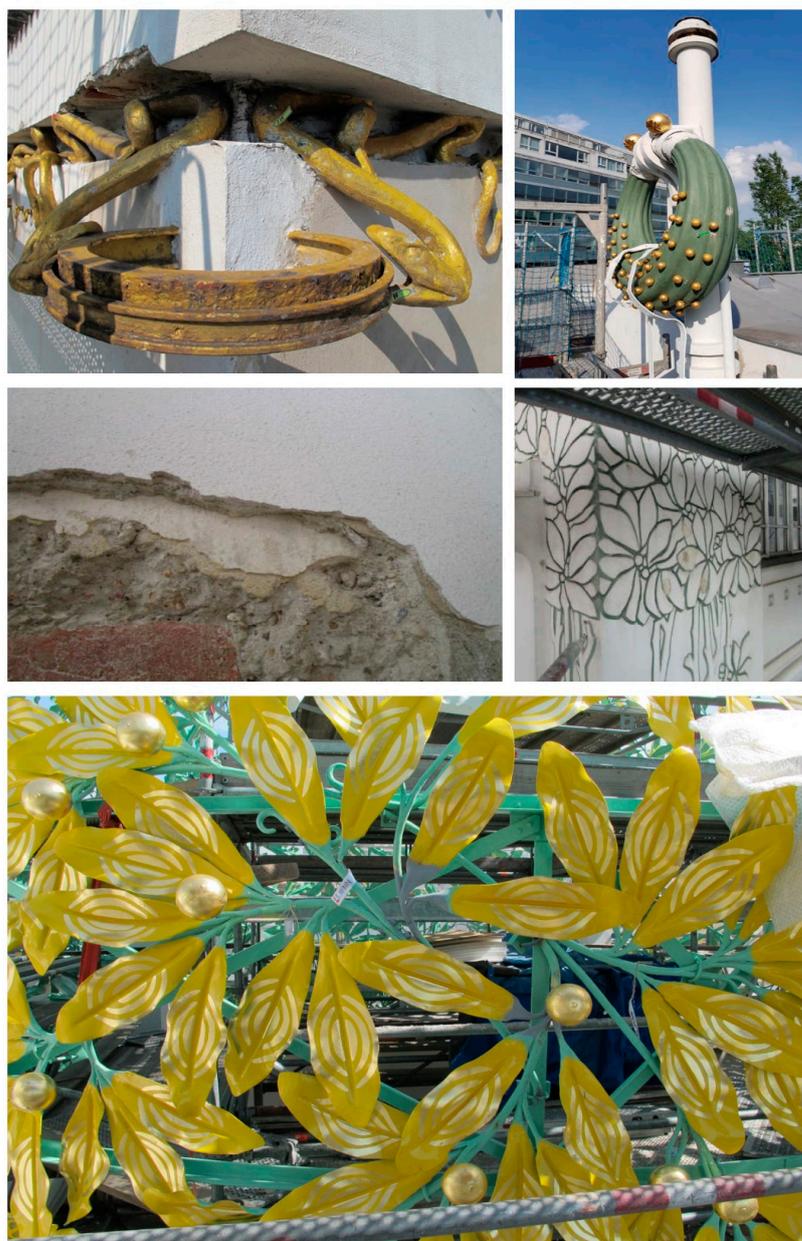
Figure 2. The exterior rehabilitation of the building of the Vienna Secession (wall coverings, metal elements and details of the dome). The material provided by the Vienna Secession.

The dome was restored by renovating the historic steel girders, welding where necessary and improving the supporting structure; its rehabilitation involved disassembling the wrought-iron structure measuring 8.5 m in diameter over a period of approximately six months. Over the course of the renovation process, it became apparent that the dome was more deteriorated than originally suspected. Its anchoring structure with four supporting pylons was practically fully detached. After a detailed examination, the supporting structure was reattached using 800 original rivets and historically proven techniques, and the weld seams were also repaired. In addition, the leaves and the berries that were damaged or missing due to heavy rusting were reforged. Finally, all 2500 laurel leaves and 342 berries were repainted and gilded.

Loose cement coatings were removed, except for the original lime plaster, which was structurally strengthened with water glass. The fine plastering was carried out using NHL fine plaster. In areas with larger hollow layers (especially in the interior flanks of the building in the entrance area), anchor points were set with Ledan along existing cracks. The Novotny Construction Company performed the facade works, which included cleaning the surface using hot steam technology, removing modern and loose plaster sections and reinforcing the plaster flanks with lime sinter water. They utilized cleaning supplements from Baunit's NHL product range. The color shade was chosen in cooperation with all project participants and the Federal Office for the Protection of Monuments. During this process, a tone of white was selected by the client for the final coat of paint. The paint coatings applied followed the NCS color chart for the facade, with the white tone coded as S 0300-N and the green for the leaf contours coded as S 2050-G20Y.

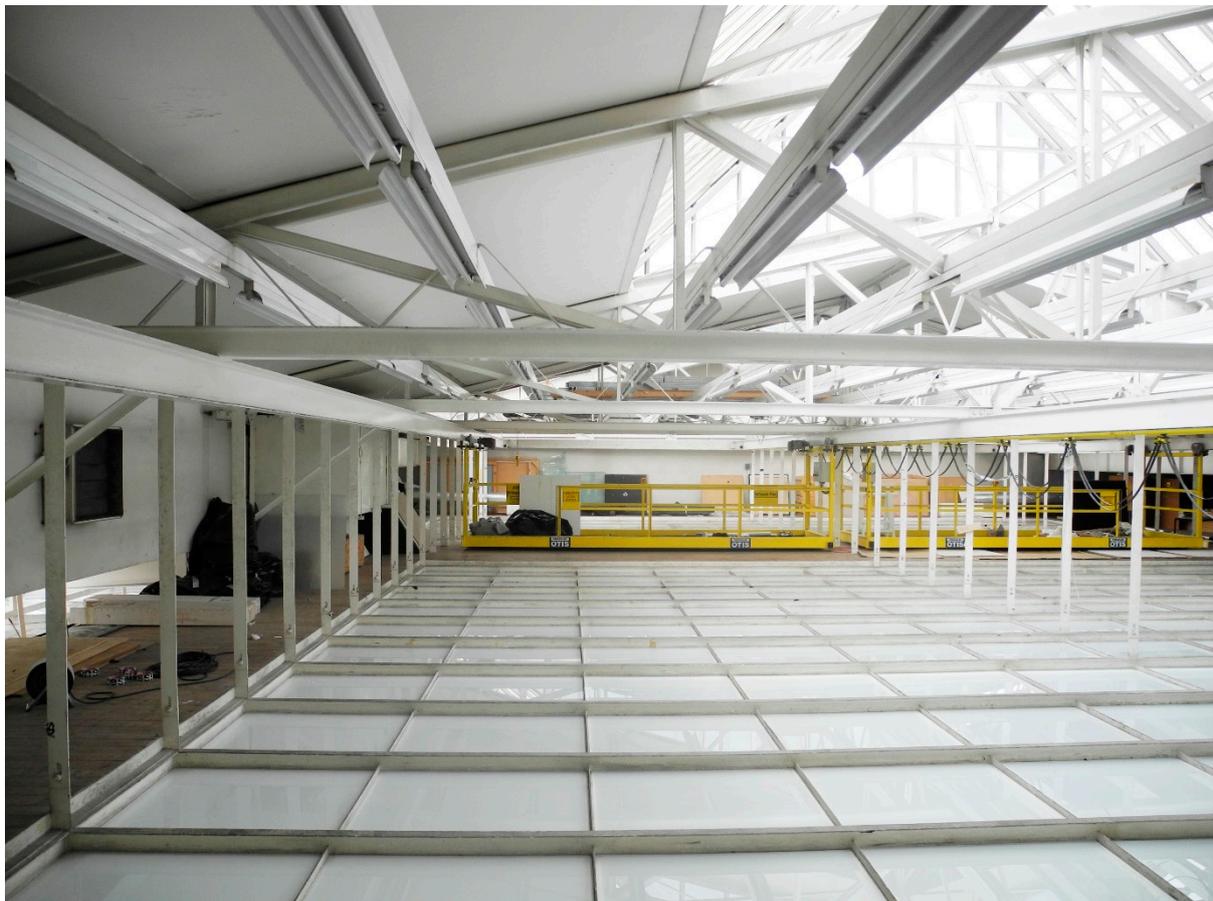
Figure 3. A photograph of the roof structure taken in 2013, a few years before the comprehensive rehabilitation of the Vienna Secession Building. Photography: Biljana Arandelovic.

The contrast between the ornamented front part of the building and the rear part of the property is clearly evident, emphasized by the iconic glass roof, which consists of several pyramid shapes. The glass roof effectively highlights the rear part of the building, which has no decoration, in contrast to the decorative front part. The glass roof was destroyed along with the rest of the building during the Second World War but was later rebuilt. The steel roof truss with the glazed skylights was rebuilt in the same style and dimensions as the original Olbrich version. The history of the building includes several rehabilitations of the glass roof construction. While noteworthy, it is not the focus of this research.

The renovation in 1984/1985 was a crucial step in ensuring the stability of the roof structure. The entire roof covering was reconstructed and the skylight above the exhibition space was reglazed, which greatly improved the overall condition of the facility. Before proceeding with the renovation, a comprehensive analysis of the facility's condition was conducted to determine the best course of action. The wooden grid, controversial from the beginning, was destroyed during the conversion of the main hall for a theater performance and had to be replaced with a temporary solution made of canvas panels. This involved improving the thermal insulation of the masonry and, in particular, the roof structure. It incorporated the thermal glazing of the skylight, the installation of additional thermal insulation under the sheet metal roof surfaces and the insertion of a lowered, light-diffusing glass grid ceiling under the iron roof structure, resulting in a thermo-technical buffer zone between the roofing and the exhibition hall. As a result, the conditions for natural and artificial lighting became more consistent than before [28].

It took years before the glass roof-ceiling could be reconstructed. Prior to 2017/2018, the glass roof had been in urgent need of renovation as the last time the glass elements were replaced was in 1985, and it was becoming a serious problem during adverse weather conditions. The glass deck had been compromised by a serious problem of leaking, endangering the artworks in the central exhibition space and the interior of the building itself. The construction of four lanterns was replaced with an OKALUX laminated panel assembly [48] during the latest reconstruction. It proved that this sophisticated lighting solution, designed to utilize daylight to maximum effect while simultaneously creating adequate solar shading and glare protection, is a good strategy toward the sustainable indoor reconstruction of culture heritage buildings.
