## **Seismic Analysis of Historic Masonry Buildings: The *Vicarious Palace* in Pescia (Italy)**

**Michele Betti \* and Luciano Galano**

Department of Civil and Environmental Engineering (DICEA), University of Florence,  
Via di Santa Marta, 3 - I-50139, Florence, Italy; E-Mail: luciano@dicea.unifi.it

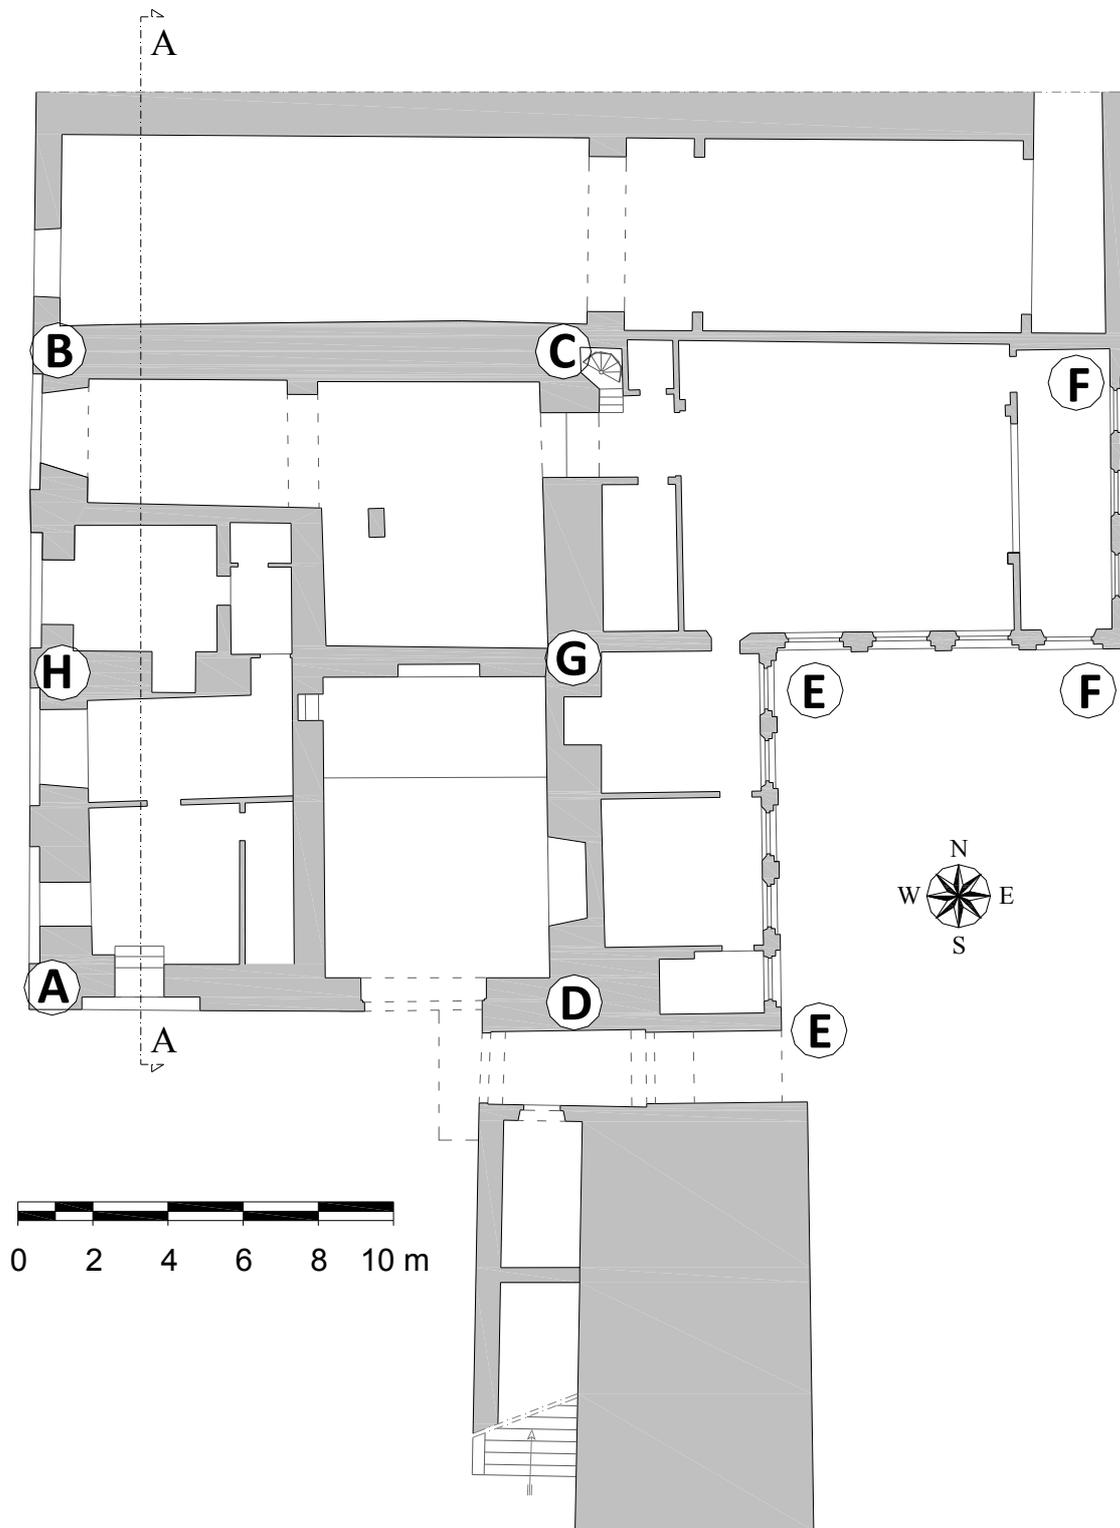
**Figure 2.** Plan layout of the ground floor (ABCD is the original medieval square nucleus; EE-FF is a twentieth century addition).

The plan layout of the ground floor of the Palace is reported in Figure 2. It is possible to recognize the original medieval square nucleus, delimited by the walls indicated with AB, BC, CD and DA, whose dimensions are about  $18\text{ m} \times 15\text{ m}$ . In particular, the wall CD probably corresponded to the main city walls [20]. This square ground floor was an open space (as a loggia) used for public administrative activities. The adjoining walls EE, EF and FF were added during the last intervention in the thirties of the last century. The actual height of the Palace, after the demolition of the fourth storey, is about 17 m as reported in the section represented in Figure 3. The horizontal structures of the first floor are made of masonry vaults, while the upper floors and the roof are timber structures. Views of the main façades of the building are reported in Figures 4, 5 and 6.

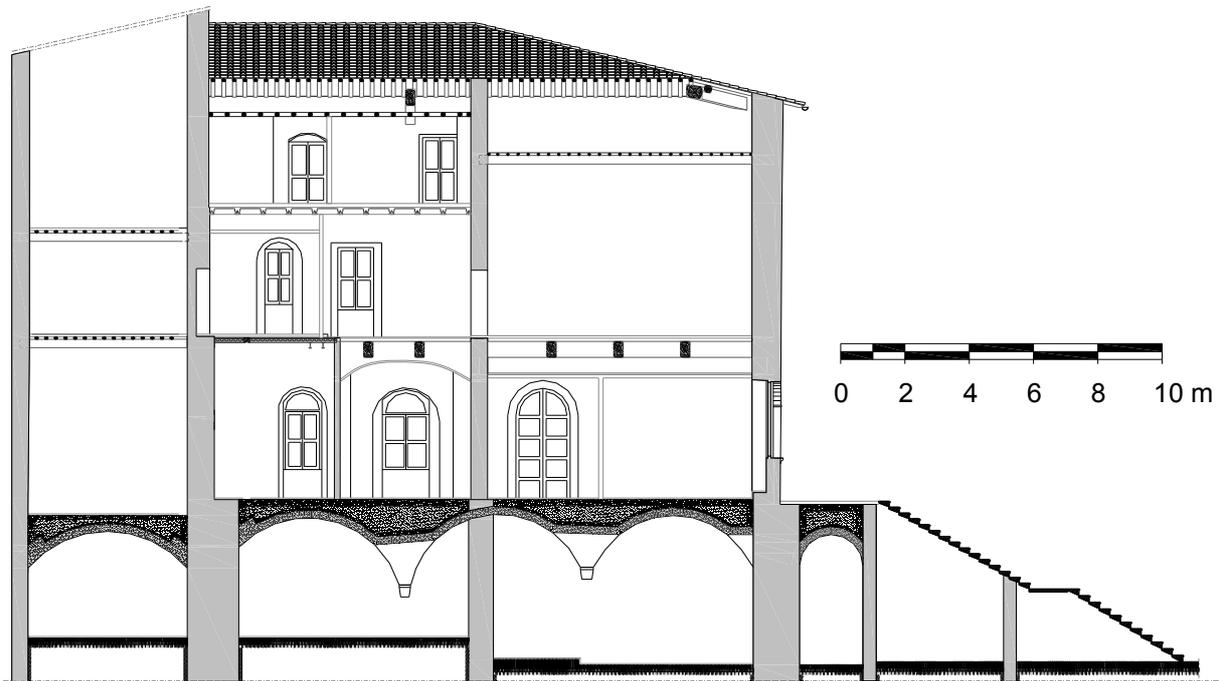
Figure 3. Section A-A of the Palace.

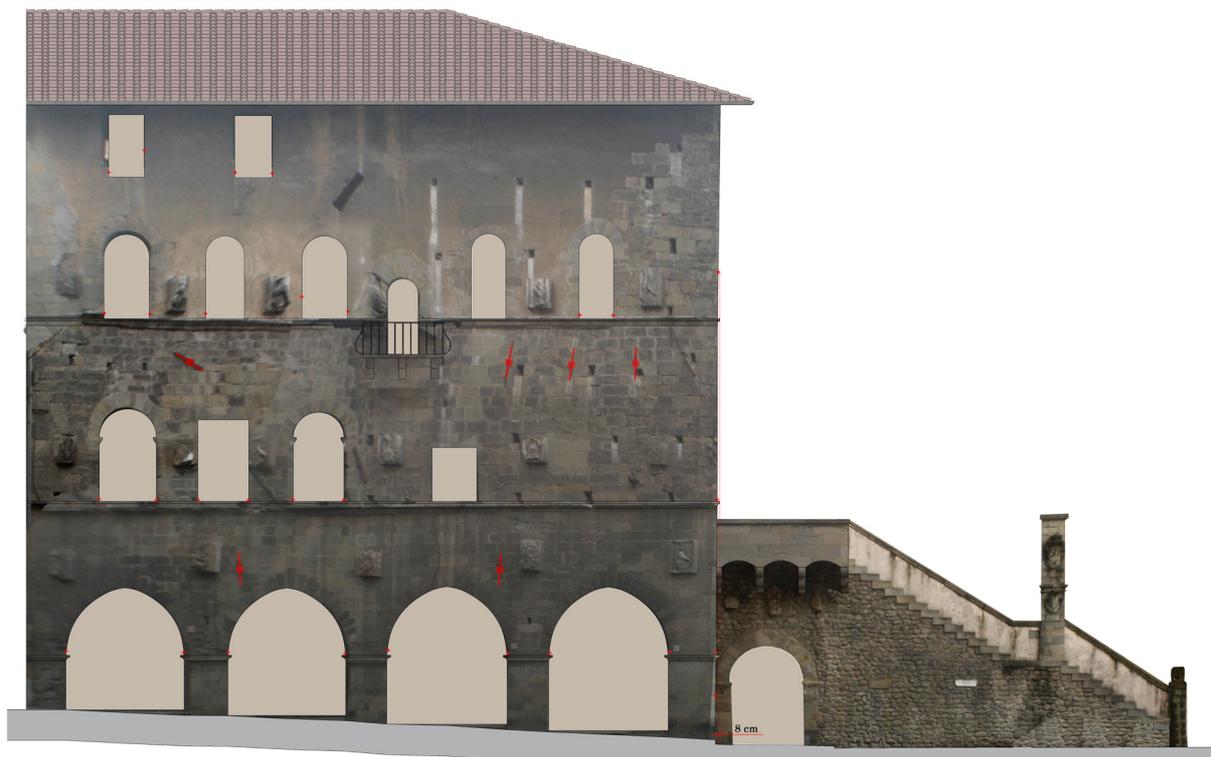
Figure 5. View of the Western façade.

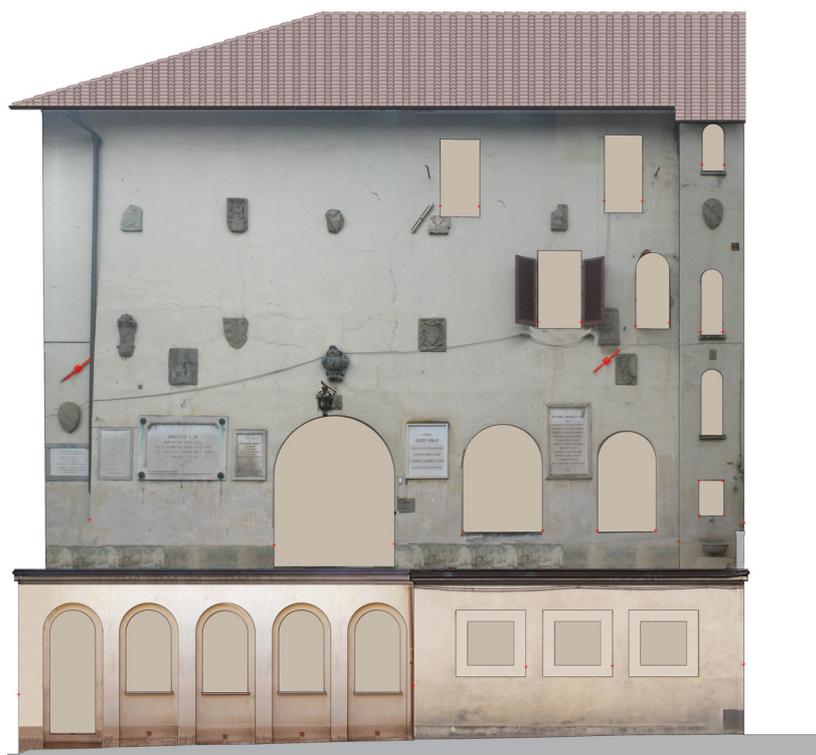
Figure 6. View of the Eastern façade.

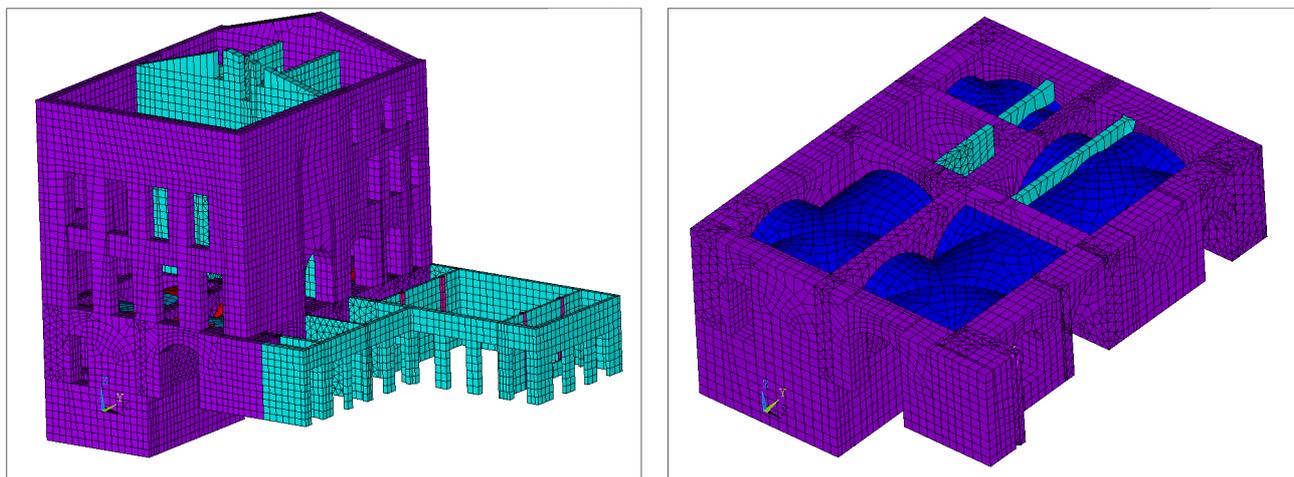
**Figure 7.** Finite element model of the Vicarious Palace.

The structural analysis of the Palace was approached by a 3D finite element model based on the concepts of homogenized material and smeared crack modeling using the ANSYS code v.11.0 [25]. The masonry walls were discretized with *Solid65* elements (isoparametric three-dimensional eight node elements), whereas the ground floor vaults were discretized with *Shell63* elements (isoparametric two-dimensional four node elements). The wooden floors and timber roof were not considered in the model and their own weights were applied on the bearing walls by means of vertical concentrated loads.

An *in-situ* survey of the building was made to accurately reproduce the geometry, the structural details and the irregularities of the Palace. This investigation consisted of a geometrical relief aimed at characterizing the masonry texture and to check up the quality of wall-to-wall, wall-to-floors and wall-to-roof connections. The 3D model is represented in Figure 7. It consists of 37,402 nodes, 36,557 *Solid65* elements and 813 *Shell63* elements, corresponding to 108,399 DOFs.

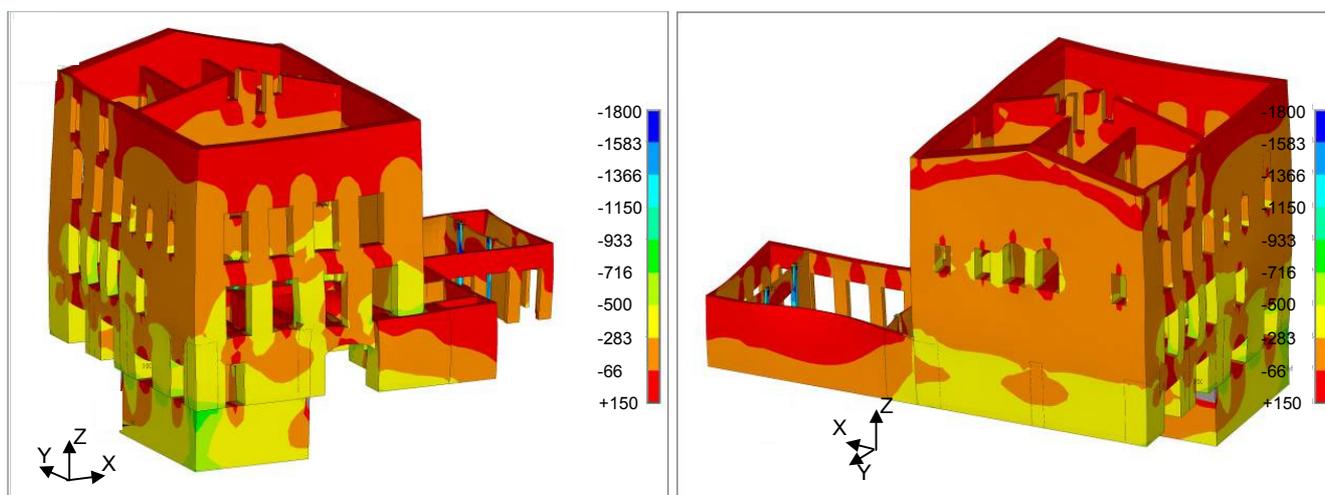
**Figure 8.** Static analysis: vertical compressive stresses (units are  $\text{kN/m}^2$ ).

Results in terms of vertical stresses are reported in Figures 8 and 9. The average compressive stress at the base of the walls is about  $0.5 \text{ N/mm}^2$  with small tensile stresses located on the top surface of the walls. These tensile stresses are produced by the local numerical effect depending on the concentrated loads of the roof. The maximum compressive stress (about  $1.7 \text{ N/mm}^2$ ) is reached in a column close to an arch opening in the internal wall (Figure 9). Even if this value is high it is much less than the crushing limit of the masonry (local sandstone). Results of the analysis illustrate that the Palace is adequate to withstand the vertical loads under exercise conditions. This is a common result for this typology of buildings designed by skilled manufacturers.

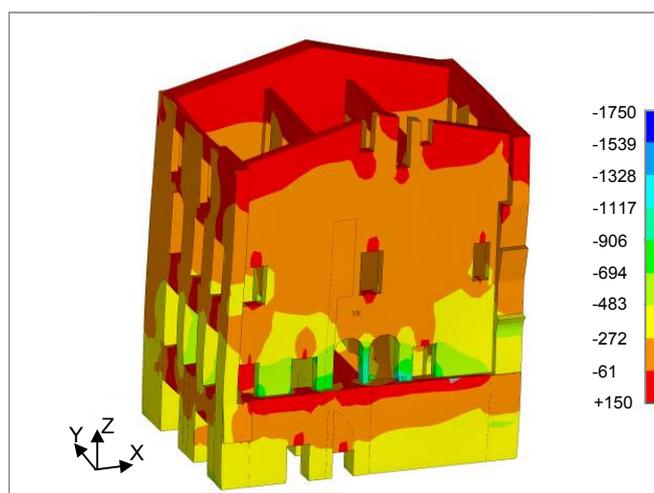
**Figure 9.** Static analysis: vertical compressive stresses, detail of the internal wall (units are  $\text{kN/m}^2$ ).

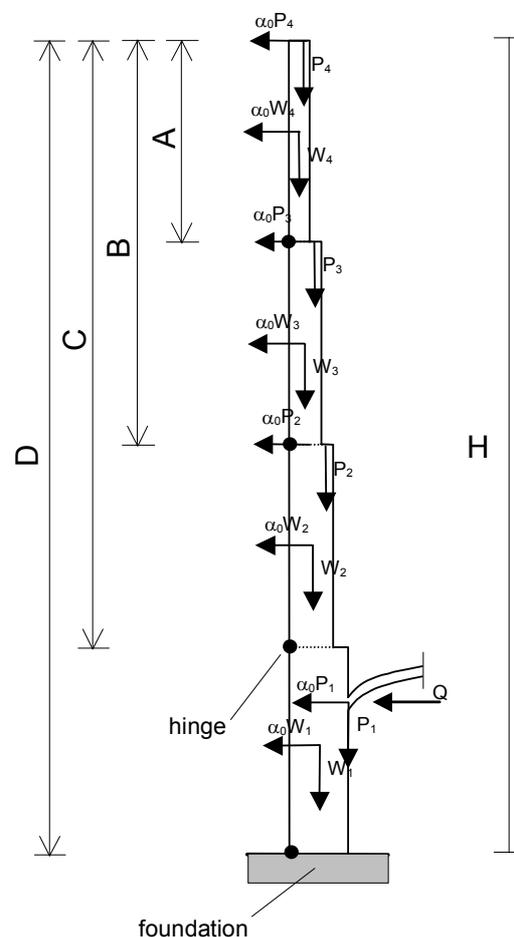
**Figure 10.** Out-of-plane mechanisms;  $P_i$  are the vault or the floor vertical loads;  $W_i$  are the own weights of the walls;  $\alpha_0 P_i$  and  $\alpha_0 W_i$  are the seismic loads.

The mechanisms considered in this study concern partial and global overturns of the main façades, and the collapse multipliers  $\alpha_0$  are evaluated according to Eq. (1) (see the general scheme reported in Figure 10; A, B, C and D identify different mechanisms):

In Equation (1)  $W_i$  are the dead weights of the elements involved in the mechanism;  $P_i$  are the weights transmitted at the selected macro-element by vault, floors or roof;  $\delta_{xi}$  are the horizontal virtual displacements of the points of application of  $W_i$  and  $P_i$ ;  $\delta_{yi}$  are the vertical virtual displacements of the points of application of  $W_i$  and  $P_i$ ;  $Q$  is the static drift of the vault;  $\delta_{xq}$  is the corresponding horizontal virtual displacement and  $L_{fi}$  is the virtual work of the internal forces, here assumed equal to zero. After the evaluation of the collapse multiplier  $\alpha_0$ , the corresponding seismic spectral acceleration  $a_0^*$  is given by:

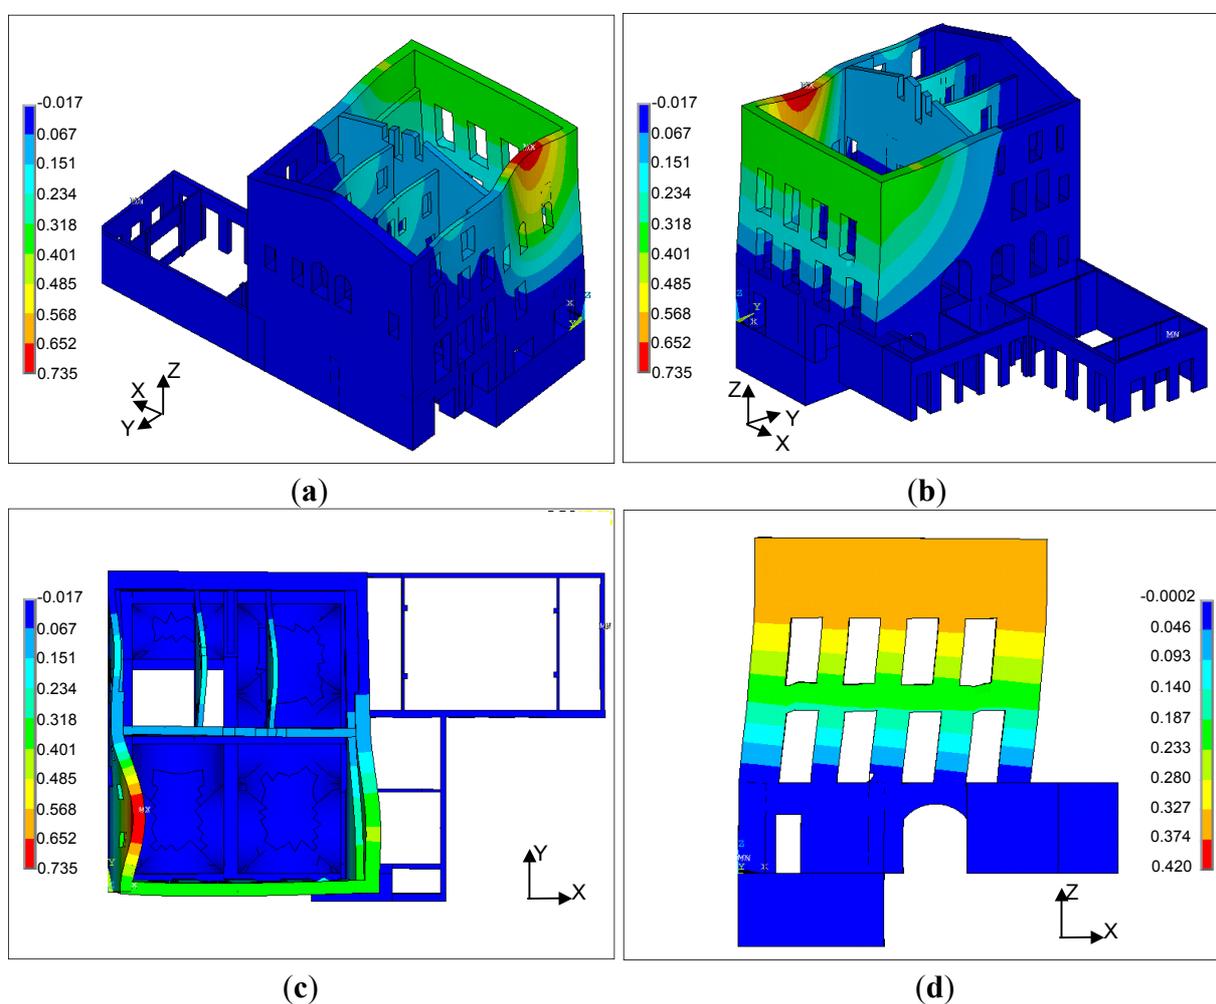
**Figure 11.** Pushover analysis results (+X direction): (a), (b), (c) and (d) horizontal displacement in X direction (units are m).

Results of pushover analysis in terms of displacements and crack and crushing patterns are reported in Figures 11 to 14. Figures 11 and 12 report the final configuration of the Palace for seismic loading acting in the transversal direction (+X and -X). In both cases there is a remarkable out-of-plane deformation of the wall AH, that confirms the results obtained with the kinematic analysis. Figures 13 and 14 show the Palace configuration for seismic loading acting in the longitudinal direction (+Y and -Y). Again it is possible to find a good agreement in terms of failure process between pushover and kinematic analysis, both confirming the overturning of the wall DA.

In case of seismic loading acting in the transversal direction (+X and -X) the analyses stop at a horizontal load corresponding to about 28–30% of the overall weight of the Palace; in case of seismic loading acting in the longitudinal direction (+Y and -Y) the analyses stop at a horizontal load corresponding to about 35–37% of the overall weight of the Palace.

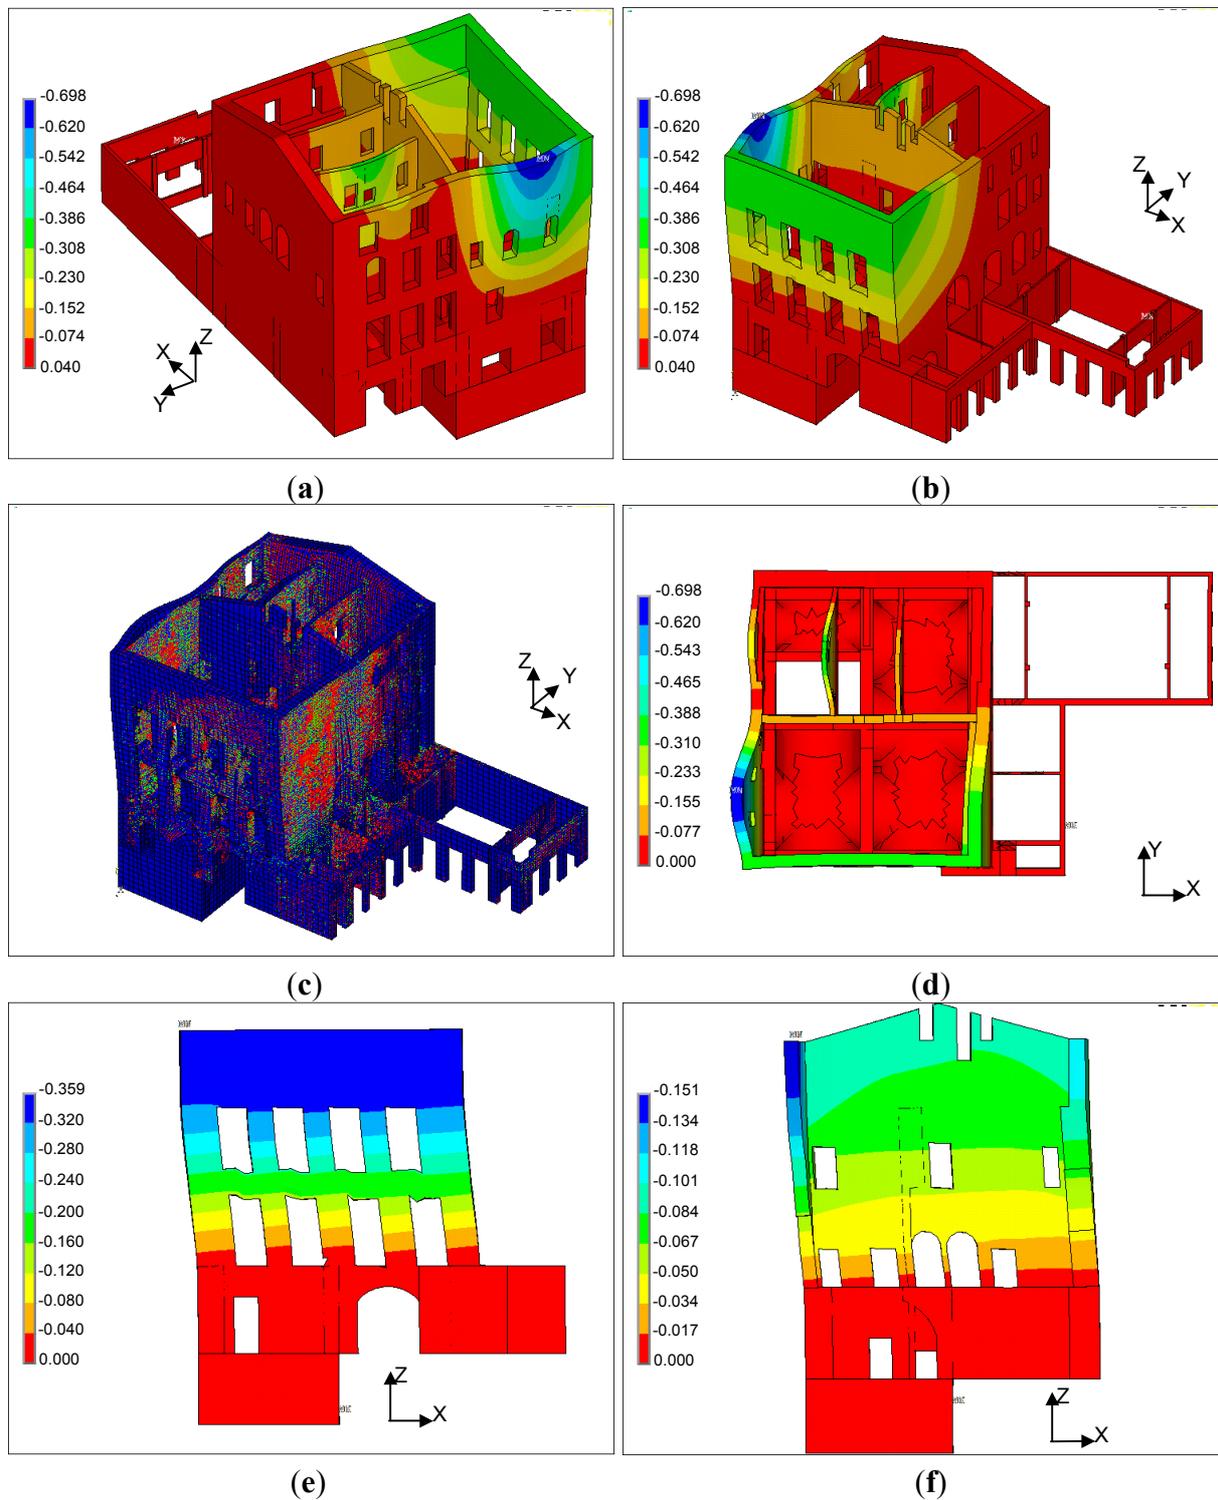
**Figure 12.** Pushover analysis results (−X direction): (a), (b), (d), (e) and (f) horizontal displacement in X direction (units are m), (c) final cracking and crushing patterns.

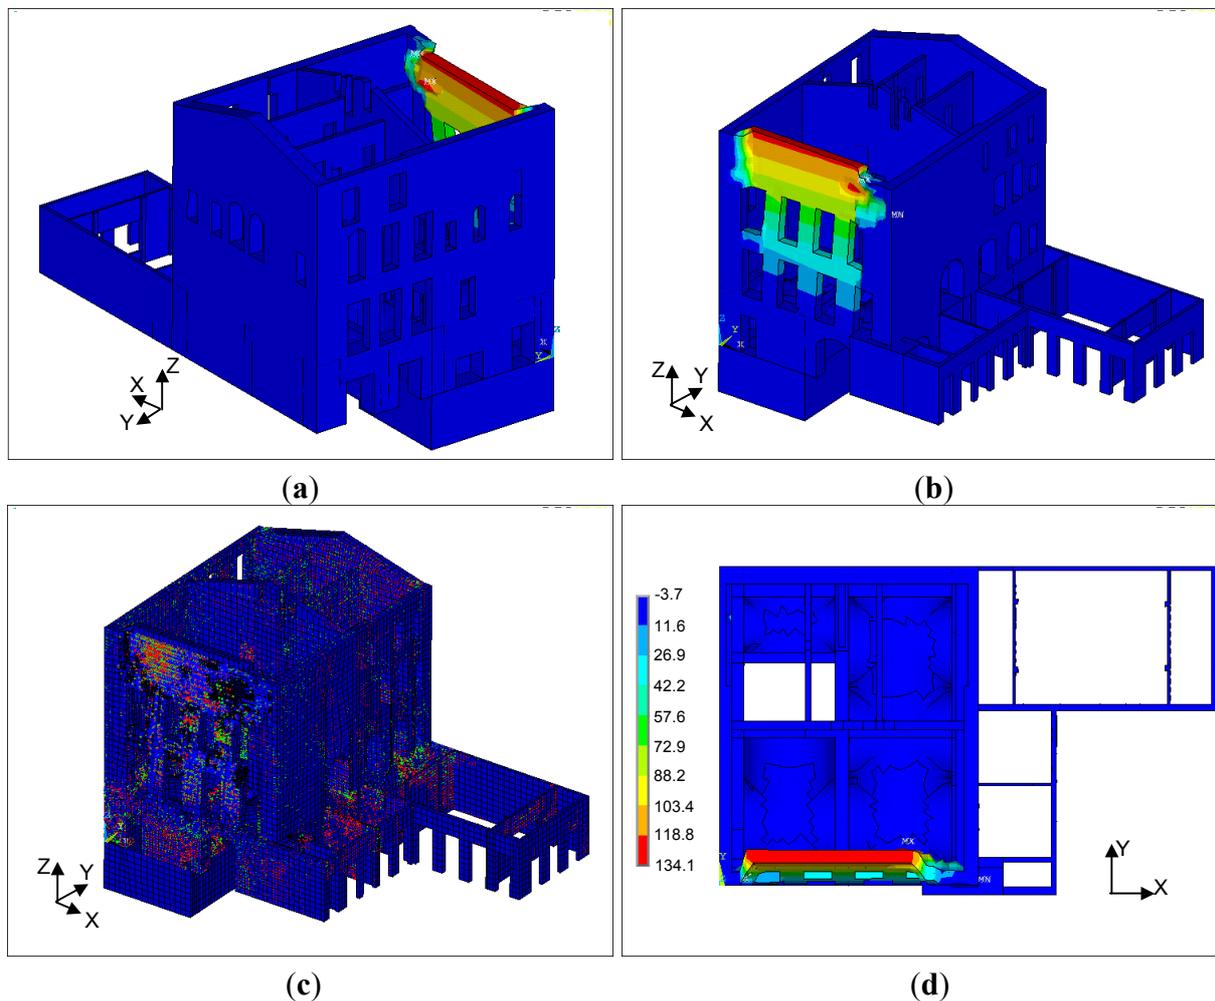
**Figure 13.** Pushover analysis results (+Y direction): (a), (b) and (d) horizontal displacement in Y direction (units are m), (c) final cracking and crushing patterns.

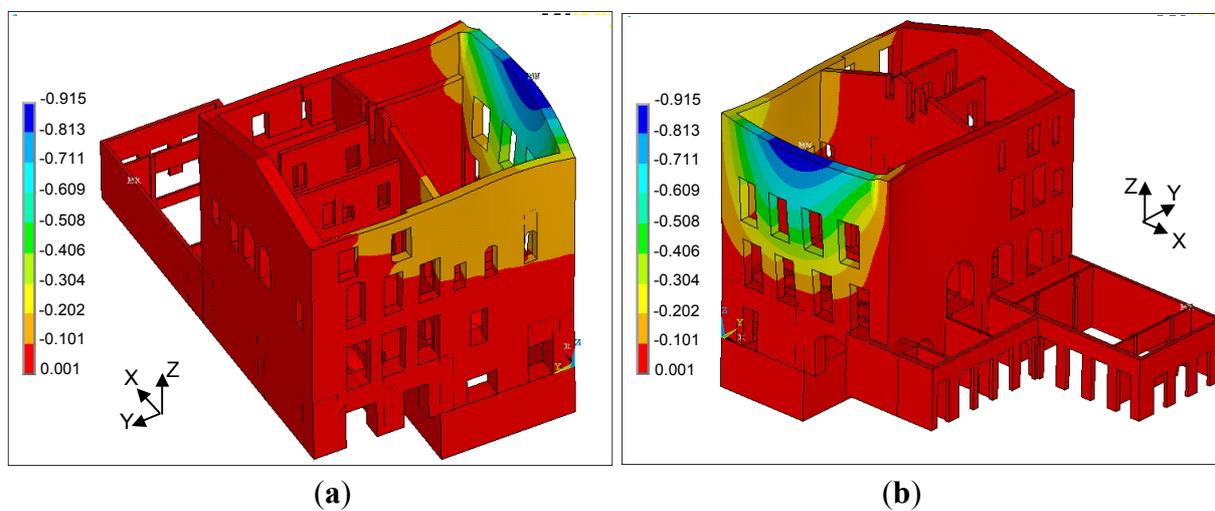
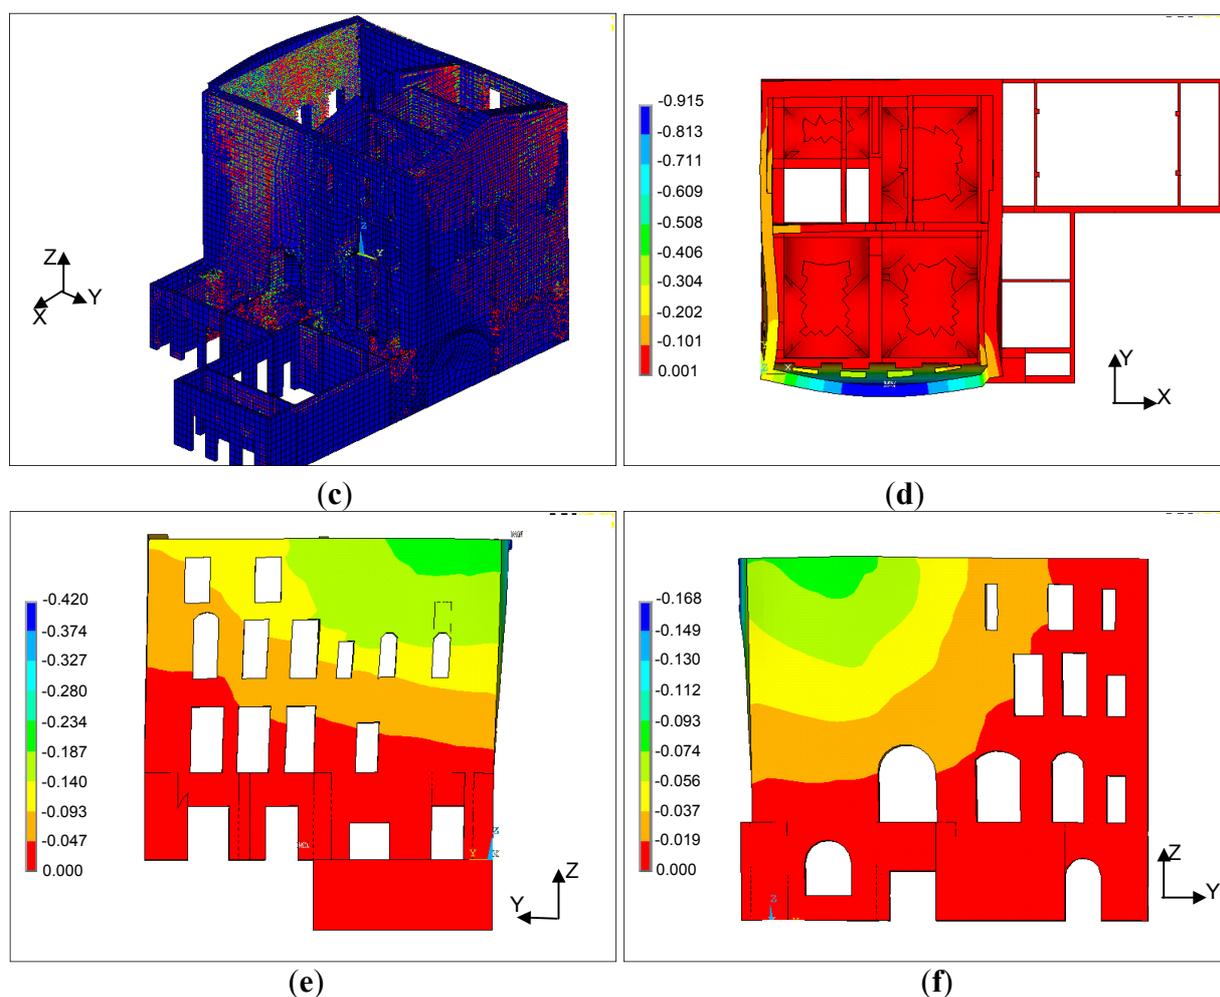
**Figure 14.** Pushover analysis results (-Y direction): (a), (b), (d), (e) and (f) horizontal displacement in Y direction (units are m), (c) final cracking and crushing patterns.
