Instruments for Assessing Historical Built Environments in Emergency Contexts: Non-Destructive Techniques for Sustainable Recovery

3. The Case Study of the Ex San Salvatore Hospital in L'Aquila (IT)

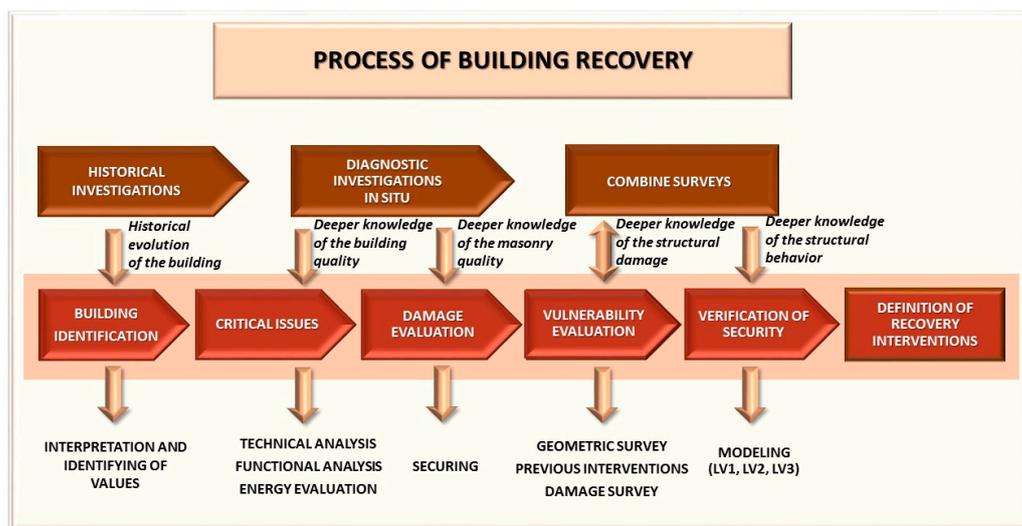
Figure 1. The methodological process and identification of the level of knowledge of a historical building. The multi-disciplinary approach is highlighted in brown and it is developed during design and construction phases as an underlying support for the whole design process.

The knowledge process is based on the study of the features of the building complex under different lights: historical-urban, historical-architectural, technical-constructive, materials and structural. These analyses, carried out in parallel, allow us to discover the history of the building, identify its significance and the features that need safeguarding as well as the technical and constructive aspects that characterize it and its state of degradation. All of these elements are fundamental in the drawing up of a project for recovery and restoration (Figure 1).

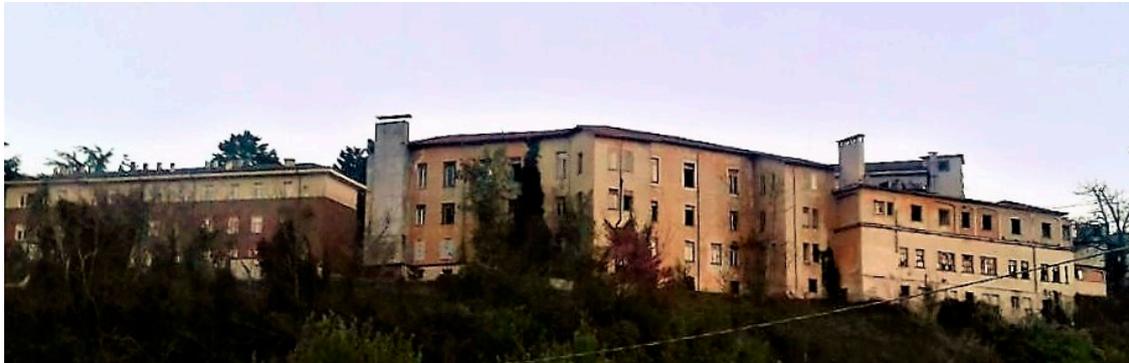
Figure 3. The north face of the former Hospital of S. Salvatore as it currently appears: view from outside the urban walls, L'Aquila.

The building complex, currently in a state of disrepair as a result of the earthquake and years of abandonment, had undergone numerous alterations over the years and its original structure has been all but lost as a result (Figure 3).

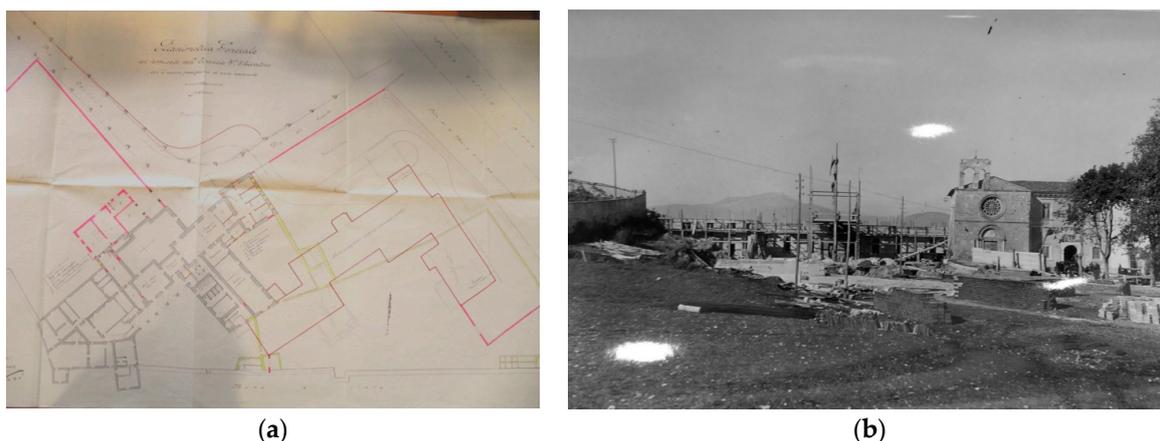
Figure 4. The expansion project of 1931: (a) The general plan of the first project/design hypothesis (Cfr. ASA, Comune Aq, cat. X, cl. II (1906–1940): Lavori al civico Ospedale di San Salvatore. Drawings highlighting the “old structures” and the new hospital plan with an explanatory report, 25 April 1931, Eng. R. Inverardi); (b) The construction yard.

external walls and the construction of a new wing behind the existing structure, which was mainly conserved (Figure 4). The plan was modified during the course of work, with additions and variations that saw the “radical transformation of the old part where only simple adaptations had been planned”. The sequence of events is summarized in “Relazione svolgimento lavori” (on 25 April 1938) in the final accounting documents (Archivio di Stato di L’Aquila, Cat. X, f. 239). The work started on 20 January 1932 and ended on 25 February 1937. The most significant of these changes was the demolition of the church of Santa Maria del Guasto and a new section to make a single front section with access, doubling the size of the building around a central court (Cfr. “Perizia Suppletiva”, 20 April 1933, f. 238).

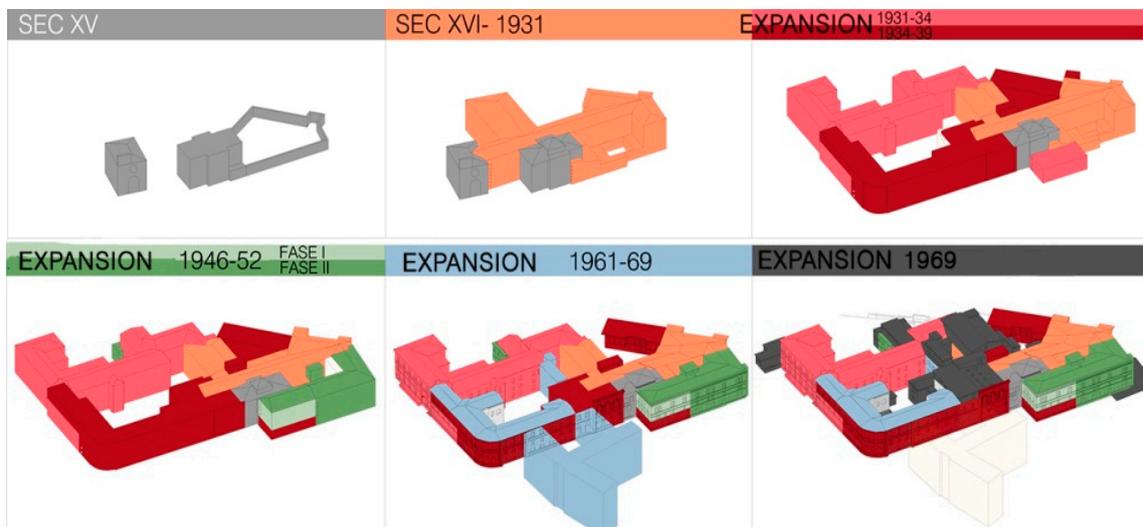
Figure 5. Axonometric view of the historical evolution of the former hospital complex [12].

complex has fallen into and successive wall renderings of the entire building. Above is a drawing highlighting the construction phases and the accretions to remove (Figure 5).

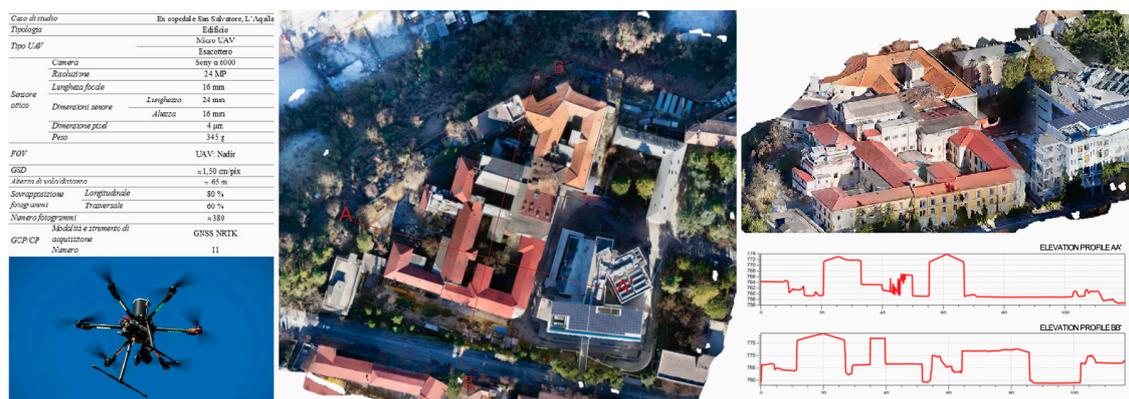
Figure 6. Unmanned aerial vehicle (UAV) photogrammetry. From left to right: features and views of the used vehicle; orthophotograph of roofing, three-dimensional reconstruction and elevation profiles obtained from the UAV campaign.

In the knowledge acquisition phase of this study, a multi-rotor Flynovex equipped with a Sony alpha 6000 camera was used in order to carry out an aerial survey. The choice of this type of UAV and equipment stems from other tests performed in different case studies in the post-earthquake period of L'Aquila in 2009 [34]. It has proved a good choice in terms of several technical aspects, in particular the payload of the camera and the stability of the vehicle during the acquisition phase (Figure 6).

The data obtained allowed a visualisation of the whole complex, three dimensional, metric reconstructions, orthophotographs of roofing and facades, as well as altitude profiles. The results of the photogrammetric survey and the use of software allowed detailed research from the evaluation and

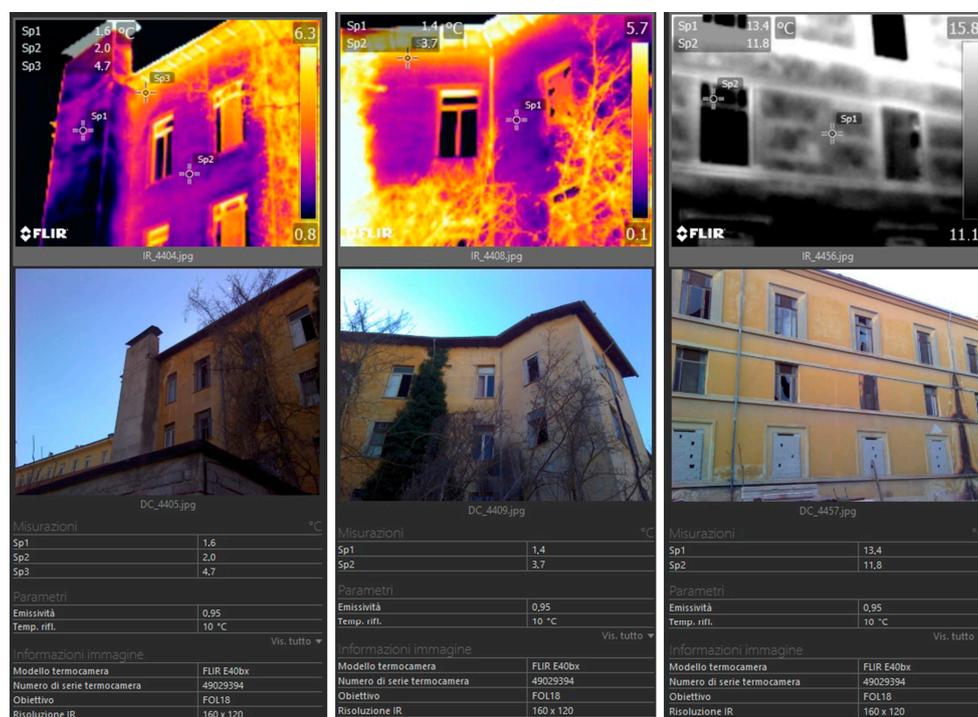
Figure 7. Thermographic survey: view of some elaborated thermal imaging data.

The use of thermal imaging in this case highlighted elevated levels of thermal dispersion associated with wall coverings and proved useful in the identification of zones without heat bridges, which require further study to establish thermal transmission and therefore thermal requirements.

In addition, the use of thermal imaging under experimental conditions, varying the surface temperature [23], allowed the identification of different stratigraphs and construction techniques, in particular of the oldest part of the complex and surrounding buildings dating back to the 1950s. This section in fact was the most seriously damaged and will therefore be subject to significant interventions structurally, as well as in terms of energy saving (Figure 7) [35].

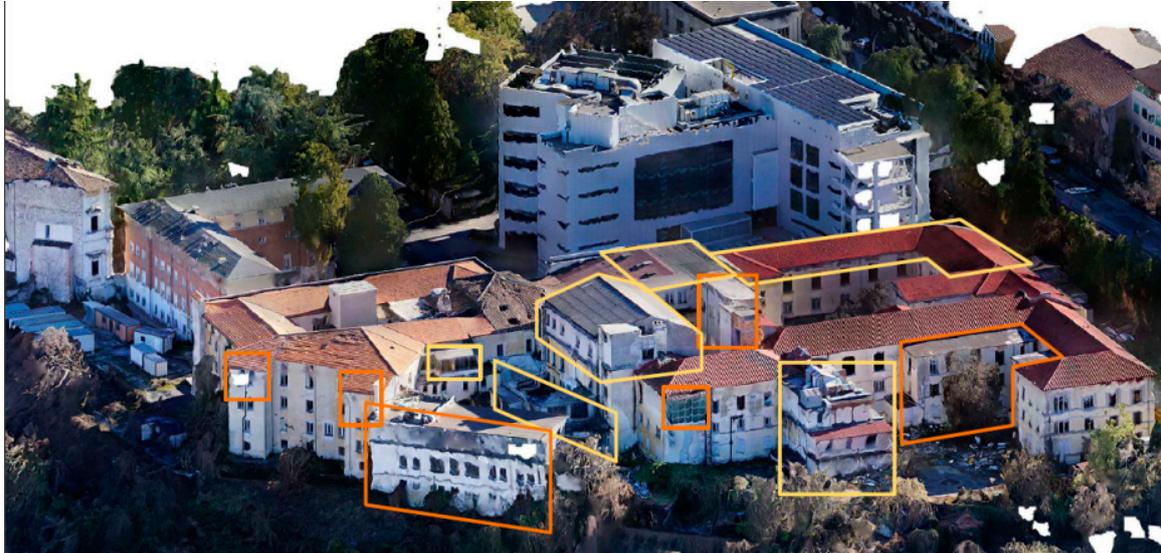
Figure 8. Identification of inadequate additions (yellow outlines) or design incongruity (orange outlines) that have to be demolished: the technologies used for the investigations allowed to carry out highly detailed studies on volumes, in order to accurately determine the configuration of the building for the project initial phase.

In the case of the former hospital, the knowledge acquisition process described proved invaluable in defining the methodology for the recovery project and for avoiding incongruous additions or interventions incompatible with the existing structures (Figure 8) [36].

Amongst the various analyses carried out, the three dimensional reconstruction of the building allowed an overall vision and definition of the formal and dimensional aspects, particular useful in gaining an understanding of the peculiarities of the complex. However it is important to point out that cross-checking of data acquired from historical and archival surveys with that of the three-dimensional studies was essential in the reconstruction of the history of this building complex and for confirming

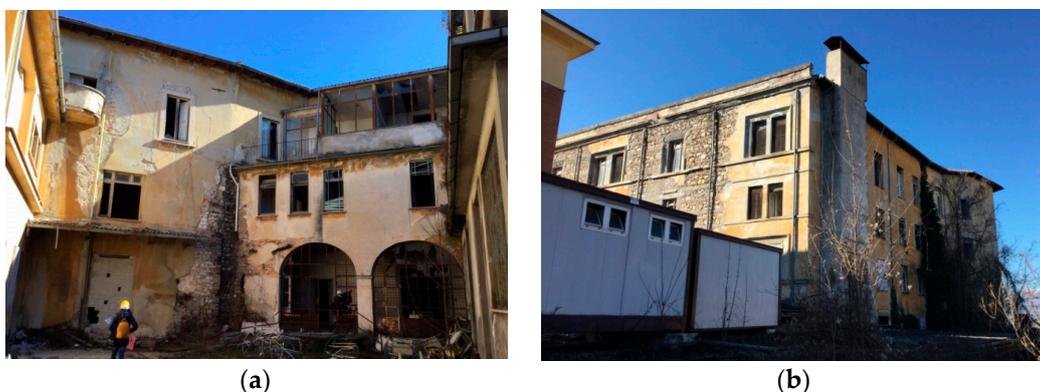
Figure 9. The current state of degradation observed in the inspection of 16 February 2016: (a) The court enclosed by inadequate extensions; (b) A view of the north face of the complex.

Thermal imaging, on the other hand, allowed us to ascertain the constructive apparatus of the building and to highlight discontinuities in materials which support documentation and hypotheses concerning the varying phases of transformation that the building underwent. They were also important for the recognition of cultural and architectonic values that are no longer evident, as well as incongruous elements that prevent a correct understanding of the building complex. A number of historical and typological features of the building were in fact hidden as a result of interventions over the years that erased traces of pre-existing structures, within the building as well as on an urban scale from sight. In addition to this architectonic clouding of the picture, years of disuse and degradation have contributed to deterioration of the state of conservation and its original material characteristics (Figure 9).
