# Durability of Stone Cladding in Buildings: A Case Study of Marble Slabs Affected by Bowing

Hipólito Sousa \*

## 2. Marble Slabs Affected by Bowing and Wind Pressure—A Case Study

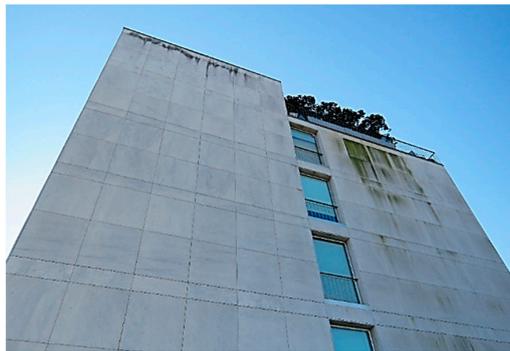
**Figure 1.** Partial view of the stone cladding applied on the north façade of the building.

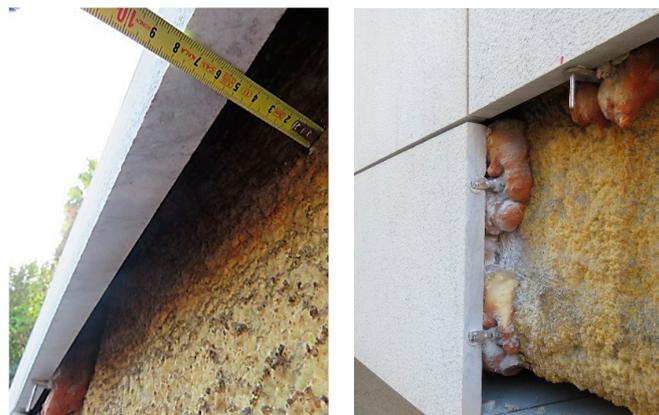
All the façades are covered by marble ventilated cladding (about 1000 m<sup>2</sup> of cover area); however, the west façade is the less covered façade since it has about 80% of glazing. The cladding system is made of marble stone slabs with 5 mm thick open joints and are fixed to building façades with an air layer/cavity, forming a “ventilated façade” (Figure 1). The most representative stone slabs have surface dimensions that range from 1.5 × 1.3 m<sup>2</sup> to 1.5 × 0.7 m<sup>2</sup>, and all the slabs have a thickness of 3 cm. These slabs are fixed to the building façade through a stainless steel dowel anchorage system (body anchorage fixed on the walls, having pin dowels inserted in holes made on the slabs), and each slab has four fixing points (Figure 2).

**Figure 2.** Detail view of cladding after removal of a stone slab (dowel anchorage system/fixing points).

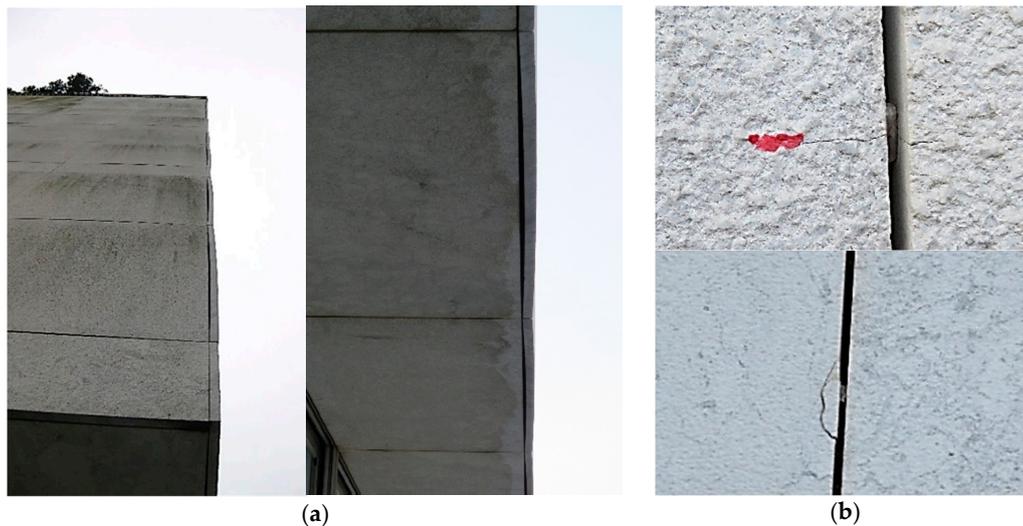
According to visual inspections and some measurements performed on the building façade, the bowing was affecting more than 50% of all the cladding applied on the façades, being more severe in the east and west façades and partially on the south façade. In general, the bowing occurs in all the height and width of these façades, except in 8 m of width of the north façade and in the first 10 m of height of the south façade. This may be related to the lower sun radiation exposure of the north façade and to the solar protection provided by nearby buildings and trees in the south façade. The bowing magnitude was higher in the slabs mounted near the vertical and horizontal corners, and on the top of the façades. In these places, permanent deflections of 8 to 12 mm (or 6 to 7 mm/m) were measured. No damage/fracture patterns were detected in the central part of the slabs with bowing; however, small fracture patterns were found near the fixing points (dowel holes) of some slabs affected by bowing (about 15%) (Figure 3).

**Figure 3.** Examples of bowing and damage detected on the marble cladding: (a) bowing of slabs in the east and west façades; (b) local damage/fracture near the fixing points of the slabs.

- The load resistance at the dowel hole for serviceability conditions is not verified for slabs located higher than 9 m (SLS security ratios are, in general, higher than 1, i.e., between 1.2 to 1.7), thus presenting a high risk of occurring permanent damage/fracture near the slabs fixing points (as observed in the inspections made—see Figure 3);

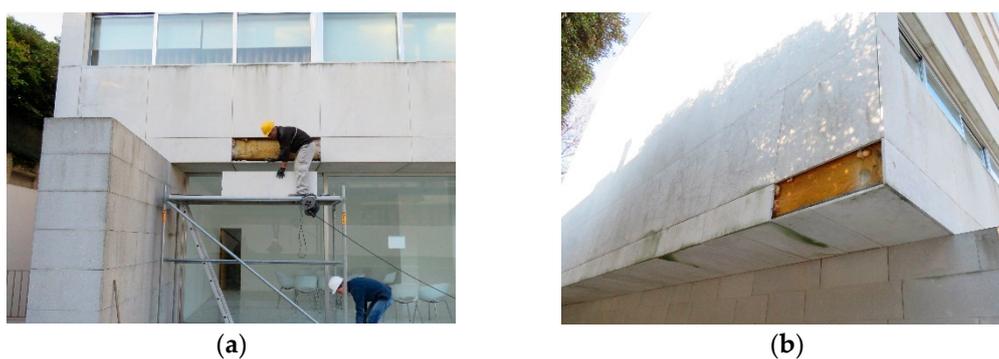
**Figure 4.** Examples of stone slabs removed from the building façade: (a) east side; (b) south side.

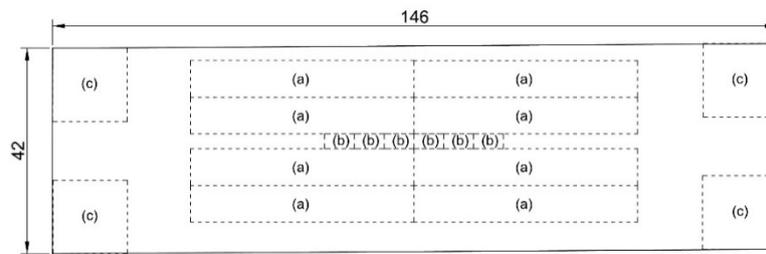
**Figure 5.** Position of the test specimens cut out from the slabs removed from the façade (dimensions in cm): (a) flexural strength; (b) compressive strength; (c) breaking load at dowel hole south side.

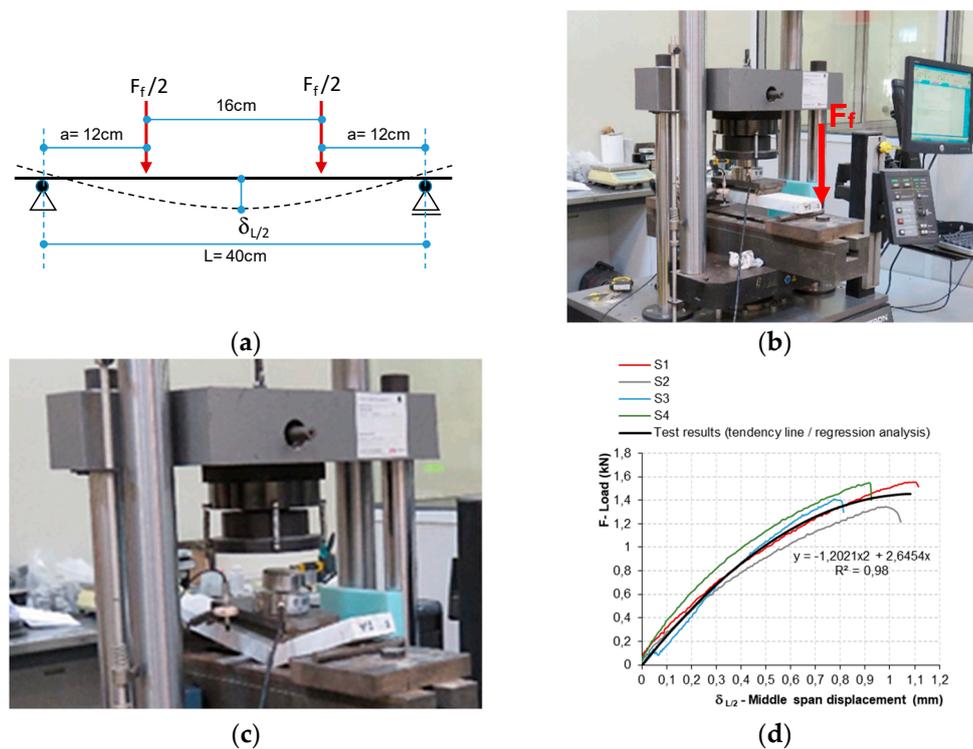
The flexural/bending strength ( $\sigma$ ) under constant moment and the static modulus of elasticity in the longitudinal direction ( $E_{sL}$ ) were determined using experimental data obtained from tests performed according to the EN 13,161 [36] methodology (Figure 6), using Equations (1) and (2). Twenty-two test specimens (8 without and 14 with bowing) having dimensions of 7.5 cm  $\times$  45 cm  $\times$  3 cm, i.e., width (b)  $\times$  total span ( $L_t$ )  $\times$  thickness (t), were mounted in a universal press/traction machine with an effective span (L) of 40 cm (Figure 6a). A vertical load ( $F_f$ ) was divided (160 mm apart) in two equal vertical loads ( $F_f/2$ ) and were applied in the perpendicular direction of the span of the specimens (i.e., facing the wind/sun exposed side of the slabs, as mounted on the building façade, i.e., in the same direction of the wind pressure pushing the slab inwards—Figure 6b). The loading was applied until failure (Figure 6c) with a rate of 0.005 mm/s and was measured through a loading cell with 100 kN of maximum capacity. The vertical displacements at the middle span ( $\delta_{L/2}$ ) were measured with a linear variable differential displacement transducer (LVDT with  $\pm 2.5$  mm of maximum displacement course) in four specimens with bowing (S1, S2, S3, S4) in order to determine the static modulus of elasticity ( $E_{sL}$ ). A numerical regression analysis was performed to obtain a force-middle span displacement ( $F_f$ - $\delta_{L/2}$ ) tendency line (Figure 6d), thus allowing a more representative calculation of the flexural/bending stresses ( $\sigma$ ) and static modulus of elasticity in the longitudinal direction ( $E_{sL}$ ) of stone samples by using Equations (1) and (2).

**Figure 6.** Examples of flexural strength and static modulus of elasticity lab tests (top side of the specimen is the sun/wind-exposed surface): (a) static model of the test; (b) test set-up with loading direction ( $F$ ); (c) specimen after breaking load; (d) force-displacement curves and regression analysis.

- Considering the experimental force-vertical displacements ( $F_f - \delta_{L/2}$ ) obtained from flexural tests, the marble exhibits a linear behavior until 40 to 55% of the maximum/breaking load;

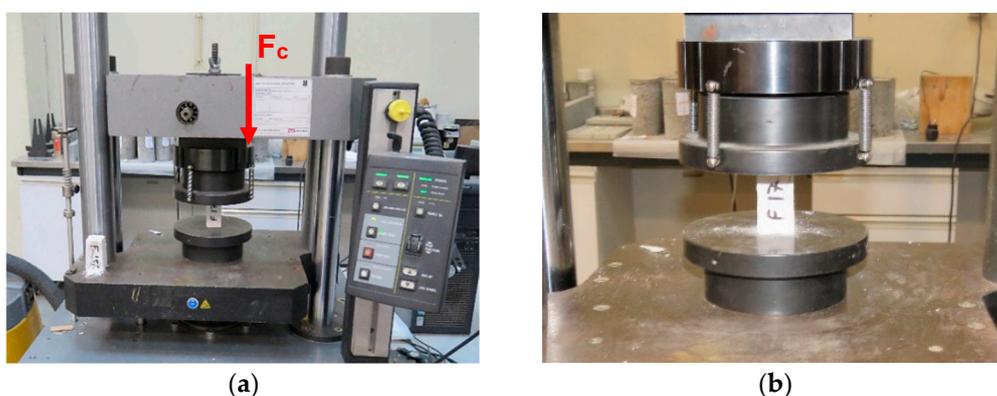
The compressive strength ( $R_r$ ) was determined according to EN 1926 [37] testing methodology (Figure 7). Ten test specimens (5 without and 5 with bowing) having dimensions of 6 cm  $\times$  3 cm  $\times$  3 cm (height  $\times$  with  $\times$  thickness) were mounted in a universal press/traction machine. A vertical compression loading ( $F_c$ ) was applied parallel to height of the specimens (i.e., loading applied on the thickness side and along the direction of the span of the slabs, as mounted on the building façade) with a rate of 0.01 mm/s until failure, and was measured through a loading cell with 100 kN of maximum capacity.

**Figure 7.** Examples of compressive strength lab tests: (a) test set-up with loading direction; (b) specimen after breaking load.

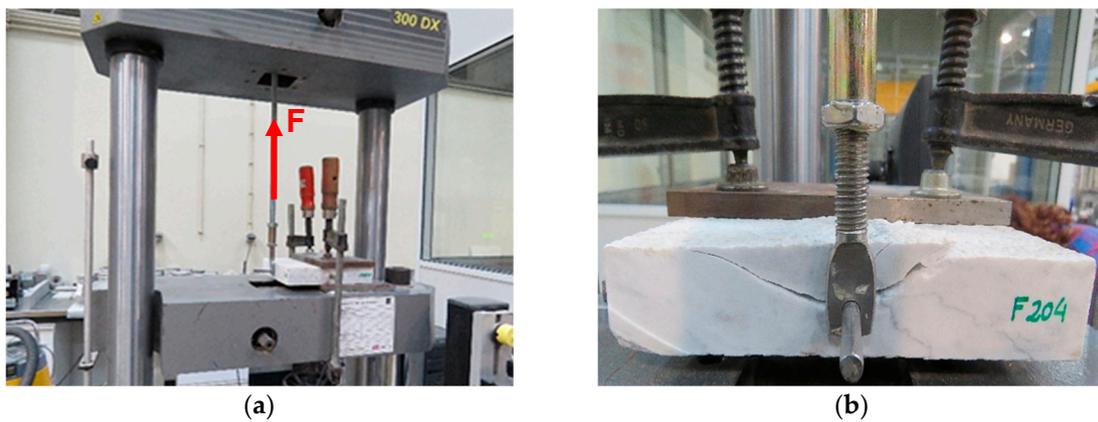
The breaking load ( $F_r$ ) at the dowel hole was determined according to the EN 13,364 [39] testing methodology (Figure 9). Nine test specimens (5 without and 4 with bowing) having dimensions of 15 cm  $\times$  15 cm  $\times$  3 cm (with  $\times$  length  $\times$  thickness) were mounted in a universal press/traction machine through clamps. A shear loading (F) was applied at the pin dowels in the perpendicular direction of the stone's exposed surface (i.e., simulating the pin action at the stone dowel hole due to the wind

**Figure 8.** Examples of breaking load at the dowel hole (top side of the specimen is the sun/wind-exposed surface): (a) test set-up with loading direction (F); (b) specimen after breaking.

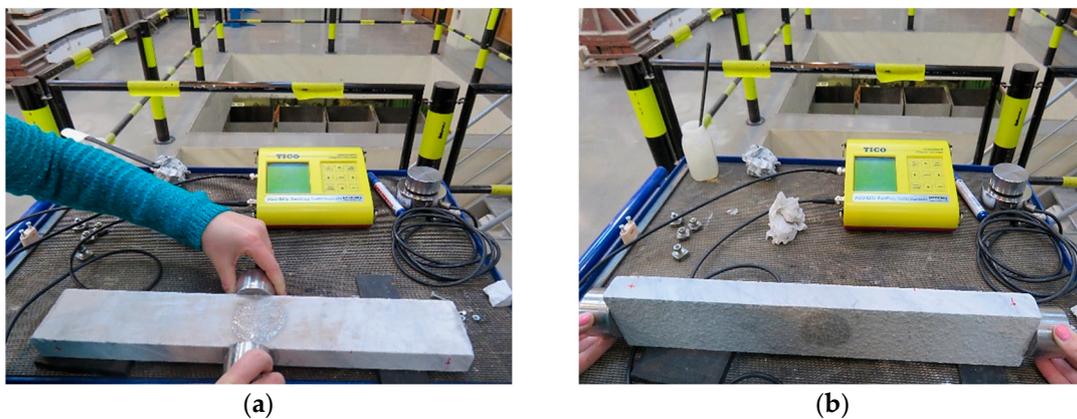
The dynamic modulus of elasticity in the longitudinal and transversal directions ( $E_{dL}$ ;  $E_{dT}$ ) of the test specimens (i.e.,  $E_{dL}$  in the direction of the slab spans and  $E_{dT}$  in the orthogonal direction, as mounted on the building façade) was determined according to the EN 14,146 testing methodology [38] (Figure 8). However, the test equipment did not allow direct measurements of the fundamental resonance frequency. Therefore, the dynamic modulus of elasticity was determined through the use of sound wave propagation velocities obtained from ultrasound tests performed on four flexural test specimens with bowing, and using the Poisson coefficients range found in literature for calcite marbles (0.25 to 0.41 [9–13]).

**Figure 9.** Examples of dynamic modulus of elasticity measurement: (a) transversal direction; (b) longitudinal direction.

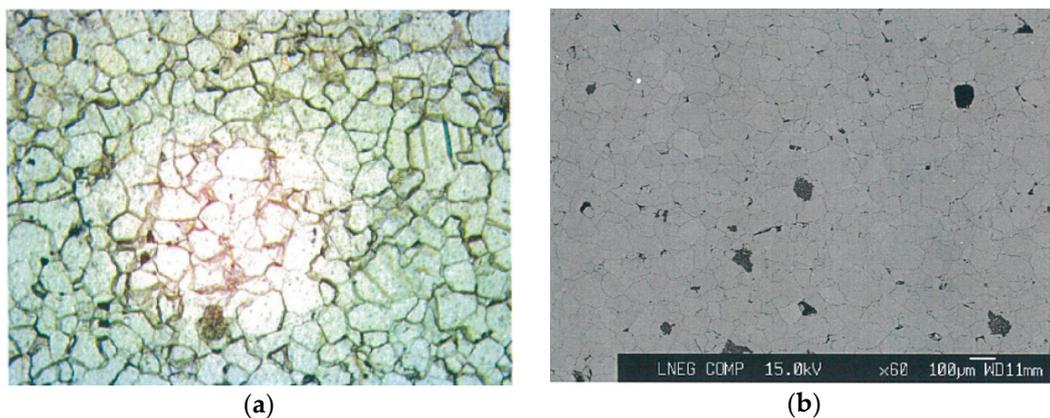
Moreover, a mineralogical/petrographic analysis was performed mainly to confirm that the stone used in the slabs was in fact a calcite marble. This analysis was based on performing detailed observations of the stone microstructure (identification of shape and type of constituent minerals), using thin cut stone specimens analyzed through petrographic and high-resolution electronic microscopes (Figure 10). This analysis was performed by a specialized national laboratory of Portugal (LNEG - Laboratório Nacional de Energia e Geologia).

**Figure 10.** Examples of petrographic/mineralogical analysis of marble: (a) images from petrographic microscope (enlarged 10 ×); (b) images from electronic microscope (enlarged 60 ×).

- The mineralogical/petrographic study revealed that the marble was made mainly of calcite, thus classified as a calcite marble, although containing other minerals in smaller quantities (dolomite, quartz, biotite and chlorite), and possessing a homogenous structure (granoblastic texture of fine equigranular grains);

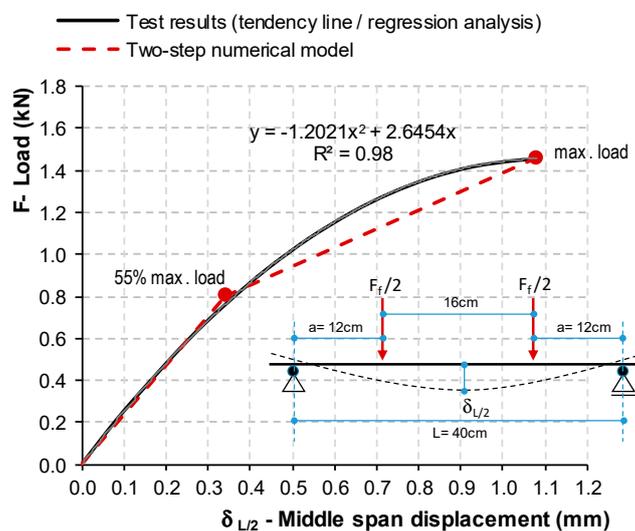
Since it was not possible to obtain stress-strain data from direct tensile or compressive tests in order to simulate the stone slabs through non-linear elastic-plastic material models, a more simplistic approach was used. A two-step linear-elastic material model was used with maximum limits for the tensile/compressive stresses, which were obtained from the flexural and compressive strength tests performed (see Section 2.3). The first step simulates the undamaged state of the stone associated to

**Figure 11.** Validation/calibration of the numerical model (simulation vs. test data).

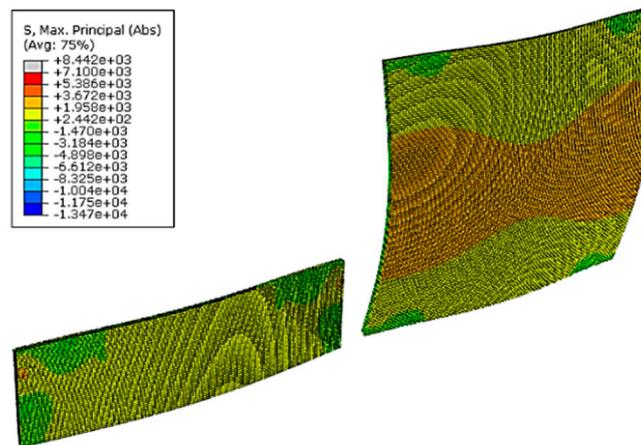
The simulations of the marble slabs applied in the building façades was performed with a 3D FEM model using the theory of thin plates and the two-step calibrated model. The slabs were supported by 4 nodes with translational restrains (in orthogonal directions  $x$ ,  $y$ ,  $z$ ) and were submitted to evenly distributed loads that simulates the wind pressure acting on the perpendicular direction of the slabs surfaces, i.e., parallel to the marble stratification plane (Figure 12). The stability/resistance of the marble slabs to wind pressures ( $W_k$ ) was evaluated through the flexural stress at the cross section of the slabs and through the loading/reaction forces at their fixings points (pin-dowel holes). The loading at the

**Figure 12.** Examples of finite element model (FEM) simulations of marble stone slabs and stress distribution associated to wind pressure for serviceability limit states (SLS) characteristic combination (values in  $\times 10^3$  Pa).
