Article

Action Protocols for Seismic Evaluation of Structures and Damage Restoration of Residential Buildings in Andalusia (Spain): “IT-Sismo” APP

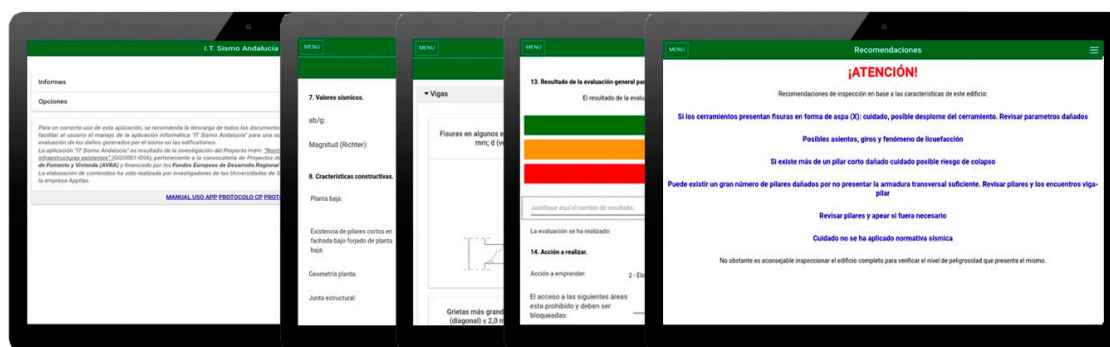
Figure 7. Several screenshots of the ICT tool developed for the assessment of existing buildings and infrastructures (IT-Sismo). Source: Prepared by the authors.

The first contact of the user with the application occurs via the presentation screen, which provides an introduction regarding the characteristics of the project, as well as a set of recommendations aimed at facilitating its use. To this end, the contents of the protocols explained above are provided, as well as a manual for the tool itself. Once the users have become familiarised with the aforementioned contents, they will be able to use the interactive protocol to good advantage (Figure 7).
