# Forensic Investigations of Geohazards: The Norcia 2016 Earthquake

**Keywords:** forensic geoscience; forensic geophysics; GPR; geohazard; earthquake

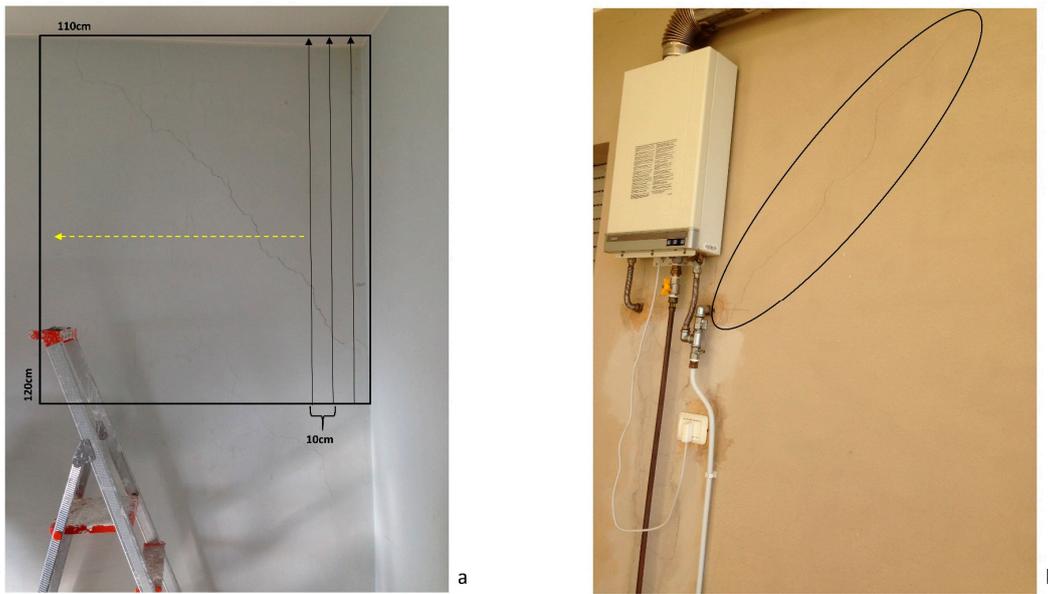
**Figure 3.** (a) The crack in the masonry and the dimension of the one-way grid; (b) shows a similar crack in the same wall in the balcony.

In the private apartment in Amelia, a visibly damaged wall was analyzed to understand the internal geometry of the fracture that was assumed to pass through the masonry from the inner part of the apartment to the outer part, which was on the balcony. This type of investigation is well documented in the literature [34–40], but less used in the post-earthquake situation. The whole house was built in the 1970s, before the new anti-seismic rules and before the modern development of the seismic vulnerability map. The building is a hybrid structure, masonry and reinforced concrete, and this was the most evident and critical crack.

Data was acquired vertically inside a 1.1 m × 1.2 m one-way grid, with a distance of 0.1 m among profiles (Figure 3). No other processing beyond the standard one (AGC, DeWOW and Average Envelope Amplitude) was required. The signal penetration velocity was calculated using the hyperbola calibration and verified using the actual measurements of the exposed masonry: 0.14 m/ns.

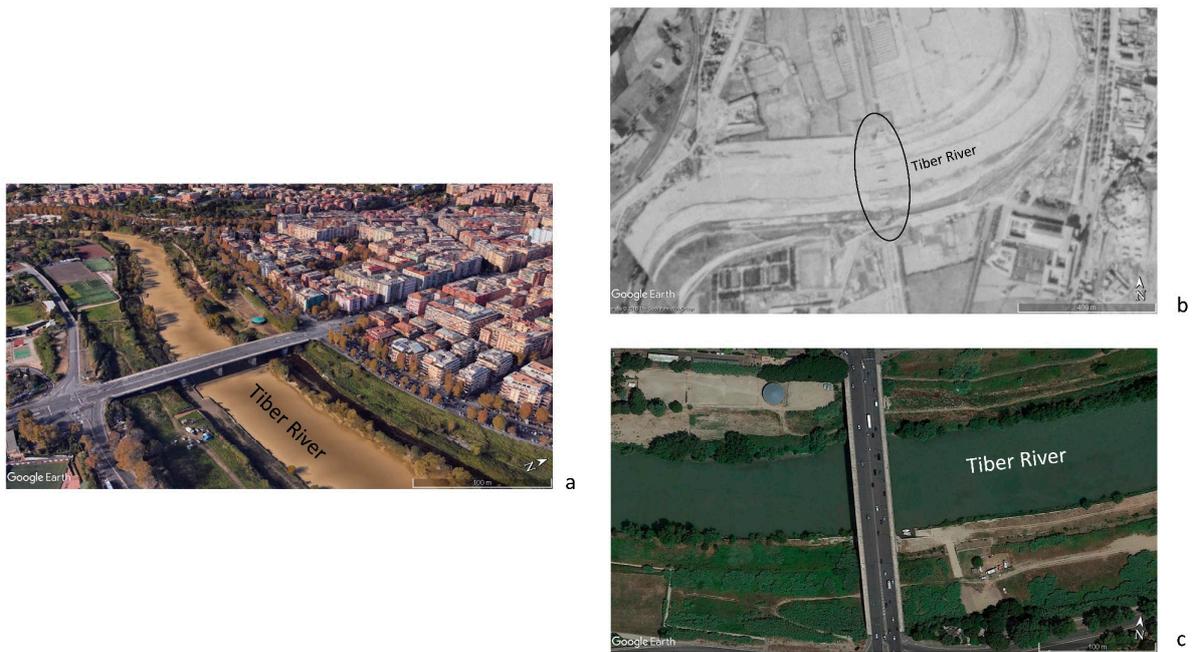
**Figure 4.** The Marconi Bridge on the River Tiber within the urban context of Rome (a,c); (b) The beginning of its construction after WWII (source: Google Earth).

On the Marconi Bridge in Rome, the GPR investigation was focused on the pavements of the bridge. This bridge was built between 1937 and 1955; the construction was interrupted due to the WWII and was only resumed in 1953. The total length is about 235 m and it is the longest bridge in Rome, with six arches and a width of about 31 m [41]. It has a “winged” structure where the central part of the bridge, supported by the pylons, is crossed by vehicles, while the external “wings” are the sidewalks (Figures 4 and 5). This type of investigation is also well known in the literature [34,42–45]; however, there has been little post-seismic application, especially in bridges having this particular structure.

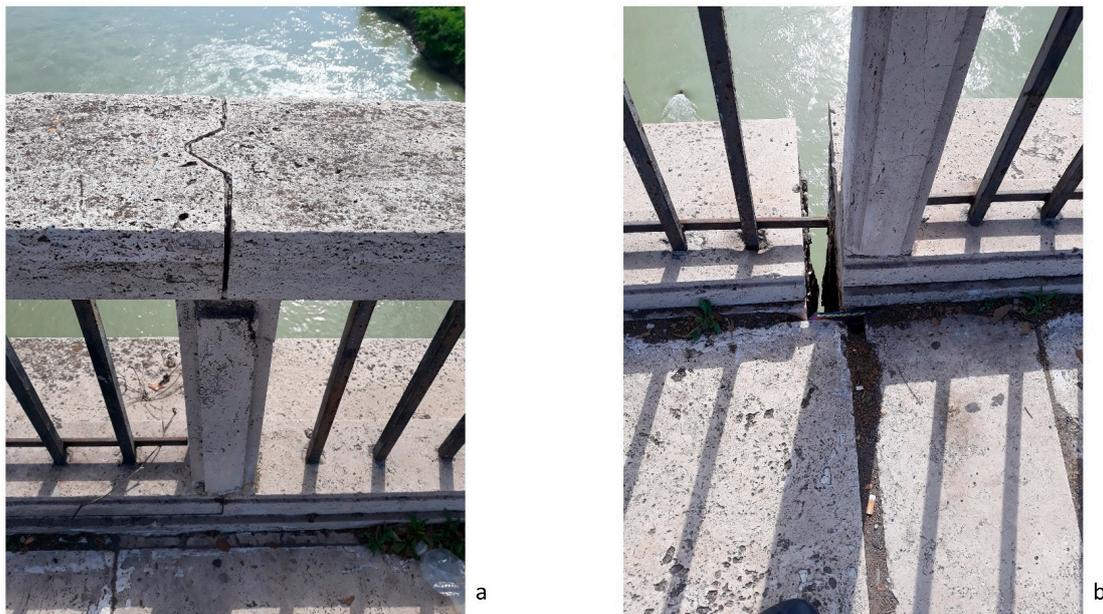
**Figure 6.** The visible detachments along the sidewalk of Marconi Bridge after Norcia 2016 earthquake (a,b).

We acquired both single profiles along the two sidewalks, above the “wings”, where the greatest damage and detachments were visible after the 2016 earthquake (Figure 6), and one-way grids of  $5\text{ m} \times 3\text{ m}$ , with a distance of 0.25 m between the profiles in the most severely damaged areas. No processing beyond the standard processing (AGC, DeWOW and Average Envelope Amplitude) was required. The signal penetration velocity was calculated by means of the calibration of the hyperboles, and subsequently verified by the real measurements of the thickness of the visible wings. It was 0.14 m/ns.
