# Graphic Applications of Unmanned Aerial Vehicles (UAVs) in the Study of Industrial Heritage Assets

**Keywords:** industrial heritage; unmanned aerial vehicles; UAV; graphic applications; sugar cane factory; aerial photograph; SWOT

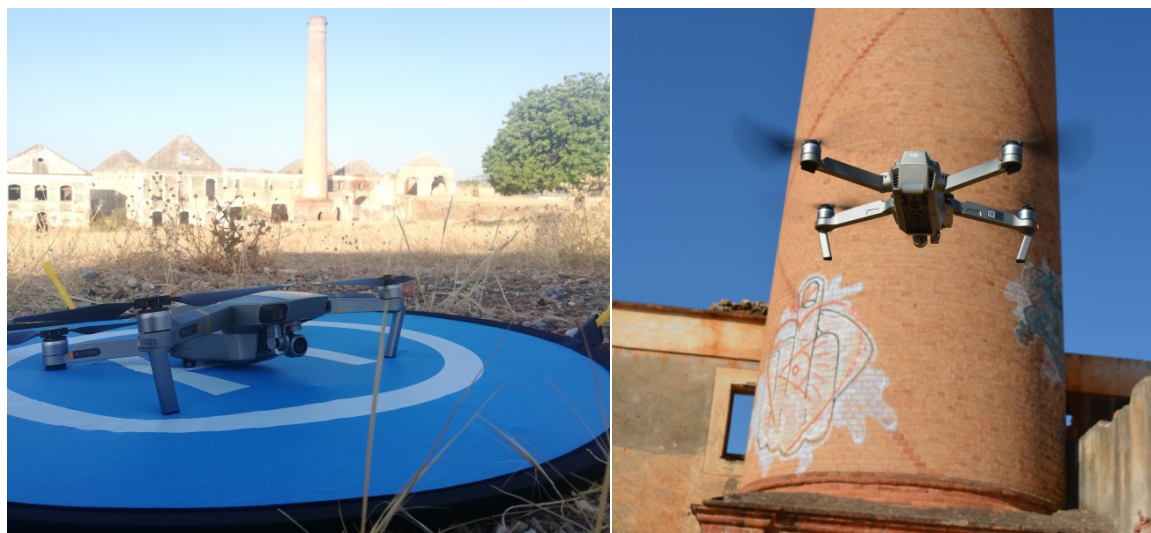
A multirotor UAV has been selected for the flight operation. A MAVIC pro platinum model has been employed (Figure 3). The main UAV technical characteristics are listed in Table 2.

Figure 3. MAVIC pro platinum model UAV.

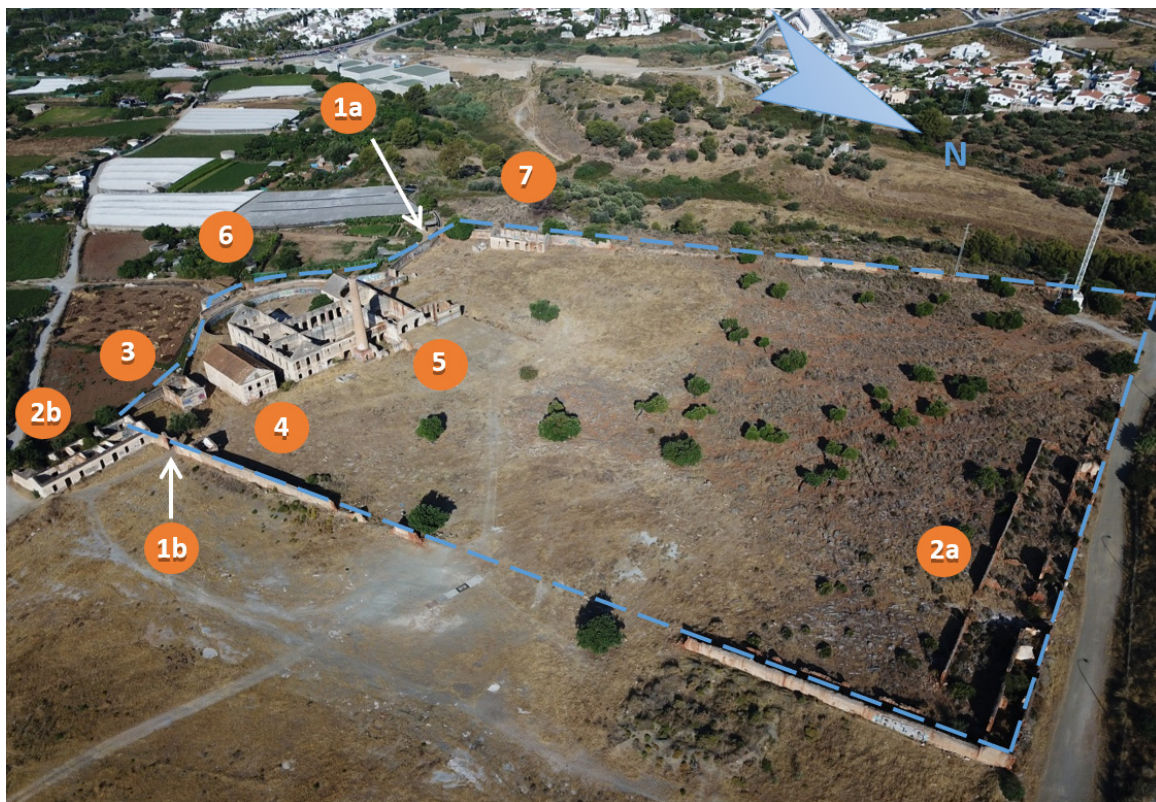
In an aerial photograph of the factory obtained with an UAV flight, different structural elements and its distribution can be observed (Figure 4):

**Figure 4.** Factory elements distribution. Aerial image obtained in the UAV flight operation.

- (1) Factory enclosure. The factory has an extension of some around 5000 m<sup>2</sup> surrounded by a masonry wall. The enclosure had two entrances. The pedestrian entrance, situated on the south side of the factory (1a), which gave access to the main entrance to the sugar factory. The other one (1b), located in the southeastern side of the enclosure, was the collected sugarcane entrance and the manufactured sugar exit. Actually, remains of the masonry wall can still be observed, although much of it is destroyed.

- (2) Worker houses. In the north part of the factory enclosure, eight houses were built for factory workers (2a). Actually, only part of the remain buildings can be observed. In addition, outside the factory enclosure, at the southeaster entrance, another building can be observed (2b), being dedicated to factory worker living quarters. The second structure remains in a better conservation state.

All the buildings had a gable roof. They were closed with wooden trusses. Currently, only the office roof remains. In general terms, the industrial set show a poor state of conservation and reconstruction actions are required. Particularly, the chimney shows different cracks that could end up with its destruction.

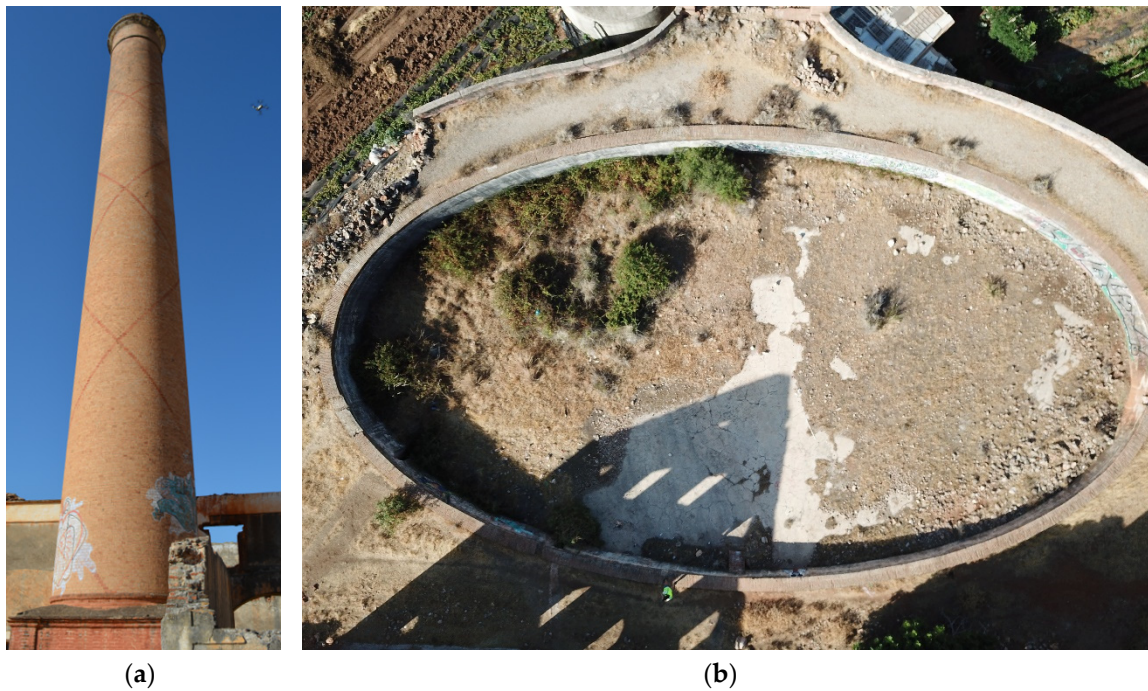
- (6) Additionally, a chimney can be observed on the north factory facade. This element was built with smudging bricks (Figure 5a). It is characterized by a double band of a darker hue brick that runs longitudinally and forms rhomboid shapes, having a wider quadrangular pedestal. This chimney is the only example of such a decorated chimney in the province.

**Figure 5.** (a) Factory chimney; (b) Irrigation water pond.
