Article

Defining a Non-Destructive In Situ Approach for the Determination of Historical Mortar Strength Using the Equotip Hardness Tester

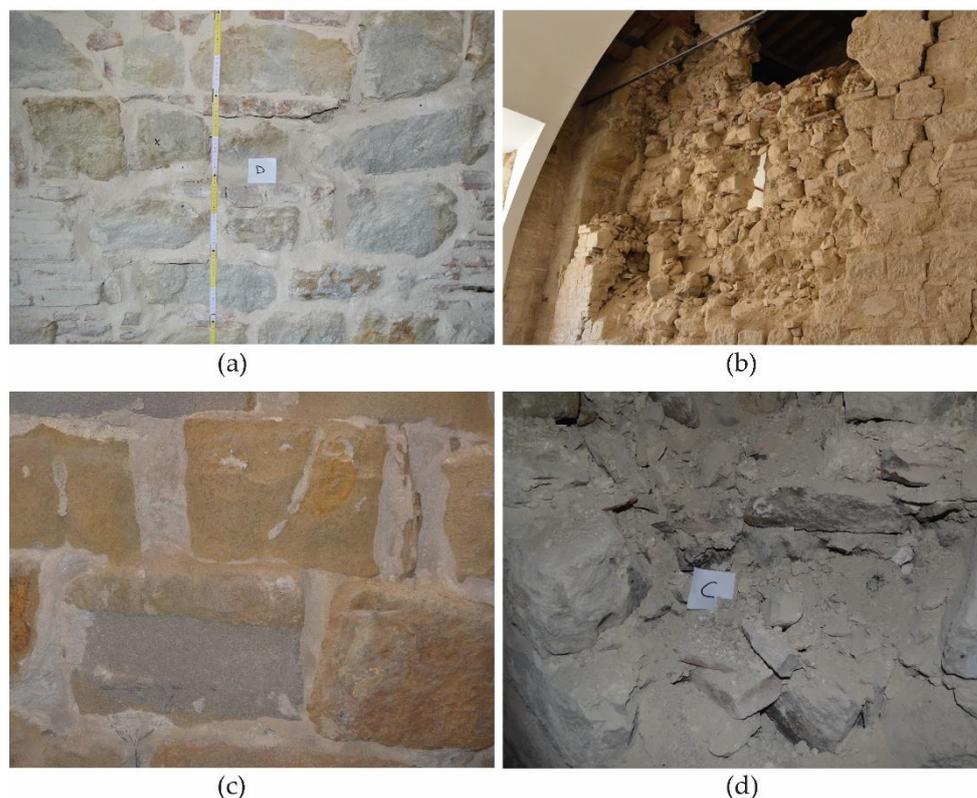
Figure 2. Pictures showing typical masonry face (internal and external) on the left and masonry core of collapsed walls of Palazzo Ducale Palace on the right side. (a) Internal masonry face. (b) Internal masonry core. (c) External masonry face. (d) Detail of internal masonry core.

The buildings chosen in this study are well representative of the built cultural heritage of the Marche Region, with their masonry walls representing a very common construction type for the area, composed of a three-leaf (stone or brick) masonry. Two external leaves made of stone or brick masonry are constructed at a distance, whereas an internal leaf is filled with a loose, low strength material, made of stone fragments and/or bricks and mortar (i.e., sack stone masonry) [30]. The main structural problems of this masonry type are: (i) the weakness of the internal layer, which has significantly poorer mechanical properties than the external leaves, (ii) the deterioration of the external joint mortar, and (iii) the absence of connection between the leaves. In turn, this type of masonry is very vulnerable to seismic actions, in fact, as the bond between the external and the interior leaves has deteriorated or is inexistent, the masonry itself does not behave as a whole. Consequently, they are very

sensitive to brittle collapse mechanisms, which usually manifest, both under vertical and horizontal loads, as detachment of the leaves and out-of-plane deformation [31]. In this regard, collapsed walls made mortar sampling possible, on both masonry face (Figure 2a,c) and core (Figure 2b,d), with an adequate sample size to perform mechanical compression tests in the laboratory.

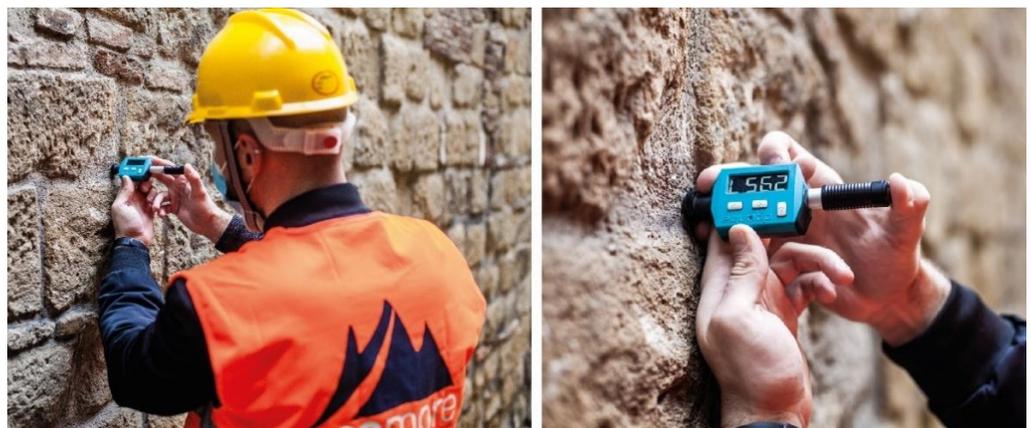
Figure 3. Non-destructive in situ survey with Equotip hardness tester on a masonry face of a building.

In the analysis of ancient mortars coming from buildings of Camerino, the use of a non-destructive test (NDT) is essential to preserve the integrity of these monuments. For this reason, and to create a comprehensive dataset of the historical mortar quality, EQ was tested both on the bed joints (Figure 2a,c and Figure 3) and inside the walls involved in collapses due to the 2016–2017 seismic sequences, thus characterizing both the mortars inside the sack stone masonry (masonry core, Figure 2b,d) and the most external mortars (masonry face). The collapse of some sack stone masonry following the 2016–2017 seismic sequence allowed a sample to be taken for each wall tested with EQ, thus avoiding further damage to intact walls of historic interest. The samples for the UCS test were collected close to the EQ tests conducted to minimize compositional changes that may affect the correlation between the EQ's rebound and the UCS.

According to the hardness tester manufacturer's manual [33], the correction of the impact value with respect to the vertical direction is automatically made by the device. All the surfaces have been smoothed manually before testing to avoid the influence of roughness on the rebound and both single impact and repeated impact strategies have been adopted for comparison. To date, a reliable data collection methodology has not been defined, and, according to the literature, it is possible to choose between at least two main methods, namely, "repeated impact test" or "single impact test" [22,23]. The repeated impact test refers to multiple impacts on the same spot while the single impact test refers

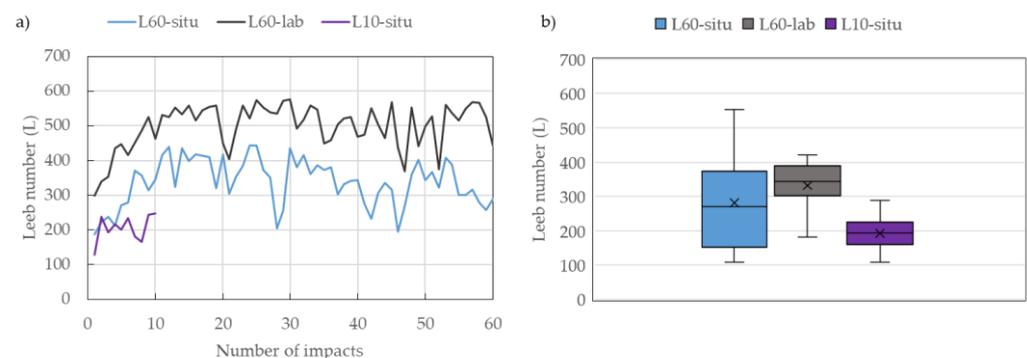
Figure 4. (a) rebound values of the EQ (Leeb number, L) for the repeated and single impact strategy for a representative sample of the dataset (sample 3011); (b) boxplots of the whole dataset.

As shown in Figure 4a, some typical behaviors have been detected: (1) the results of the “repeated impact test” shows a progressive increase of the rebound values for the first 10 impacts, followed by a general stabilization as the number of impacts increases; (2) beyond 30–40 impacts, a slight decrease of the rebound value was sometimes observed; (3) comparing the results of L10-situ with L60-situ, we can observe generally lower values of the single impact method; (4) the results of L60-situ and L60-lab mortars are different, with constantly higher rebound values for L60-lab.

These observations indicate that: (1) at the beginning of the rebound test, the result is affected by the settling between the tip of the instrument and the mortar surface. This may probably be due to the initial compaction of the material; (2) the decrease of rebound value after many impacts can be related to a progressive damaging of the tested mortar; (3) the results of L10-situ agree with the first values of L60-situ, indicating that the single impact is aimed at representing only the hardness of the most superficial portion of the material [22]; (4) the differences between laboratory test and in situ test are probably due to the real difference between the elastic properties of the mortar close to the surface and inside the mortar mass.

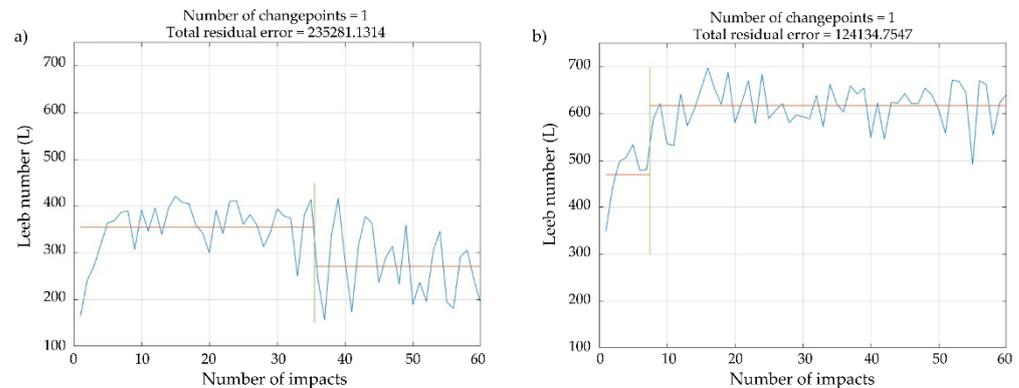
Figure 5. Changes in the rebound value of EQ with the number of repeated impacts at the same point for two mortar samples. (a) masonry core; (b) masonry face.

Examining the average values of the two types of mortars (red lines in Figure 5) it can be observed that the mortar of the masonry core is of lower quality (Figure 5a) compared to that of the masonry face (Figure 5b), with the former showing a mean value of ≈ 350 and the latter $L \approx 600$. Moreover, in the mortar of the masonry core, after ≈ 40 repeated impacts, a sudden fall of the average value is evident, respectively indicating damage of the material caused by the repeated impacts at the same point, which could thus be explained with the formation of micro-fractures. The outermost mortar of the masonry face, on the other hand, is of higher quality and the average value is stable until the 60th repeated impact. As reported before, both mortars show very low values until the 10 repeated impacts, probably due to the initial compaction of the material.

Based on this evidence, it was chosen to adopt the “repeated impact test” method and assume the mean value of the 20 impacts located between the tenth and the thirtieth repeated impacts, as representative of the elastic properties of the mortar. From now on, we refer to $L_{mean_{situ}}$ and $L_{mean_{lab}}$ as the respective in situ and laboratory EQ measurements with the average value calculated with the just proposed criterion.

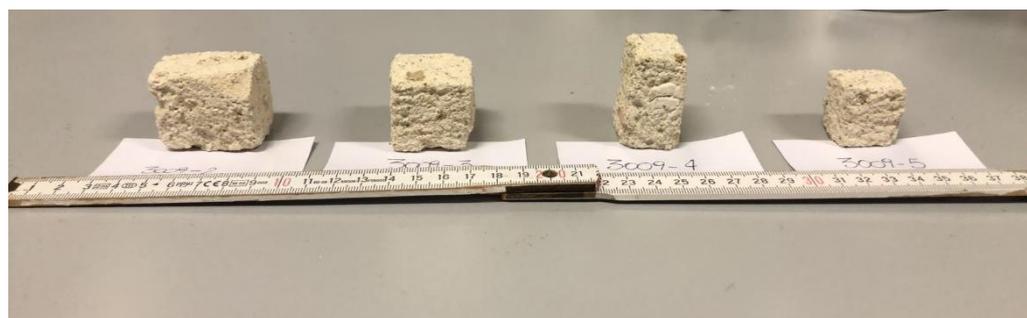
**Figure 6.** Some of the tested mortar samples.

To evaluate the mechanical properties of the study’s historical mortars, several uniaxial compressive tests were carried out. A total number equal to 14 specimens were tested, and the corresponding stress-strain behavior was recorded. It should be noted that the opportunity of carrying out a standard test, that is, a uniaxial compressive test, on historical mortar samples is quite rare [34]. Due to preservation matters related to architectural value buildings, it is very difficult to collect volumes of material large enough to obtain prism-shape specimens to be tested. In this context, the experimental results of this study represent a precious dataset able to improve the knowledge about the mechanical characterization of ancient mortars. A hand-held electric angle grinder was used to obtain cuboid shape specimens from larger mortar blocks directly taken in situ. Due to the irregular starting geometry of the latter and the general tendency of the material to crumble, it was not possible to obtain the standard cubic samples (i.e., $40 \times 40 \times 40$ mm). Since it is well-known that the sample geometry affects the value of the measured compressive strength [35], each obtained UCS value has been put in relation to the associated slenderness ratio, as will be discussed in detail in the dedicated section. In Table 2 the geometry of each specimen is shown where h is the height (that is the dimension parallel to the load application direction), l_{max} and l_{min} are the maximum and minimum dimensions of the cross-sectional area respectively, while h/d is the slenderness ratio. The latter was computed by dividing the height of the specimen for the diameter d of the circular area equivalent to the cross-sectional area of the specimen. In Figure 6 some of the tested samples are shown.

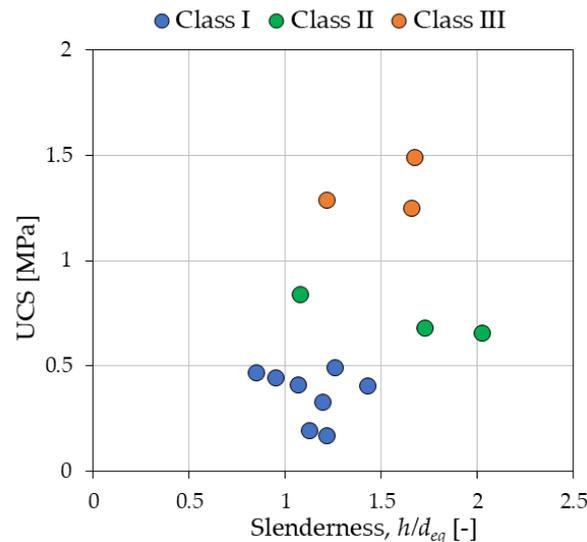
**Figure 7.** Comparison between UCS and slenderness for the three classes of mortar identified.

In order to evaluate the possible effect of the specimen geometry on the measured compressive strength, each UCS value was plotted against the corresponding slenderness ratio, as shown in Figure 7. Moreover, this comparison has been done by considering three different classes of mortar, identified based on the UCS values range: Class I (UCS < 0.5 MPa), Class II (0.5 MPa ≤ UCS < 1 MPa), and Class III (UCS ≥ 1 MPa).

Even though the number of samples for each class is limited (especially regarding Class II and Class III), no evident dependency of the UCS value from the slenderness has been found, at least within the slenderness ratios considered in the experimental testing. For a given class, it seems that the variability of the compressive strength is more related to the intrinsic inhomogeneity of the material rather than the geometrical features of the samples. As far as Class I is concerned, for instance, it can be observed that the variability of the UCS value for a fixed slenderness ratio is greater than the variability found for different slenderness ratios. Such consideration can be also observed for the samples owing to Class III. Only for the data of Class II, an increase of the compressive strength as the slenderness decreases can be detected. However, based on the findings concerning the other two classes and the very limited number of specimens, such a relationship between the UCS values and the corresponding slenderness ratios seems not to be representative. Naturally, such an aspect requires further study, and the possibility of testing more samples characterized

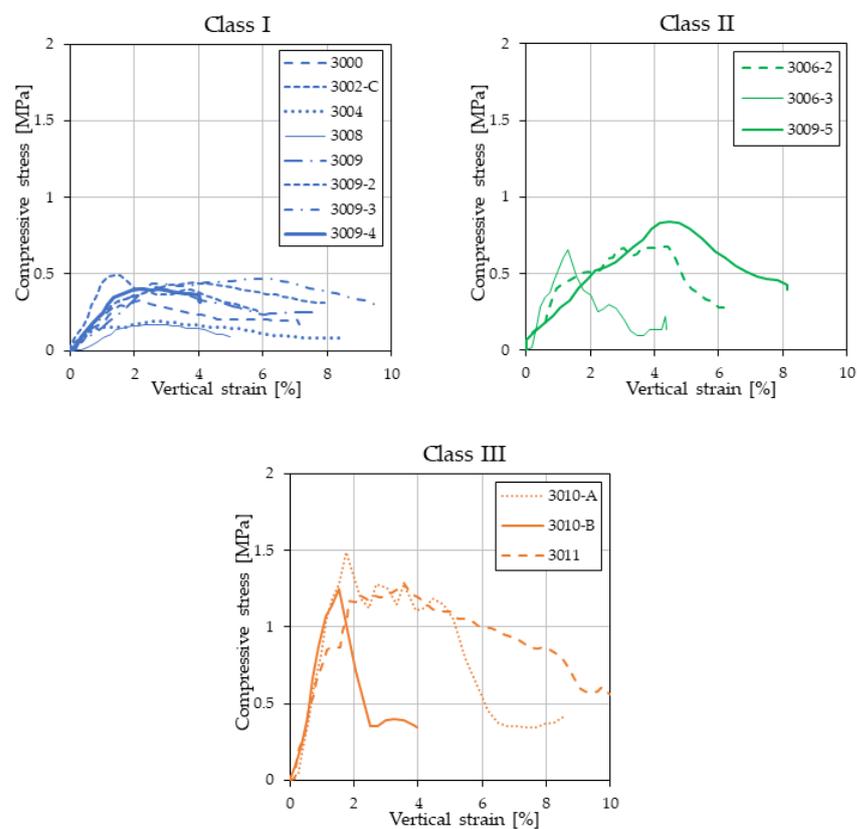
Figure 8. Axial stress-strain curves of the samples divided into the classes considered.

For the sake of completeness, in Figure 8 the stress-strain curves of the tested specimens are reported by considering the three classes previously described. It is worth mentioning that the samples owing to Class I (that is the weakest one) exhibited a markedly ductile behavior, showing a progressive increase of the compressive stress as the axial strain increases. On the contrary, the samples owing to the Class III (that is the strongest one) showed a clear brittle failure mode, highlighted by the presence of a peak of the stress-strain curve after which the material underwent a more or less pronounced softening. The samples grouped in Class II, finally, exhibited a mechanical response in between the two formers. The same findings, in terms of the mechanical response of the material, are reported in [34] regarding compressive tests carried out on Ancient Roman mortars coming from the archeological site of Pompei (Italy).

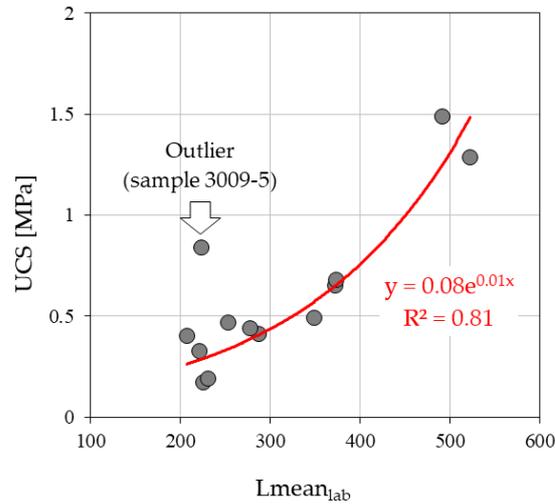
Figure 9. Correlation between $Lmean_{lab}$ and the UCS. Pearson’s correlation coefficient is reported.

The results obtained using the proposed test method make it possible to plot the mean value of EQ of the specimens ($L_{mean_{lab}}$) vs. the UCS, expressed in MPa (Figure 9), proposing a correlation curve for the evaluation of the mortar compressive strength based on the EQ average values for each site examined. A strong positive exponential interpolation is evidenced by Pearson's coefficient of determination ($R^2 = 0.81$), and one sample (sample ID 3009-5) could be considered as an outlier. The latter has been visually identified on the plotting since it lies well above the correlation curve obtained by fitting the other experimental measurements. This is related to the fact that this sample furnished a higher UCS value in relation to the associated $L_{mean_{lab}}$. Moreover, if this datum is considered in

the fitting process, the coefficient of determination drops significantly from 0.81 to 0.62. The interpolation law presented to correlate EQ values with the UCS is reported in Equation (1):

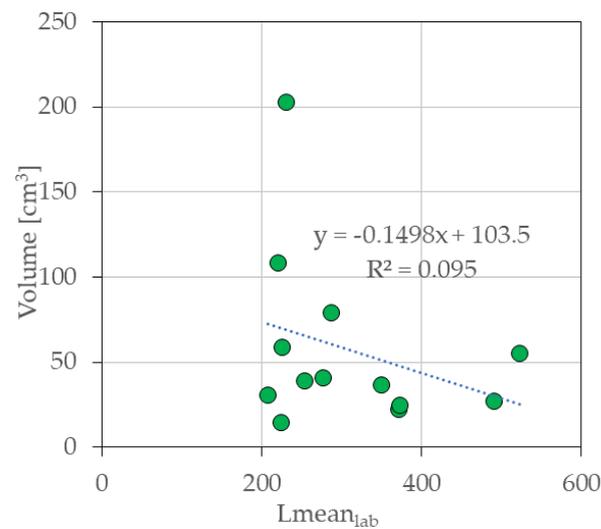
Figure 10. $Lmean_{lab}$ plotted vs the volume of specimens.

It should be noted that $Lmean_{lab}^*$ and UCS* values for each masonry mortar examined have been calculated averaging the values obtained for each specimen. At first, a discrepancy is clearly observed between $Lmean_{situ}$ and $Lmean_{lab}^*$, with the site value always lower than the values obtained on the specimens in the laboratory. Based on that, the block volumes of the laboratory specimens have been assessed to see if they influence the rebound of the EQ, excluding its relationship with the inconsistency between $Lmean_{situ}$ and $Lmean_{lab}$ values. In Figure 10, the volumes of fourteen blocks of mortar sampled from the eight masonry sites examined were plotted against $Lmean_{lab}$. The volumes ranged between under 14 cm³ to almost 200 cm³. Based on the extremely low Pearson’s coefficient of determination ($R^2 = 0.095$) there is no correlation, or relationship, between the block volume and $Lmean_{lab}$ (Figure 10), so the discrepancy in mean values cannot be attributed to the different volumes tested. This aspect is in accordance with [23] who tested the influence of block volume and edge effect on the EQ measurements.

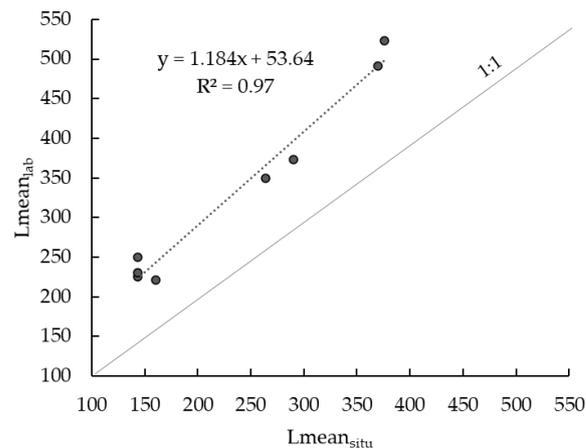
Figure 11. Linear interpolation of $Lmean_{situ}$ vs $Lmean_{lab}$. Pearson's coefficient of determination (R^2) is reported in the graph.

The δ values range from 0.57 to 0.78, indicating that the in situ mortars are characterized by a strength reduction due to surface alteration ranging from 22% to 43%. This aspect, coupled with the previous statistics evidence, confirms that the in situ mortars have generally higher variability of the mechanical properties in respect to EQ measurements on the laboratory specimens. As already evidenced in the literature [15,22], surface alteration generally lowers material's strength, as reflected in the rebound values indicative of surface hardness. Based on this evidence, we think that this aspect is crucial in the direct evaluation of the in situ strength properties and should be considered. In light of the results obtained, although the discrepancy between $Lmean_{lab}$ and $Lmean_{situ}$ is observed in the whole dataset, additional research deserves to be deepened, focusing on the influence of different methodologies on laboratory sample preparation. To substantiate all the consideration just made, the most striking observation that emerges plotting $Lmean_{situ}$ vs. $Lmean_{lab}$ * (Figure 11) is that, although the depicted line of interpolation has a slope approximately equal to the reference line 1:1 and the correlation is strong ($R^2 = 0.97$), the intercept on the y axis is not on the origin. This demonstrated also that if using the in situ measurements as it is to empirically estimate the UCS with Equation (1), an incorrect UCS evaluation is made because it would be affected by the superficial altered layer. Based on our observations we can suggest correcting the in situ measurements of the historical mortars based on the linear interpolation formula of Figure 11 (Equation (3)) and then use these values to estimate the UCS with Equation (1):
