Identification and Mitigation of Subsidence and Collapse Hazards in Karstic Areas: A Case Study in Alcalá de Ebro (Spain)

Abstract: Sinkholes are a severe problem in urban areas located in karstic regions, especially where evaporitic rocks such as gypsum exist. Identification and proposal of mitigation measures are needed to reduce this geo-hazard effect on buildings and social urban living. This paper presents a case study of the town of Alcalá de Ebro (Spain), which is located in the highest sinkhole risk region of Europe. The identification and mitigation of a series of sinkholes that appeared are analyzed. The former involves a geological investigation, including boreholes, field tests and geophysics. The latter is addressed by the use of geogrids, mortar injections and polyurethane injections. A complementary finite element analysis is carried out to set the ground behavior associated with the sinking process and assess its future evolution. The Ebro River appears to be the main cause of sinkholes, and results show that ground treatments applied were successful in their purpose, as there are no apparent deformations indicating that the subsidence or sinking process is still a

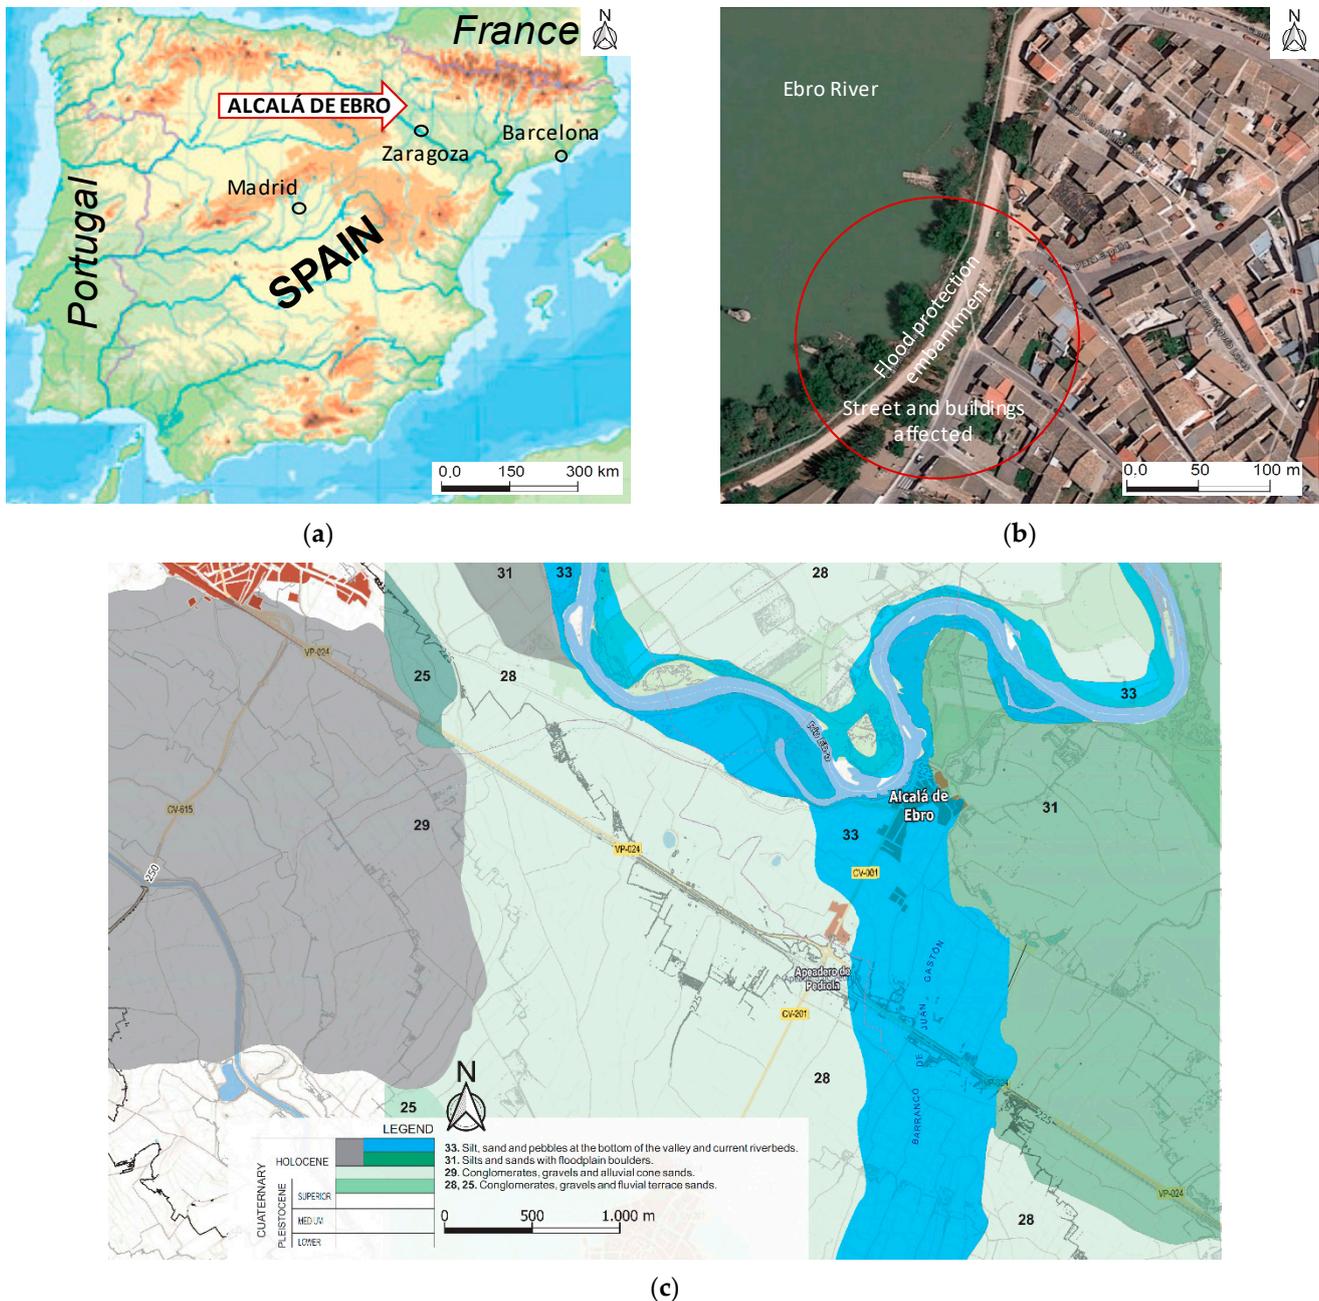
Figure 1. Geographical and geological framework: (a) Location of Alcalá de Ebro in the Iberian Peninsula; (b) Aerial view of the area under study (source: google maps); (c) Geological map of Alcalá de Ebro and its surroundings [29].

Alcalá de Ebro is found in the NE of the Iberian Peninsula (Figure 1), about 35 km northwest of the Spanish city of Zaragoza, the fifth largest city of Spain. It is approximately halfway between Madrid and Barcelona (about 330 km from each one). Geologically, it is located in the sedimentary basin of the Ebro River and surrounded by three mountain systems: Pyrenees, Iberian Mountain Range and Coastal-Catalan Mountain Range. The stratigraphy of the area consists mainly of a Tertiary rock substratum of marls and gypsum, strongly altered in its superficial levels, on which Quaternary materials are deposited of variable thickness and compactness. The gypsum presents a rather monotonous aspect, being constituted by white gypsum with nodular structure. Gray-greenish marls and shales appear associated with the gypsum materials or alternating with them [28,29]. Quaternary formations outcrop widely throughout the area, arranged in several terrace levels associated with the Ebro River, as well as different glacial deposits and colluviums [29].

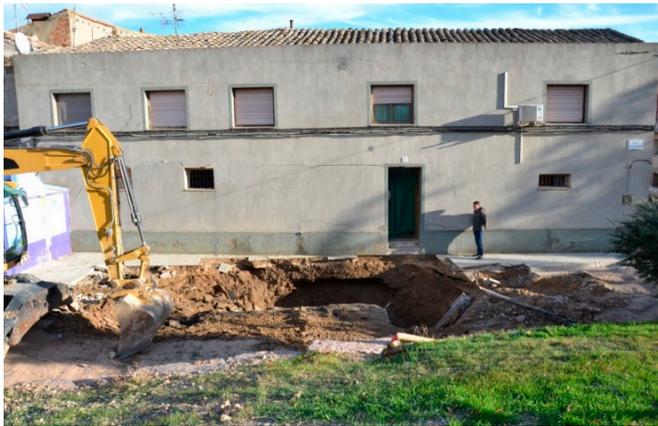
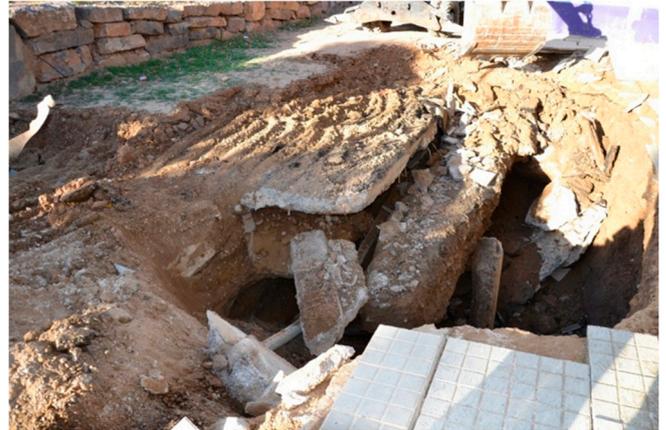
In April 2013, the area around the river's protective embankment showed soft spots on the sidewalks and pavements near some houses (Figure 2). Once those elements were removed, the existence of a large sinkhole of a surface between 35 and 40 m² and 4 m deep was confirmed. The sinkhole reached the water table and caused the foundations of the buildings to be cantilevered over the hollow. Affected building constructions were made of load-bearing walls and shallow strip foundations and showed some cracks in the main

façade forming unloading arches towards the ends. The foundations appeared cracked at their center, next to the point where the center of the collapse was located in the street.

Figure 2. Sinkhole appeared in 2013: (a) General view once the pavement was removed (note foundations cantilevered over the hole between 4 m and 5 m); (b) Detail view showing debris from the sidewalk and pavements of the street poured into the hole.

As an emergency measure and to avoid further structural deterioration, the sinkhole was backfilled with riprap blocks with a transition to gravel and pebbles at the top, trying to fill the gap below the overhang created in the foundations. Additionally, the foundations were underpinned using expansive polyurethane (PU) resins injected from the outside of the house. In the most affected façade, the number of injections was increased, also injecting them from inside the house. The walls of the adjoining buildings affected by the differential settlement were also reinforced using the same technique (PU resins).

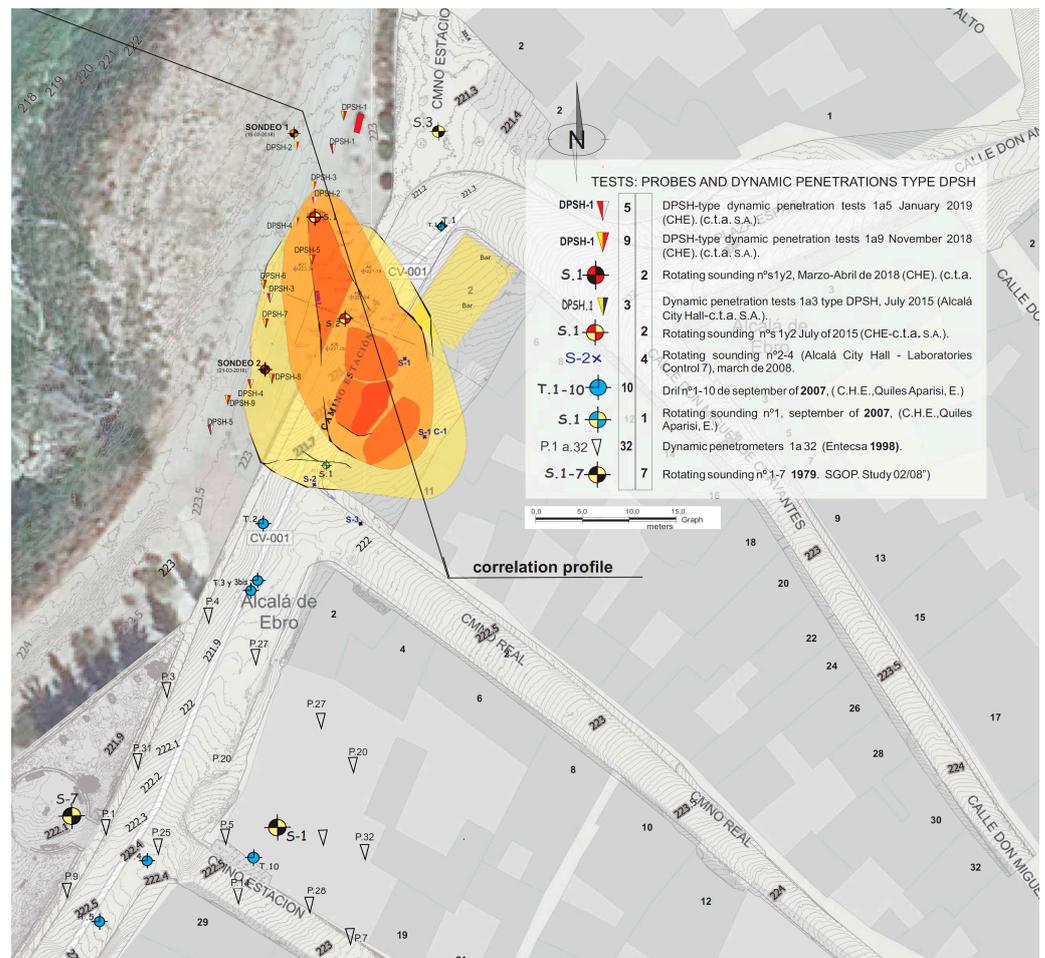
Figure 3. Location of the geotechnical investigation works carried out. The areas marked in red indicate sinkholes occurred in the last 15 years. The areas in orange and yellow indicate the contour zones affected by cracks in pavements and buildings, which also show evident signs of subsidence.

As subsidences are common in Alcalá de Ebro, some geological exploration works were performed by public services in the past [28,29], providing abundant information on the subsoil (Table 1). A complimentary geotechnical investigation (Figure 3) was carried out during the different works involved in this work, including a total of 19 Dynamic Penetration Super Heavy (DPSH) in situ tests and 4 boreholes reaching depths up to 30 m. Between those boreholes, cross-hole seismic tomography was performed. This geophysical technique estimates the value of P- and S-waves velocities of the ground, enabling identifying punctual anomalies, possible altered zones and contacts between the different geotechnical units of the ground.

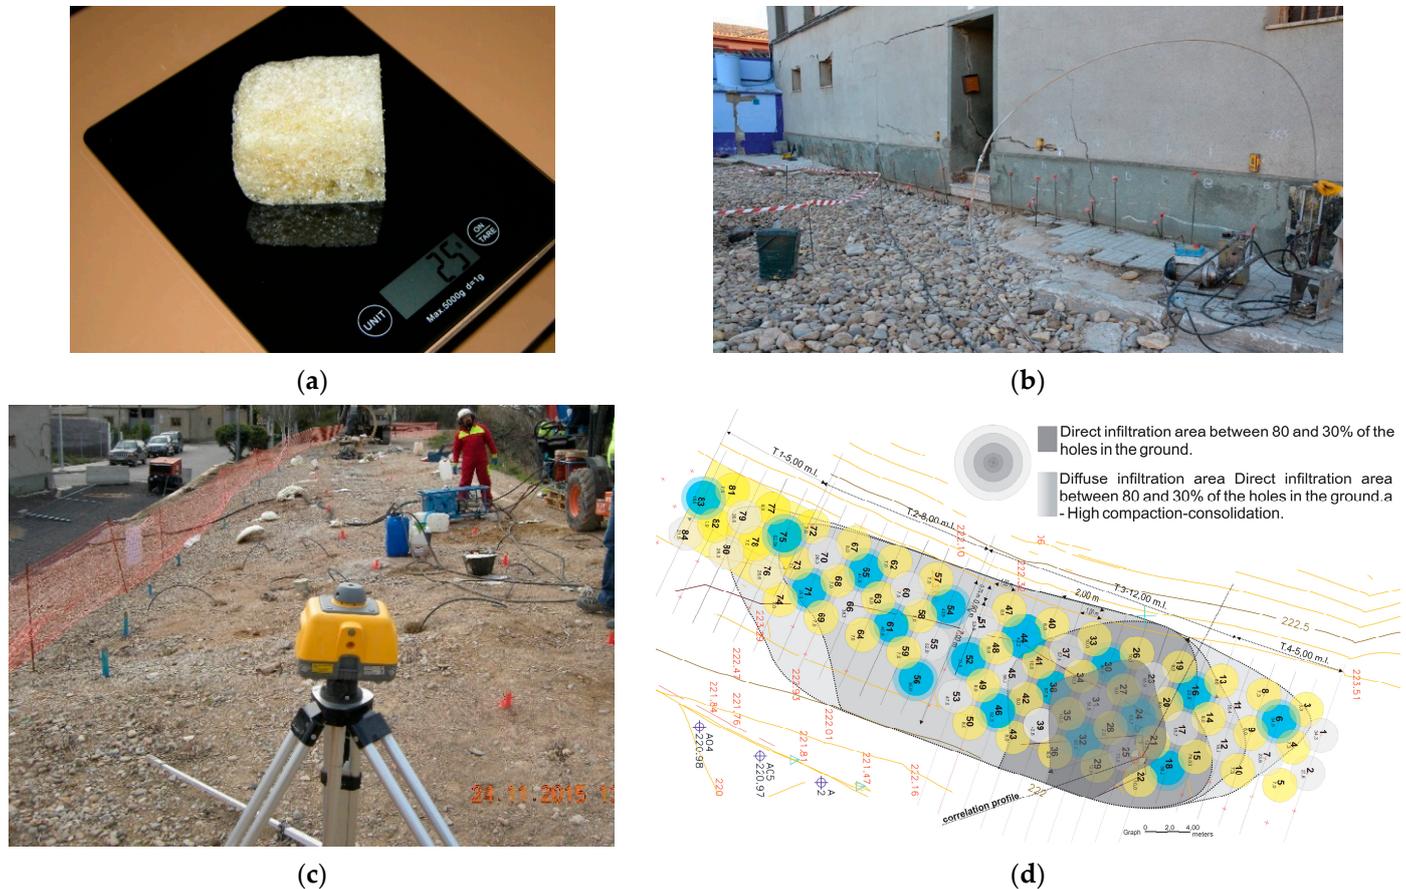
Figure 4. Expansive PU injections: (a) Resin sample (considering the weight/volume ratio, the expansion is more than 20 times the initial volume); (b) Façade of the building where resin injections were performed; (c) Injection works at the flood protection embankment; (d) Resin injections layout in the embankment (mesh 1 in yellow, mesh 2 in gray, mesh 3 in blue); this graph-summary has been made by superimposing all the corresponding data with the excess injection recorded. With this, a scheme is obtained in which the most sensitive area to subsidence-collapse processes is shown.

In November 2013 (Table 1), the subsidence problem was tried to be solved by injecting expansive polyurethane (PU) resins (Figure 4) under the buildings affected and below the street itself, on the closest side to the riverbank. Such injections bind the soil by infiltrating through the porosity of the material itself and the existing voids or fissures while exerting a consolidating/compacting effect in its expansion process (their volume increases between 10 and 30 times). This injected material expands and solidifies in a very short time (between 12 s and 15 s), so it normally is located less than 2 m below the injection point. PU resins help create a good support interface, even when foundations are degraded or cracked.

Additionally, two years later, in November 2015, expansive resin PU injections were performed in the body of the Ebro River flood protection embankment (Table 1). This action involved a total length of 30 m (Figure 4c,d) and was motivated due to the observance of

settlements at the embankment and the appearance of cracks at its surface. A length of 12 m was identified as the affected sinkhole area. Two lengths of 8 m and 5 m were defined at each side as a peripheral zone of influence, while an additional length of 5 m was defined towards the south as this area showed signs of apparent subsidence.

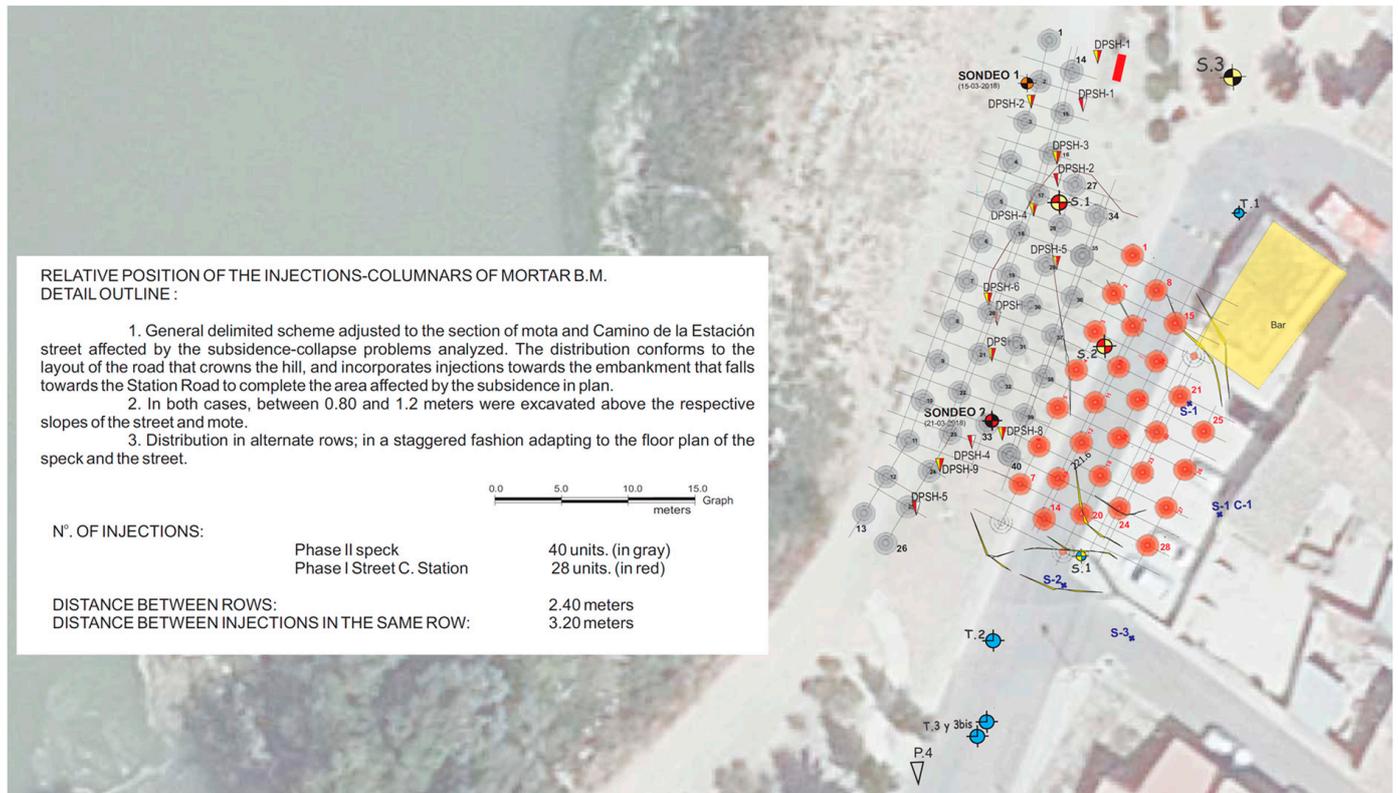
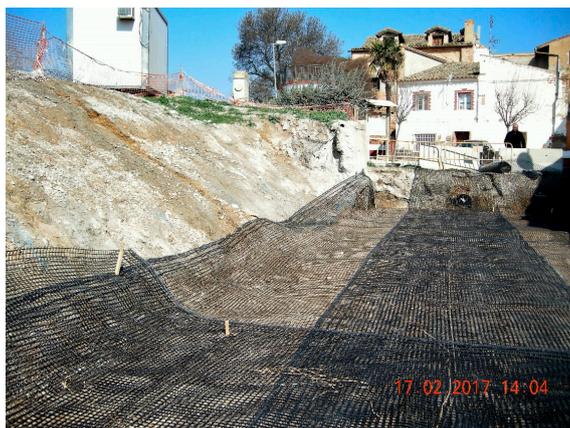
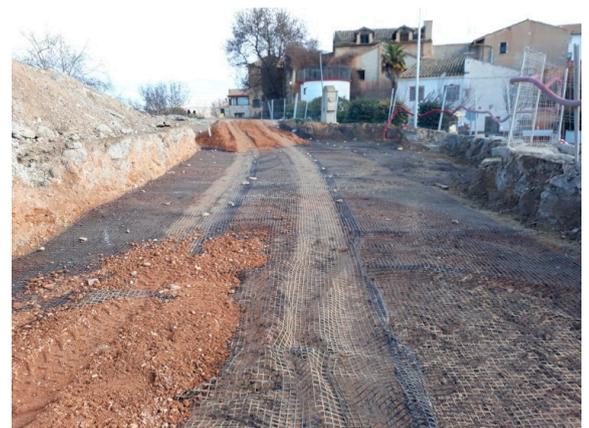
Figure 5. Low mobility mortar injections and high tensile strength geogrids execution: (a) Injections layout (in red, injections conducted in December 2016; in gray, injections conducted on November 2018); (b) Street area; (c) Embankment area.

In December 2016 (Table 1), a total of 28 mortar injections were used to solve the subsidence problems affecting the street between the embankment and the buildings affected (Figure 5a), where PU injections were previously performed. First, an excavation and sanitation of the street and the annexed area where ground collapses were conducted until reaching a depth of 1.5 m. Then, a series of mortar injections were performed in alternating rows (staggered rows). Mortar injections help in the compaction of the ground by displacement due to the high-pressure attained and generate firm support in the form of columnar structures. Injections were made of a low mobility mortar (8.1% cement, 79.8% sand 0/2, 11.9% fly ash and 0.2% additives, approximate water/mortar ratio of 16%) and

reached a depth between 18 and 21 m. Each drilling was found to penetrate between 2 and 3 m into the intact rock substratum. After executing the mortar injections, high tensile strength geogrids were placed on the base of the excavation to reinforce it and help in tying all the injections (Figure 5b). The street at its top was thereafter reconstructed, resting on the injected zone.

As the subsidence process could be reactivated due to variations in the position of the water table, the Ebro River flood protection embankment was subjected in November 2018 (Table 1) to a ground treatment similar to the one applied a year before at the street. An excavation of around 1.5 m was done at the embankment, and a total of 40 mortar injections (same characteristics as the previous ones) were performed in the body of the

Ebro River flood protection embankment (Figure 5a). Those injections reached 24 m (where drilling resistance was high), and their elevation was 1 m above the surface of the street. Similar to the previous mortar injections, each drilling was found to penetrate between 2 and 3 m into the intact rock substratum. Once the injections were finished, high-tensile strength geogrids were installed at the level where the injections were performed, and the embankment was reconstructed (Figure 5c).

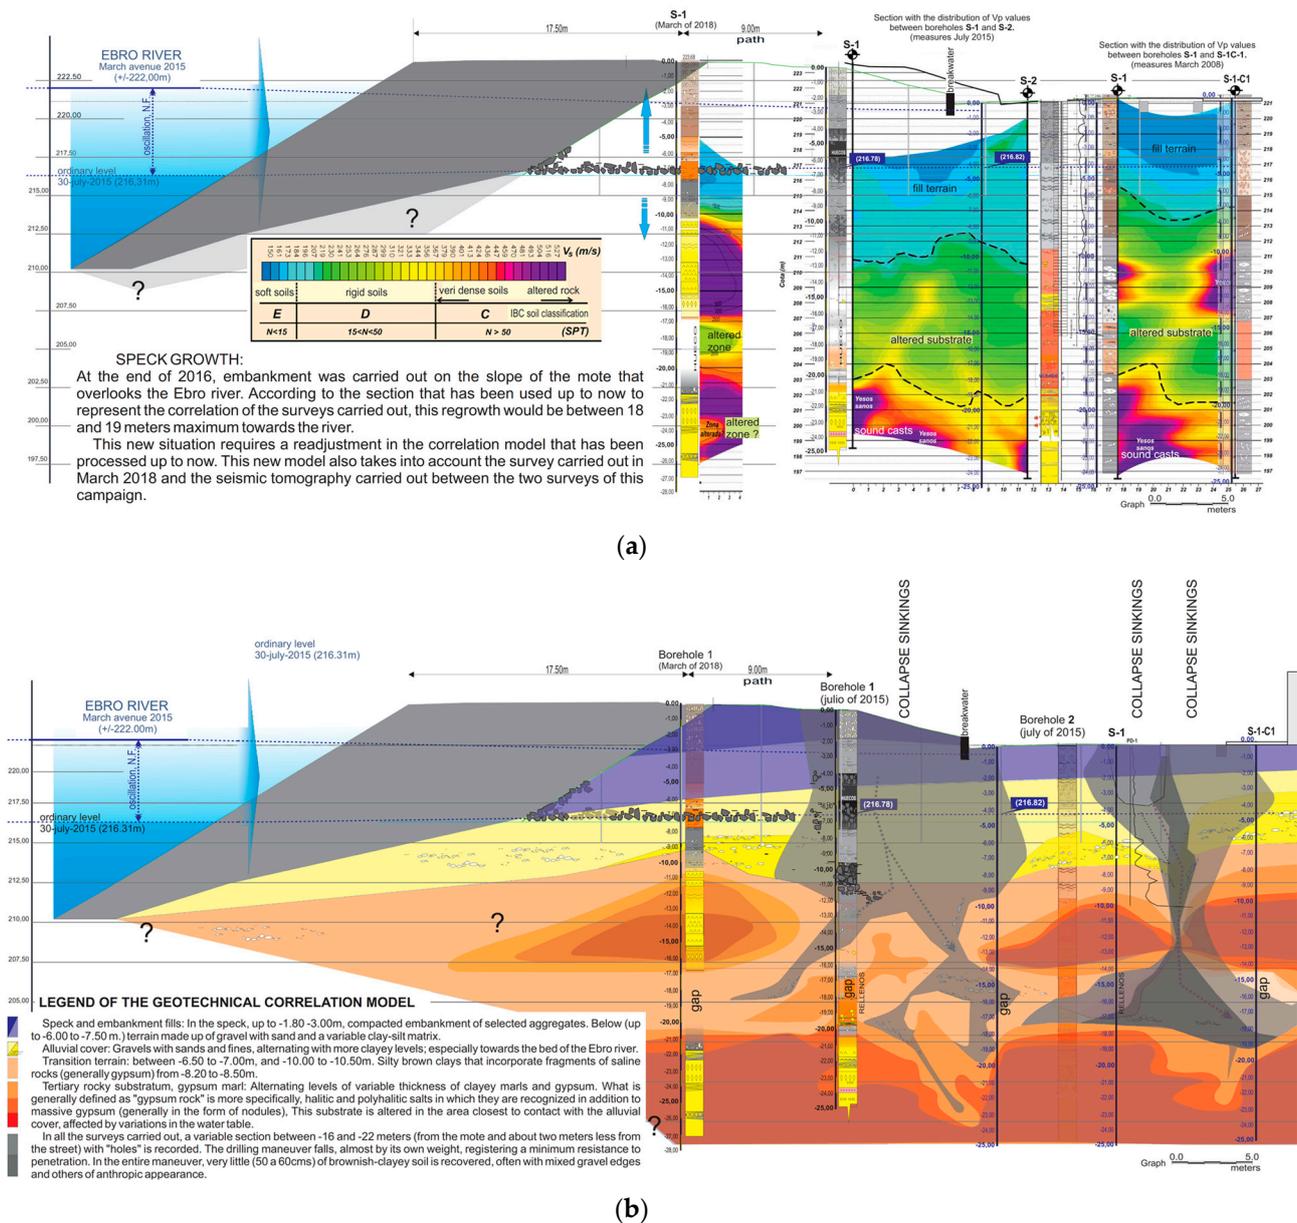
Figure 6. Geotechnical investigation results with geological interpretation: (a) Correlation between boreholes S-1 and S1-C1 (March 2008), S-1 and S2 (July 2015) and S-1 and S-2 (March 2018), including the seismic tomography between them and the DPSH tests performed; (b) Proposed geotechnical profile following section A-A' (see Figure 3).

The second model considered the ground following the geotechnical profile obtained in this work (see Figure 6 and Table 2 for their corresponding properties). The level found between a depth of 16 m and 21 m (from the embankment) was considered the location of the alteration and dissolution of the marl–gypsum rocky substrate, so one cavity of 5.3 m in diameter was located at various positions.

From the results of the boreholes, in situ test and cross-hole seismic tomography tests conducted, the stratigraphy of the area under study (Figure 6) may be divided into four main units: (i) the filling of the embankment, which consists of gravels with sands and a variable brown silty clay matrix, although up to a depth between 1.8 m and 3.0 m compacted gravels prevail; (ii) alluvial cover, composed of gravels with sands and fines, alternating with brown silts and clays, often with traces of organic matter, towards the Ebro River, and with a chaotic appearance due to being affected by the karstic processes; (iii) a transition ground, consisting of brown silty clays that incorporate fragments of evaporitic rocks (generally gypsum) and (iv) tertiary rock substratum. Deep boreholes indicate that this substratum can be divided into four lithostratigraphic units, in ascending order [30–32]:

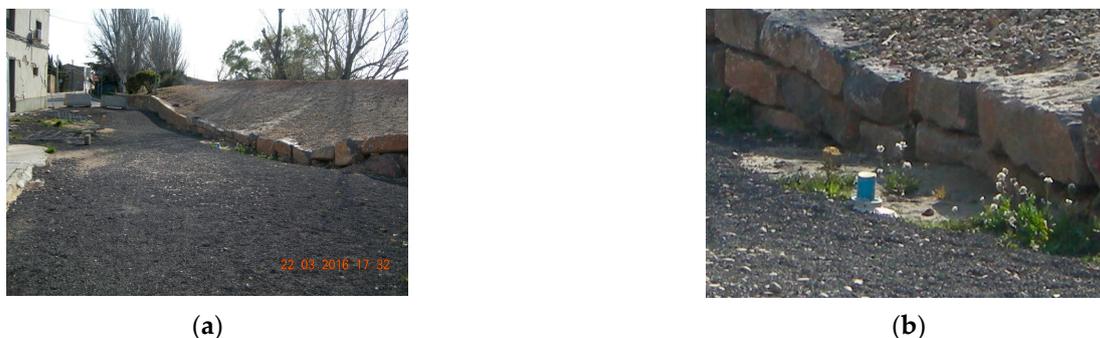
Figure 7. Settlement observed in the street after performing the PU resin injection treatment: (a) general view; (b) piezometric pipe (corresponding to borehole #2) used as a reference point; this borehole had a depth of 25 m and the pipe rested on firm ground. Note how the relative descent of the surrounding ground causes the pipe to protrude from the ground.

Injection of expansive resins under the buildings affected, performed in 2013, showed that the procedure was quite effective, recording minimal settlement and movements according to the topographic control. However, the injected area in the street was not enough. Relative subsidence in the center of the area affected by a sinkhole of about 12 to 15 cm was observed (Figure 7). This is explained by the depth of the injection in the street area, of only 4 m. Considering the extent of the apparently sunken area (more than 20 m) and the depth of the area affected by dissolution processes (between 14 and 20 m), this depth was clearly inadequate.

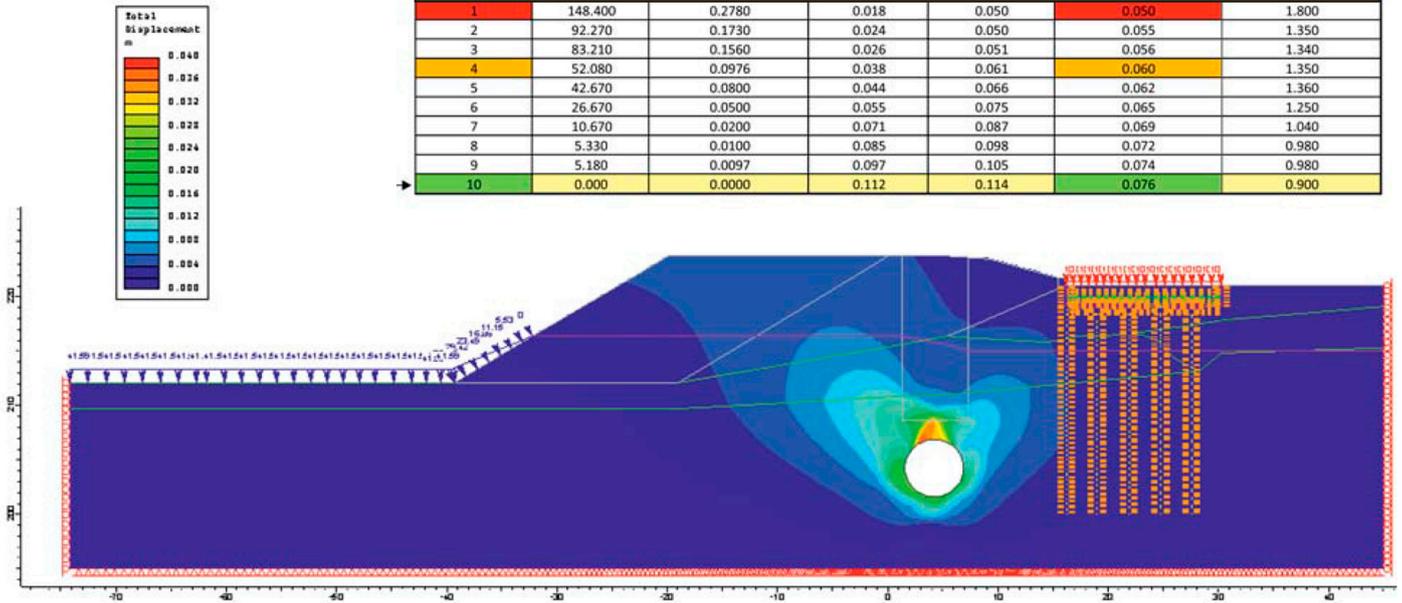
Figure 8. Final phase of the analysis with a homogenous substratum and a fixed position of the cavity in the model.

Two models were built. The first model considered the ground as a homogeneous marl-gypsum rocky substrate, defined by the Mohr–Coulomb behavior (properties are found in Table 2). A circular cavity of 5.3 m in diameter was introduced below the embankment simulating the possibility of the development of a sinkhole in that area, with an overburden thickness equal to 16 m (both the diameter of the cavity and the overburden thickness were based on the results obtained from the geotechnical investigation).

As can be observed, in the first model (Figure 8), the existence of the cavity means a maximum displacement at the surface of about 0.076 m, while this value was nearly 0.115 m at the cavity crest. In the second model, where the ground was considered according to the geotechnical profile seen in Section 3.1 (Figure 6), the most unfavorable position of the cavity was found to be below the embankment. In this model, for the strength properties without any reduction, maximum displacement at the surface was found at around 50 mm, this value being nearly 18 mm at the cavity crest, while the safety factor was 1.2. When the strength reduction factor technique was applied to the model, progressively reducing the strength properties of the geological materials, a minimum safety factor of 1.05 was obtained (Figure 9). Maximum displacement at the surface was around 76 mm, this value being nearly 112 mm at the cavity crest. As the safety factor was greater than 1.0, the cavity was stable against collapse, meaning that the mortar injections and geogrids treatment applied were capable of successfully controlling the sinkhole phenomenon.

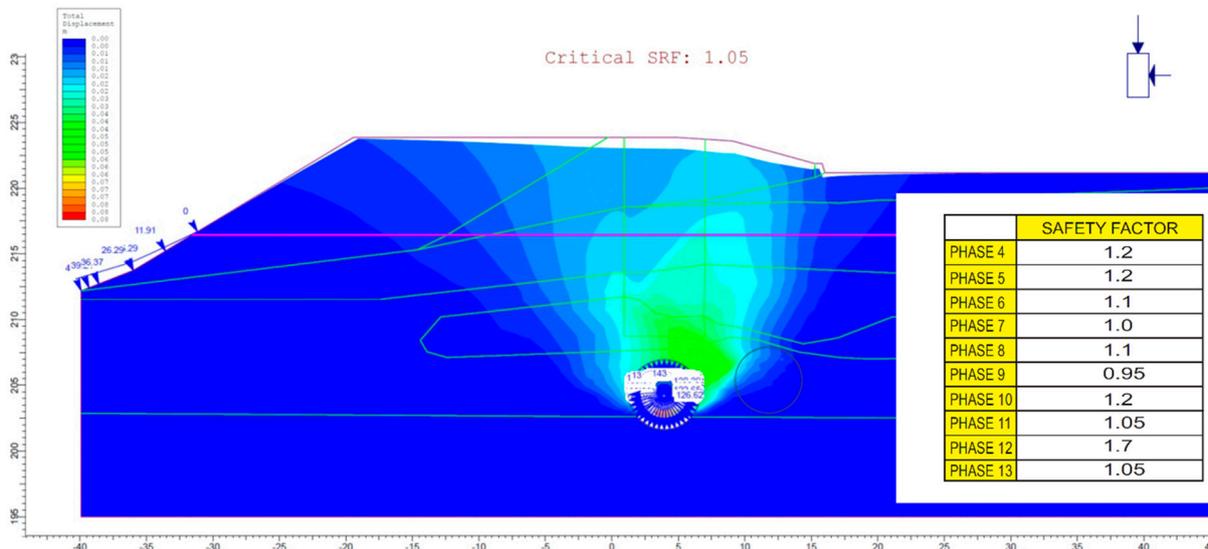
Figure 9. Final phase of the analysis with a non-homogenous substratum according to the geotechnical model and the most unfavorable position of a potential cavity.
