Article

# Effect of Harsh Conditions on the Tensile Behaviour of Lap-Spliced Carbon Fiber Textile-Reinforced Mortar (TRM) with Different Surface Treatment Methods

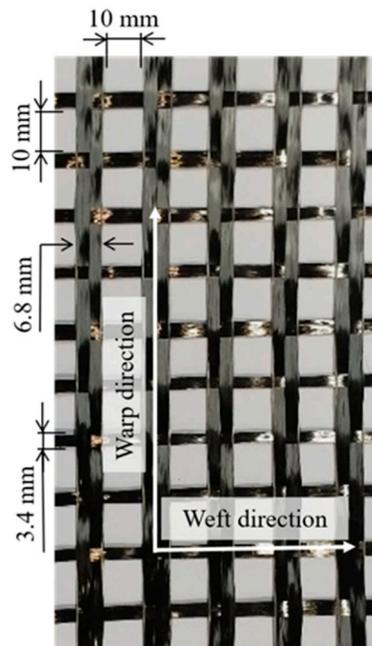
Figure 1. Geometrical properties of the carbon fiber mesh used as textile reinforcement.

In this study, the textile-reinforced mortar (TRM) composite materials were composed of alumina cement-based mortar reinforced with carbon fiber textile. Figure 1 shows the geometrical characteristics of the carbon fiber textile utilized in this experiment as a textile reinforcement. According to the manufacturer, each warp yarn of the carbon fiber textile had an approximate width of 6.8 mm and an approximate thickness of 0.35 mm and was composed of 12,000 carbon filaments with filament diameters of 7  $\mu\text{m}$  (Toray T700-12k). In addition, the carbon fiber textile had an average tensile strength and elastic modulus of 4300 MPa and 240 GPa, respectively.

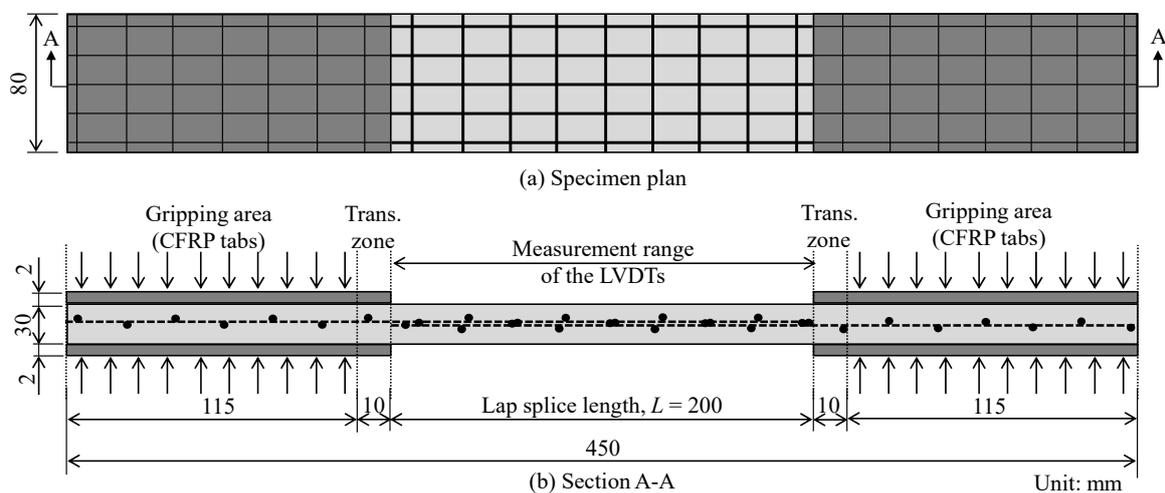
Figure 2. Configurations and details of the test coupons.

The details of the TRM coupons fabricated in the laboratory are presented in Figure 2 and Table 1. All TRM coupons were a rectangular prism with dimensions 450 mm × 80 mm × 30 mm. The total length of the TRM coupons was 450 mm, including two clamping regions, each of length 115 mm, two transition zones of length 10 mm, and the central zone with a length of 200 mm.

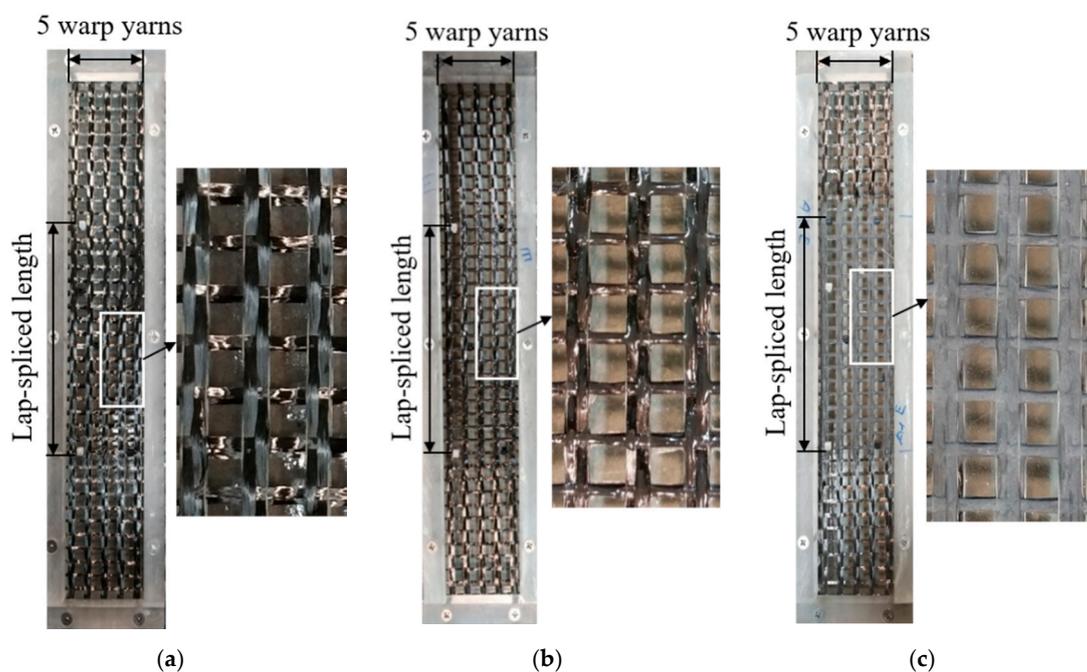
**Figure 3.** Photos of carbon fiber mesh with different coating treatments: (a) carbon fiber mesh (without surface treatment); (b) carbon fiber mesh impregnated by epoxy; (c) carbon fiber mesh coated with aluminum oxide powder after epoxy impregnation.

Two different surface treatment methods at the lap-spliced region of carbon fiber textile were used and tested: carbon fiber textile impregnated by epoxy (Figures 3b and 4b), and carbon fiber textile covered with aluminum oxide ( $\text{Al}_2\text{O}_3$ ) powder after epoxy impregnation (Figures 3c and 4c). The purpose of the surface treatment was to avoid slippage at the lap-spliced region of the carbon fiber textile. Furthermore, the surface treatment using epoxy was able to completely penetrate between the carbon filaments that constitute carbon fiber yarns, which enhanced the mechanical bond strength at the fabric–mortar interface and affected the tensile behavior of the TRM composite in harsh conditions.

For the first surface treatment method (Figures 3b and 4b), approximately 60 g of epoxy resin was used to fully impregnate the carbon fiber filaments within the lap-spliced region of the textile reinforcement. For the second surface treatment method (Figures 3c and 4b), at the lap-spliced region of the textile reinforcement, the carbon fiber filaments were also completely impregnated with epoxy resin (60 g). Then, the carbon fiber textile was covered with aluminum oxide ( $\text{Al}_2\text{O}_3$ ) powder with a diameter of 250  $\mu\text{m}$  by using a high speed-spraying gun one day after epoxy impregnation [37,38]. The surface treatments were performed on both sides of the carbon fiber textile to ensure uniformity. The surface treatment methods were applied according to Truong et al. [39].

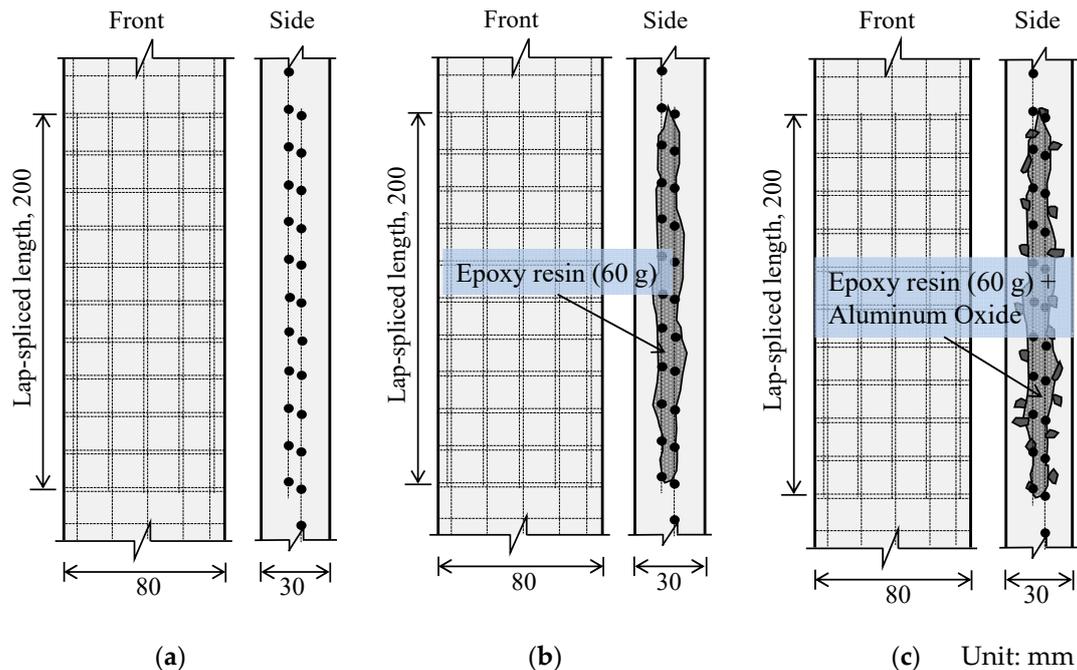
**Figure 4.** Illustrative details in the lap-spliced zone: (a) lap-spliced zone without surface treatment; (b) lap-spliced zone impregnated by epoxy; (c) lap-spliced zone coated with aluminum oxide after epoxy impregnation.

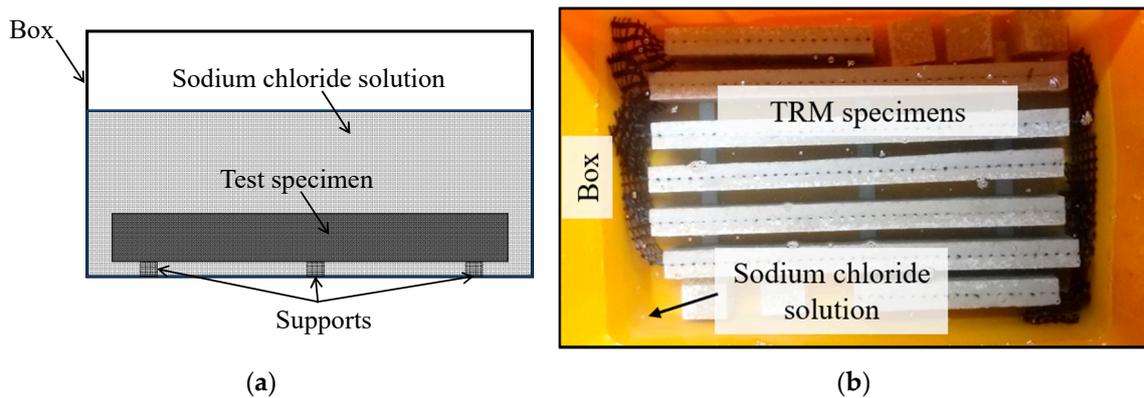
**Figure 5.** Test setup of TRM coupons subjected to the chloride environment: (a) scheme of the test setup of TRM coupons subjected to the chloride environment; (b) photo of test setup.

For the first test series, the TRM coupons were demolded one day after casting, and then cured for 27 more days in the laboratory condition ( $11 \pm 2$  °C and 45% relative humidity), before being subjected to the chloride environment. Considering the ocean's seawater average salinity [40], a 3.5 wt.% sodium chloride (NaCl) distilled water solution was used (Figure 5). The TRM coupons were cured for 60 days in such chemical conditions. The TRM coupons were taken out of the sodium chloride solution three days prior to the direct tensile test.

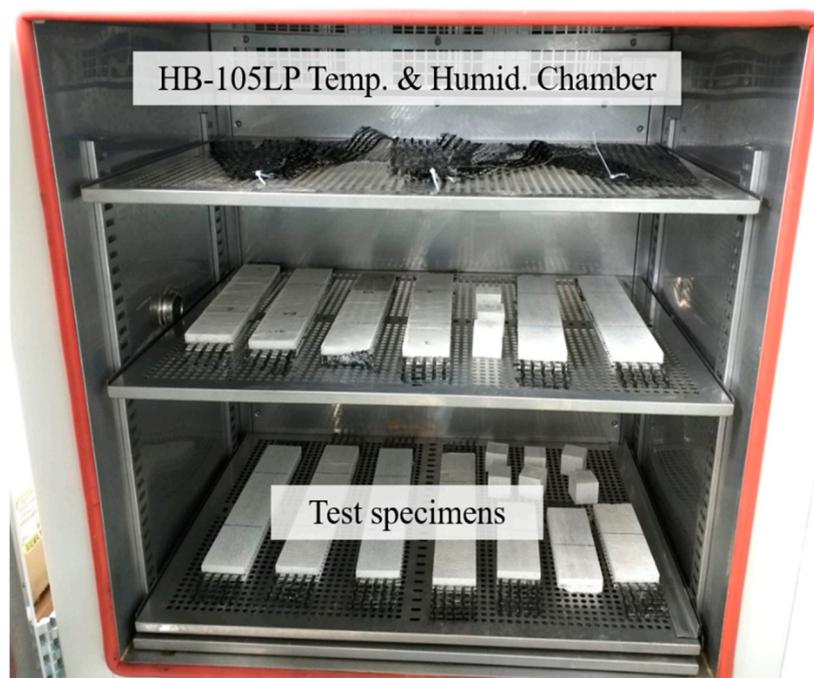
**Figure 6.** Photo of the test setup of TRM coupons subjected to the high temperature and humidity environment.

For the second test series, the TRM coupons were prepared in a similar manner to the first test series. However, to create a high temperature and humidity environment, the TRM coupons were stored at a constant temperature of 50 °C and relative humidity of 95% in a chamber for 60 days (Figure 6). The TRM coupons were then taken out of the chamber two days prior to the fixing of the CFRP tabs onto the ends of the TRM coupons. Then, the direct tensile test was performed one day later.

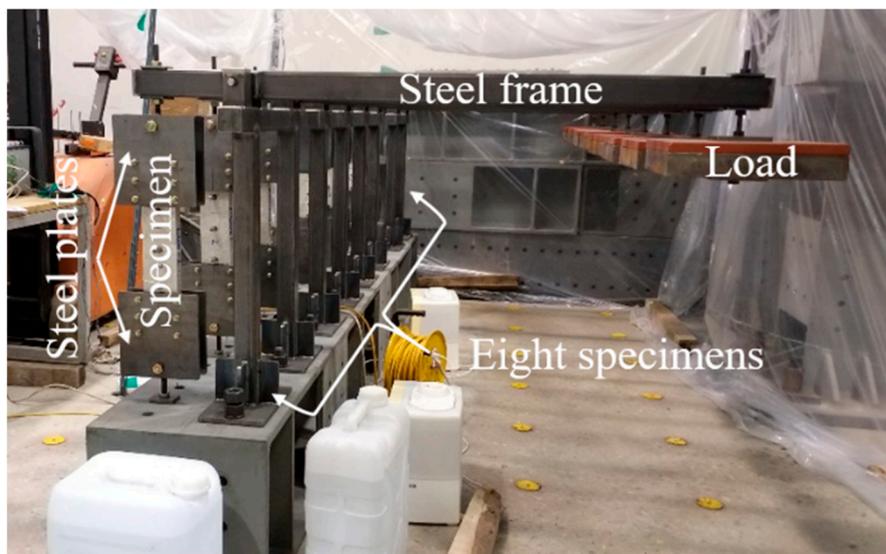
**Figure 7.** Photo of the test setup of TRM coupons subjected to sustained load.

For the last test series, the TRM coupons were demolded one day after casting, and then adhered by CFRP tabs onto the ends. Next, the TRM coupons were cured for six more days in laboratory conditions, before being subjected to a sustained load (2.5 kN), as shown in Figure 7. The sustained load corresponded to 30% of the tensile strength at the seven-day aging. The last series was performed in the laboratory with the same conditions as those of the first two series. The TRM coupons were subjected to a sustained load for 60 days, and then the direct tensile test was performed.

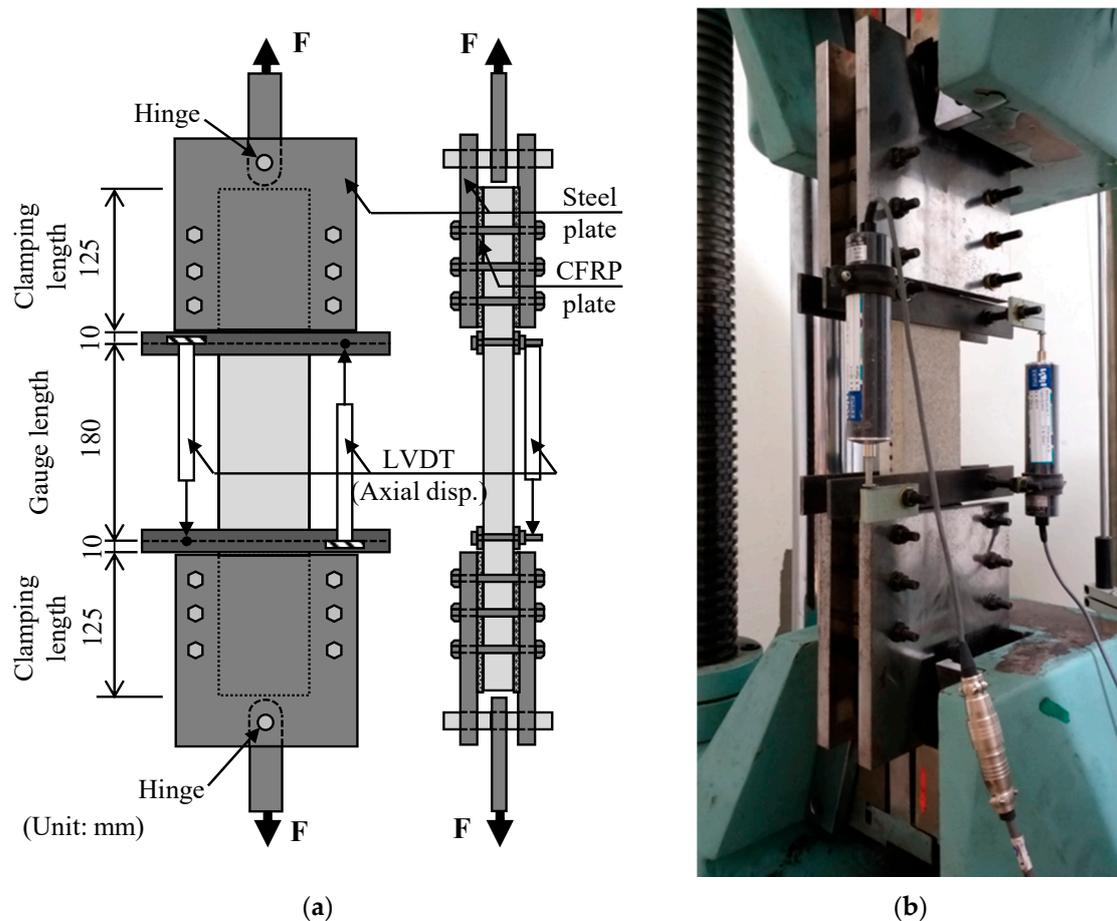
**Figure 8.** Test setup and measuring instruments: (a) schematic of the test setup; (b) photograph of the test setup.

Figure 8 shows the experimental setup of the direct tensile test for the TRM coupons. The steel plates were utilized to clamp the gripping regions of the TRM coupons and fixed by steel bolts. The clamping force induced during fixing the steel plates may have caused a high compressive force to be acting on the gripping area of the TRM coupons. Therefore, to avoid any damage within the clamping areas, and to ensure an effective force transfer from the universal testing machine, carbon fiber reinforced polymer (CFRP) tabs with a thickness of 2 mm were utilized to strengthen the gripping regions of the TRM coupons (Figure 8a). The slippage phenomenon may have occurred at the interface between the CFRP tabs and the steel plates. Hence, the surface of the steel plates was roughened to increase the friction between them. Furthermore, the non-alignment of the TRM coupons and the steel plates may have triggered a bending moment during the tensile test. Thus, a steel bar which could rotate freely around a hinge (Figure 8a) was used to connect the TRM coupons with a testing machine. This clamping method was also used in the studies of Truong et al. [39] and Kim et al. [41]. To perform the tensile tests, a universal testing machine (UTM) with a loading capacity of 1000 kN was utilized. The tensile test was performed according to ASTM D3039, with the applied load under displacement control at 0.5 mm/min [42].

To measure the tensile deformation, two linear variable displacement transformers (LVDT) were fixed at both sides along the longitudinal direction of the TRM coupons by means of the steel frames. Thus, the tensile strain of the TRM coupons was calculated as the average values obtained from LVDTs divided by the length of the central zone (180 mm).

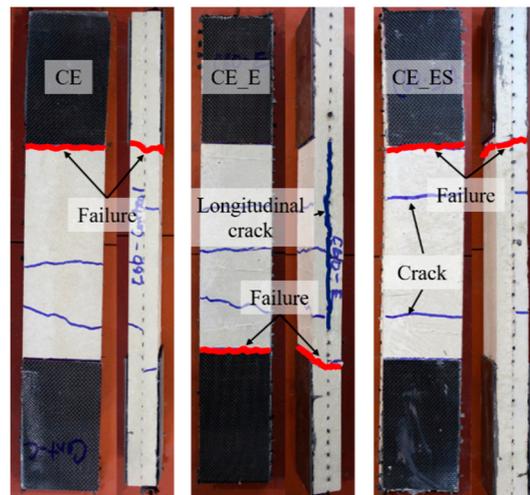
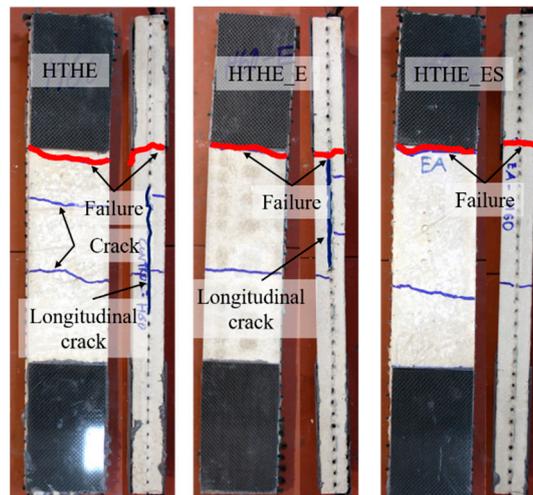
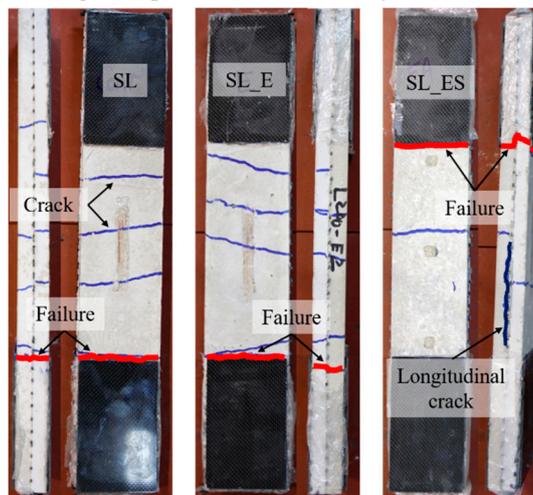
Figure 9. Failure modes of TRM test coupons.

(a) Failure modes of TRM coupons subjected to the chloride environment

(b) Failure modes of TRM coupons subjected to the high temperature and humidity environment

(c) Failure modes of TRM coupons subjected to sustained load

Figures 9 and 10 show the typical crack patterns and failure modes observed for each series in this study. The results observed from all the TRM coupons exhibit the same failure mode, corresponding to the failure at the transition zone, as described in Figure 10. Meanwhile, the phenomena of the carbon fibers rupture and the carbon fibers slippage were not observed. During the tensile test, cracks appeared at the middle part of the TRM coupons (at the lap-spliced carbon fiber textile zone). Then, more cracks appeared near the transition zone, and continued to widen, until failure. According to Leone et al. [43], this failure mode occurs due to the fact that the compressive action of the clamping force and the applied tensile load occurred simultaneously in the gripping zone. This failure mode is desirable because it indicates the lap-spliced region is strong enough.

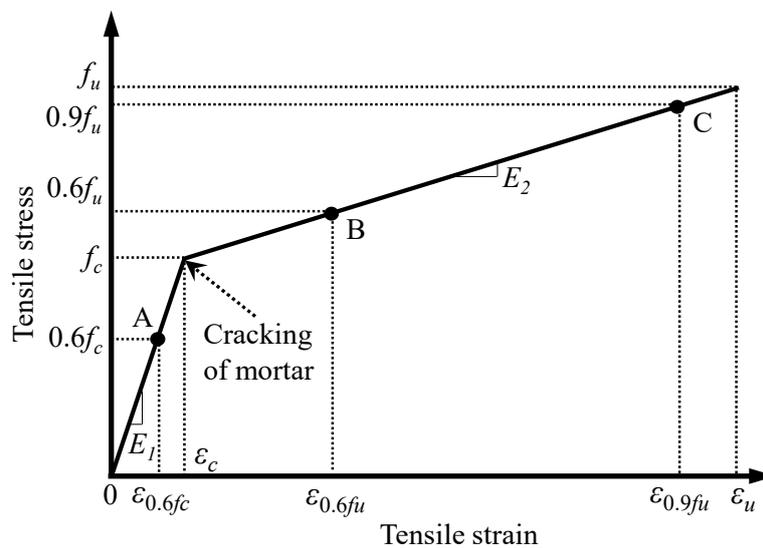
Figure 11. Idealized stress–strain curve of the TRM coupons [33].

The tensile test results of TRM coupons were analyzed based on ACI 549.4R-13 [33]. The idealized stress–strain curve includes the initial segment as the uncracked stage, and the second segment as the cracked stage, which is distinguished by the significant stiffness change (transition point), as shown in Figure 11. The initial linear segment of the curve corresponds to the TRM uncracked linear behavior, and it is presented by the cracking tensile strength ( $f_c$ ), cracking tensile strain ( $\epsilon_c$ ), and tensile modulus ( $E_1$ ) of elasticity of the uncracked coupons. In the first stage, the elastic modulus is governed by the mechanical characteristics of the mortar and carbon fiber textile based on the perfect bond at the interfaces. The second linear segment, which corresponds to the TRM cracked linear behavior, is presented by the ultimate tensile strength ( $f_u$ ), ultimate tensile strain ( $\epsilon_u$ ), and tensile modulus ( $E_2$ ) of elasticity of the uncracked coupons.

where  $\Delta\sigma$  is the difference in tensile stress at the point where 60% of the cracking strength (MPa) is applied and  $\Delta\epsilon$  is the corresponding difference in tensile strain (see point A in Figure 11).

where  $\epsilon_{0.9f_u}$  and  $\epsilon_{0.6f_u}$  are the strains at a tensile stress level, equal to  $0.9f_u$  and  $0.6f_u$ , respectively (see points B and C in Figure 11). This is due to the fact that the mechanical characteristics of carbon fiber mesh mainly govern the elastic modulus in the second stage.

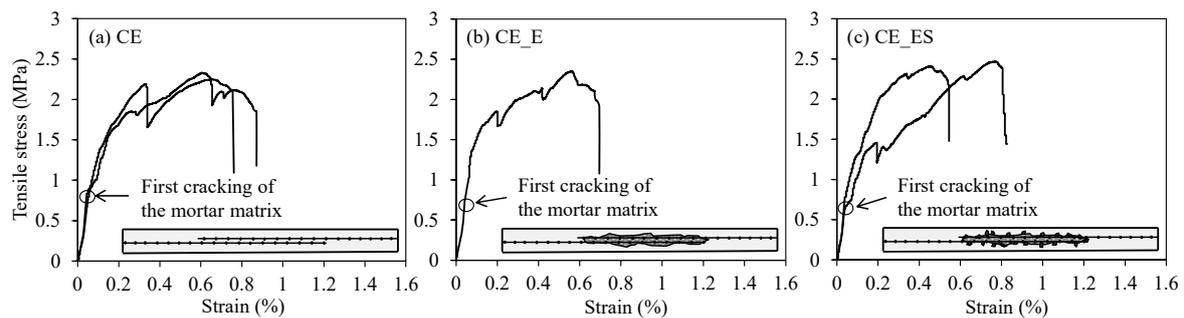
**Figure 12.** Tensile stress–strain relationship of TRM coupons with different surface treatments in the chloride environment: (a) coupons without surface treatment; (b) coupons impregnated by epoxy; (c) coupons coated with aluminum oxide powder after epoxy impregnation.

Figure 12 shows the stress–strain relationship of the first test series with different surface treatment methods in the chloride environment. In the uncracked stage, the stress–strain relationship of the TRM coupons showed a linear elastic curve with a high slope by the combined working of both the mortar matrix and carbon fiber textile. After that, at around 0.75 MPa of tensile stress, the first cracks appeared in the middle of the TRM coupons, then more cracks appeared near the transition zone, and these cracks continued to widen, until failure (Figure 9a). Figure 13 compares the average values of initial stiffness, ultimate strain, cracking tensile strength, and peak tensile strength between TRM coupons with different surface treatments. There was no significant difference in most of the tensile behavioral characteristics, regardless of the surface treatment (Figure 13a and Table 2). However, the ultimate strains of the surface-treated TRM coupons decreased, in particular, the CE\_E coupons showed a decrease of 13.09% compared to that of the CE coupons. The chloride environment might negatively affect the interfacial bonding once the chloride solution penetrates the interface made of epoxy and coating with aluminum oxide powder. The CE\_E coupons showed longitudinal cracks that appeared during the tensile test (Figure 9a), during which cracking is expected to be related to bond deterioration.

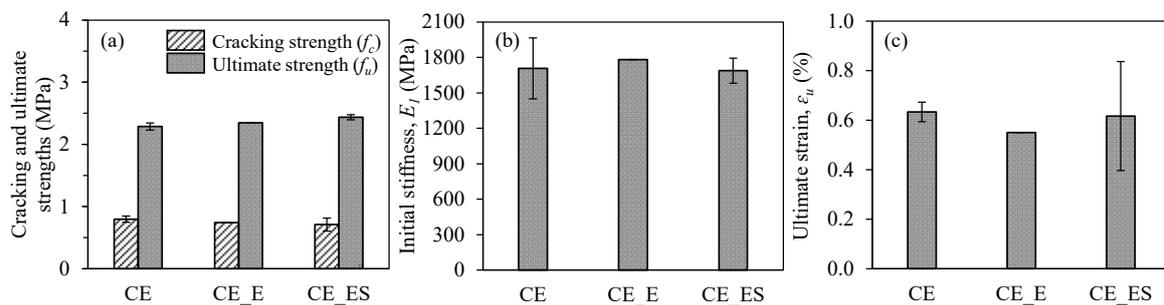
**Figure 13.** Effects of different surface treatments on the tensile behavior of TRM coupons in the chloride environment: (a) cracking and ultimate strength; (b) initial stiffness; (c) ultimate strain.

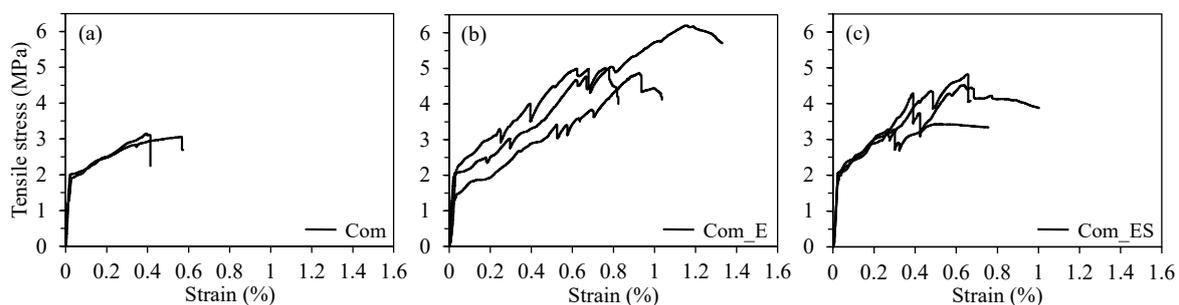
**Figure 14.** Tensile stress–strain relationship of TRM coupons under sound conditions: (a) coupons without surface treatment; (b) coupons impregnated by epoxy; (c) coupons coated with aluminum oxide powder after epoxy impregnation.

Note that those CE coupons slightly differ from the Com coupons in the carbon fiber amount and details, but the main difference is the chloride environment. When comparing three previous TRM coupons (Com series), they showed a significant change in strength and deformability (Figure 14). However, in the coupons of the CE series subjected to chloride environment, such a difference was not observed (Figure 12). This indicates that the improvement of bond behavior by means of surface treatment in the Com series almost disappeared in the CE series, because of the chloride environment.

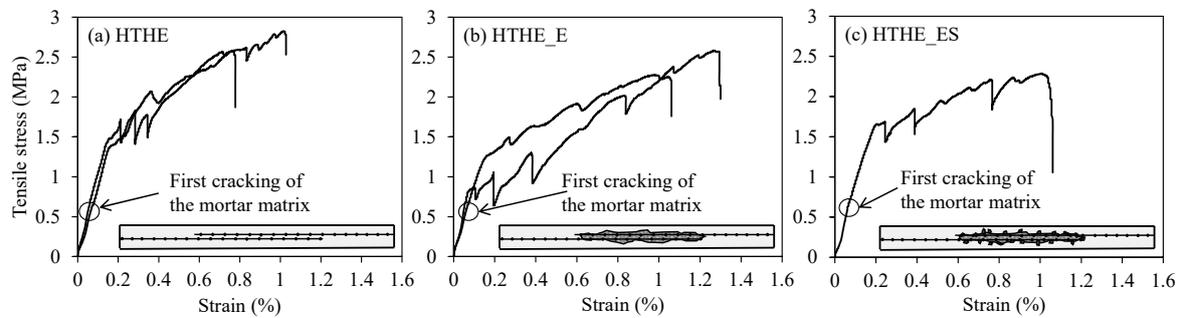
**Figure 15.** Tensile stress–strain relationship of TRM coupons with different surface treatments in the high temperature and humidity environment: (a) coupons without surface treatment; (b) coupons impregnated by epoxy; (c) coupons coated with aluminum oxide powder after epoxy impregnation.

Figure 15 shows the stress–strain relationship of the TRM coupons with different surface treatment methods in the high temperature and humidity environment. In the uncracked stage, the TRM coupons in this series showed almost the same initial stiffness values (Figure 16a and Table 2). The crack pattern and failure mode in this series were the same as in the first series (Figure 9b). In addition, Figure 16 shows the average values of ultimate strain, cracking tensile strength, and ultimate tensile strength of TRM coupons. As presented in Figure 16a, the cracking tensile strengths were almost the same, but the ultimate tensile strengths of the HTHE\_E and HTHE\_ES coupons showed a slight decrease of 10.09%

and 12.53% compared to that of coupons HTHE, respectively. In contrast, the ultimate strain of the HTHE\_E and HTHE\_ES coupons showed increases of 25.50% and 12.53%, respectively, compared to that of coupons HTHE. The results show that the high temperature and humidity environment affected the bond strength and deformability at the fabric–mortar interface. During the tensile test, longitudinal cracking at the side of the test coupons HTHE and HTHE\_E was also observed (Figure 9b).

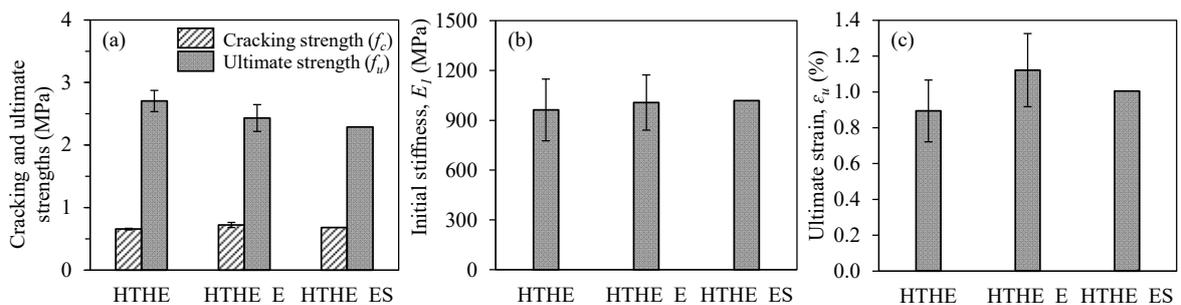
**Figure 16.** Effect of different surface treatments on the tensile behavior of TRM coupons in the high temperature and humidity environment: (a) cracking and ultimate strength; (b) initial stiffness; (c) ultimate strain.

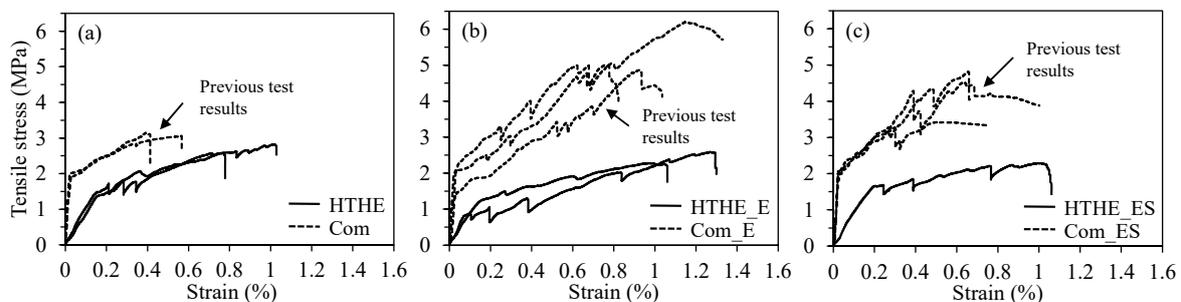
**Figure 17.** Tensile stress–strain relationship of TRM coupons subjected to the high temperature and humidity environment: (a) coupons without surface treatment; (b) coupons impregnated by epoxy; (c) coupons coated with aluminum oxide powder after epoxy impregnation.

Figure 17 shows the tensile stress–strain relationship of TRM coupons subjected to the high temperature and humidity environment. Figure 17 shows that the HTHE coupons subjected to the high temperature and humidity environment revealed a significant reduction in stiffness, but a slight reduction in strength, and a slight increase in strain compared to that of the Com coupons. In addition, in the Com series, the positive effect of the surface treatment on the tensile behavior was significant, while that in the HTHE series was not significant.

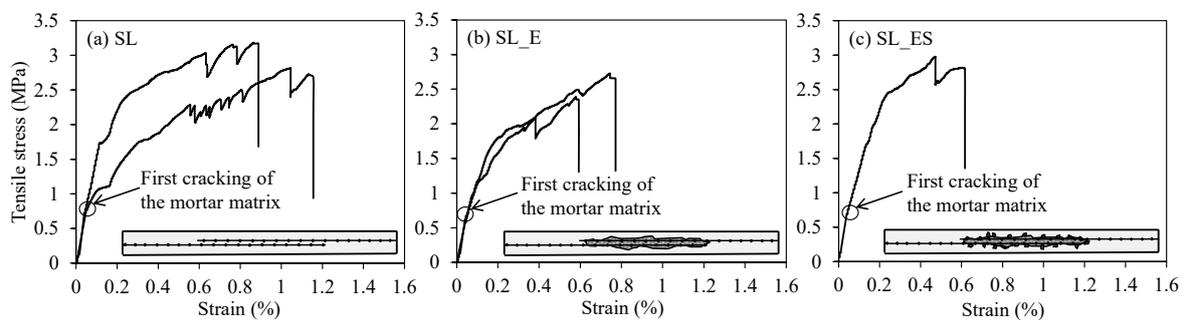
**Figure 18.** Tensile stress–strain relationship of TRM coupons with different surface treatments subjected to sustained load: (a) coupons without surface treatment; (b) coupons impregnated by epoxy; (c) coupons coated with aluminum oxide powder after epoxy impregnation.

Figure 18 shows the stress–strain relationship of the TRM coupons with different surface treatment methods subjected to sustained load. Similar to the first two test series, the average cracking tensile strengths and the initial stiffness in this series were almost the same (Figure 19 and Table 2). Figure 19b clearly shows the effect of sustained load on the ultimate strain of TRM coupons with the different surface treatment methods. The ultimate strain of the SL\_E and SL\_ES coupons decreased by 30.78% and 50.59%, respectively, compared to that of the SL coupons. Meanwhile, the ultimate tensile strength in this series showed a fluctuation.

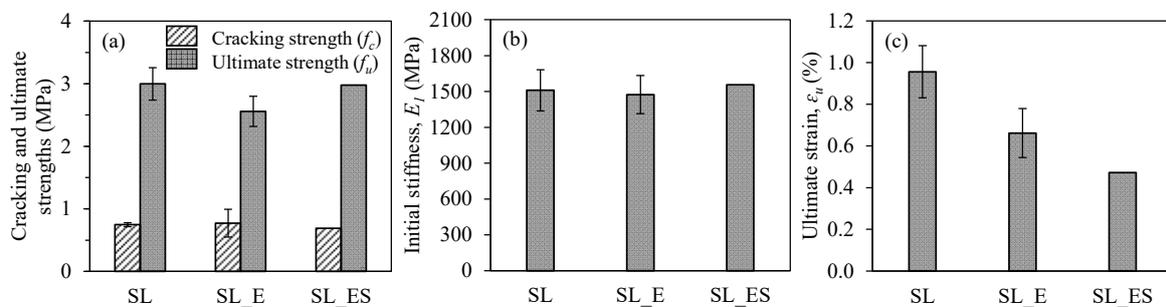
**Figure 19.** Effect of different surface treatments on the tensile behavior of TRM coupons subjected to sustained load: (a) cracking and ultimate strength; (b) initial stiffness; (c) ultimate strain.

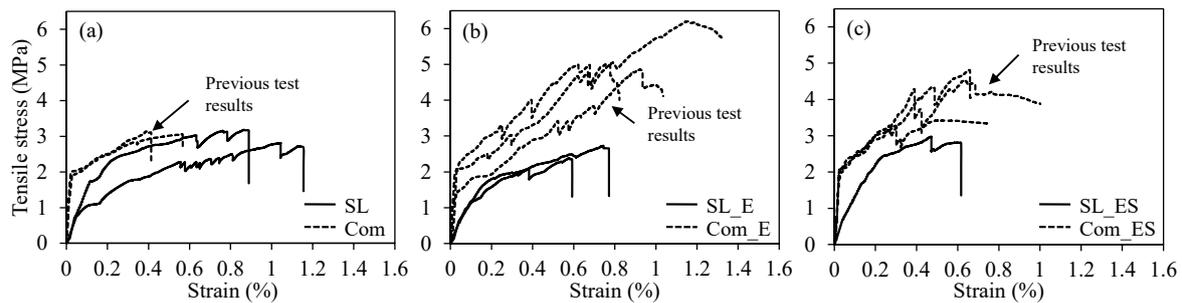
**Figure 20.** Tensile stress–strain relationship of TRM coupons subjected to sustained load: (a) coupons without surface treatment; (b) coupons impregnated by epoxy; (c) coupons coated with aluminum oxide powder after epoxy impregnation.

Figure 20 shows the comparison between TRM coupons with and without sustained load. The SL and Com coupons without surface treatment showed almost equal strength, but 95% deformability difference (Figure 20a). In the three previous test coupons of the Com series, the tensile strength showed a significant difference according to the surface treatment method. However, in the coupons of the SL series under sustained load, such a difference was not observed. This indicates that the improvement of tensile behavior due to surface treatment decreased because of the sustained load.
