Article

Failure Analysis on a Collapsed Flat Cover of an Adjustable Ballast Tank Used in Deep-Sea Submersibles

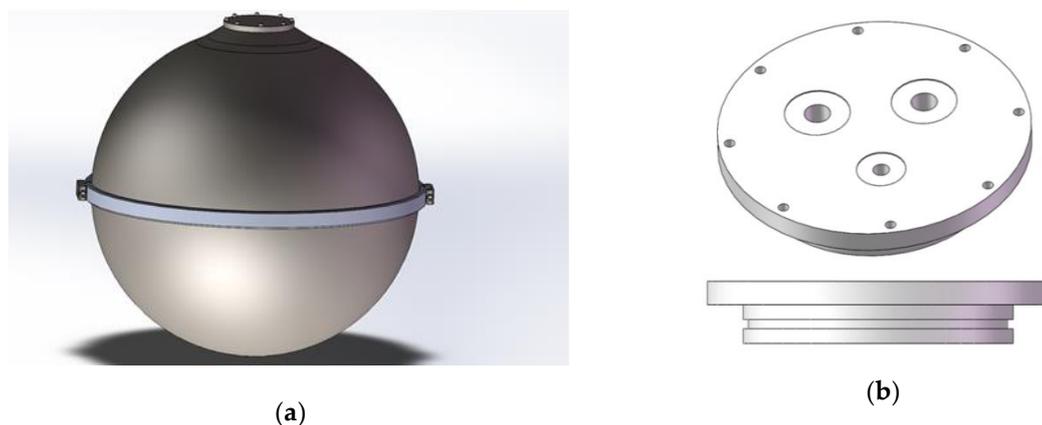
ultra-high strength maraging steel 18Ni(350) was used for first time for this purpose, as shown in Figure 1. The adjustable ballast tank is composed of upper and lower hemispheres, which are connected by a Huff clamp. An O-ring seals the hemispheres at the end. Fine-tuning makes the weight of the submersible maintain positive buoyancy or produce enough negative buoyancy for safely sitting at bottom. A flat cover is beneficial for installation of different cabin piercing parts. Sealing is carried out through a radial O-ring and is evenly locked with the sphere by screws. The selection of maraging steel for the current ballast tank is exactly based on the principle of strength enhancement for lower weight. This is also the first time that this material has been used in deep-sea pressure vessels. Some of the candidate materials for underwater pressure hulls, such as titanium and high strength steel, and their main properties can be found in literature [6–9]. The candidate material for pressure hulls using 18Ni grade maraging steels has been preliminarily investigated in terms of their application history, performance, and manufacturing capability by the authors [9]. The damage tolerance related performances of 18Ni grade maraging steels, including yield ratio (σ_y/σ_b) and fracture toughness, have been evaluated. There are basically four wrought commercial maraging steels of the 18 percent nickel family i.e., 18Ni (200), 18Ni (250), 18Ni (300), and 18Ni (350) with yield strength ranging from 1400 MPa to 2400 MPa [10]. In the development of ‘MIR’ submersibles in the 1980s [11], new techniques to produce high strength, high nickel-content steel 18Ni(250) for pressure hulls are applied for its two pressure spheres. Up to now, other grades of 18Ni series of maraging steels have no application experience in deep-sea pressure hulls.

Figure 1. Sketch of the adjustable ballast tank and its sealing cover: (a) front view of the adjustable ballast tank; (b) description of the sealing cover.

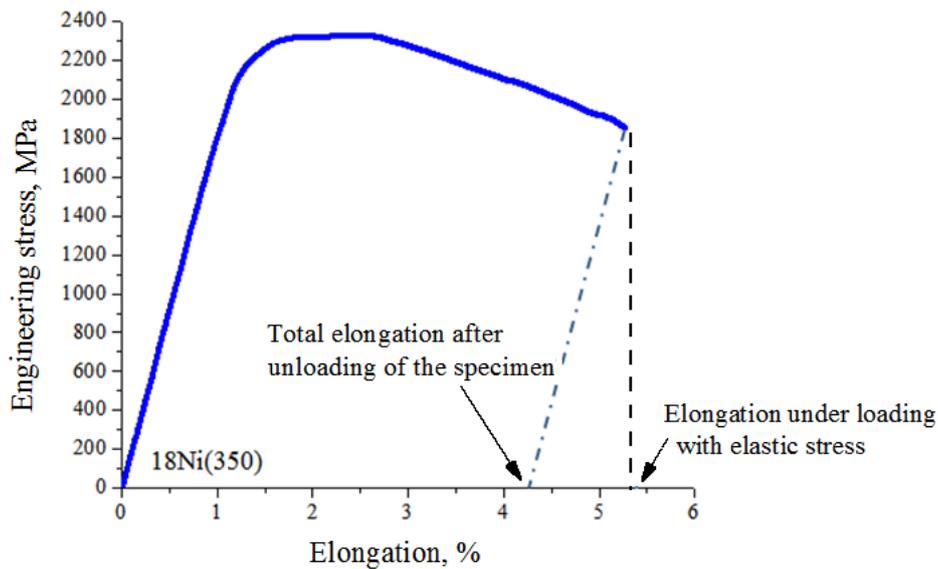
Figure 2. Stress–strain curve of 18Ni(350) (solution heat treatment: 820 °C for 1 h; aging treatment: 510 °C for 4 h).

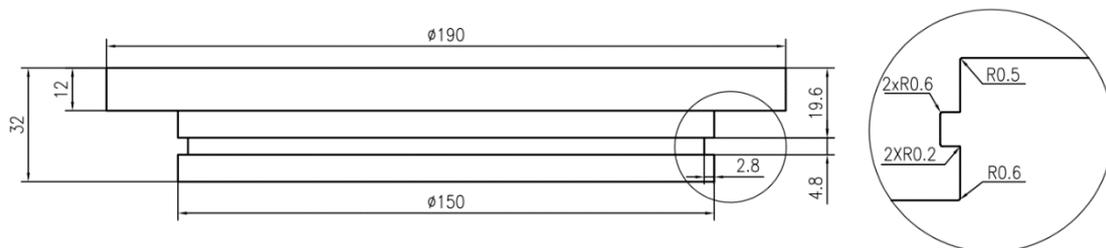
Figure 3. Dimension of the flat cover (unit: mm).

(3) From the design point of view, it is suggested to optimize the transition from right angle to chamfer at variable cross-sections, and to increase the thickness of the outer edge liner of the cover appropriately, which will reduce the possibility of damage. During processing, the surface finish of structural parts should be ensured, especially the root surface of the variable cross-section, so as to avoid surface processing defects.

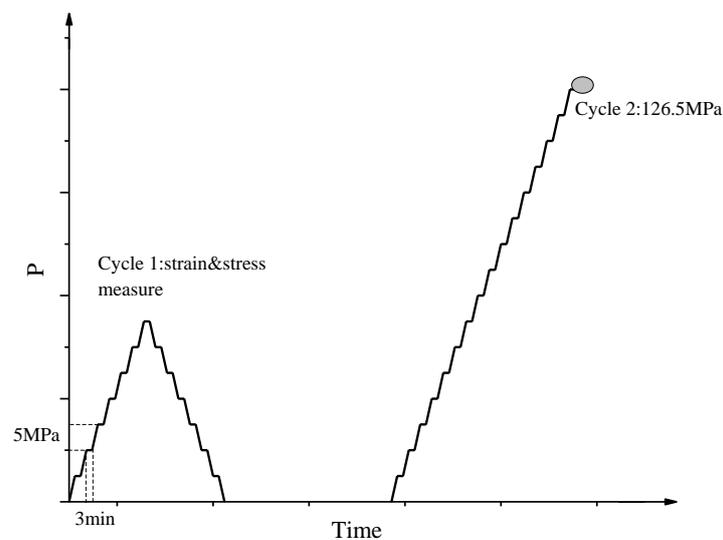
pressure in order to stop and examine it periodically. The scheduled loading scheme is shown in Figure 4. A shorter load cycle was done before formal test. The maximum pressure set for this cycle was 75 MPa. The ultimate goal of the pressure test was to check if the tank could endure the external pressure of 126.5 MPa (i.e., 115 MPa for the 11,000 m deep-sea environment times a safety factor of 1.1 for pressure testing). After test preparation, the tank with strain gauges pasted outside the shell in three typical positions was sent to the pressure chamber, then the first cycle for watertight and insulation tests combining with strain and stress measurements was conducted. The loading phase was carried out gradually with the step of pressure increase of 5 MPa and maintained for 3 min in the loading and unloading stage. It was presumed that when the first cycle was finished, the tank should be taken out from the pressure chamber for a further inspection. If there was no problem, the tank was sent to the chamber for a final test.

Figure 4. Loading scheme of pressure test.

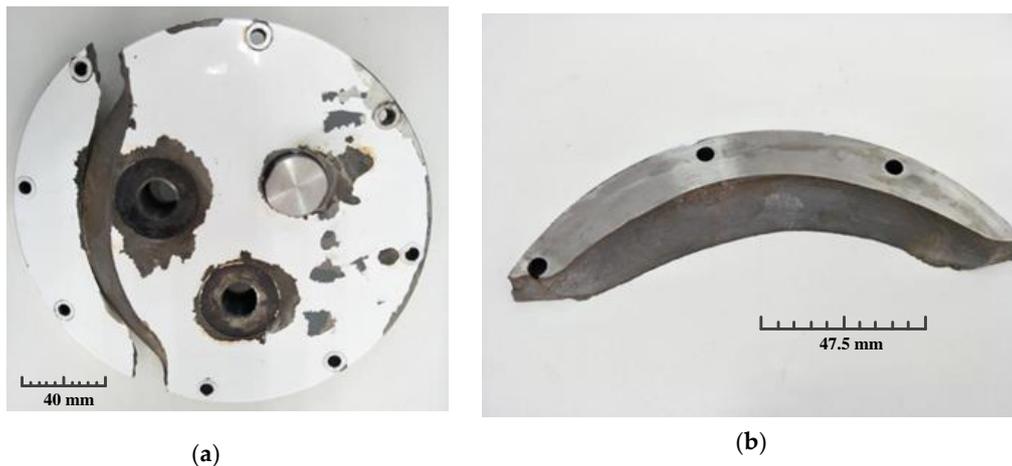
However, when the tank was taken from the chamber after the first load cycle, it was found that the flat cover is cracked as shown in Figure 5. Local fracture occurred at the top part of the flat cover. The upper surface and fracture surface of the flat cover are respectively shown in Figure 5a,b. Based on the macroscopic observation, it was found that the flat cover bore large stress from outside to inside, and stress concentration occurred at the right-angle transition root. The crack morphology presented intergranular cracking, which was a brittle fracture.

Figure 5. Photography of the cracked flat cover: (a) upper surface of the cover; (b) fracture surface in the outer edge of the cover.

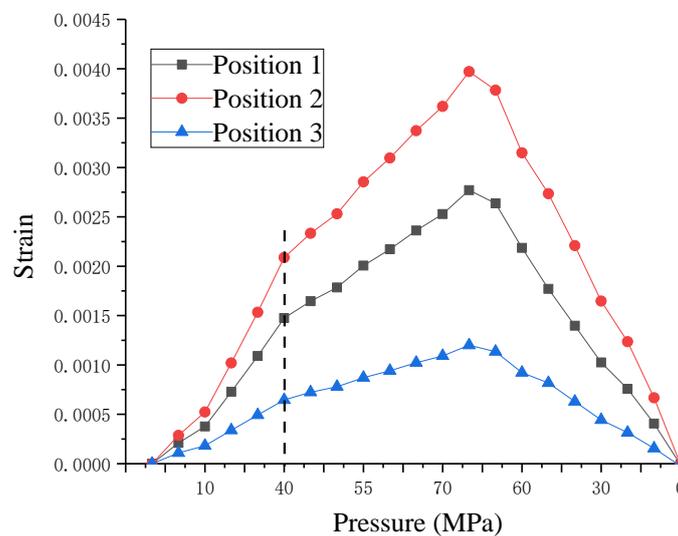
Fracture occurred before the maximum pressure reached 75 MPa; however, it is difficult to assess at what pressure level the failure starts. The strain–load curves in Figure 6 show some abnormal phenomenon. Position 1 is at the opening reinforcement part of the spherical hull; position 2 is above the equatorial flange of the spherical hull; position 3 is at the bottom of the spherical hull. At a pressure of 40 MPa, there is a relatively obvious change of strain rate in the curves for three recording positions. This indicates that under this loading condition, the whole stress state of the spherical shell changes. At this point, the obvious stress concentration may appear on the flat cover. Because the external load is distributed both on the outer surface of the spherical shell and the flat cover, the change of stress state of the flat cover will cause stress concentration on the shell. From the fracture surface position, the stress concentration may come from the existence of crack-like defects, such as inadequate chamfer and scratches when the sharp part was processed. Therefore, in the next section, defects and fracture analysis will be carried out by means of microscopic observation and finite element calculation.

Figure 6. Recorded strains in the three positions outside the shell with variations of pressure.

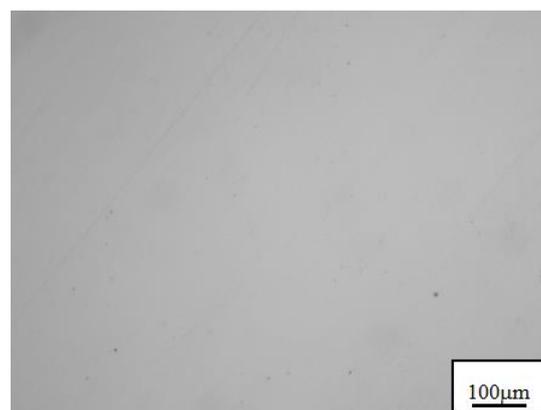
Non-metallic inclusions in flat cover samples were inspected [18]. The results of non-metallic inclusions rating and the inclusion morphology in the most important part of the flat cover showed that there were fewer kinds of non-metallic inclusions. The inclusions specified in the standards include sulfide inclusions, alumina inclusions, silicate inclusions, and spherical oxides. The original state of the material meets the design requirements. Figure 7 shows the inclusion morphology of the sample.

Figure 7. Inclusion morphology of the sample.

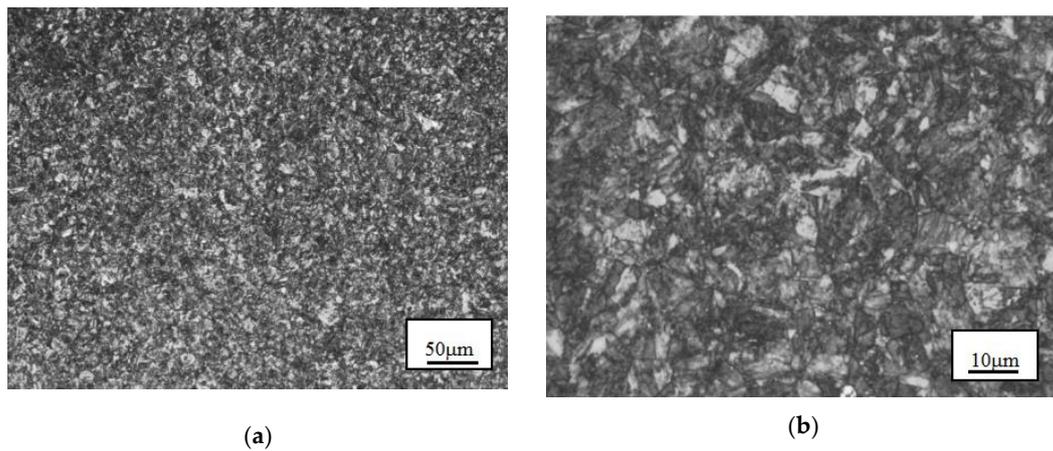
Metallographic specimens were taken from the sealing cover. After mechanical grinding and polishing along the longitudinal section, the specimens were etched by an alcohol solution of FeCl_3 + hydrochloric acid at room temperature. The structure was observed under a ZEISS Axiovert 200MAT optical microscope (OM). The grading method of the grain size of samples was carried out according to grain size rating determination standard [19]. Figure 8 shows the structure of the flat cover material which is martensite.

Figure 8. Metallographic structure of the cover sample: (a) low magnification; (b) high magnification.

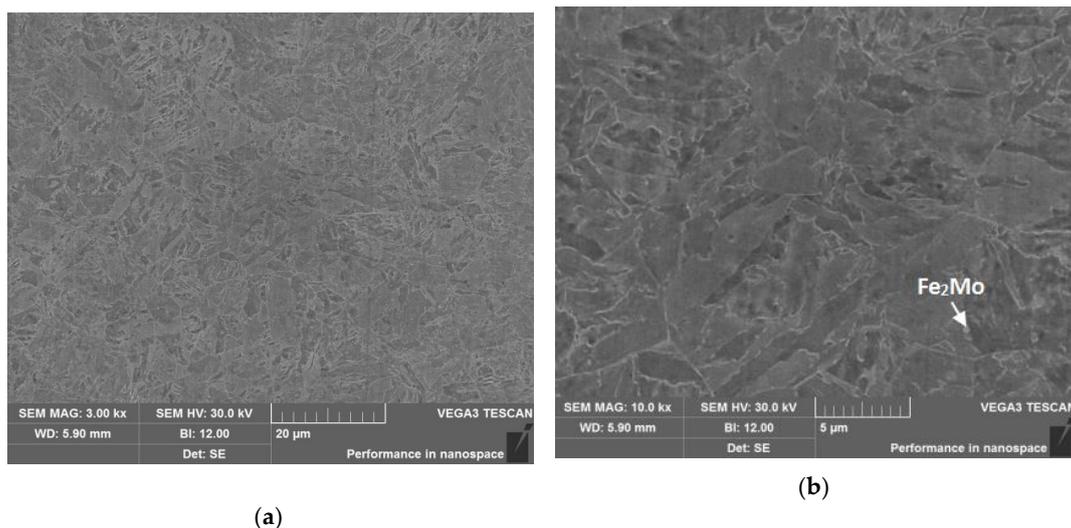
Microstructure and morphology of the flat cover material were observed and analyzed by TESCAN VEGA3 XMU scanning electron microscopy (SEM). Figure 9 shows the SEM low and high magnification microstructures of the specimens. The martensite structure of the material was uniform, and a small amount of precipitated phase particles could be seen at the grain boundary.

Figure 9. SEM microstructure of the cover sample: (a) low magnification; (b) high magnification.

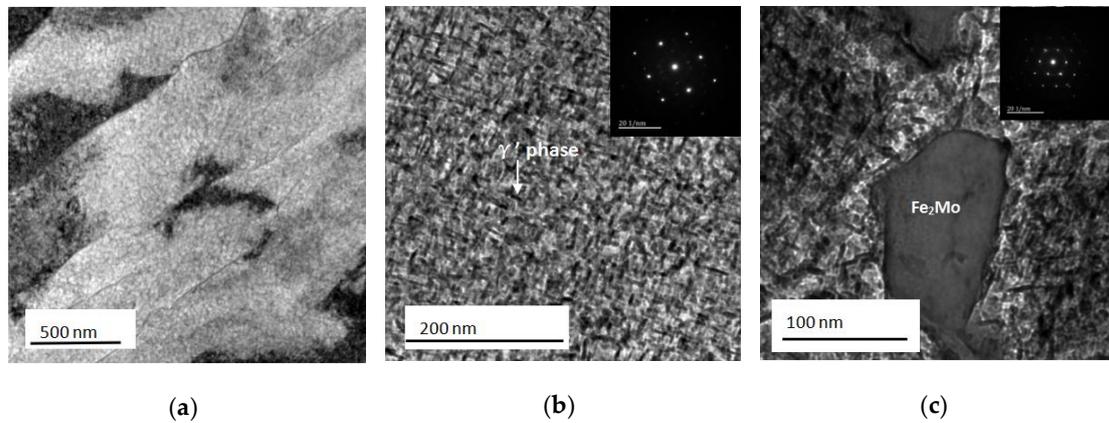
Further observation was conducted under JEOL JSM-2100 transmission electron microscopy (TEM). Figure 10 shows the TEM morphology of the specimen. It can be seen that the width of martensite lath is about 0.2–0.8 μm , and a large number of precipitations were uniformly distributed in martensite matrix with high density. Electron diffraction analysis results show that a large number of rod-like particles are $\text{Ni}_3(\text{Al}, \text{Ti})$ -type γ' precipitates, as shown in Figure 10b,c. In addition, large spherical granules in Figure 10c are Fe_2Mo precipitates. Some studies [20] have shown that the precipitations of Fe_2Mo occur with the increase of aging time and aging temperature.

Figure 10. TEM microstructure of sealed top cover sample: (a) low magnification; (b) high magnification; (c) precipitated phase Fe₂Mo morphology.

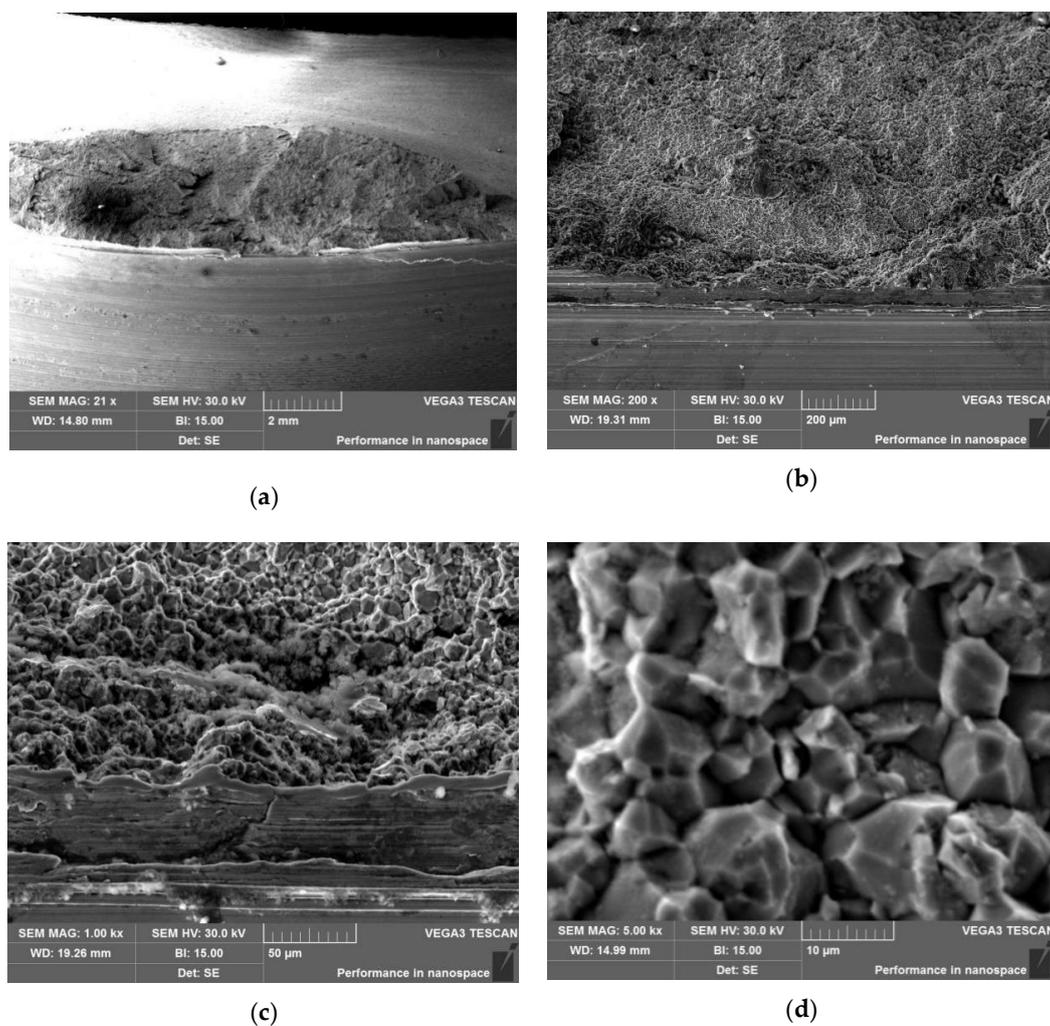
The fracture surface morphology was observed and analyzed by scanning electron microscopy after ultrasonic cleaning of the sample. Figure 11 shows the fracture morphology in the vicinity of the fracture source. It can be seen at the low magnification (Figure 11a,b) that the crack source is located at the root of the transition between the upper cover and the edge liner. It can be seen at high magnification (Figure 11c,d) that the crack source has an intergranular morphology and shows brittle

fracture. During the external pressure test, the flat cover was subjected to a large stress from the outside to the inside, and a large stress concentration was generated at the right-angle transition root in which a crack source was easily generated and resulted in fracture.

Figure 11. SEM morphology of crack source at the fracture surface of the flat cover: (a) low magnification morphology; (b) low magnification morphology at the crack source; (c) high magnification morphology at the crack source; (d) partially magnified morphology at the crack source.

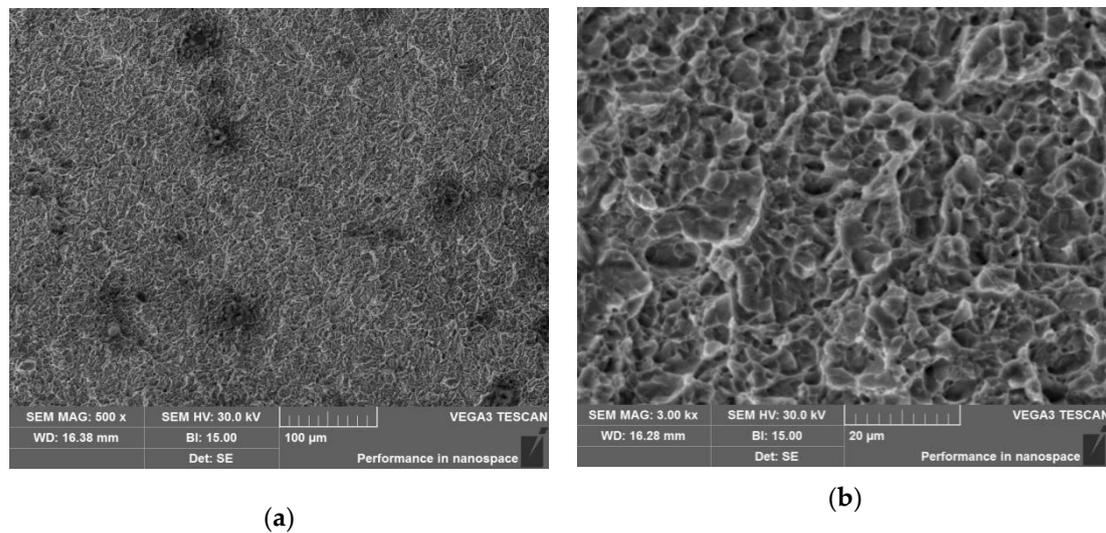
Figure 12 shows the SEM topography of the tearing area of the flat cover. The tearing surface has a dimple morphology, which shows ductile fracture characteristics.

Figure 12. Topography of cracking area of the flat cover: (a) low magnification morphology; (b) high magnification morphology.

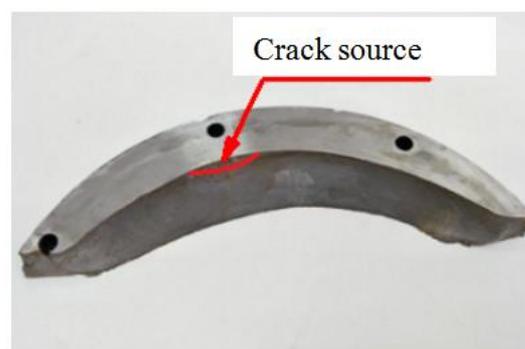
Based on the observations in Section 3, it can be concluded that the final fracture of the flat cover is due to the large stress concentration generated at the right-angle transition root of the thicker central part and the thinner edge. A crack initiated from this point is shown in Figure 13. It was initiated from improper manufacture and has the length of 3 mm and the depth of 1.5 mm. Final failure easily occurs because the material has low impact and toughness properties. A presumed semi-elliptical surface crack is considered in this section to analyze the failure mode of the flat cover during loading process. The fracture criterion is that the stress intensity factor at the crack tip reaches the plane strain fracture toughness of the material.

Figure 13. Crack position at the right-angle transition root.

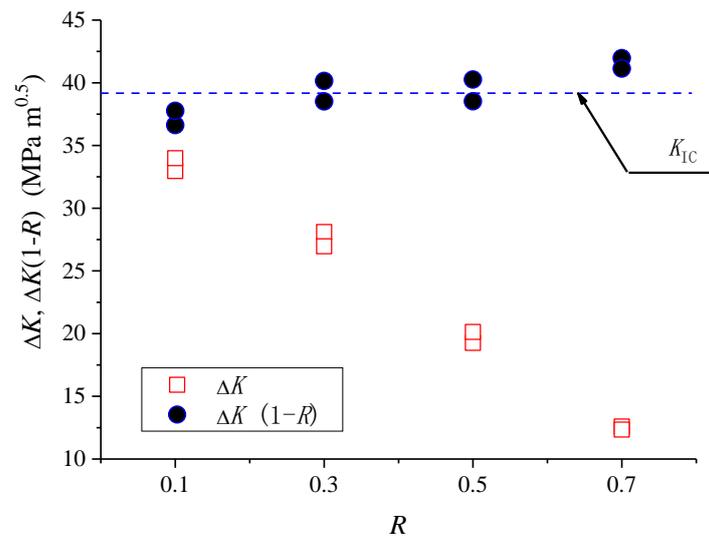
The crack growth rate curves ($da/dN \sim \Delta K$ curves) at four load ratios of 0.1, 0.3, 0.5, and 0.7 were experimentally obtained in [9]. At each load ratio, two groups of tests were carried out. When the crack growth curve began to transit from stable growth stage to unstable growth stage, the requirement of $K_{max} = K_{IC}$ should be satisfied. Then a value of K_{IC} can be calculated based on each crack growth rate curve. The average of these values can be taken as the final value of K_{IC} as shown in Figure 14. The data of $\Delta K(1 - R)$ are within a relatively stable range, and the fracture toughness of 18Ni (350) can approach $37 \sim 40 \text{ MPa}\cdot\text{m}^{1/2}$, which agrees well with the data range in literature [12,13] and can be applied for fracture analysis. The dotted line shows the average level of the calculated data of K_{IC} , which was about $38 \text{ MPa}\cdot\text{m}^{1/2}$. It must be emphasized that the toughness of this material is greatly reduced compared to 18Ni (250), which is traditionally used in the pressure hulls of deep-sea manned submersible [9].

Figure 14. ΔK and $\Delta K(1 - R)$ values of 18Ni(350) determined by unstable crack growth properties.

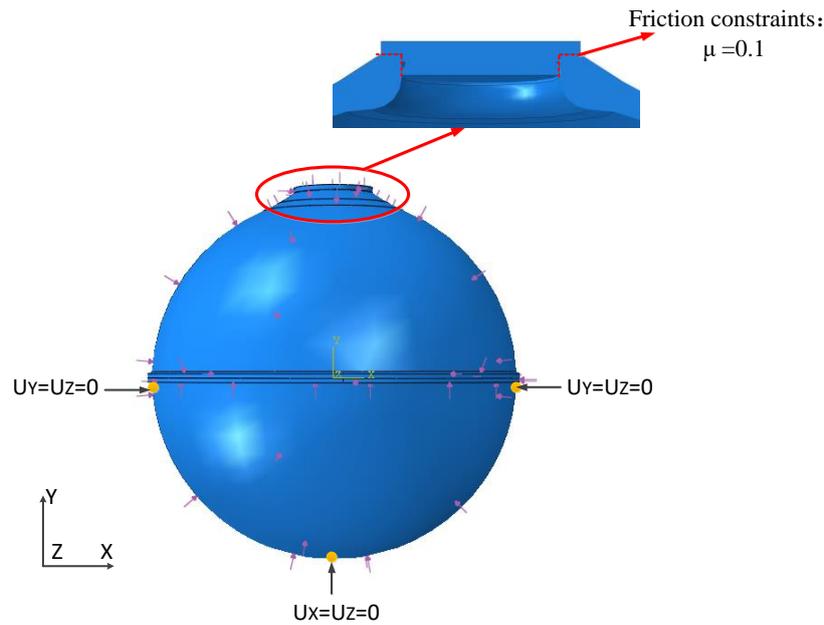
SolidWorks software was used for three-dimensional modeling, and ABAQUS software is used for finite element analysis after modeling. C3D8R element is used for meshing. Local mesh encryption was made in the vicinity of key chamfers of the flat cover and contacts the part between the spherical model and the flat cover, with mesh size of 1 mm, compared to the mesh size of 20 mm in other parts. The small chamfer was not included in the calculation model, because when the crack was inserted into the model, the stress concentration at the crack tip would be the dominant factor, and the stress concentration at the small chamfer was no longer important. The whole structure model was used in finite element calculation to obtain the critical stress area and the surface crack was inserted into the local model after stress analysis. Figure 15 gives the whole model for stress analysis. The ballast tank used in the deep-sea submersible was subjected to uniformly distributed hydrostatic pressure, which was applied both in the spherical shell and the flat cover. In order to eliminate the overall rigid body displacement without hindering the relative deformation, the boundary conditions were set symmetrically with six displacement components constrained by the three-point support method recommended in [22]. The contact surface between the flat cover and the sphere was set as the friction contact with the friction coefficient of 0.1.

Figure 15. Finite element model for stress analysis.

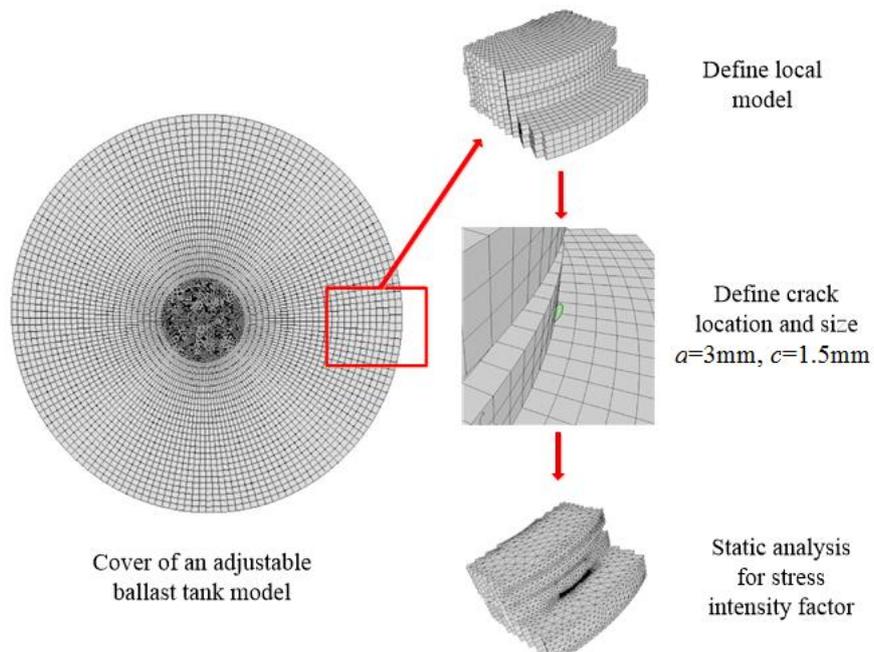
When a crack is simulated, the crack will be inserted into a sub-model. The sub-model was taken out separately for the study. The calculation can be conducted by using the connection between the global model and the sub-model, thus greatly reducing unnecessary computation and time costs. According to the results of previous failure observations, the defective part of the cover is treated as a sub-model and the crack with the length of 3 mm and the depth of 1.5 mm is inserted into the model. After static analysis, the stress intensity factor of crack front can be obtained. The position relationship between the sub-model and the global model is shown in Figure 16.

Figure 16. The position relationship between the sub-model and the global model.

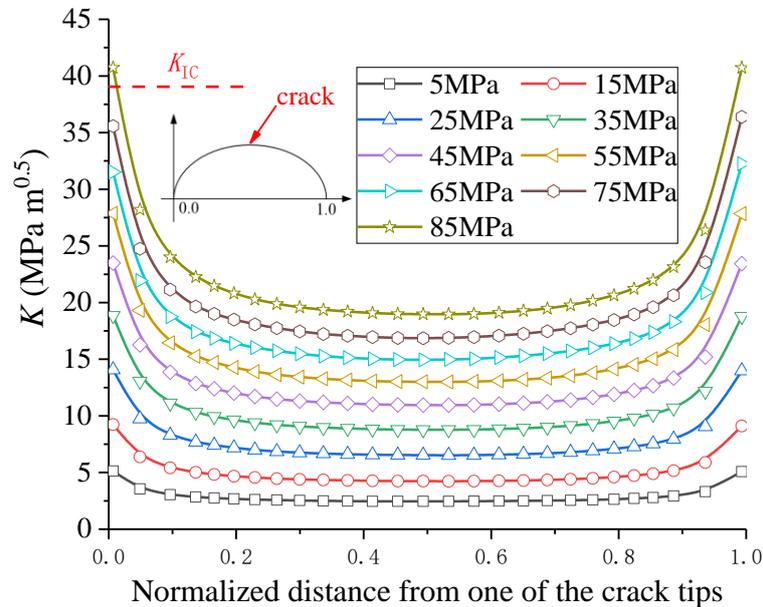
When the flat cover is subjected to different external pressures from 5 to 85 MPa, the stress intensity factors of the crack can be obtained. Figure 17 depicts the stress intensity factors along the crack front with increasing the external pressure. Figure 18 shows the changing of the stress intensity factors at

Figure 17. Stress intensity factor along crack front with increasing external pressure.

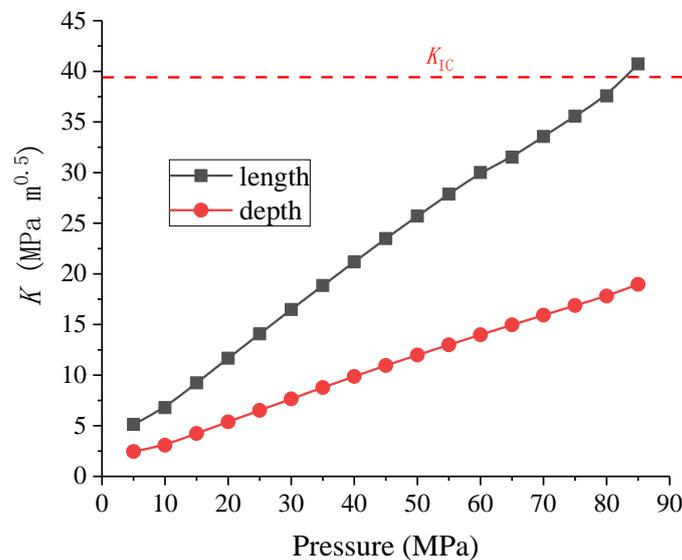
the surface points and the deepest point with the external pressure. The stress intensity factor in the length direction is larger than that in the depth direction. The maximum value of the stress intensity factor occurs at the surface points. When the external load increases to about 75–85 MPa, the stress intensity factor at the crack tip reaches 35–42 MPa·m^{1/2}, i.e., approximating to the value of fracture toughness, 38 MPa·m^{1/2}, shown in Figure 14, which is the ultimate cause of the damage.

Figure 18. Stress intensity factor at the surface points and the deepest point.
